HYRUM PROJECT - UTAH

PROPOSED
REHABILITATION
AND
BETTERMENT
PROGRAM
DRAFT

FEBRUARY 1989

BUREAU OF RECLAMATION
C. Dale Duvall, Commissioner

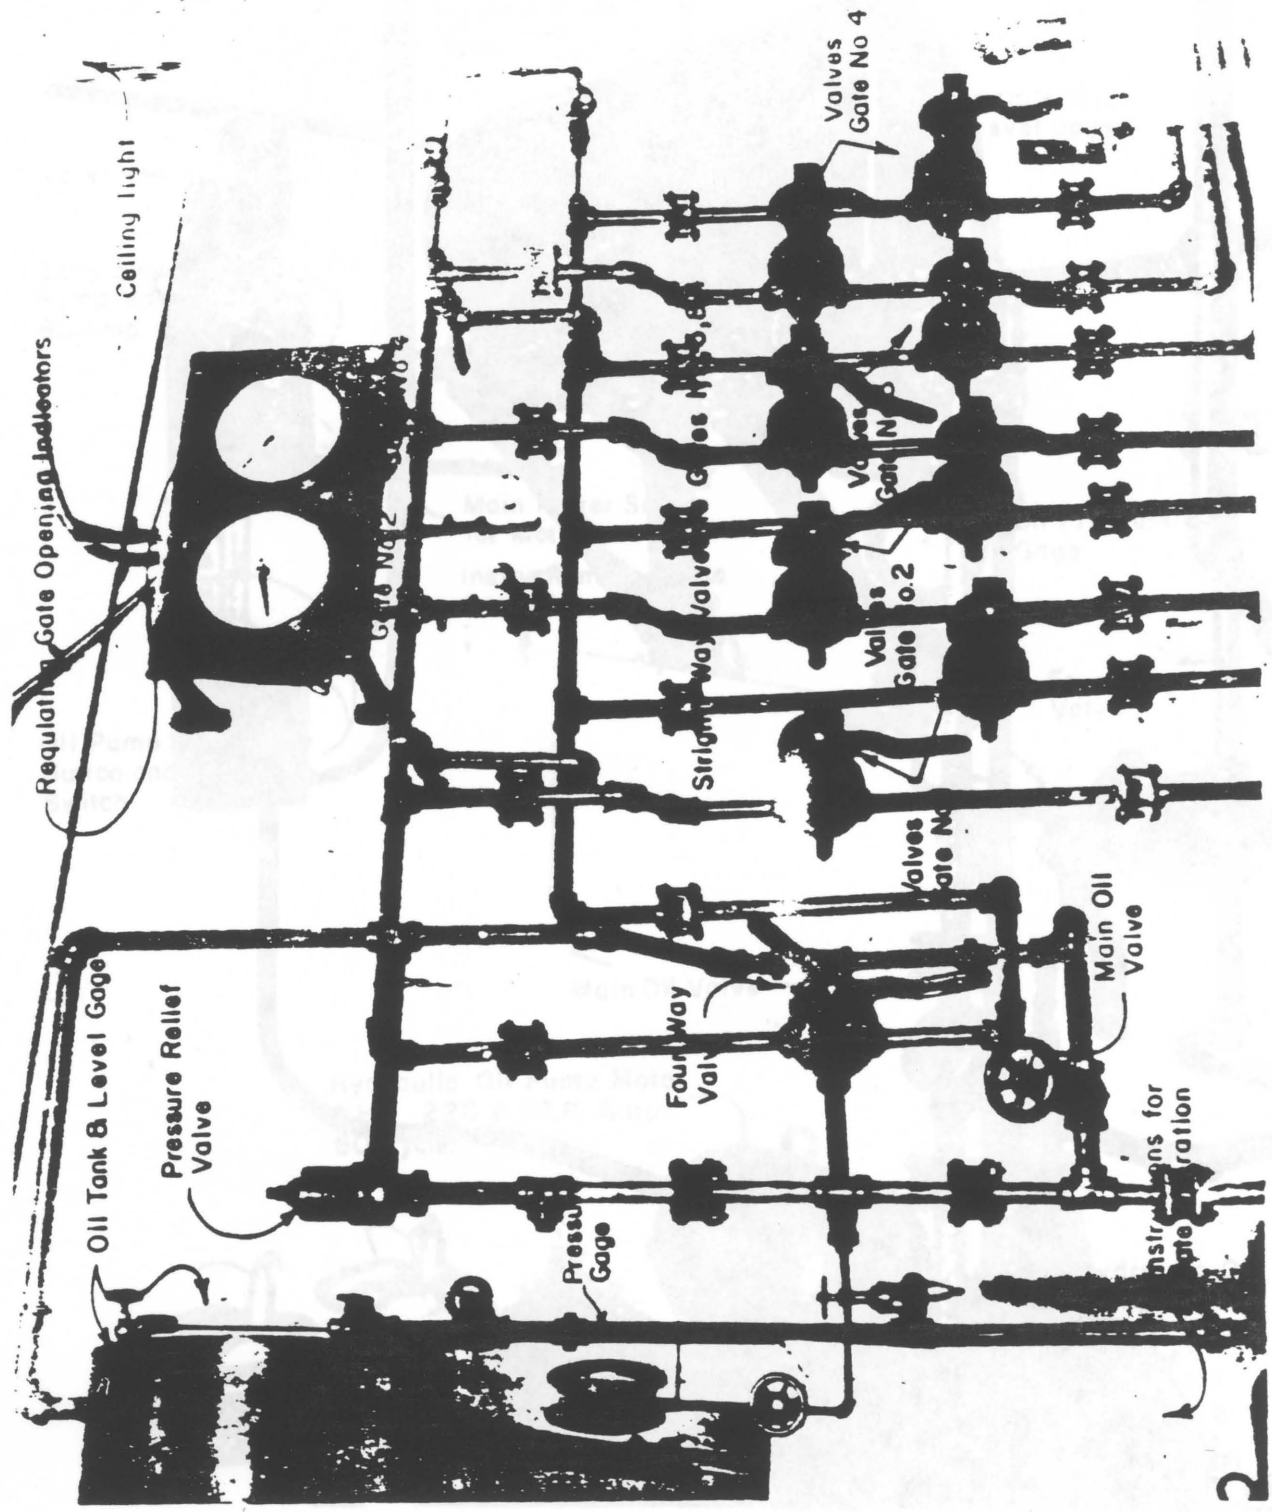
Figure II-3

3. Hydraulic control system--At present, internal leakage past the "straightway (2-way) valves," which direct hydraulic oil to the hoist

for the control gates to be operated, results in the movement of other gate leaves. This unintended movement breaks safety studs on the semiautomatic gate hangers for the high-pressure emergency gates. As a result, the semiautomatic gate hangers are not being used, which allows the emergency gate leaves to drift into the fluid-way of the conduit outlets. Also the electrical system in the gate house does not meet current electrical codes and should be replaced to reduce the electrical hazards at the facility. Due to these problems and the fact that the hydraulic control and electrical systems are over 50 years old and in need of modernization, it has been recommended by RO&M (87-1-B), to replace the hydraulic control and electrical systems to the control gates. The continued degradation of the hydraulic control facilities and electrical system at Hyrum Dam, will seriously effect the future safety and integrity of the dam. Figures II-3 and II-4 show the hydraulic system controls and the hydraulic power unit respectively.

View of the Hydraulic Control Valves
at Hyrum Dam

3. Install new hydraulic control system--The proposed program would include installing new control valves, installing a new hydraulic pump, installing an oil filter, repairing any hydraulic system leaks. Also, the electrical system would be removed and replaced with new wiring, electrical outlets, switches, and control panels. The existing hydraulic lines and electrical conduit would be refurbished and reused.

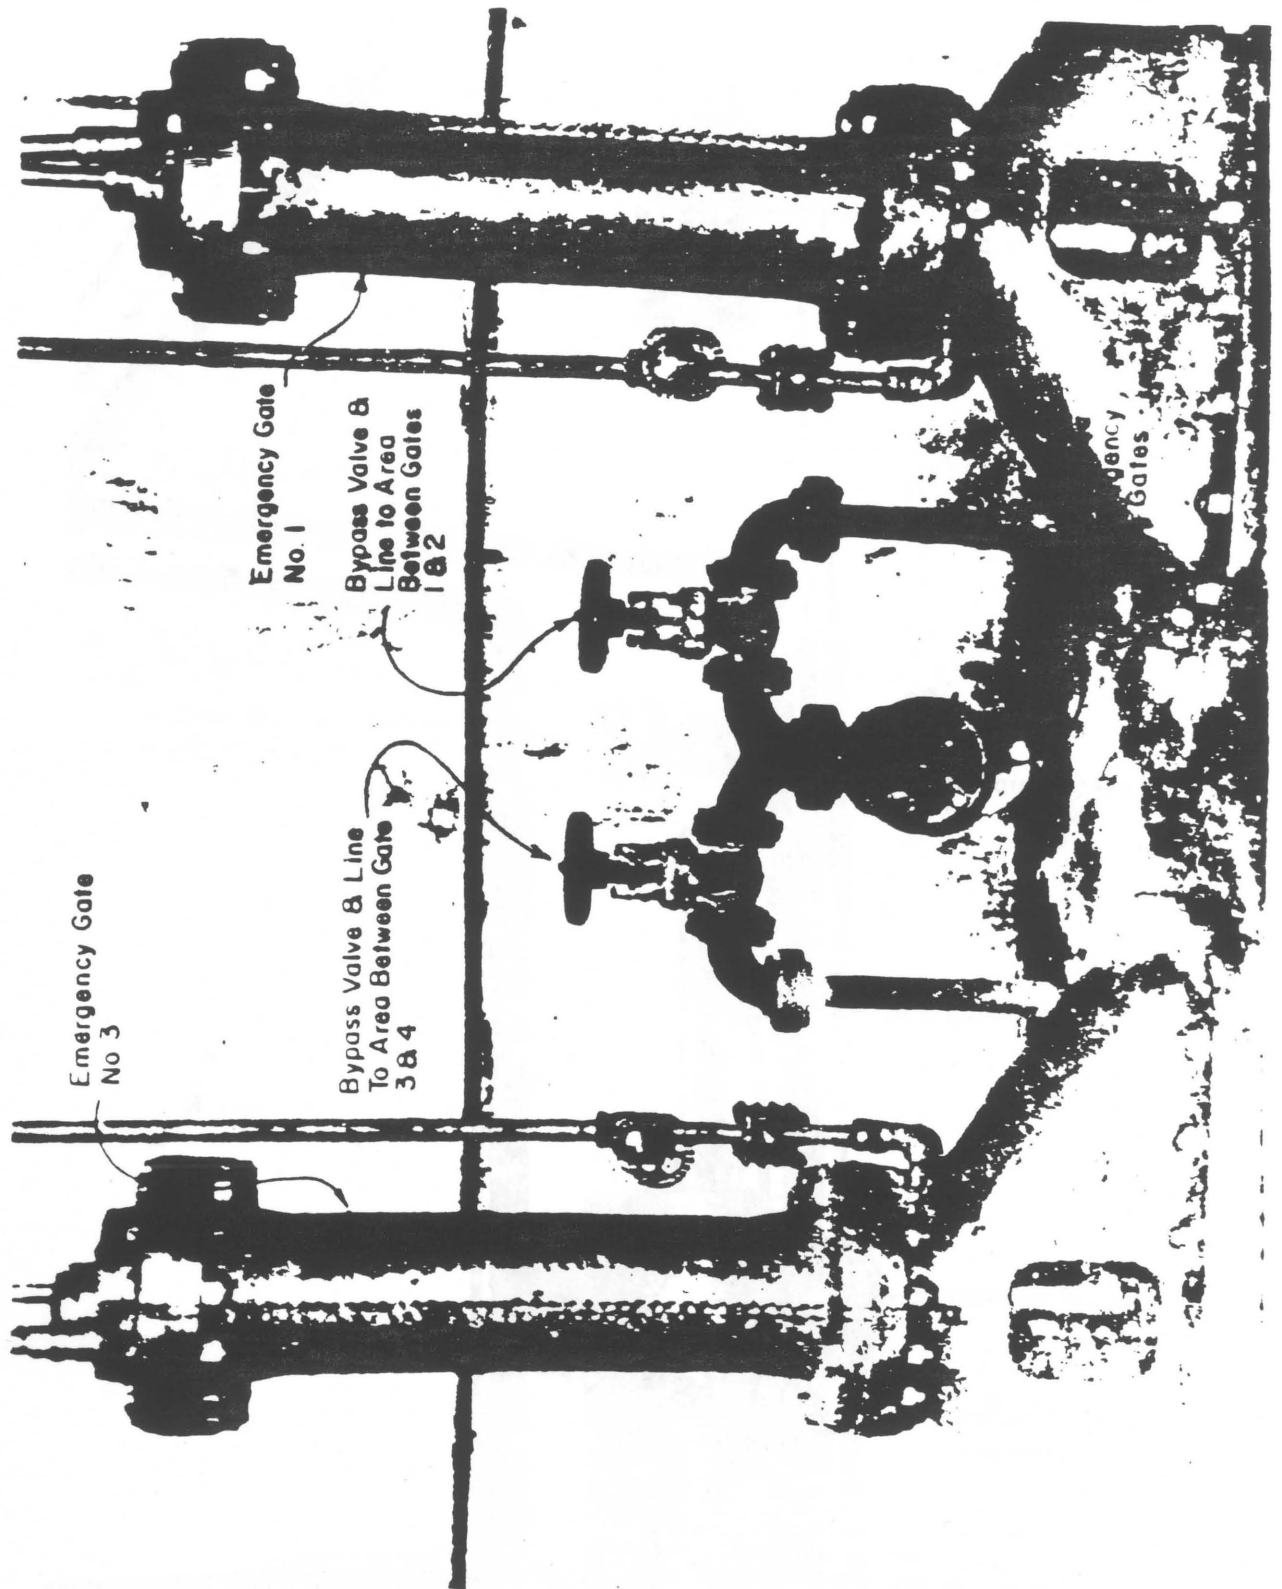
Figure II-5

4. Outlet control gates--An inspection of the control gates in April 1988, revealed that the seals and gate leaves are in need of repair or replacement. Additionally since the gates are over 50 years old, many minor items on the gates are in need of repair. There is one outstanding RO&M recommendation (81-2-A), to replace the safety studs on the semiautomatic gate-hangers on the emergency gates. Continued deterioration of the control gates will result in their failure. Figures II-5 and II-6 show the emergency gates and the semi-automatic gate hangers respectively.

View of Emergency Gates at Hyrum Dam

4. Refurbish outlet control gates--The proposed program for rebuilding the control gates would include cleaning and repainting the valves; fixing packing glands, hangers, and valves leading to the hydraulic system; and replacing the gate seals and the worn or damaged gate leaves and the safety studs on the semi-automatic gate hangers.

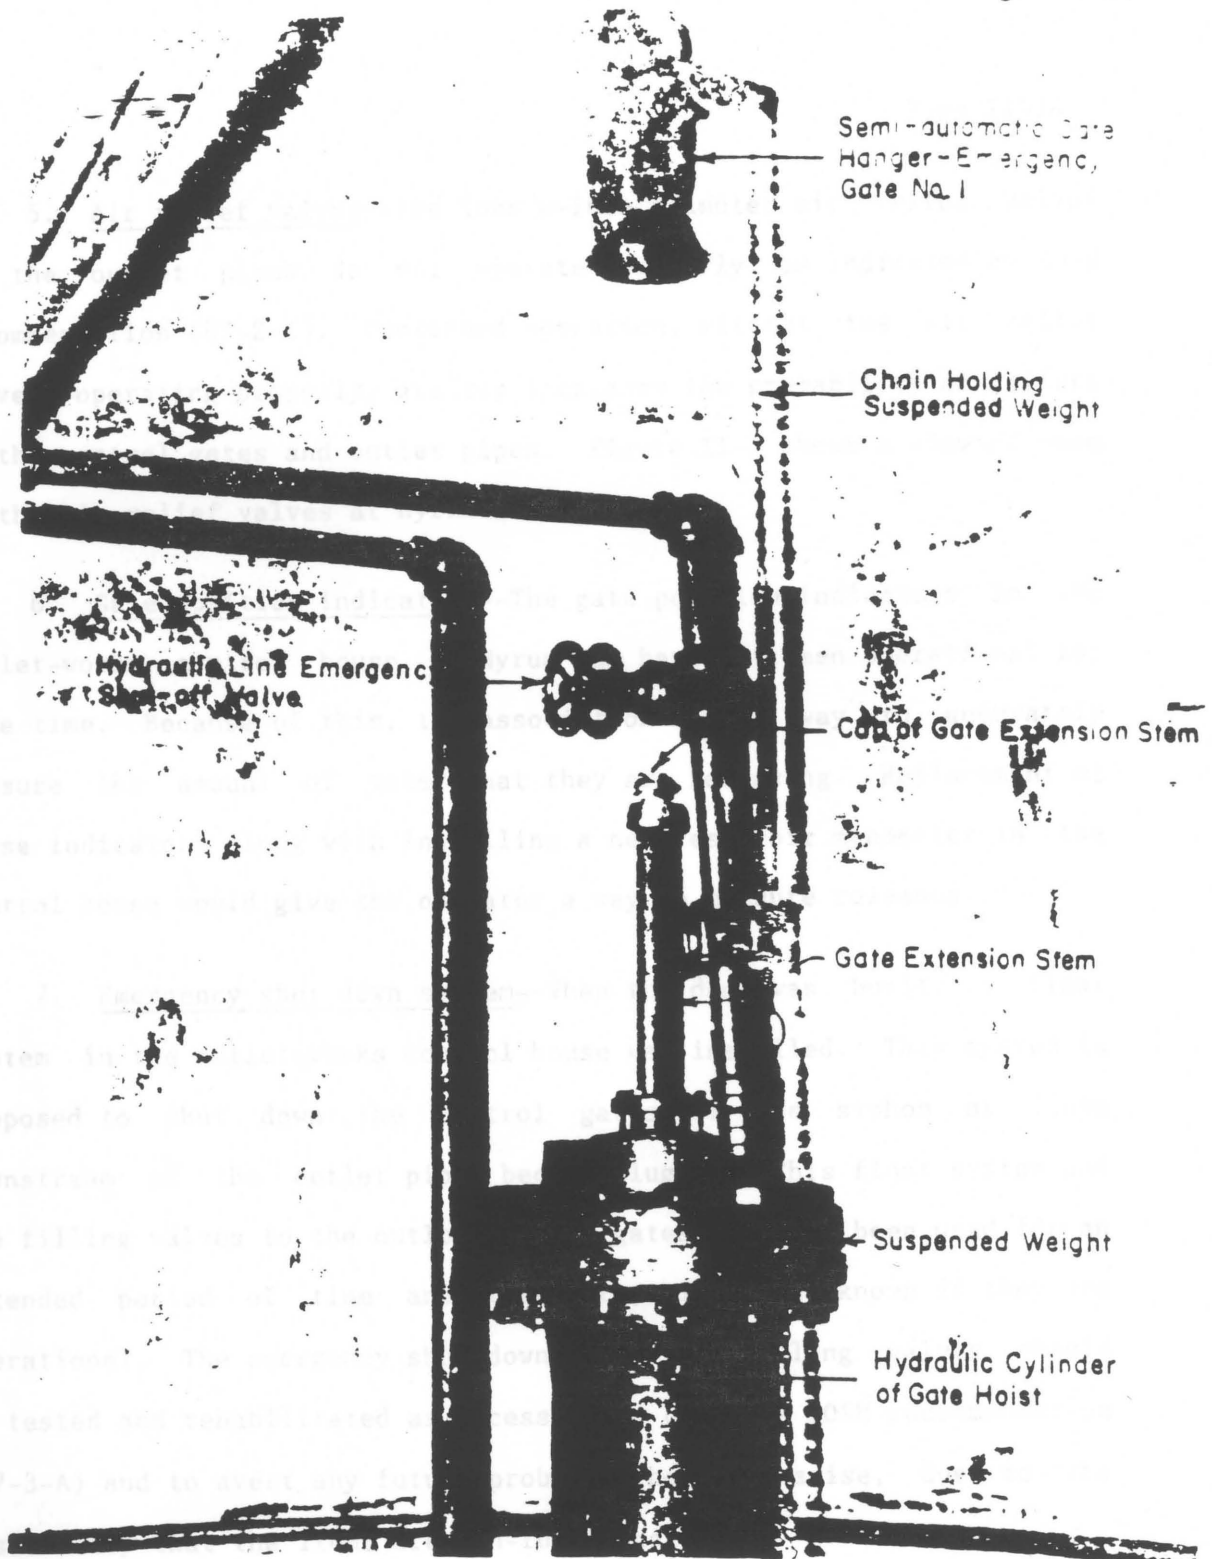
Figure II-6

View of Semi-automatic Gate Hanger at Hyrum Dam

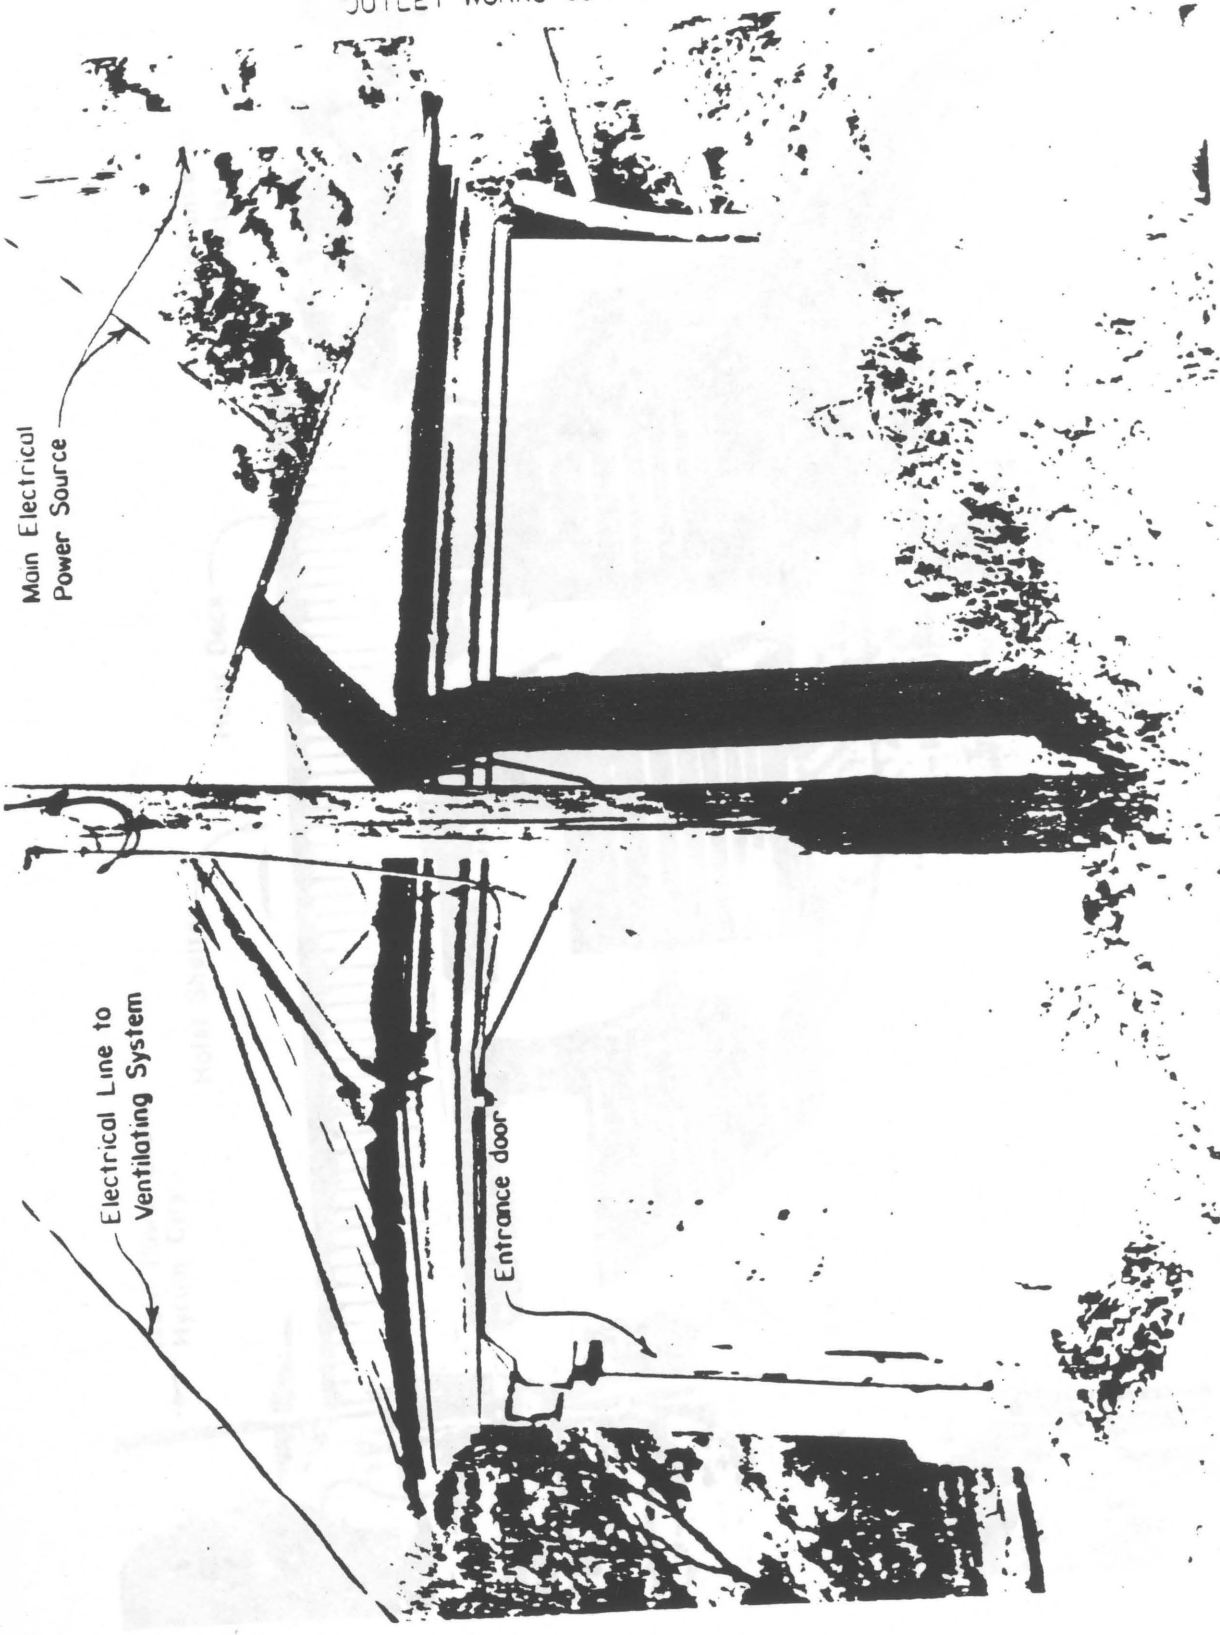
Figure II-9
View of Control House, Looking West at Hyrum Dam

8. Miscellaneous repair work--The door and roof on the gate house are in bad repair and in need of replacement to protect the facility. Additionally, there are a number a places in which the metal work in the outlet works facility are starting to rust, such as on the spiral staircase from the gate house to the outlet works tunnel; on the catwalk in the access tunnel; on the electrical conduit; and on the hydraulic lines from the controls to the control gates. Figure II-9 shows a view of the control house looking West.

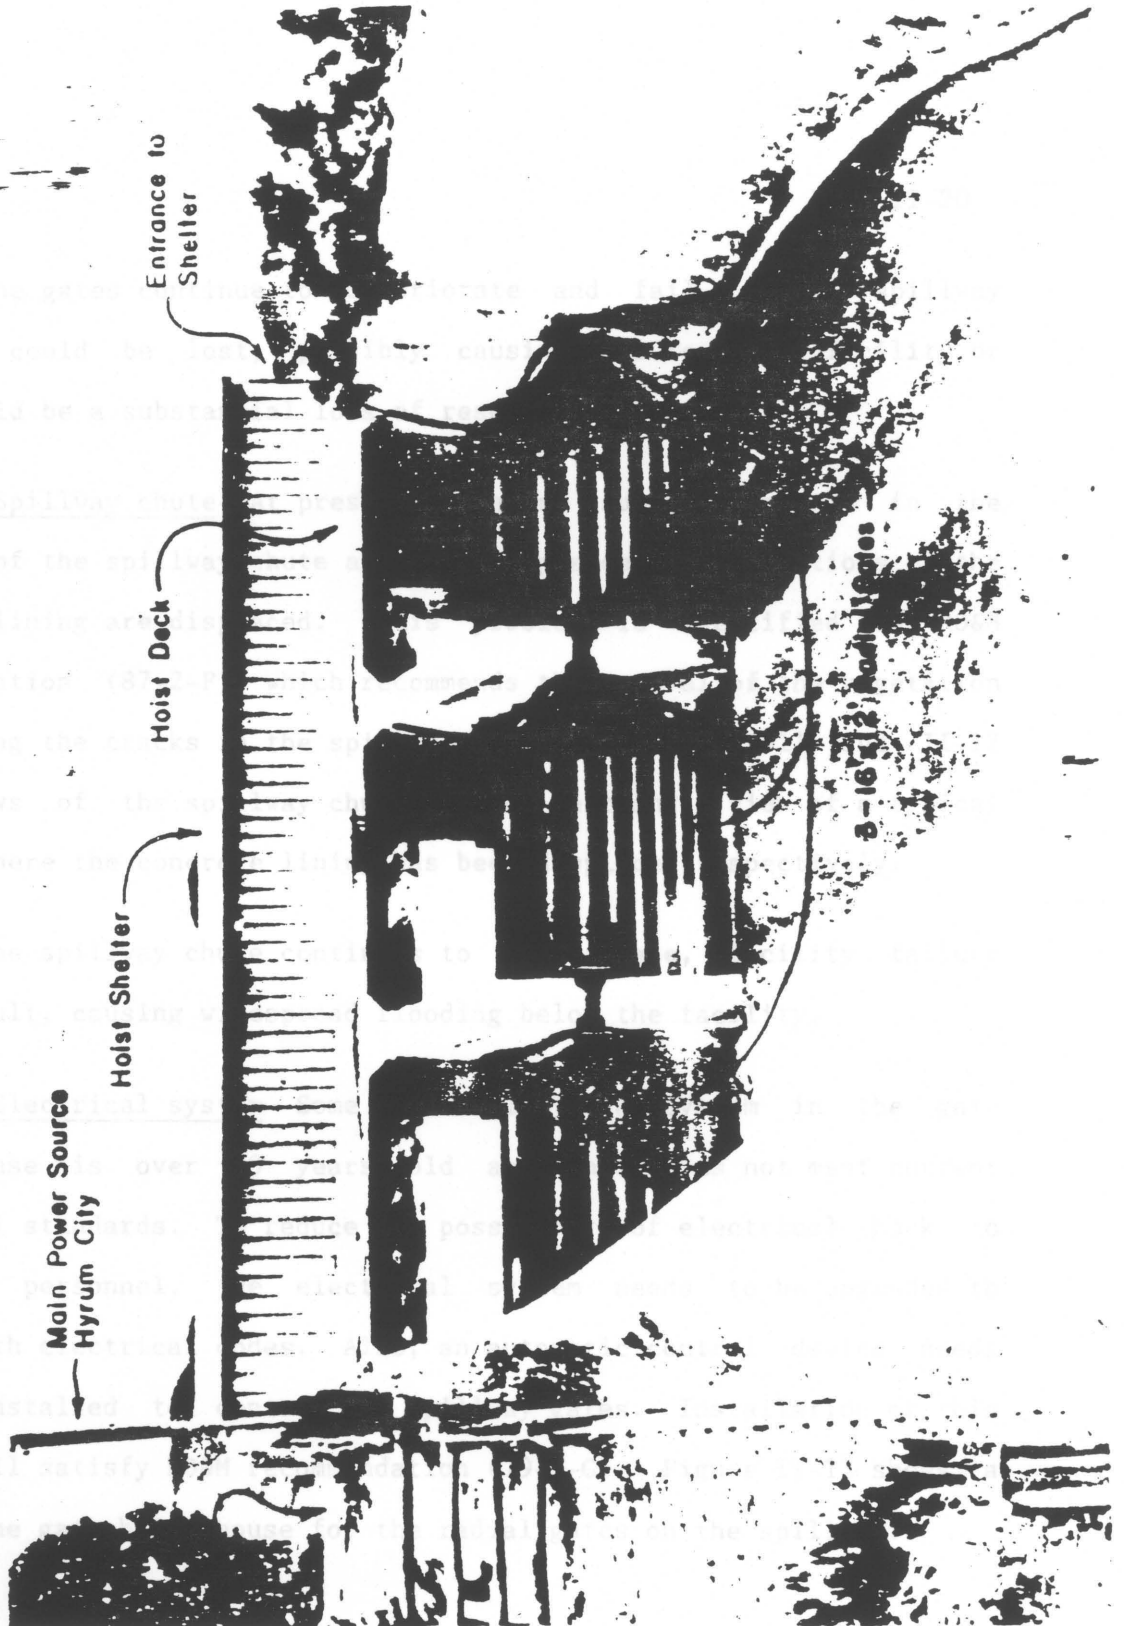
1. Radial gates--The radial gates at Hyrum dam are starting to rust in places and are leaking around the seals. Additionally, RO&M recommendation (79-2-D), to replace the 0.75-inch diameter wire rope that is used to hoist the radial gates remains outstanding. Figure II-10 shows a view of the three radial gates that control flow into the spillway.

View of Spillway Radial Gates at Hyrum Dam

If the gates continue to deteriorate and fail, either spillway capacity could be lost, possibly causing failure of the facility or there would be a substantial loss of reservoir capacity.

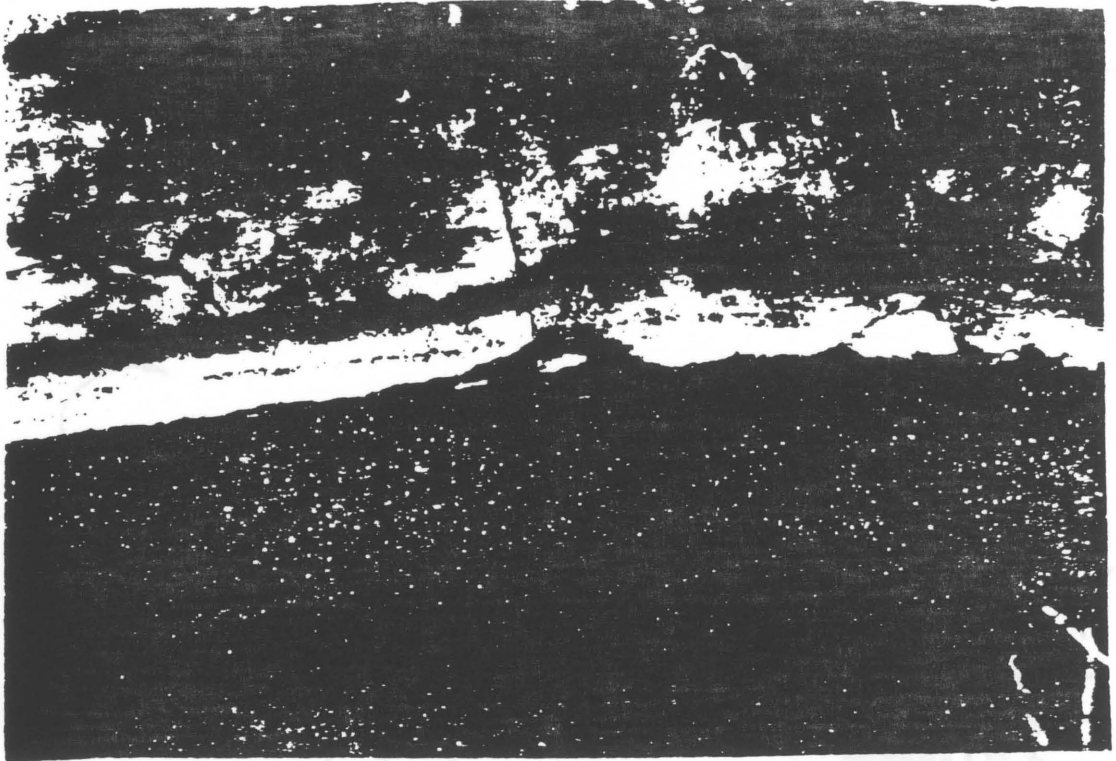
Figure II-11
View of Displaced Concrete Lining
in Spillway Chute

2. Spillway chute--At present there are numerous cracks in the concrete of the spillway chute and in some places, large portions of the concrete lining are displaced. This problem is identified in RO&M recommendation (87-2-F), which recommends the removal of the vegetation and sealing the cracks in the spillway chute. Figures II-11 and II-12 show views of the spillway chute looking west and a view of a typical section where the concrete lining has been displaced respectively.

If the spillway chute continues to deteriorate, facility failure could result, causing widespread flooding below the facility.

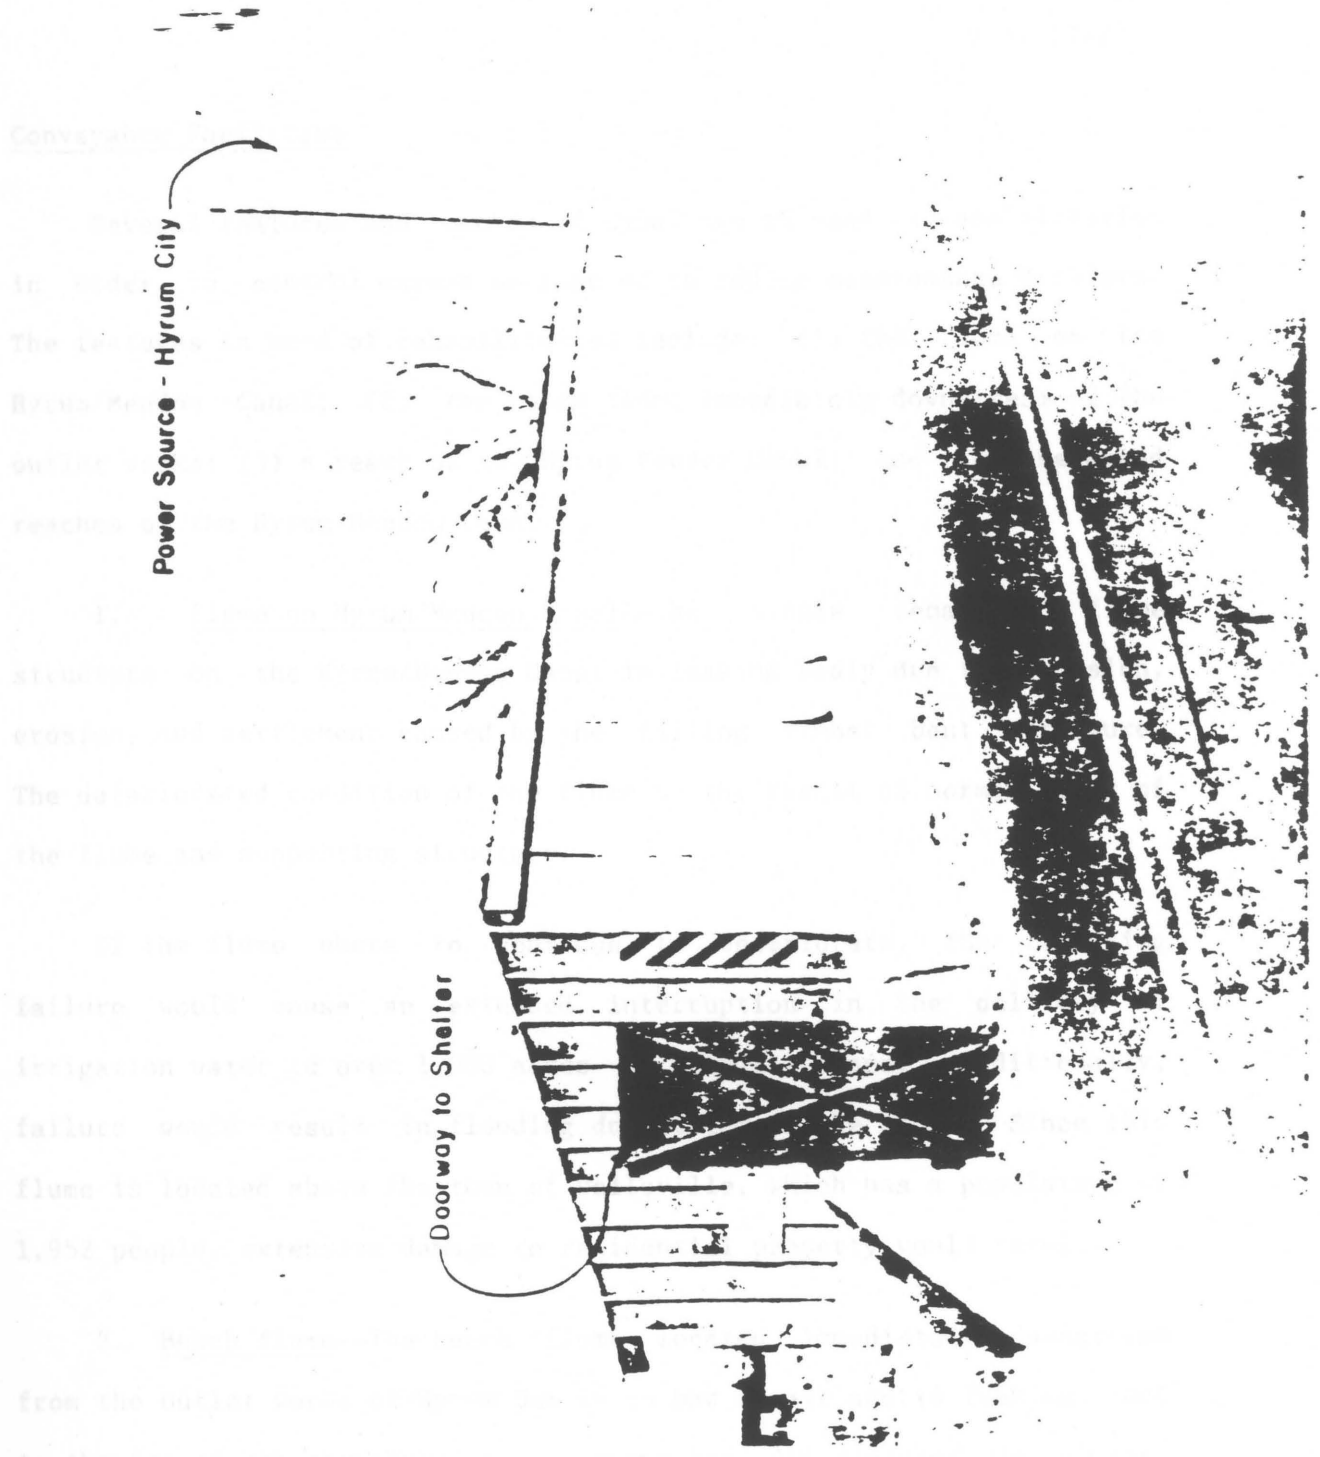
3. Electrical system--Some of the electrical system in the gate hoist house is over 50 years old and thus, does not meet current electrical standards. To reduce the possibility of electrical shock to operating personnel, the electrical system needs to be upgraded to comply with electrical codes. Also, an automatic control device needs to be installed to control the spillway gates. Installation of this device will satisfy RO&M recommendation (79-1-G). Figure II-13 shows a view of the gate hoist house for the radial gates on the spillway.

View of Gate Hoist House for the Gates on the Spillway at Hyrum Dam

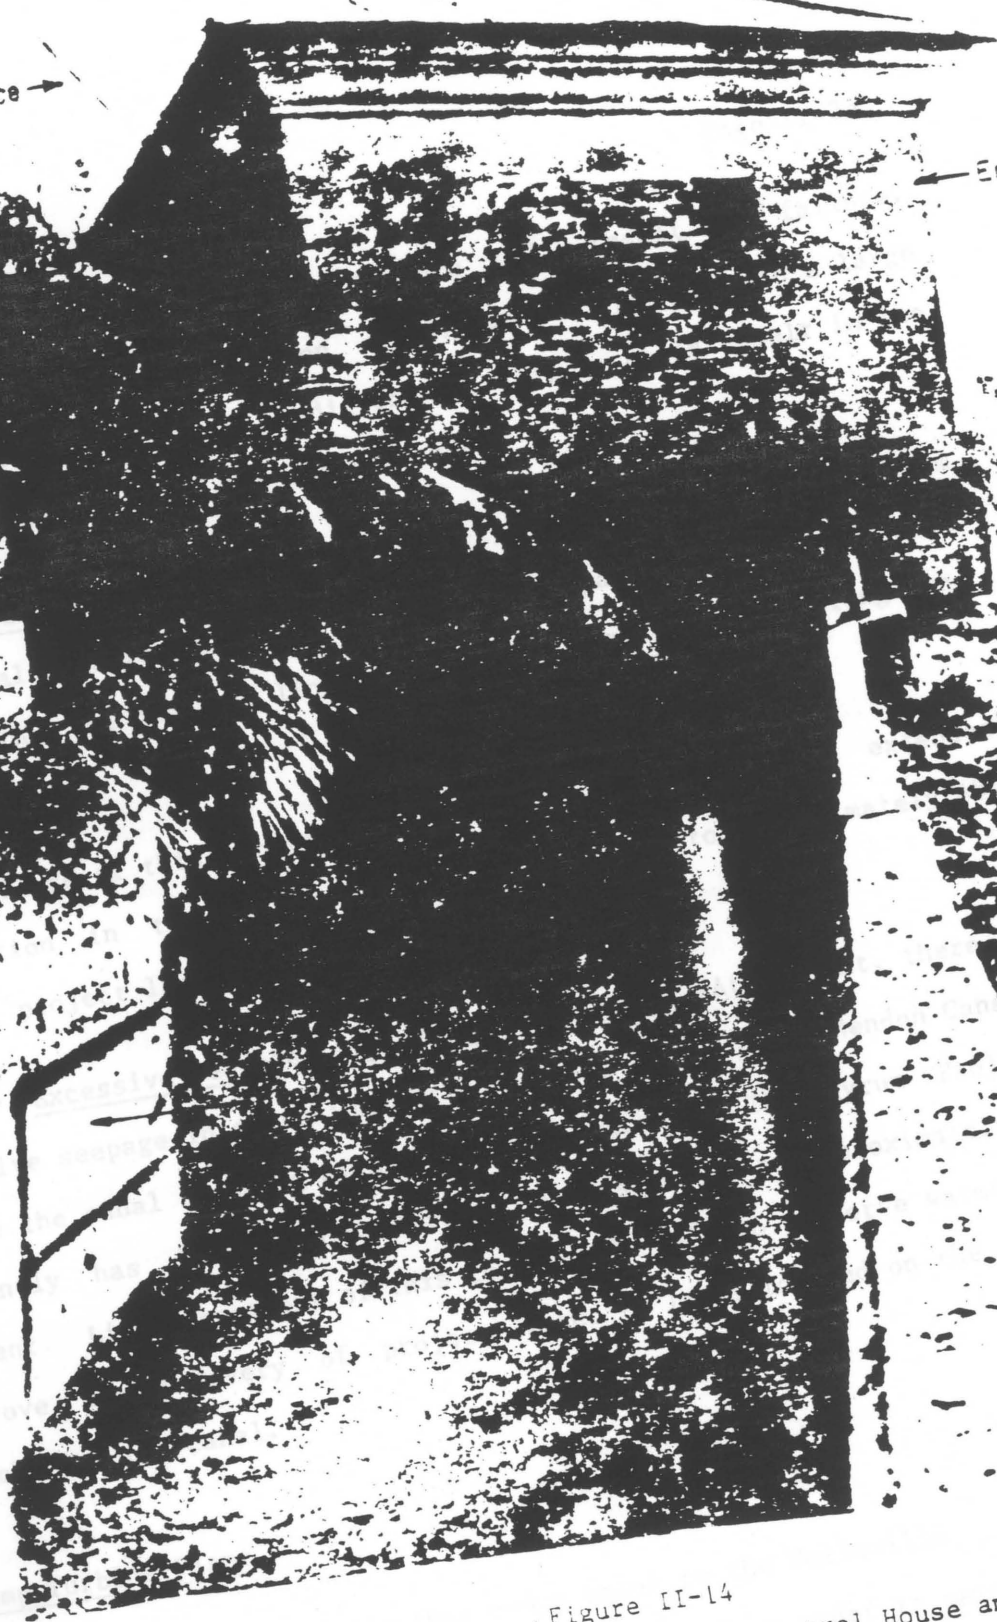
2. Bench flume--The bench flume located immediately downstream from the outlet works of Hyrum Dam is in bad repair and is leaking. Due to the age of the structure, the concrete has deteriorated in places. Figure II-14 shows a view of the north and west sides of the control house and the bench flume.

View of North and West Side of Control House and
Center Line of Bench Flume at Hyrum Dam

Continued degradation of this feature will result in failure, causing an extended interruption of irrigation service to a large portion of the project lands. Additionally, failure could result in the loss of the foundation for the control house.

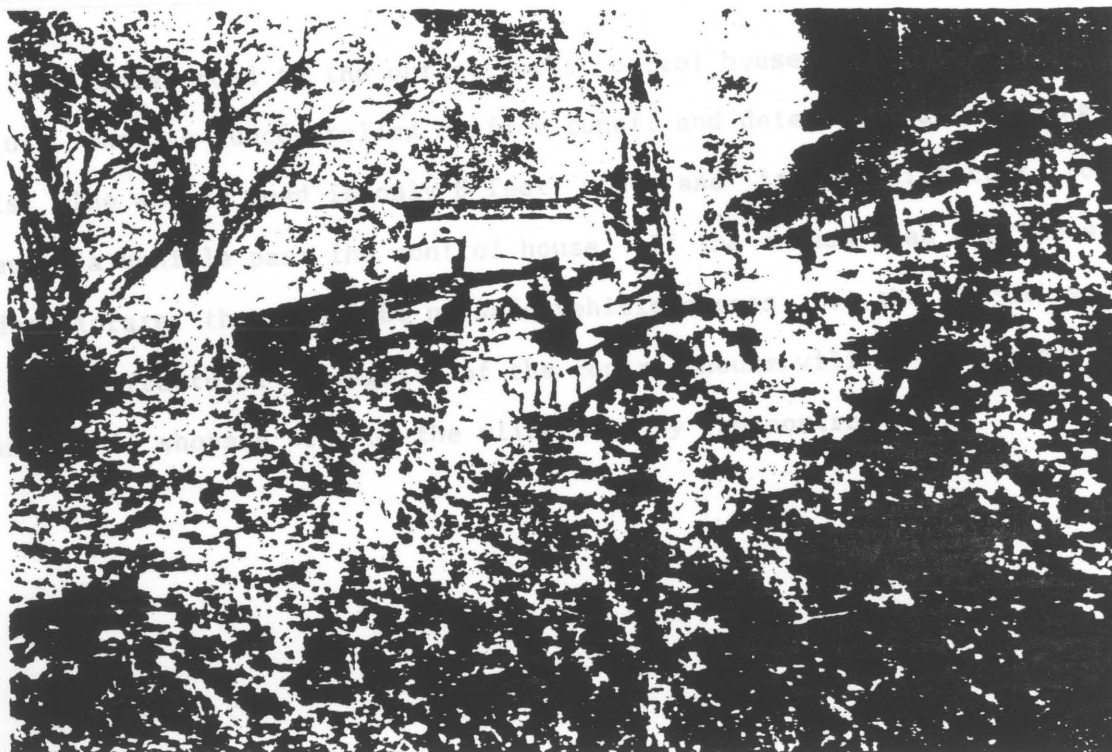
View of Slide Area by the Control House at Hyrum Dam

The access road to the outlet works control house is in danger of failure due to uncontrolled surface runoff and deteriorated retaining walls. The access road is only 8 feet wide and it is difficult to maneuver a vehicle past the control house. If the access road continues to deteriorate, there will be no safe vehicle access to the facility, and the structural integrity of the control house will be threatened. Figure II-16 shows a view of the slide area by the control house.
