## A Study of Geologic Hazards and Geotechnical Input for Selected Critical Facilities - Cache Valley, Utah

A STUDY OF GEOLOGIC HAZARDS AND GEOTECHNICAL INPUT FOR  
SELECTED CRITICAL FACILITIES - CACHE VALLEY, UTAH

A thesis submitted in partial fulfillment  
of the requirements for the degree

MASTER OF SCIENCE

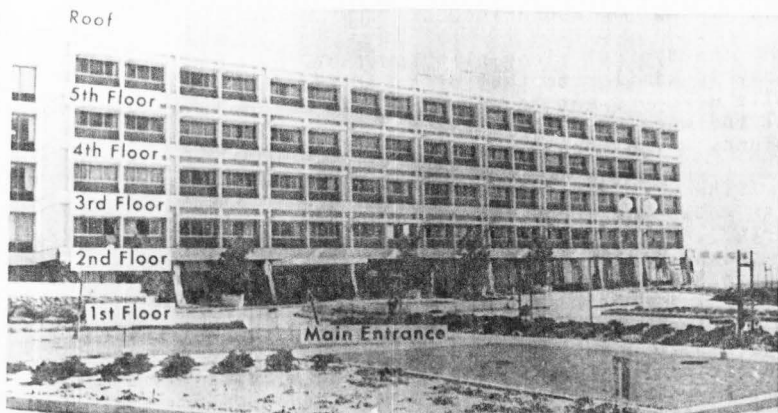
Figure 3-3. Olive View Medical Center, showing extensive damage resulting from the 1971 San Fernando Earthquake (after Lew, Leyendecker, and Dikkers, 1971).

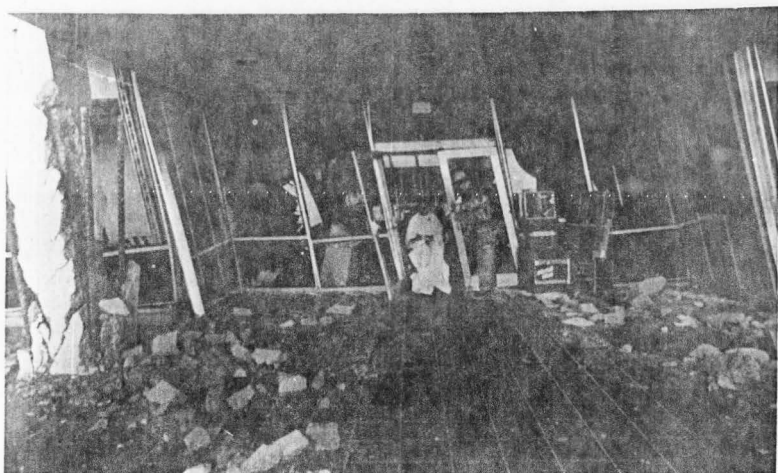
Figure 3-4. Lateral displacement of first floor of Olive View Medical Center (after Lew, Leyendecker, and Dikkers, 1971).

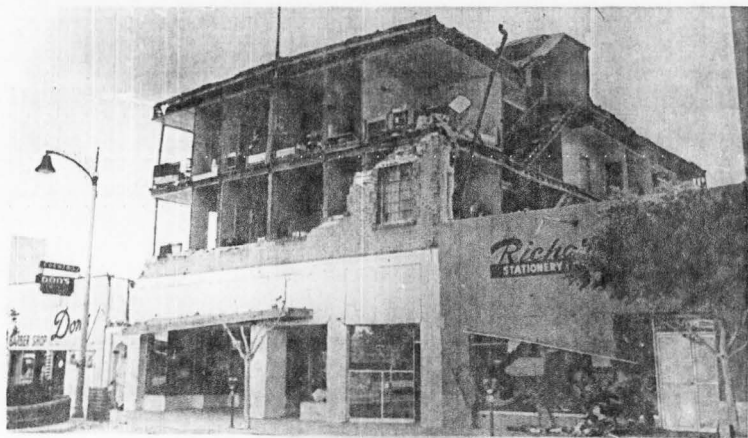
Figure 3-6. Total collapse of brick masonry wall surrounding three-story wood frame building (after Lew, Leyendecker and Dikkers, 1971).

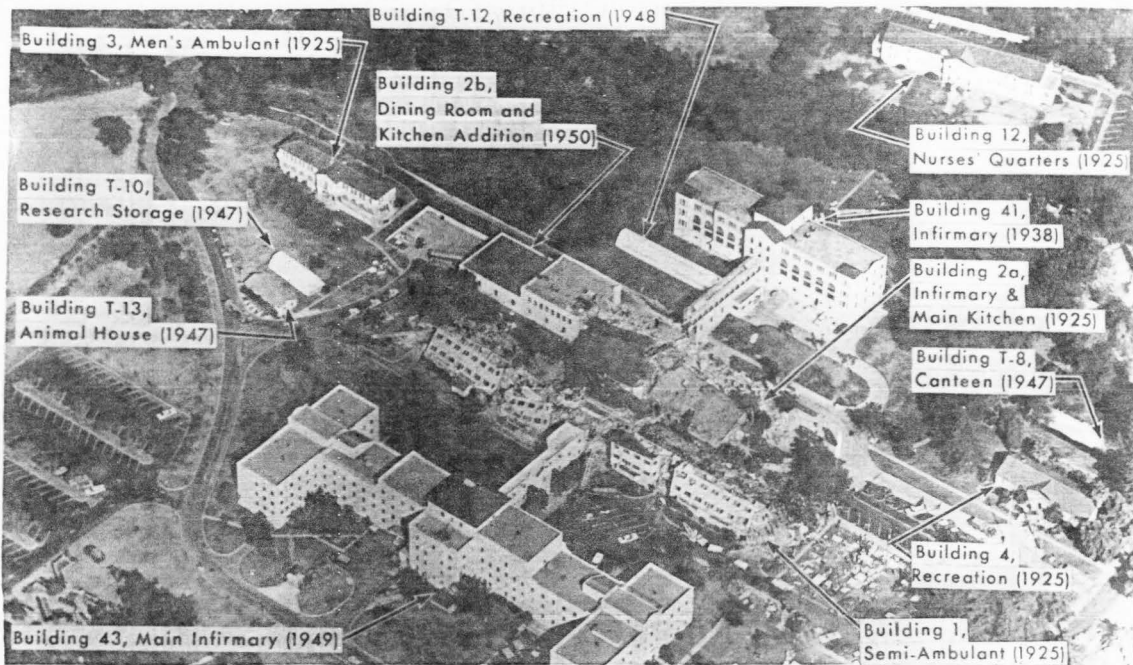
Figure 3-7. Aerial view of the San Fernando Veterans Administration Hospital. Collapsed building (No. 1 and 2a) constructed in 1925, where 46 patients and hospital workers were killed. Many of the buildings, also constructed in 1925 (buildings 3, 4, and 12), although still standing, were severely damaged (after Lew, Leyendecker and Dikkers, 1971).

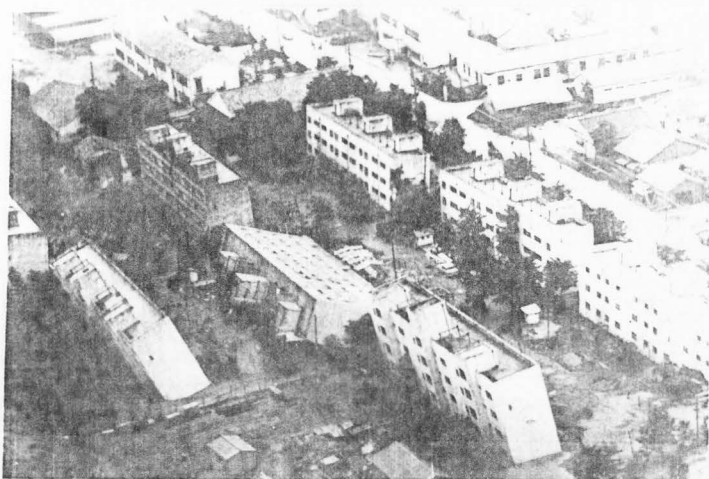
Figure 3-8. Foundation failures in Niigata, Japan (1964)  
(after Seed, 1975a).

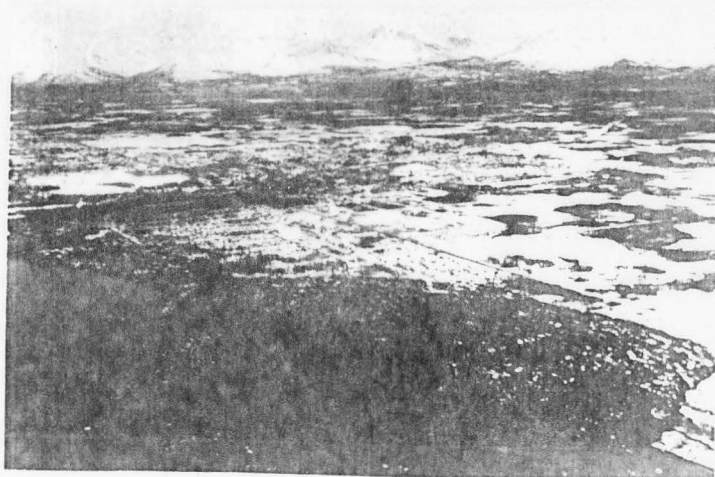
Figure 3-9. Turnagain Heights landslide, Anchorage, Alaska  
(1964) (after Seed, 1975a).

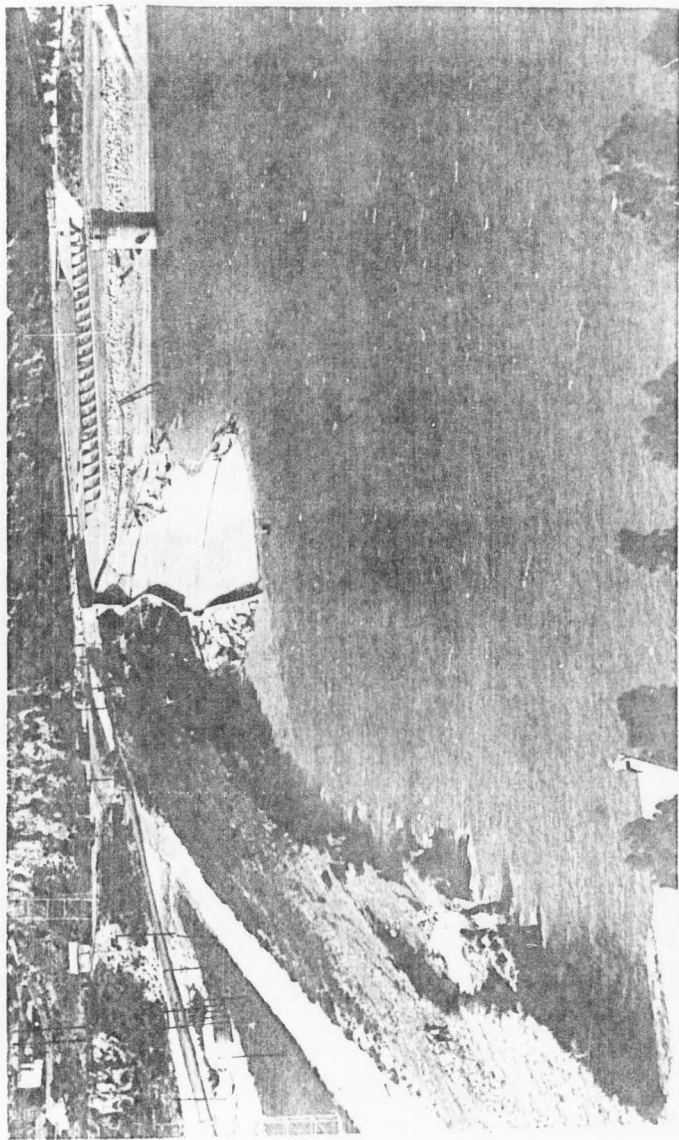
Figure 3-10. Collapsed crest and near failure of the lower San Fernando Dam as a result of Liquefaction (after Lew, Leyendecker, and Dikkers, 1971).

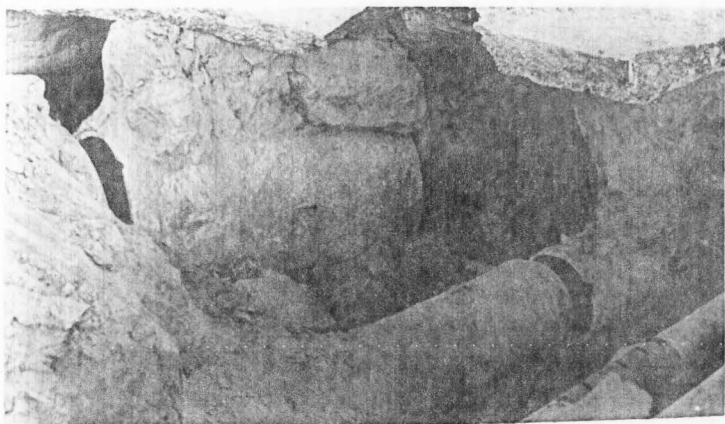
Figure 5-1. Ruptured sewer, water, and gas lines after the San Fernando Earthquake (after Lew, Leyendecker, and Dijkers, 1971).

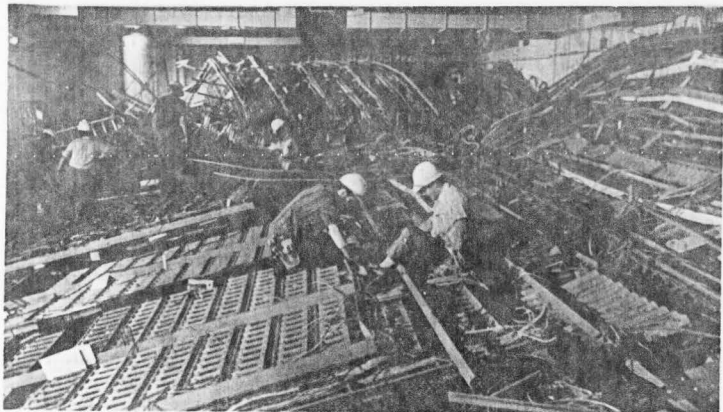
Figure 5-2. Toppled and damaged telephone switching equipment at Sylmar Central Office of General Telephone Company (after Lew, Leyendecker, and Dijkers, 1971).

library. If the rows are tied together to act as a unit rather than each row being supported individually, the unit will become much more stable. Instead, if the rows act individually, and one row topples, the result may be the same as a row of closely spaced dominos falling, each domino upsetting the next one.

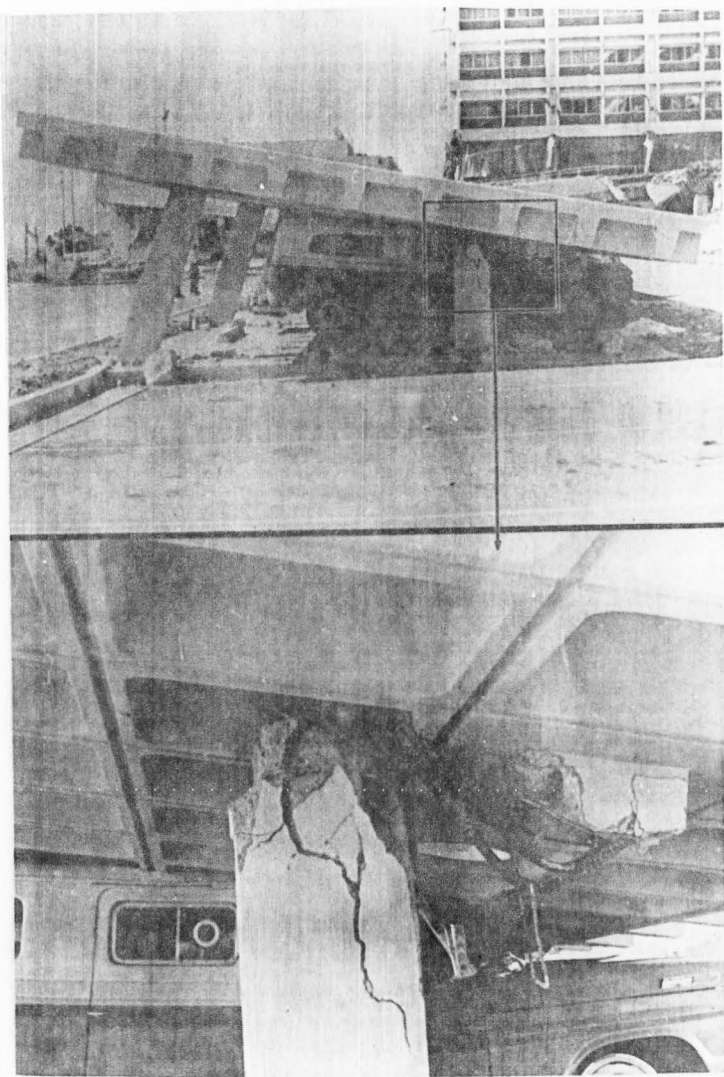
Figure 5-3. Destruction of emergency service vehicles parked in a collapsed ambulance port (after Lew, Leyendecker and Dikkers, 1971).

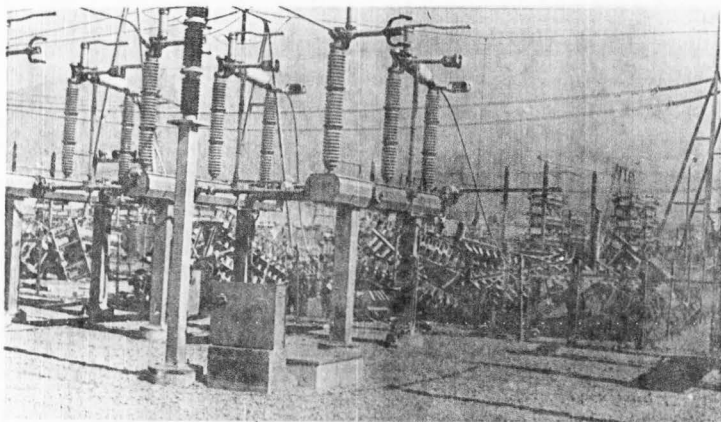
Figures 5-4 and 5-5 show similar destruction. The electrical power transmission equipment shown in the figures was destroyed simply because of insufficient lateral support. A detailed evaluation of similar critical components of any lifeline system, should suggest many relatively inexpensive measures which can be taken to safeguard the system.

Figure 5-4. Destroyed electrical equipment at Sylmar Converter Station as a result of the San Fernando Earthquake (after Lew, Leyendecker, and Dikkers, 1971).

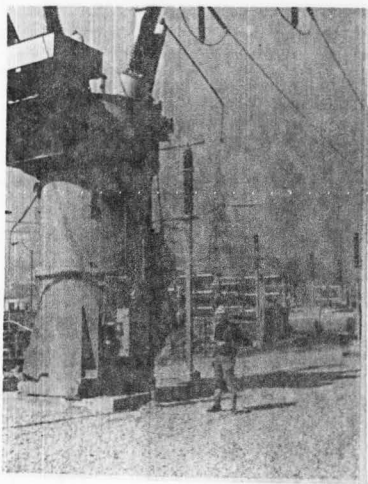
Figure 5-5. Destroyed electrical equipment at Sylmar Converter Station as a result of the San Fernando Earthquake (after Lew, Leyendecker, and Dikkers, 1971).
