Lightning arc channel effects on surface damage development on a PRSEUS composite panel: An experimental study

Abstract. Composite aircraft structures are vulnerable to lightning strike damage due to their relatively low electrical and thermal conductivities. A preceding work has investigated the lightning damage resistance of a carbon-epoxy Pultruded Rod Stitched Efficient Unitized Structure (PRSEUS) panel. The damage includes intense local damage (*i.e.*, matrix decomposition/sublimation, fiber rupture, delamination) accompanied by widespread surface damage (*i.e.*, distributed fiber rupture and tow splitting) further from the lightning attachment point. This study focuses on investigating the cause of the widespread surface damage. Two possible driving mechanisms are explored: *i*) magnetically-induced currents and *ii*) lightning arc-root/channel expansion. Fifteen laboratory-scale lightning strike tests at nominal peak currents of 50-125 kA were performed on modified PRSEUS mid-bay locations. The surface modifications were placed adjacent to or enclosing the intended lightning arc attachment point, including through-slots, a non-conductive silicon-filled slot, insulating tape

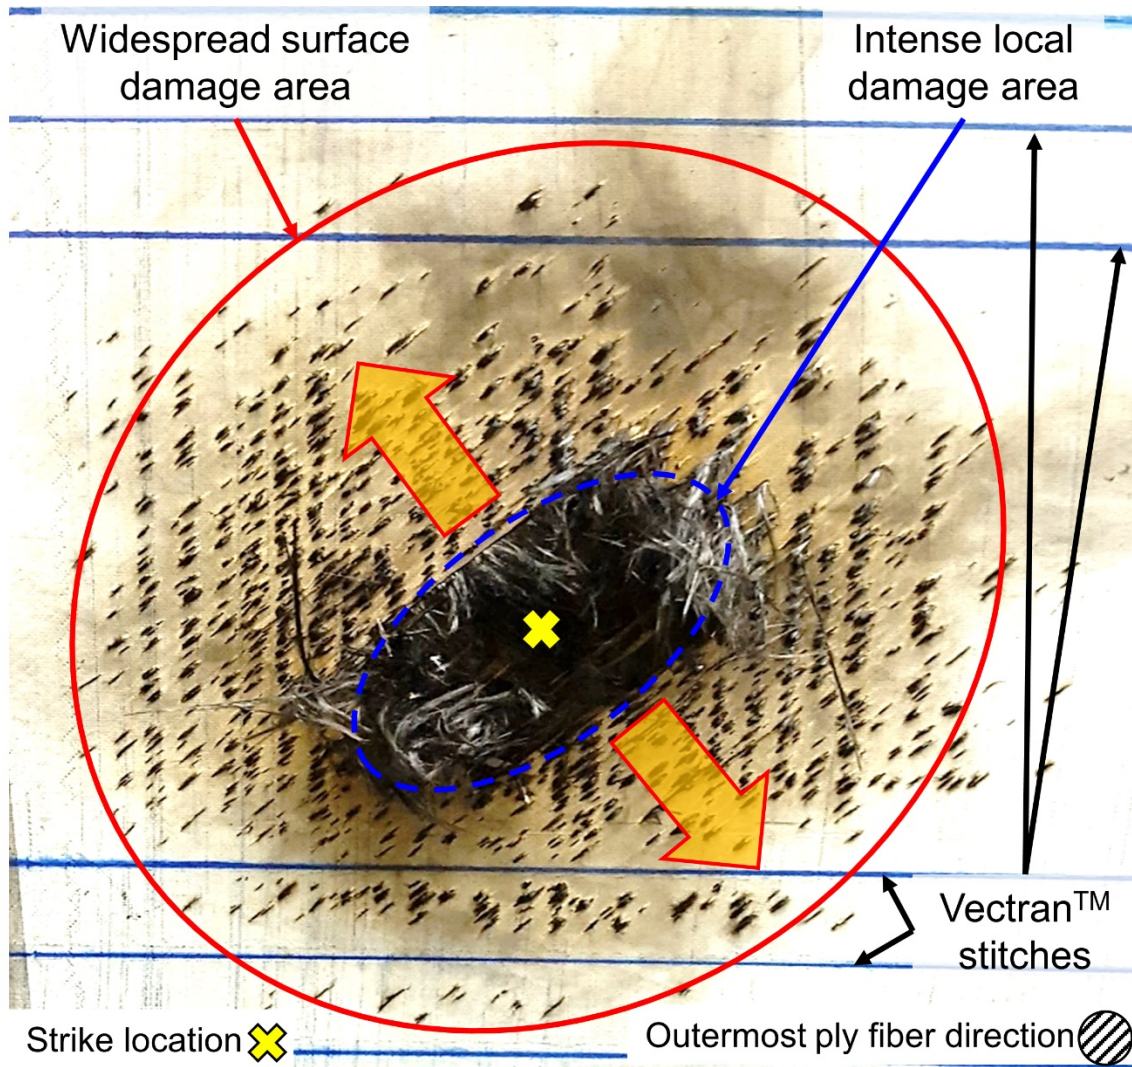
Figure 2 [24] shows typical lightning strike damage at a PRSEUS mid-bay location (*i.e.*, skin area between VectranTM stitch lines) subjected to a 124 kA peak current. The lightning-induced damage consisted of *i)* “primary” intense local damage (*i.e.*, combined large-scale matrix decomposition, fiber sublimation/ablation, fiber rupture, tow splitting, and delamination observed within the dashed blue ellipse in Fig. 2) occurring at the lightning attachment

point; and *ii*) “secondary” surrounding widespread surface damage (*i.e.*, small-scale fiber damage in the form of periodically dispersed tufts of broken fibers, and surface scorching/burning shown within the red ellipse in Fig. 2) occurring in the proximity but further from the intense damage zone. The primary intense local damage was mainly due to the direct lightning current conduction at the attachment point [13]. Essentially, the local composite temperature increased rapidly (due to Joule heating) as the lightning arc-core attached to the surface of a PRSEUS panel. As the epoxy matrix started to degrade, progressive evolution of volatile compounds, breakdown/depolymerization of the molecular chains, and char and residue formation occurred. As the local composite temperature increases, the carbon fibers will contract rapidly because of their negative CTE. This contraction, coupled with large CTE mismatches between the carbon fibers and epoxy matrix, can contribute to large-scale fiber breakage; this process can be exacerbated by high-temperature gradients in the composite. However, the widespread surface damage (Fig. 2) cannot be attributed to direct current injection since the primary conduction path occurs in the outer ply fiber direction. This diffuse widespread surface damage forms away from the lightning attachment point in a direction perpendicular to the fibers, as indicated by the yellow arrows in Fig. 2.

The lightning damage pattern observed in the mid-bay location of the PRSEUS panel (Fig. 2, [24]) prompts the question: what causes the formation of the widespread surface damage (*i.e.*, periodic distributions of tufts of broken fibers) found in the domain surrounding the area with intense local damage? Two potential causes of the widespread surface damage were investigated in this paper: *i*) magnetically-induced currents generated by a time-varying magnetic field, and *ii*) lightning arc-channel expansion over the struck surface.

Fig. 2. Typical lightning-induced damage at a PRSEUS panel mid-bay location subjected to 124 kA peak current level. Adapted from [24]

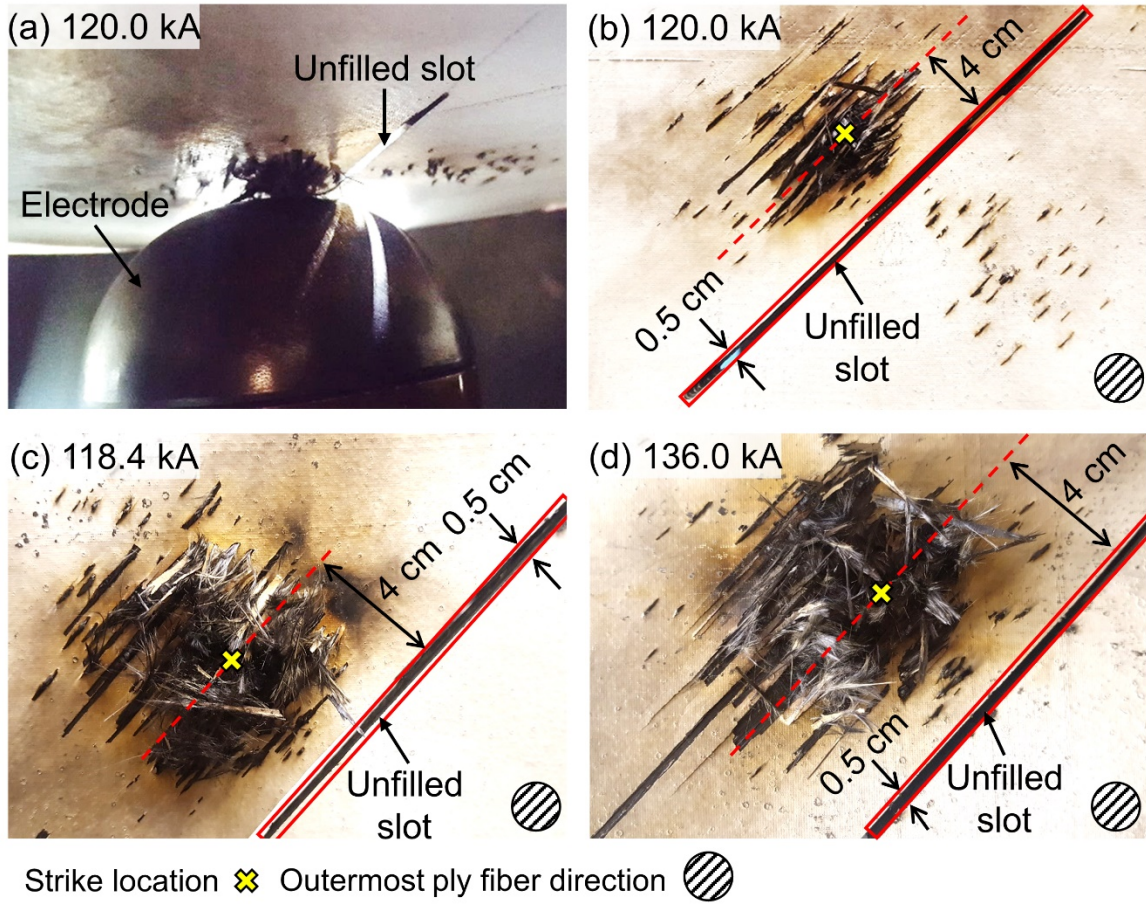
Figures 6a-b show lightning damage due to an actual 120 kA mid-bay strike, where the slot was oriented parallel to the outer ply fiber direction (+45°). Similar to the results shown in Fig. 2, a region of intense local damage formed at the attachment point and was elongated in the outer ply fiber direction. In addition, widespread surface damage formed on both sides of the slot (Fig. 6b) but was less pronounced on the isolated side of the slot. This distributed damage tended to be loosely clustered about an axis perpendicular to the fiber direction that also passed through the attachment point. This axis roughly defines the direction of maximum arc expansion [20], as well as the location of the peak magnetically-induced currents [25, 35, 40]. In this experiment, it is unclear whether the surface damage occurring on the opposite side of the unfilled slot resulted from reattachment of the expanding arc (which “jumped” the slot due to the presence of high electric field) or from the formation of strong secondary currents induced by the primary magnetic field. This was the only experiment, however, where damage formed on the opposite side of an unfilled slot.

Additional strikes at 118.4 kA (Fig. 6c) and 136 kA (Fig. 6d) were performed adjacent to parallel slots at mid-bay locations. In each case, the domain with intense fiber damage was more rectangular-shaped and noticeably more pronounced than for the earlier 120 kA strike (Fig. 6b). Moreover, in these latter two cases, *no widespread surface damage appeared across the slot from the attachment point*. It seems reasonable that the discontinuity in surface geometry provided by the slot caused the expanding arc to detach from the surface, leading to more pronounced

damage on the strike side of the slot. In addition, any magnetically-induced currents were insufficient to produce damage across the slot (the magnetic field decays with radial distance from the arc core [41]).

Fig. 6. Lightning strike damage adjacent to unfilled through slots oriented parallel to the outermost ply fiber direction due to peak currents of (a) 120 kA typical strike test setup, (b) 120 kA, (c) 118.4 kA, and (d) 136 kA.

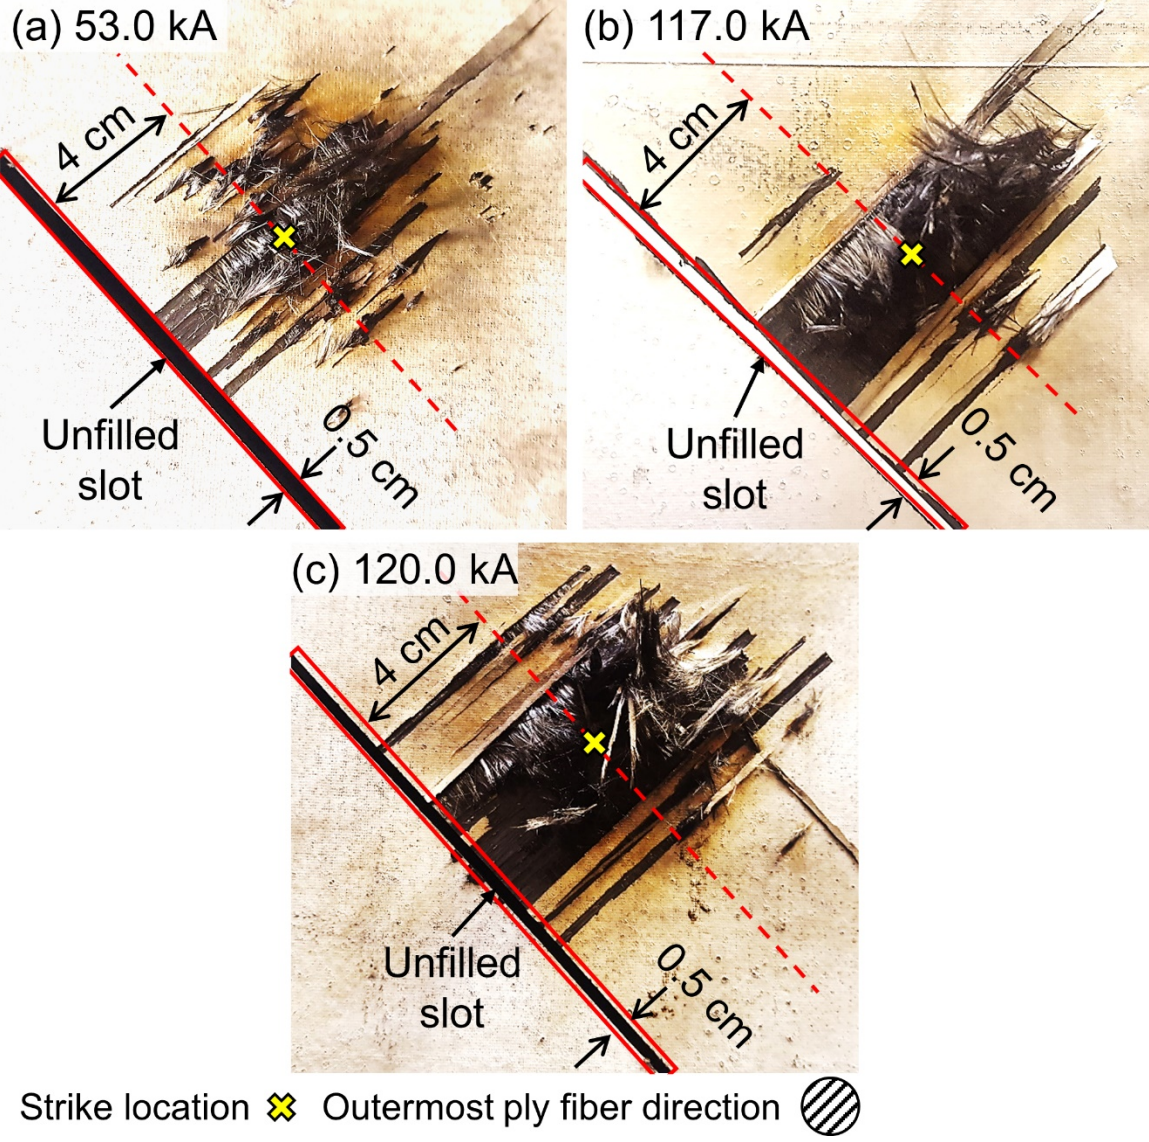
The central regions with intense local damage appeared more rectangular-shaped, with clear evidence of spallation of outer ply material at the edge of the slot (Fig. 7a-c). This is similar to lightning strike damage observed adjacent to unfilled parallel slots (*cf.*, Fig. 6c-d). The damage was not symmetric about the axis perpendicular to the +45° outer ply fiber direction passing through the attachment point due to the presence of a perpendicular slot. In addition, a number of ribbon-like strips with severe fiber damage and/or spallation formed parallel to the fiber direction at and near the slots; these strips were located somewhat outside the typical regions with intense damage. Such ribbon-like regions with acute fiber/surface damage were not widely observed in previous lightning strike experiments performed on unmodified PRSEUS panels [13, 24, 25]. Moreover, no large-scale widespread surface damage (periodically distributed tufts of broken fibers) appeared in the OML skin of the slotted panel (Fig. 7). The results support the assumption that the non-conductive barriers disrupt damage formation on the panel.

The presence of a slot appears to alter the arc root-shape, attachment, expansion, as well as the distribution of local primary electrical currents, magnetically-induced currents, Joule heating, and other factors contributing to composite lightning damage formation. For an unbounded PRSEUS panel subjected to lightning strike, severe damage will generally form in an elliptical domain symmetrically located about the attachment point, where the semi-major radius of the ellipse is aligned with the primary conduction path (Fig. 2). For panels with orthogonal slots, the primary conduction path is severed on one side of the attachment point. This likely leads to increased local Joule heating at the attachment point near the slot, which may explain proportionally more matrix decomposition, acute fiber ruptures, and/or spallation occurring near the slot. The slot may also result in forced electrical current flow *perpendicular* to the fiber direction (that subsequently gets conducted away from the slot in parallel fiber tows) and/or strong magnetically-induced currents that drive the formation of ribbon-like regions with acute fiber/surface damage rather than distributed surface damage. Also, arc expansion will be more pronounced perpendicular to the outer ply fibers (*i.e.*, parallel to the slot), which may contribute to the spread of surface damage.

Fig. 7. Lightning strike damage adjacent to unfilled through slots oriented perpendicular to the outermost ply fiber direction due to peak currents of (a) 53.0 kA, (b) 117.0 kA, and (c) 120.0 kA.

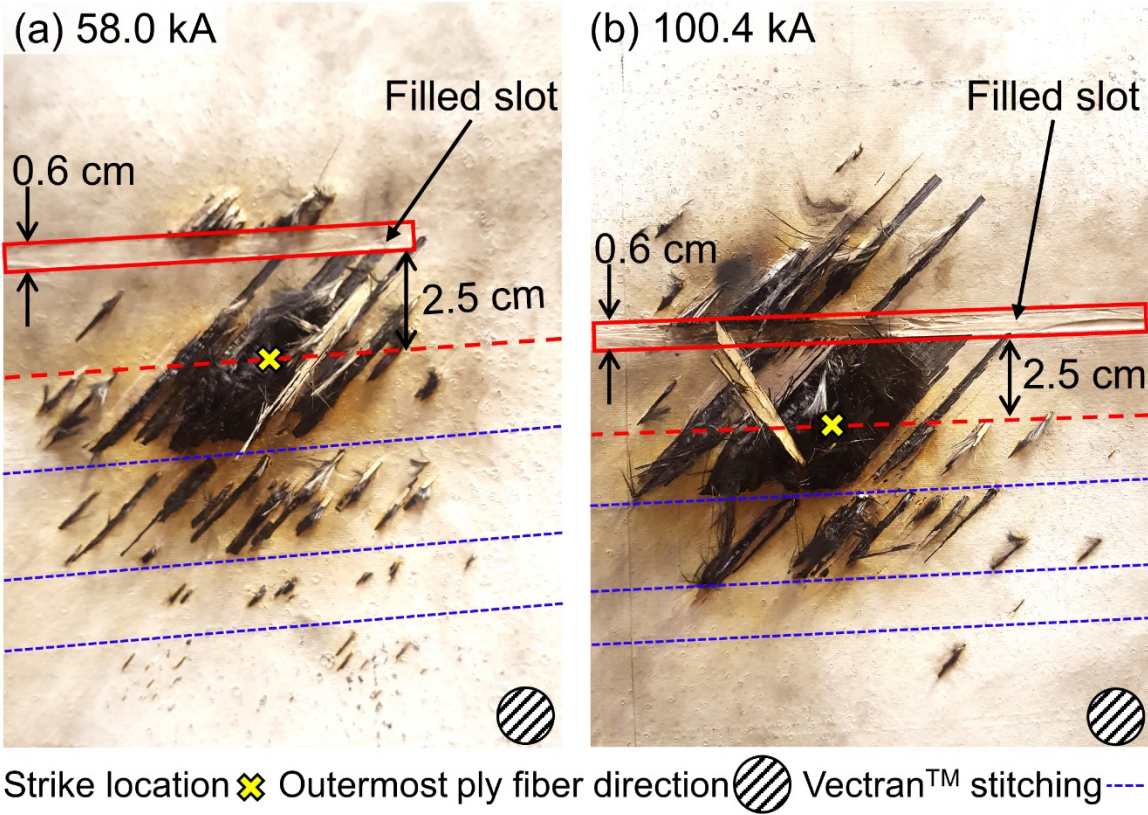
The presence of the filled slot appeared to limit the spread of the primary intense local damage. In contrast to the case for unfilled perpendicular slots (Fig. 7), however, *damage formed on both sides of the slot*. For example, the

100.4 kA strike (Fig. 8b) induced parallel strips with severe fiber breakage on both sides of the filled slot. A solid insulator (*e.g.*, silicon) can become conductive under extreme conditions such as a massive current flow or an external electric field. Its change in electrical conductivity is typically followed by irreversible deformation. Careful inspection near the attachment points in Fig. 8 showed that the silicon paste within the slot was relatively undeformed, except for slight surface scorching due to excessive heating. This suggests that there was little to no current flow through the filled slot, and surface damage on the isolated side of the slot resulted from arc expansion. Since there was no *geometric* discontinuity in the PRSEUS OML surface, it is possible that the expanding arc remained attached or reattached after traversing the filled slot.

Fig. 8. Lightning strike damage adjacent to a horizontal slot parallel to the 0° fibers filled with non-conductive silicon paste due to peak currents of (a) 58.0 kA, and (b) 100.4 kA.

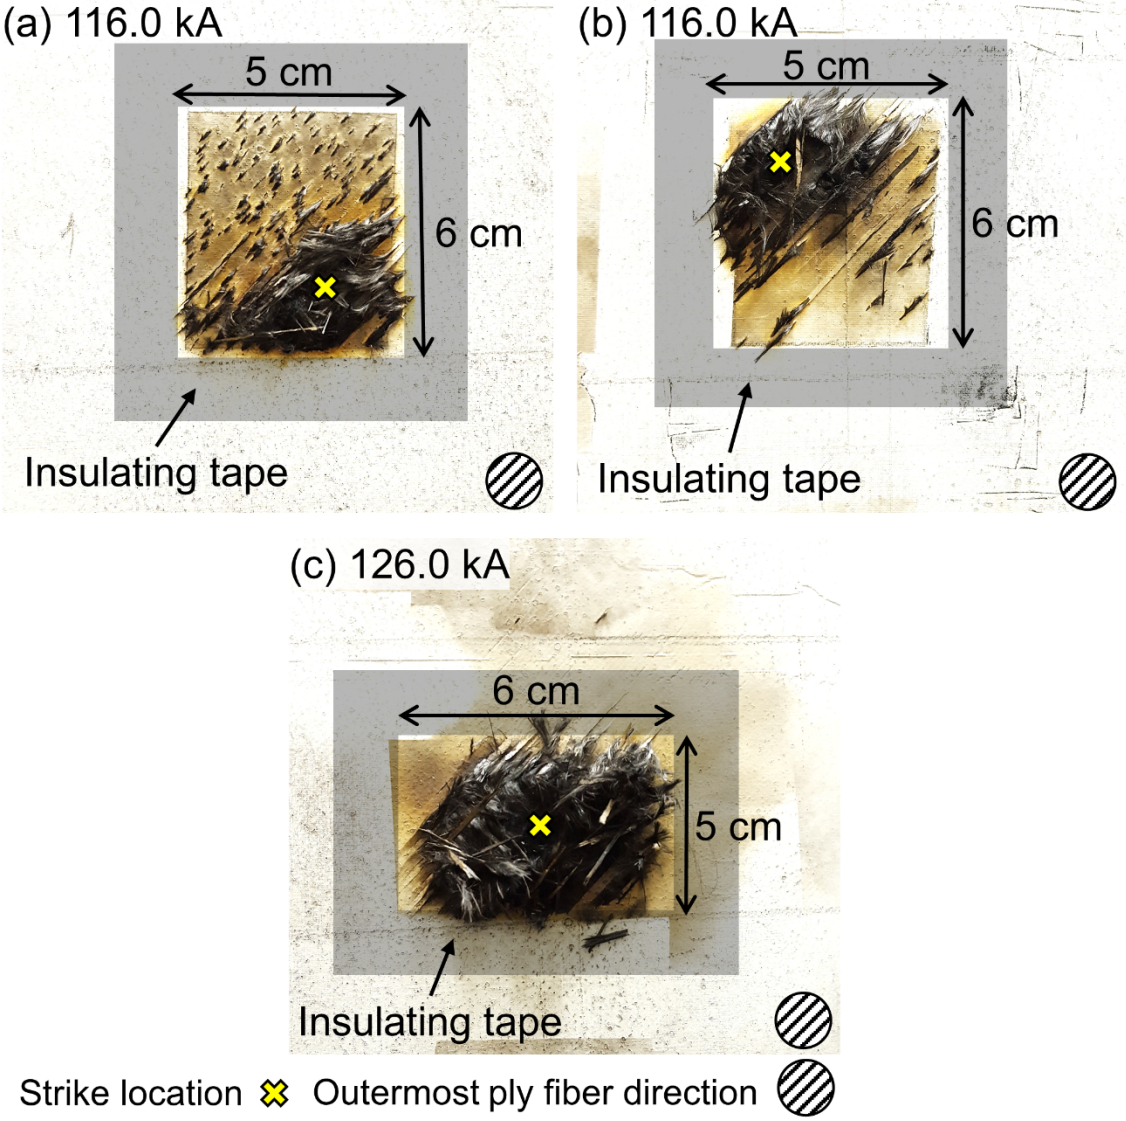
Figures 9a-c show lightning damage within the enclosed area for measured lightning peak currents of 116.0, 116.0, and 126.0 kA, respectively. The symbolic tape boundaries in the figure are not scaled. Consistent with results reported in references [13, 24, 25] and shown in Fig. 2, the two 116.0 kA strikes (Fig. 9a-b) resulted in intense local damage at the attachment point accompanied by surrounding tufts of broken fibers. While the intended strike location was the center of the rectangle, the actual lightning attachment point was somewhat off-center. The complex plasma physics, spherical output electrode geometry, and finite gap distance make it difficult to precisely control the trajectory of the lightning arc discharge. Careful inspection of the inner edges of the non-conductive tape showed minor scorching surrounding the exposed PRSEUS OML surface with intense fiber damage. Additionally, the 126.0 kA strike (Fig. 9c) resulted in more severe localized damage (*i.e.*, matrix decomposition/pyrolysis, fiber rupture, and delamination) that extended all over the uncovered rectangular area; the inner edges of the non-

conductive tape were partially melted/burned. As previously discussed, higher peak current leads to more Joule heating resulting in significant lightning damage.

Remarkably, *no widespread surface damage occurred under or across the non-conductive tape boundary* for all the three strikes (Fig. 9). In each case, the visible surface damage was completely confined to the 5 cm × 6 cm open area; except for some minor surface scarfing mostly around the perimeter of the intense fiber damage area. These experiments confirm that the widespread surface damage in a PRSEUS panel must be a result of an expanding lightning arc-root/channel upon attachment to the surface of the composite. The insulating tape prevented significant current injection from the expanding arc into the underlying skin. In addition, the slight step discontinuity in OML surface geometry due to the tape may cause the expanding arc to detach.

Fig. 9. Lightning strike damage at three mid-bay locations bounded by a non-conductive tape due to peak current levels of (a) 116 kA, (b) 116 kA, and (c) 126.0 kA.

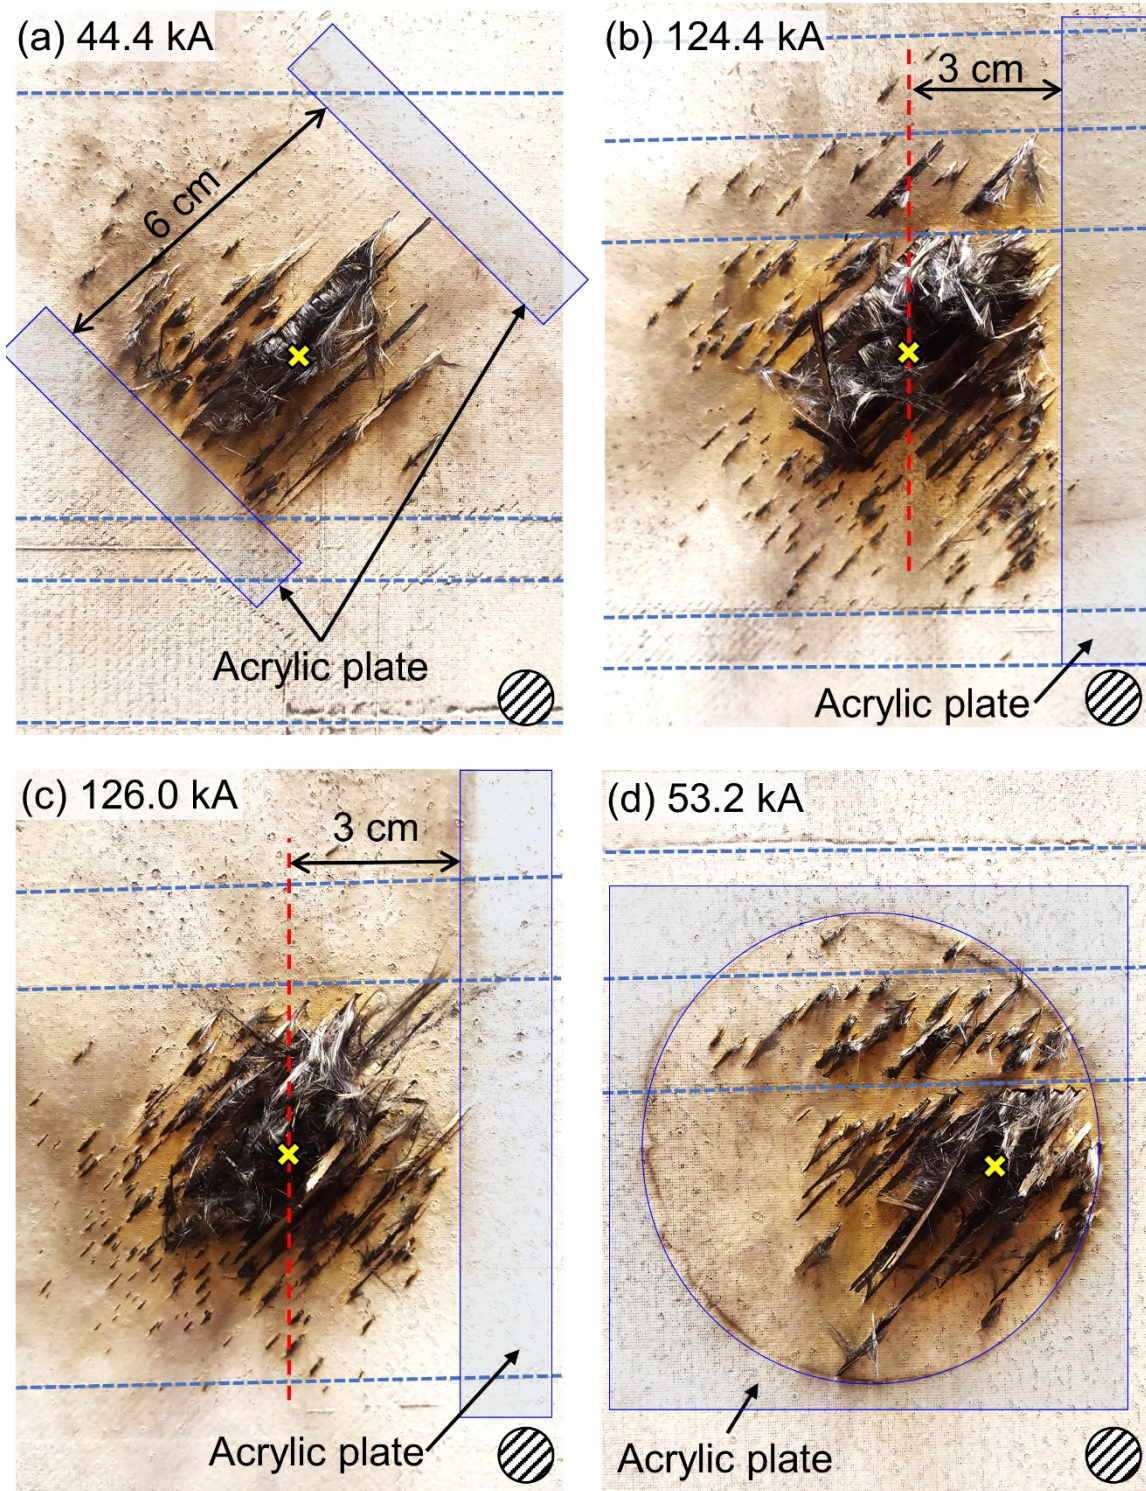
In each of the performed lightning strike tests, *no visible surface damage formed across and/or beneath the insulating acrylic plate boundaries*. For instance, in Fig. 10a, the placement of the two (10 cm W × 20 cm L × 0.5 cm T) acrylic plates 3 cm above and 3 cm below the intended strike location,

respectively, limited the intense local damage along the fiber axis. The widespread surface damage, however, expanded normal to the outermost ply fiber direction on the unconstrained sides, which correspond to the direction of a rapid arc expansion [20]. Similarly, the lightning damage due to the 124.4 and 126.0 kA peak current strikes (Fig. 10b-c) was constrained by the adjacent vertically orientated (10 cm $W \times 20$ cm $L \times 0.5$ cm T) acrylic plates. The lightning surface damage extended in the fiber direction right up to the insulating acrylic plate but did not cross the acrylic barriers. The acrylic plate boundaries (oriented 45° and 90° to the fiber direction as shown in Fig. 10a-c) prohibited continued arc expansion/attachment along the fiber direction, forcing the surface damage to expand in unconstrained directions and parallel to the acrylic barrier edges.

In addition, a 53.2 kA mid-bay strike was conducted at the center of a (21 cm $W \times 21$ cm $L \times 0.5$ cm T) square acrylic plate with a 9 cm diameter circular cut out (Fig. 10d). Consistent with the non-conductive tape experiment results (Fig. 9), the lightning damage was completely confined in the open circular cut-out area of 64 cm². For comparison, a typical surface damage area of an unconstrained mid-bay strike subjected to a nominal peak current of 50 kA is 96 cm² [24]. The damage consisted of a relatively smaller intense local damage area at the attachment point surrounded by tufts of broken fibers that were limited by the acrylic plate boundary.

The insulating properties of the acrylic plates coupled with the 0.5 cm step discontinuity in surface geometry at the plate boundaries clearly altered the interaction between the expanding arc and the surface, which influenced the shape of the surface damage. The acrylic sheets, however, would not influence the magnetically-induced currents. These results confirm that lightning arc-root/channel expansion is responsible for widespread surface damage formation on a PRSEUS panel.

Fig. 10. Lightning strike damage to four mid-bay locations bounded by insulating acrylic plates positioned in different orientations with respect to the outermost ply fiber direction due to peak current levels of (a) 44.4 kA, (b) 124.4 kA, (c) 126.0 kA, and (d) 53.2 kA.
