International Symposium on Hydraulic Structures

## Effect of Deficient Tailwater on the Performance of Slotted Roller Bucket of Indira Sagar Dam, Madhya Pradesh

## Effect of deficient tailwater on the performance of slotted roller bucket of Indira Sagar Dam, Madhya Pradesh

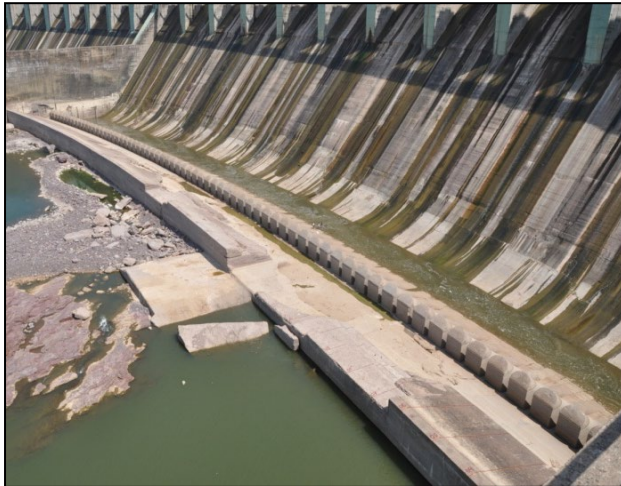
The Indira Sagar project is in operation from 2004-2005. According to Project authorities, it was observed that discharges of the magnitude 30,000 m<sup>3</sup>/s were released for a considerable time during the monsoon of 2013 and it was observed that the entire slotted roller bucket in front of spans 6 to 12 was washed away. It was necessary to assess the possible reasons for the damage to the energy dissipator and recommendation of remedial measures. It was observed that the slotted roller bucket of the Indira Sagar dam spillway was damaged remarkably. Almost all the teeth of the bucket along with the apron downstream of the lip were overturned and thrown away by the flood waters. Out of the total 71 teeth of the main spillway only about 33 were seen intact, the remaining teeth were seen at a distance of about 100-150 m from bucket invert. Lip and teeth of the bucket in bays 6-12 have got dislodged from the main dam. The spillway was in operation with high discharges and it was opined that the damage to the energy dissipation arrangement is due to both hydraulic as well as structural reasons. Deficient tailwater levels during the initial period of operation leading to ski action, generation of high hydrodynamic pressures during roller formation due to very high incoming velocities of the order of 30 m/s and negative pressures on the teeth, were few of the hydraulic parameters leading to damage to the bucket. Damages to surface concrete were observed at various locations of the area of lip/ downstream apron. The surface of the teeth intact was found damaged due to abrasion/ erosion of concrete. These damages may have failed to boost up required tailwater levels resulting progressive erosion of bucket downstream. Photos 1 to 4 show the eroded bucket portion of spillway and severity of damage occurred to bucket. While designing slotted roller buckets, specific model tests should therefore be conducted to verify the pressures on the teeth and bucket invert should accordingly be fixed at such an elevation as to restrict the sub-atmospheric pressures to the permissible magnitude. As per calculations the velocities of flow for the period under consideration (2006-12) were about 30 m/s. It was opined that energy dissipator blocks got separated from the spillway due to untreated lift joints. These lift joints were formed possibly due to the placement of concrete at the lift joint after considerable time leading to separation due to shrinkage and no cold joint treatment. These construction joints facilitated ingress of water and high hydrodynamic pressures as a result major part of the energy dissipation arrangement got dislodged. The dislodged blocks were carried by the flow and dumped at about 100-150 m downstream forming an endsill type structure. This facilitated rise in tailwater besides the building of tailwater in due course of time and formation of the hydraulic jump at the toe of the spillway, which may prevent further damage to the spillway toe.

**Photo 1.** Damage to bucket portion of spillway

As it was experienced that slotted the roller bucket does not function satisfactorily during the last few years of operation due to its inherent limitations, it was felt that the ski jump bucket is a better long term solution. It has the advantage that it will have the same footprint as the roller bucket and also downstream apron's footprint will remain the same. This will enable the construction of ski jump bucket raising the already existing downstream coffer dam constructed during dam construction.

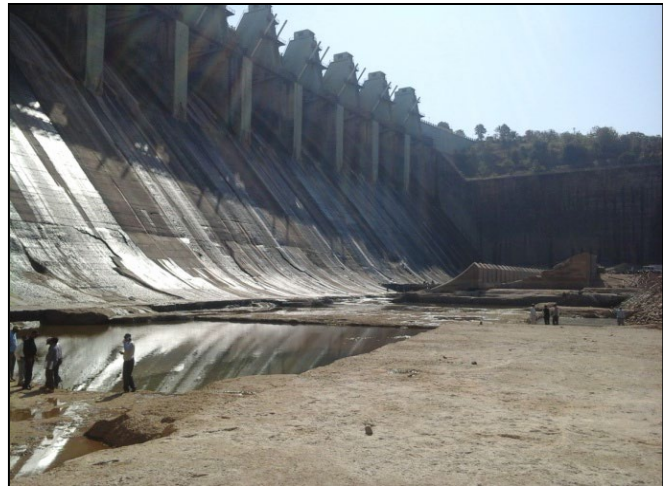
**Photo 2.** The eroded apron of bucket

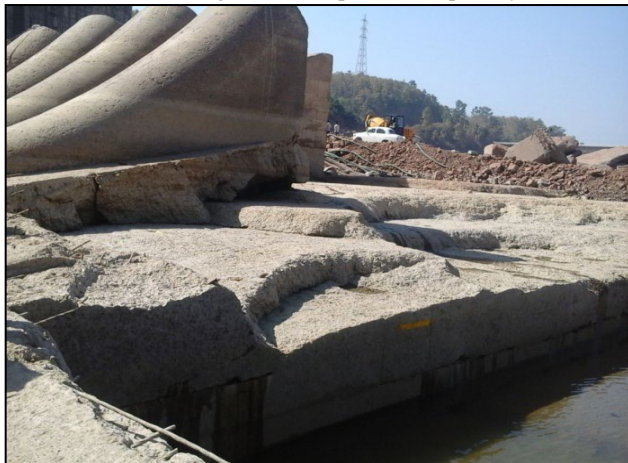
**Photo 3.** The detachment of bucket teeth

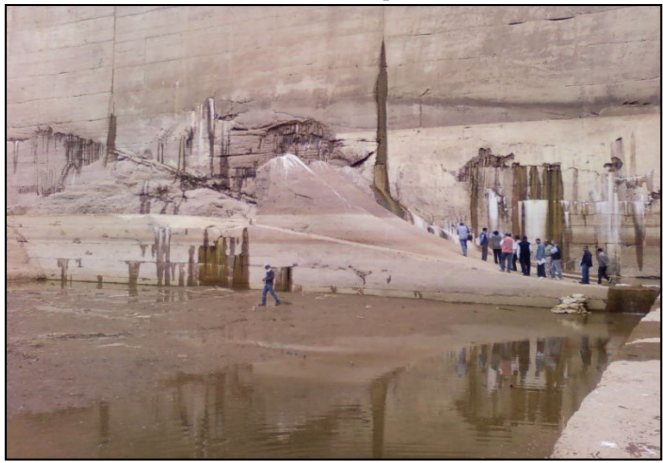
**Photo 4.** Exposed reinforcement of teeth

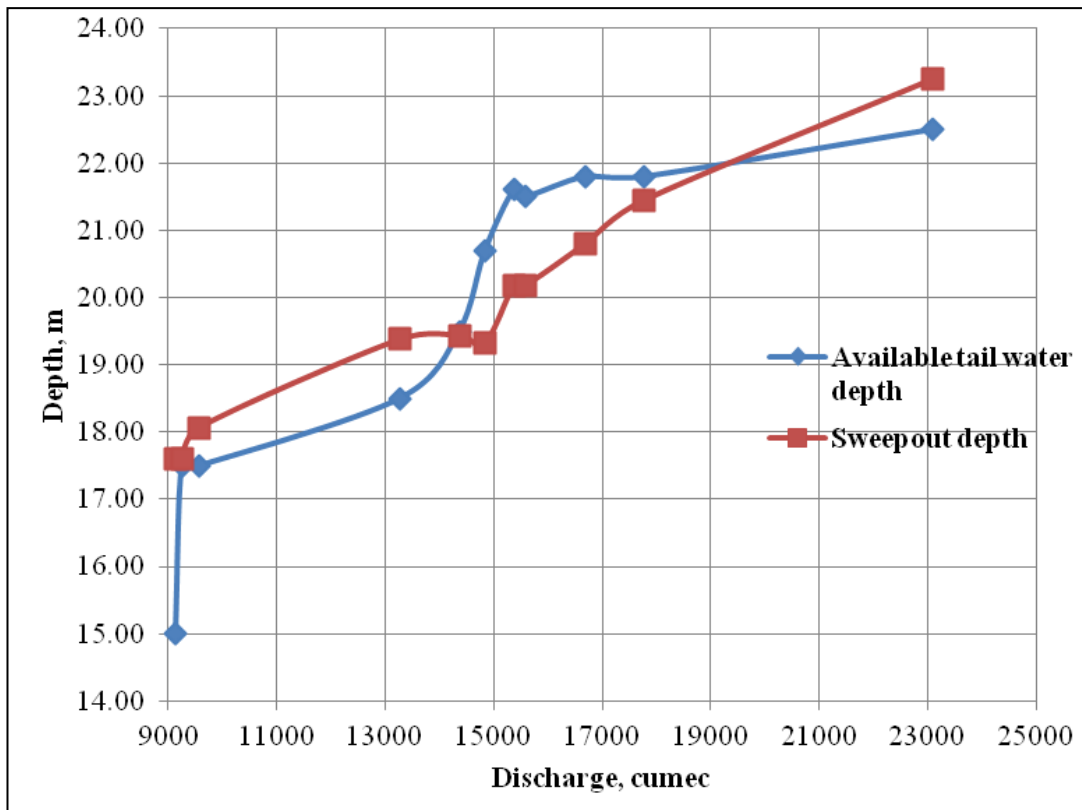
The discharges released through the main spillway and the corresponding tailwater levels observed are tabulated in Table 1. The analysis of data indicated that the observed tailwater levels were below or marginally above the design tailwater levels for most of the flood conditions. Building up of tailwater may take considerable time with heavy flood releases with considerable high velocities. The analysis indicated that the roller action was not forming for most of these conditions and instead ski action might be taking place due to deficient tailwater levels. There was also a transition from ski action to roller action for increasing discharges till the tailwater build was realised. The Froude number was found to be of the order of 9. In fact, this is the inherent shortcoming of roller bucket type of energy dissipators and damages to the bucket have been reported elsewhere also (CBIP Publication No. 247, 1998). From the data, it is known that the tailwater available was marginally above or sometimes lesser than the sweep out depth for the floods under review. Fig 2 shows the plot between the tailwater depth and sweep-out depth for various

floods under review. Slotted roller bucket type energy dissipators are provided for spillways when the tailwater depth is 1.2 times the sequent depth required for the formation of a hydraulic jump. But, for most of the flood releases, the observed tailwater levels were marginally above the jump height levels and also lesser than the designed tailwater rating curve for which the slotted roller bucket was designed. Fig 3 shows the plot of designed tailwater depth, observed tailwater depths and jump height for the discharges under review.

**Figure 2.** Tailwater depth realised versus sweep out depth

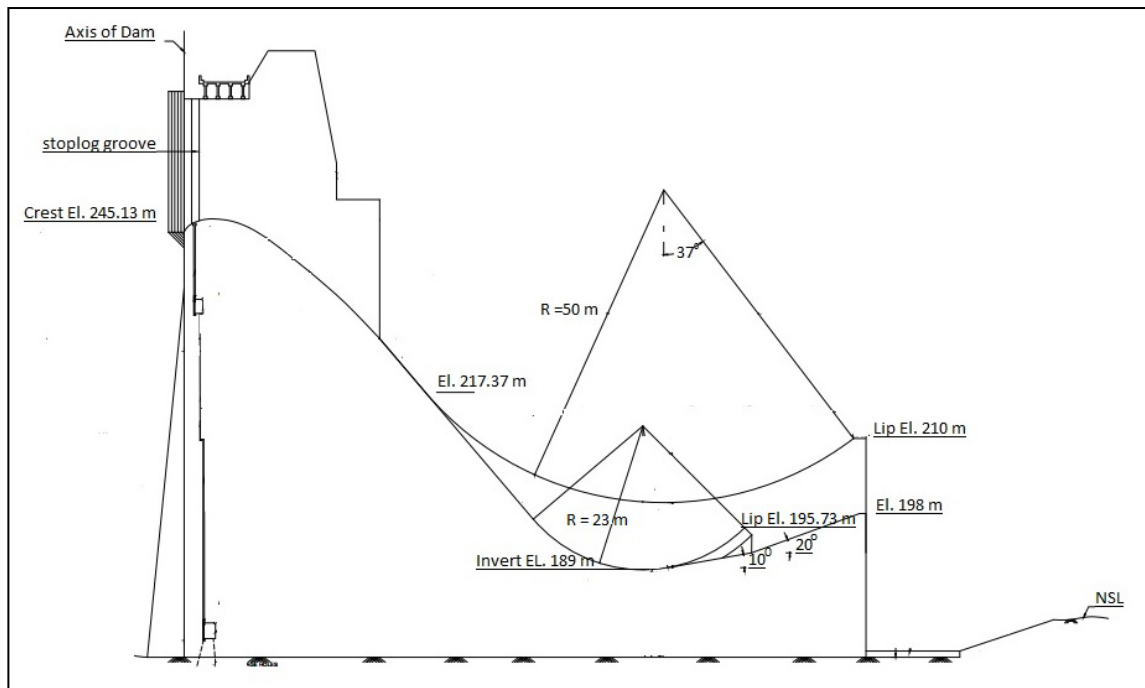
**Figure 4.** Cross section of modified energy dissipator

For the Indira Sagar spillway, the original energy dissipator in the form of slotted roller bucket with invert at El. 189 m and lip at El. 195.73 m was modified to the form of ski jump bucket with a radius of 50 m, invert at El. 199.75 m, lip at El. 210 m and the lip angle is 37° which was recommended by CWC in consultation with CWPRS. The radius of bucket was increased from 23 m to 50 m to accommodate the ski jump bucket profile. Fig 4 shows the cross

section of ski jump bucket superimposed on a slotted roller bucket type energy dissipator. Photo 5 shows downstream view of spillway with ski jump bucket.

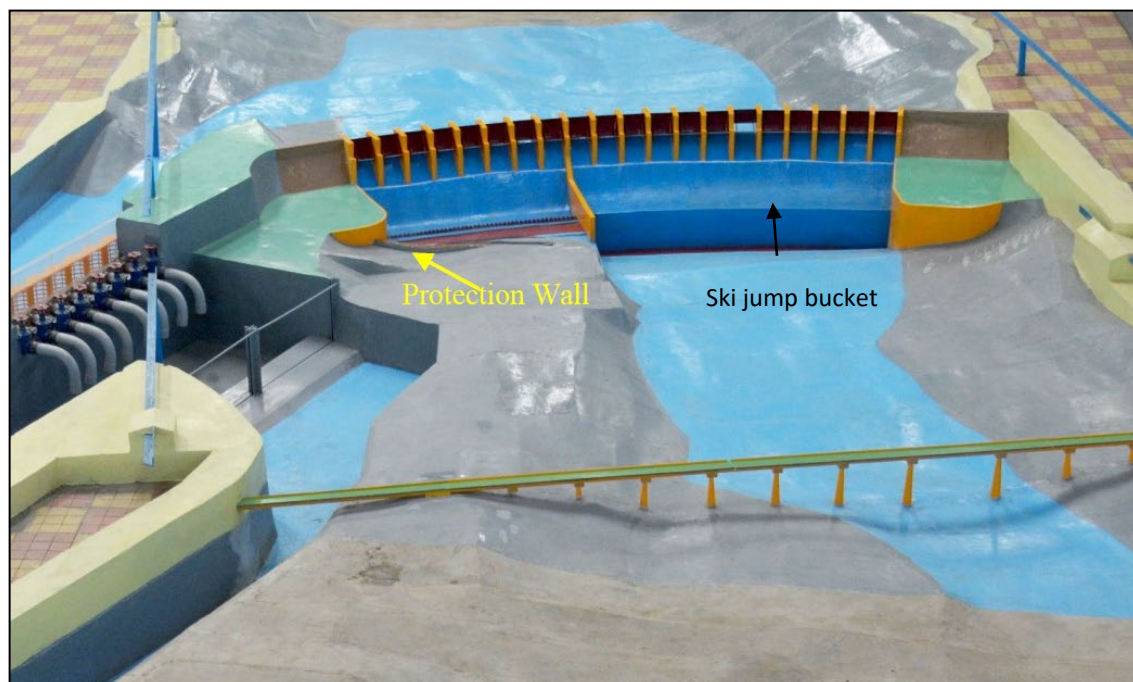
**Photo 5.** Downstream view of spillway with ski jump bucket

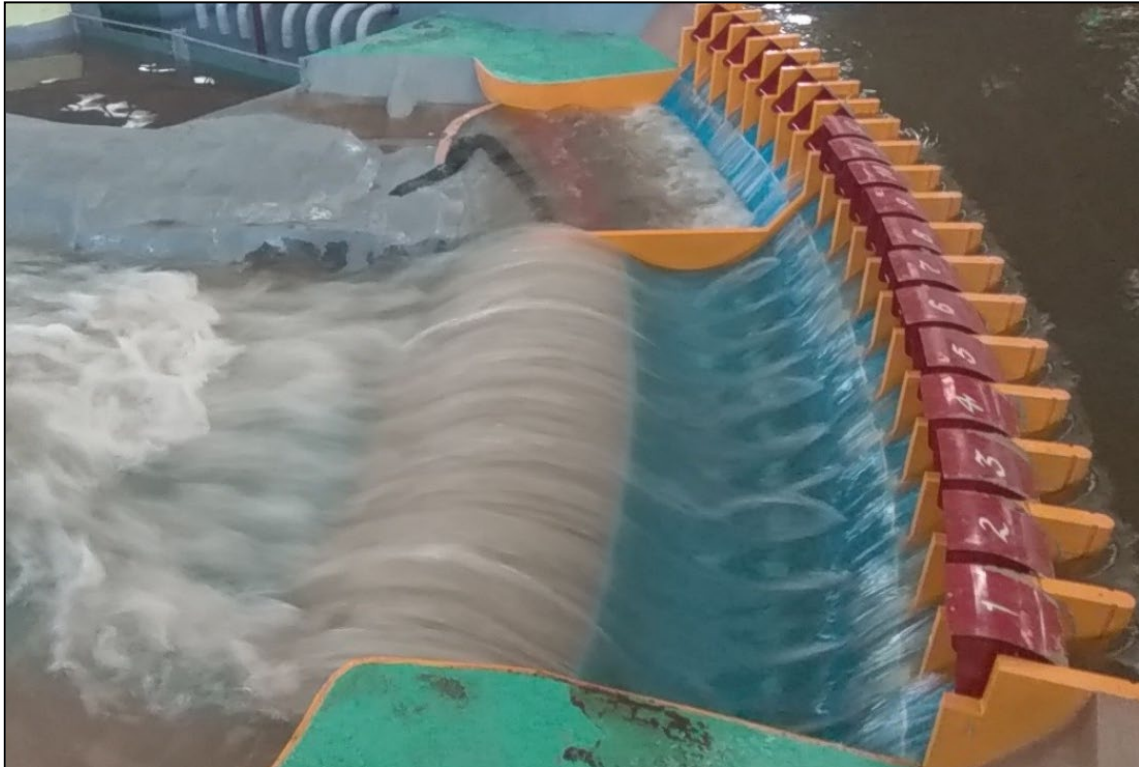
Hydraulic model studies were carried out on a 1: 130 scale geometrically similar 3-D comprehensive model for assessing the performance of ski-jump bucket for various operating conditions of spillway. Studies indicated that the discharges of 55,727 m<sup>3</sup>/s and 62,566 m<sup>3</sup>/s could be passed with the ungated operation of main and auxiliary spillways keeping the reservoir water level at Full Reservoir Level (FRL) at El. 262.13 m and MWL El. 263.35 respectively and at Full Reservoir Level (FRL) El. 262.13 m, the discharge of about 32872 m<sup>3</sup>/s could be passed through the main spillway. Performance of ski-jump bucket of the main spillway was satisfactory as the clear ski action was seen forming in the bucket. The throw distance was found to be about 86 m from the lip of the bucket. Photo 6 shows the performance of ski jump bucket while passing discharge of 32,872 m<sup>3</sup>/s at Full Reservoir Level (FRL) El. 262.13 m with all 12 gates fully open.

**Photo 6.** Performance of ski jump bucket,  $Q= 32872 \text{ m}^3/\text{s}$  at Full Reservoir Level (FRL) El. 262.13 m
