## Electron Beam Induced Current Analysis of Voltage Breakdown Sites in Thin MOS Oxides

ELECTRON BEAM INDUCED CURRENT ANALYSIS OF VOLTAGE  
BREAKDOWN SITES IN THIN MOS OXIDES

Abstract

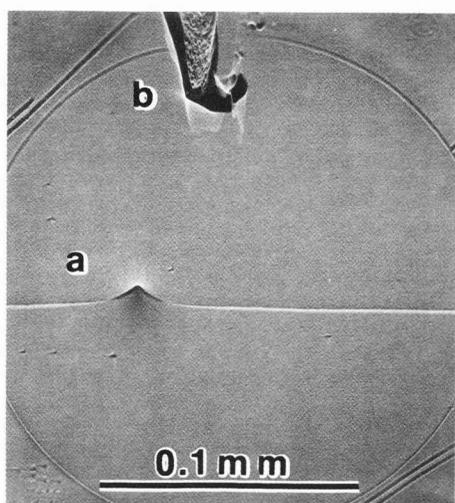
Figure 1: Circular capacitor of  $3.2\text{mm}^2$  area with EBIC spot (a) and probe contact (b) in y-modulation mode.

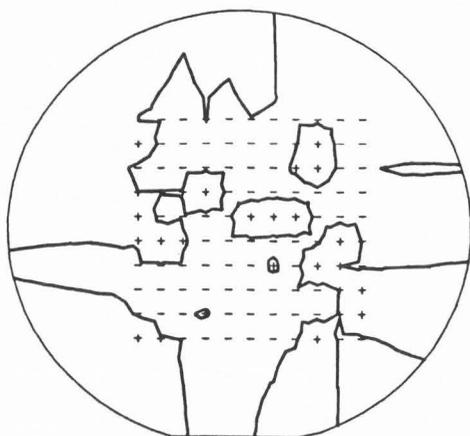
Figure 2 shows a contour map of the spatial distribution of the oxide breakdown voltage. The solid line represents the contour of the mean breakdown voltage of  $5.54\text{V}$ . The + and

Figure 2: Contour map of breakdown voltage data for thin oxide capacitor on a 4-inch Si wafer. (+) denotes site of defective capacitor.

A direct correlation was found between defective capacitor sites, as indicated by (+) in the breakdown voltage contour map, and the observation of EBIC spots. Capacitors whose breakdown voltage was less than 3.51 V showed EBIC spots. Capacitor sites in Figure 2, denoted by (-), where the breakdown voltage was greater than 7.57 V, did not produce EBIC spots under the same experimental conditions.

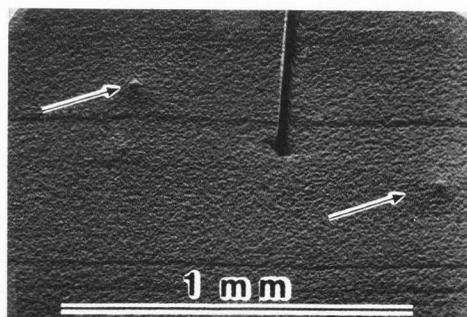
Figure 5: EBIC spots in Y-modulation in capacitors ( $90\text{\AA}$  oxide) as observed in accumulation or depletion.

In Figure 5 typical EBIC spots can be seen in the Y-modulation mode of the SEM. These

EBIC spots were observed in accumulation (-0.75 V bias) and depletion (+0.75 V bias) conditions, as shown in Table 1, with no appreciable change noticeable with respect to bias polarity. The defect site of these EBIC spots is typical for a capacitor location denoted by (+) in Figure 2. The dark line in the center of the SEM micrographs in Figure 5 is due to an inadvertent tungsten probe scratch mark.

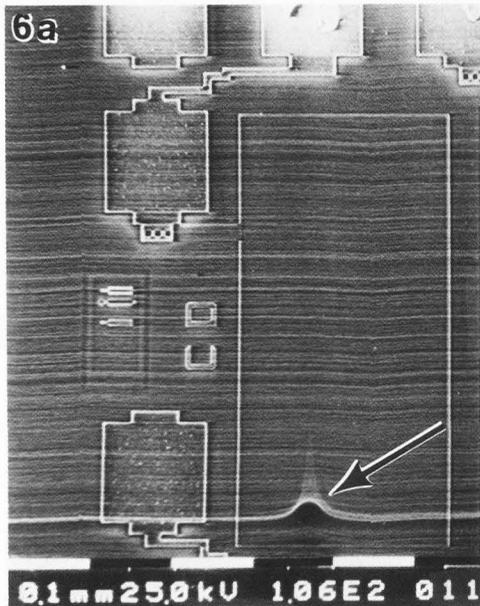
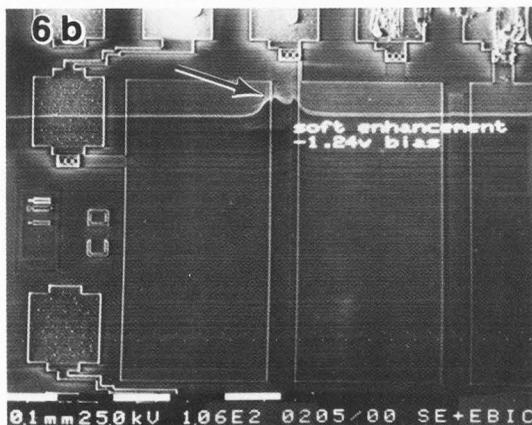
Thin oxide capacitor structures of 450Å thickness, similar to the one shown in Figure 3, have been examined, as well, using the EBIC technique, to locate voltage breakdown sites. Figure 6 displays Y-modulated EBIC signals superimposed on secondary electron images of two capacitors of the same area at different sites on the same wafer. In both cases the capacitors were biased in accumulation. It can be seen from Figure 6 that a defect associated with the EBIC signal can be located within the capacitor's area(a) or at the LOCOS edge(b).

The cause for a defect at the capacitor edge (Figure 6a) can be attributed to the oxide isolation process (Kooi et al., 1976). During preparation of the LOCOS structure, an inadvertent chemical reaction may form silicon nitride (10-20Å) at the Si-SiO<sub>2</sub> interface near the edge of the nitride oxidation mask. Consequently, this anomalous silicon nitride formation hinders the subsequent gate oxide (<100Å) growth. The result is reduced oxide thickness in the area where the silicon nitride was formed. Such a weakened location in the oxide is a very likely site for voltage breakdown.

Defects associated with EBIC spots in the field of a capacitor (Figure 6b) are thought to have their origin in particles. Such particles can be present on the substrate surface or be carried there with the process gases from either the gas sources, the furnace wall or wafer carrier. Proper material and equipment handling can usually prevent particle problems.

Figure 6: Y-modulated EBIC signals, indicated by arrows, on capacitors (450Å), showing different locations of the defects in the oxide: (a) within the field of the capacitor, (b) at the LOCOS edge of the capacitor.

Also proportional is the intensity of the EBIC signal displayed. The size of a Y-modulated EBIC spot, such as shown in Figure 6b, does not reflect the actual size of its corresponding defect. In reality these leakage channels can be expected to be micron or sub-micron features. The amplitude of the EBIC signal does, however, provide a relative measure of defect size, of which the induced current is a direct function. Multiple defects in a capacitor are displayed individually while their current is measured cumulatively.

Authors: The sacrificial oxidation step referred to is part of standard processing during wafer fabrication and prevents the detrimental silicon nitride growth. For the sample shown in Fig. 6b, however, this procedure was not used and the defect, as shown by EBIC, has resulted.

This problem can be controlled by introducing a sacrificial oxidation step prior to the gate oxide growth which consumes enough silicon to eliminate the small silicon nitride growth. The oxide then is stripped to provide a clean surface for the gate oxidation step.
