Hazard Analysis of a Segment of Highway SR-12 through Bryce Canyon National Park, Southern Utah

HAZARD ANALYSIS OF A SEGMENT OF HIGHWAY SR-12 THROUGH BRYCE
CANYON NATIONAL PARK, SOUTHERN UTAH

Tomsen Reed

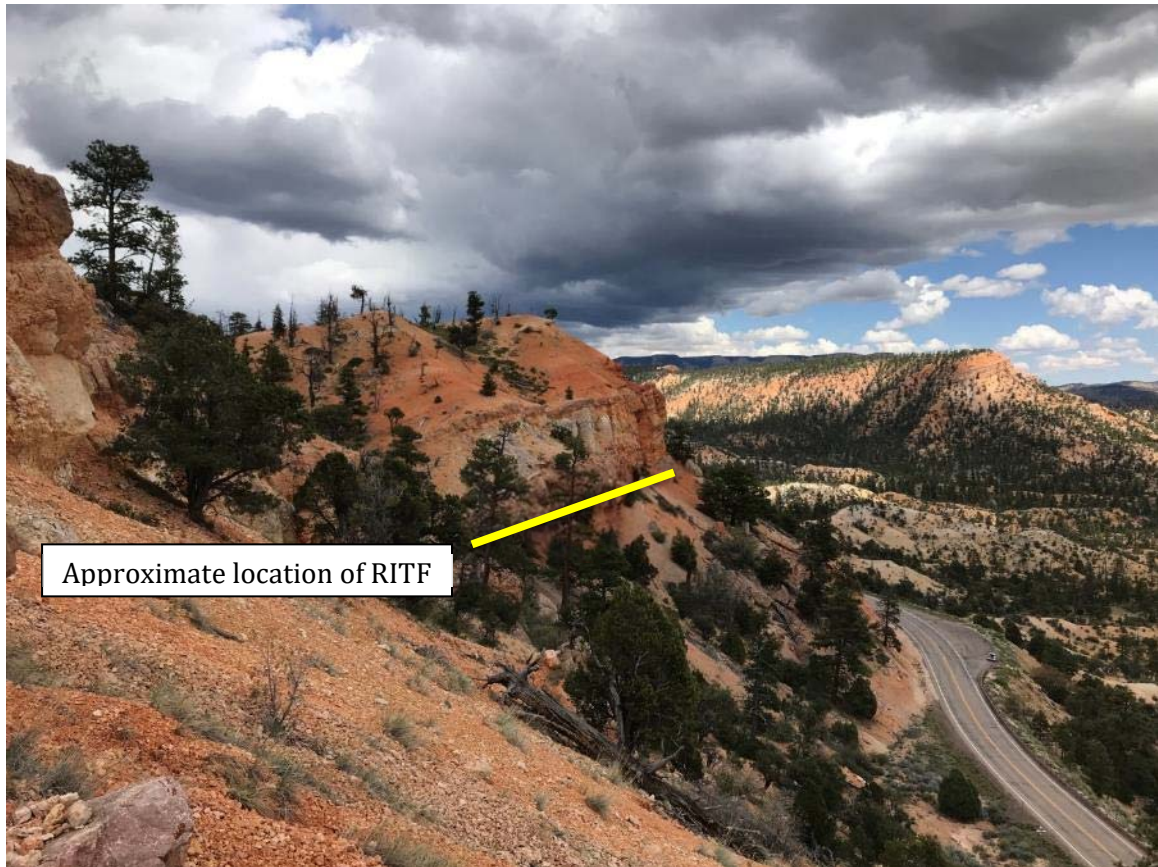
Figure 3 - Cliffband above a toeslope leading down to SR-12, view looking east.

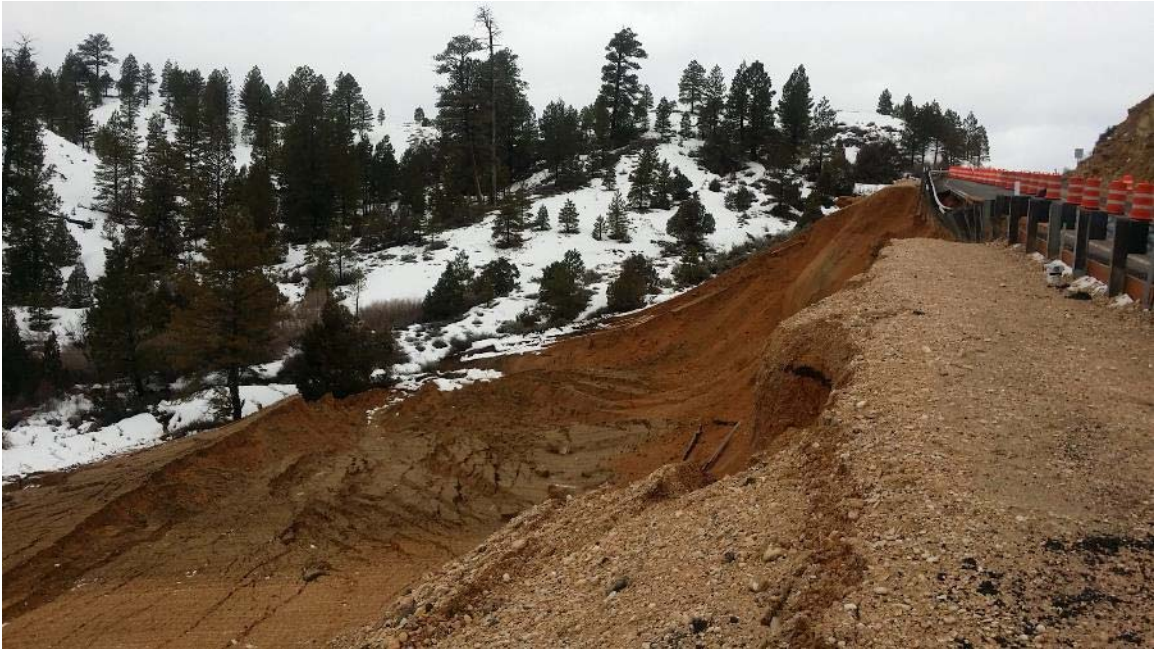
More directly, rockfalls could have devastating impacts because of the sharp turns, low visibility, and steep drop-offs in the study area. A landslide occurred in the study reach in 2017 (Figure 4) and emergency repairs cost over \$2.6 million dollars (UDOT, 2019).

Figure 4 - Landslide along SR-12 in 2017 looking west, photo credit UDOT.

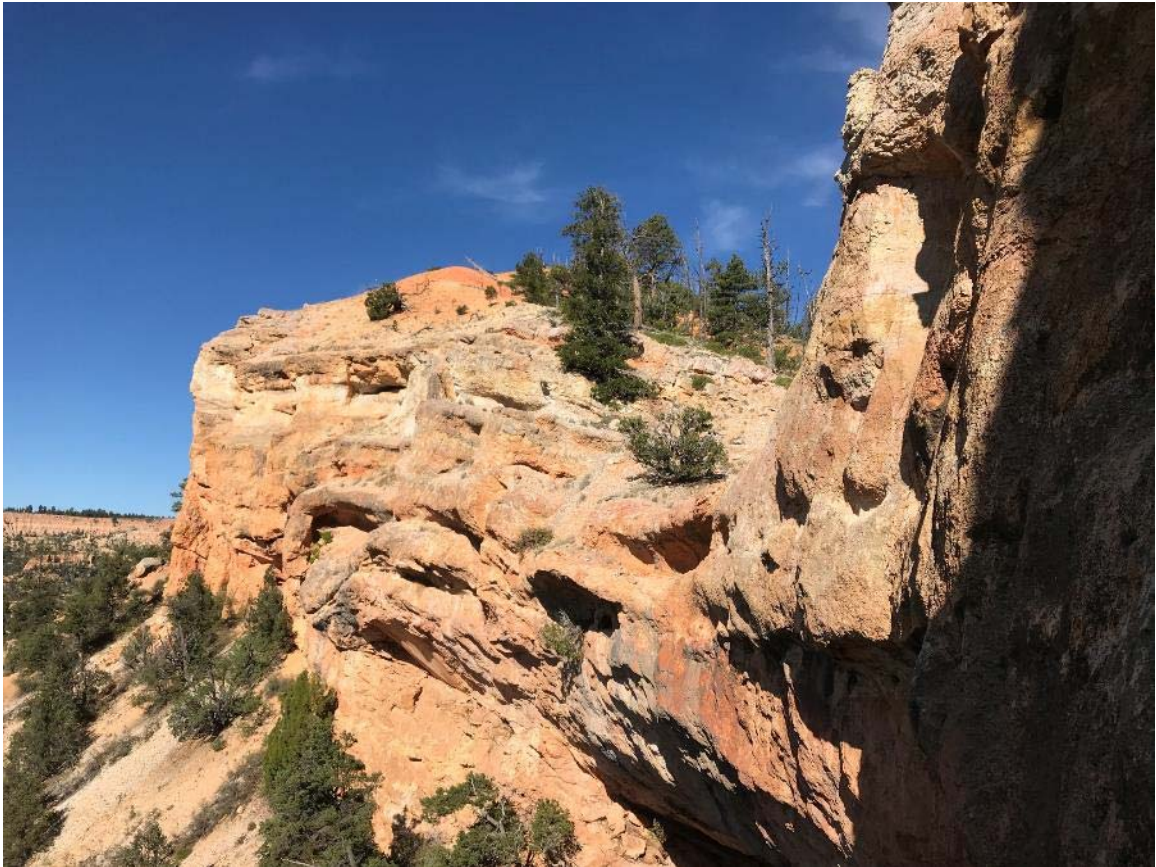
Figure 10 – Typical outcrop along the RITF, cliffs approximately 20 to 30 meters tall. RITF at the base of the cliff

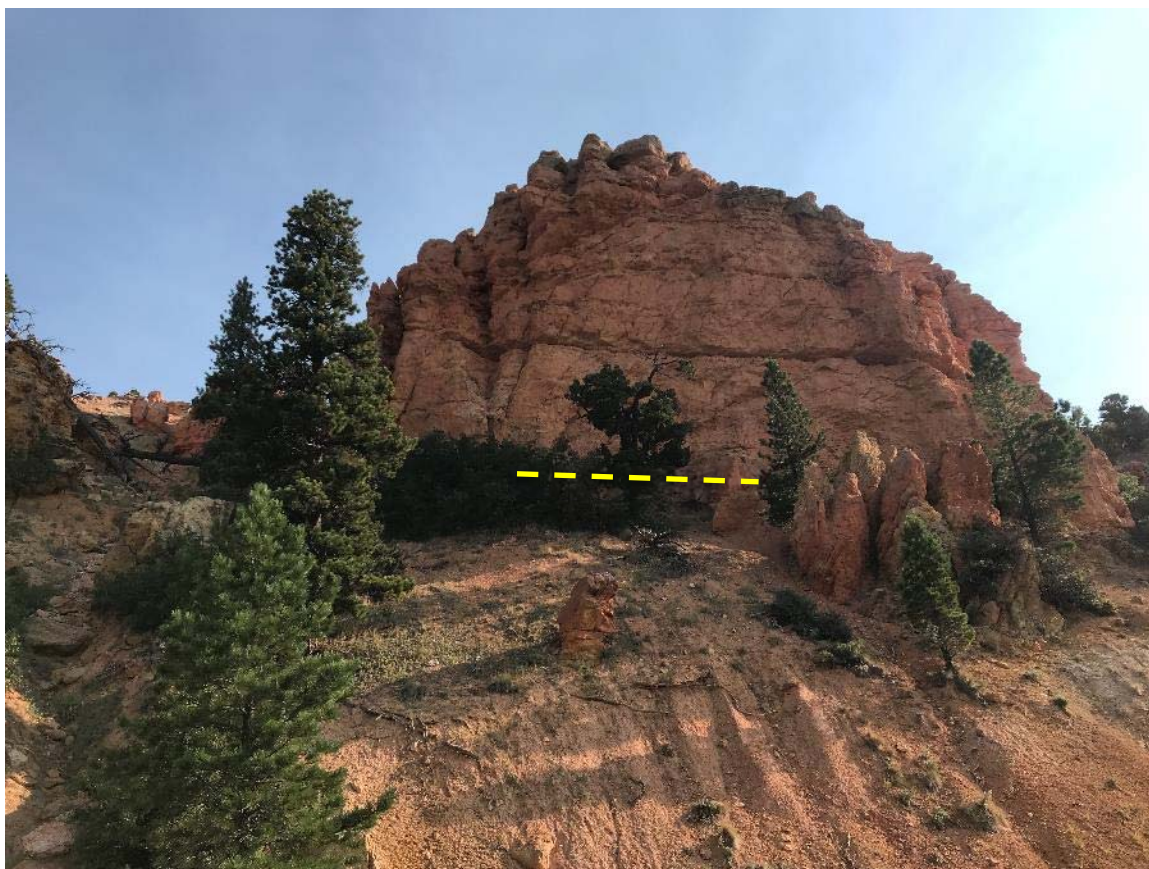
Scanline 1 was performed at an outcrop that is approximately 30 to 35 meters high, and contained 3 main units that could be observed from the scanline location, at the base of the cliff: a lower, highly altered unit that was truncated laterally by a fault in the outcrop, a dolomite, and a limestone (Figure 24 and Figure 25). The dolomite overlies the limestone, and continues vertically for several meters above the scanline location. Observations of the upper portions of the cliff could not be made due to access.

Figure 24 - Upper portion of outcrop where Scanline 1 was performed (scanline location obscured by the trees, but general location marked in yellow dashes). View looking north, and up at the outcrop from the roadway

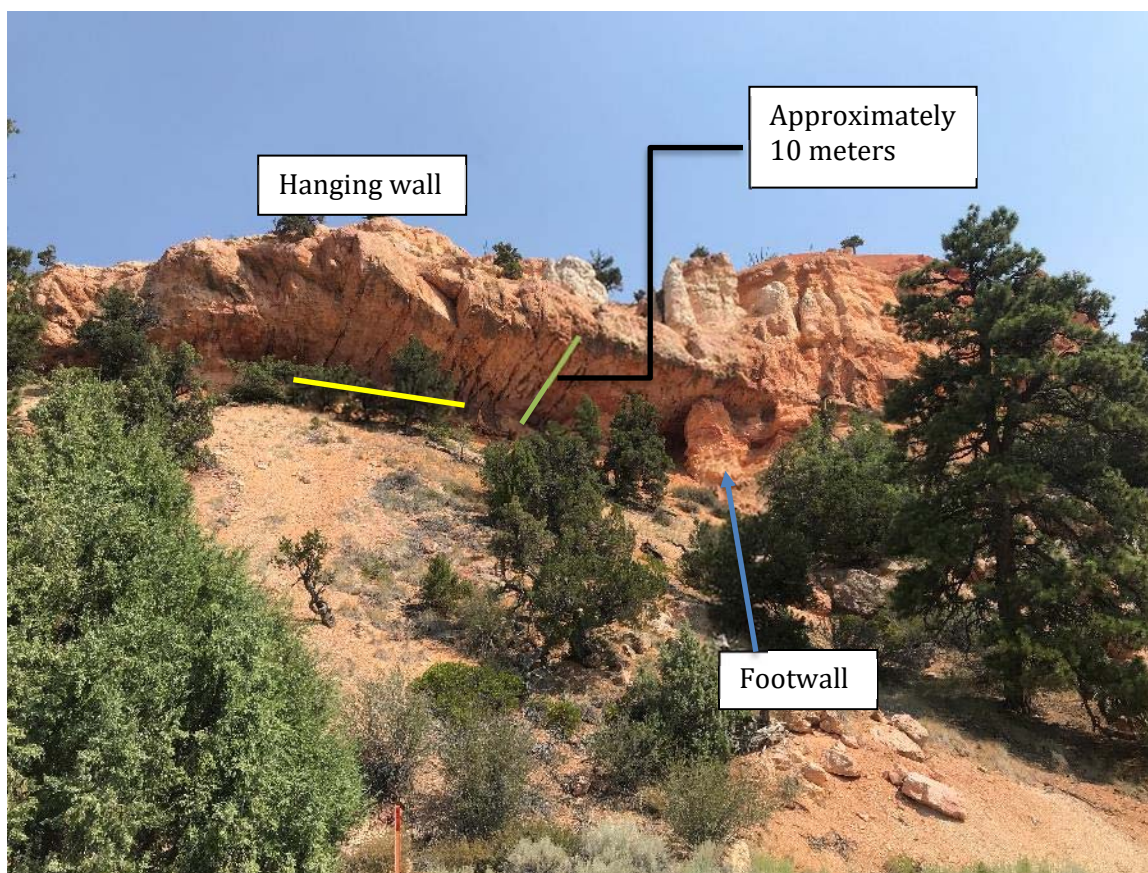
that could be observed from the scanline location: a footwall unit and a hanging wall unit. The unit in the footwall was interpreted to be weak calcareous mudstone that was not included in the scanline data collection (Appendix A for additional description). The footwall at this location eroded out much more quickly than the overlying hanging wall material, leaving a large overhang above the thrust fault (Figure 31).

Figure 31 – Outcrop view of location of Scanline 2 (marked in yellow, behind the vegetation). Note the large overhang, and small portions of footwall material underneath the overhang, but mostly eroded away. The overhang extends approximately 8 meters out from the back of the wall (scanline location) to the cliff face. View looking north from the roadway.

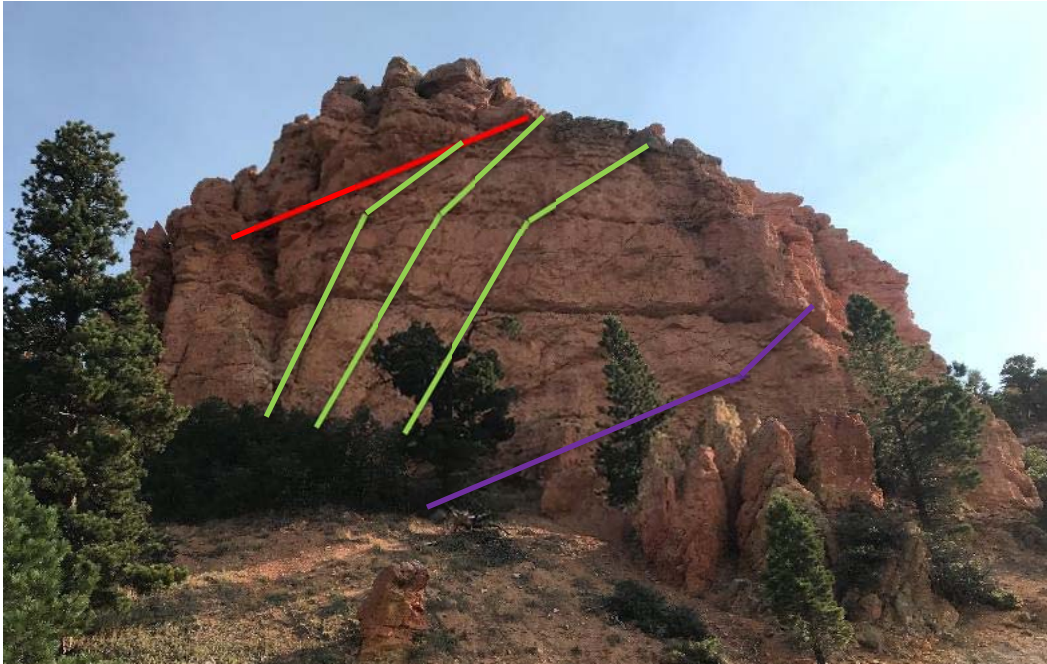
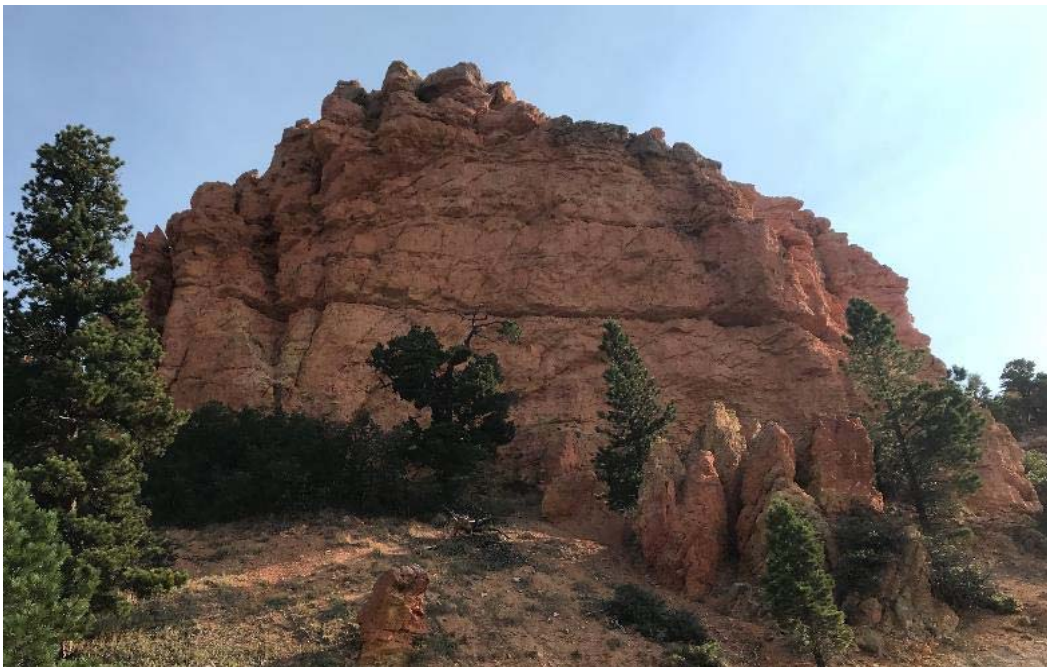
Figure 49 - Scanline 1 with major fractures marked in green, thrust fault strand marked in red, and a long, prominent fracture marked in purple which is not part of a major set (upper photo), and unmarked but visible (lower photo)

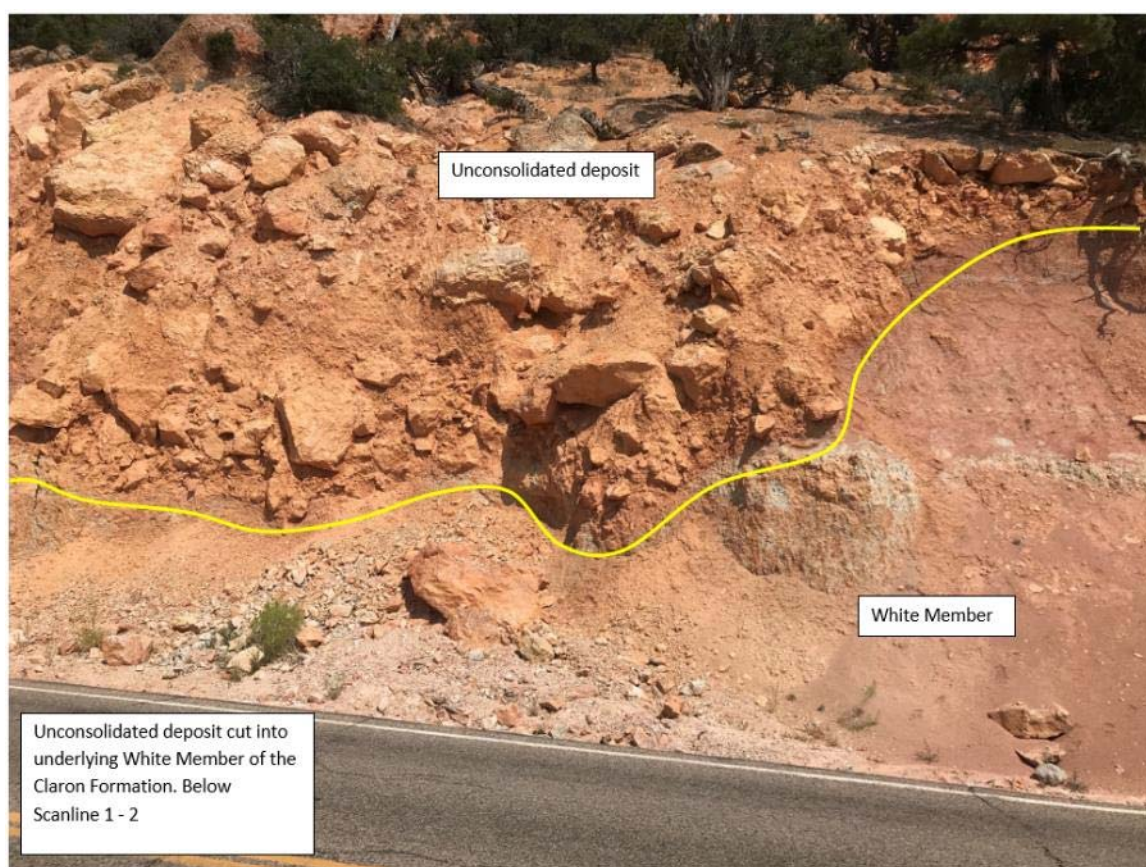
Figure 61 – Photograph of an unconsolidated deposit that has scoured out part of the underlying White Member bedrock and replaced it. This photograph was taken from the roadway between Scanlines 1 and 2, looking north. Labeled Photo 2 on the geologic map in Figure 60.

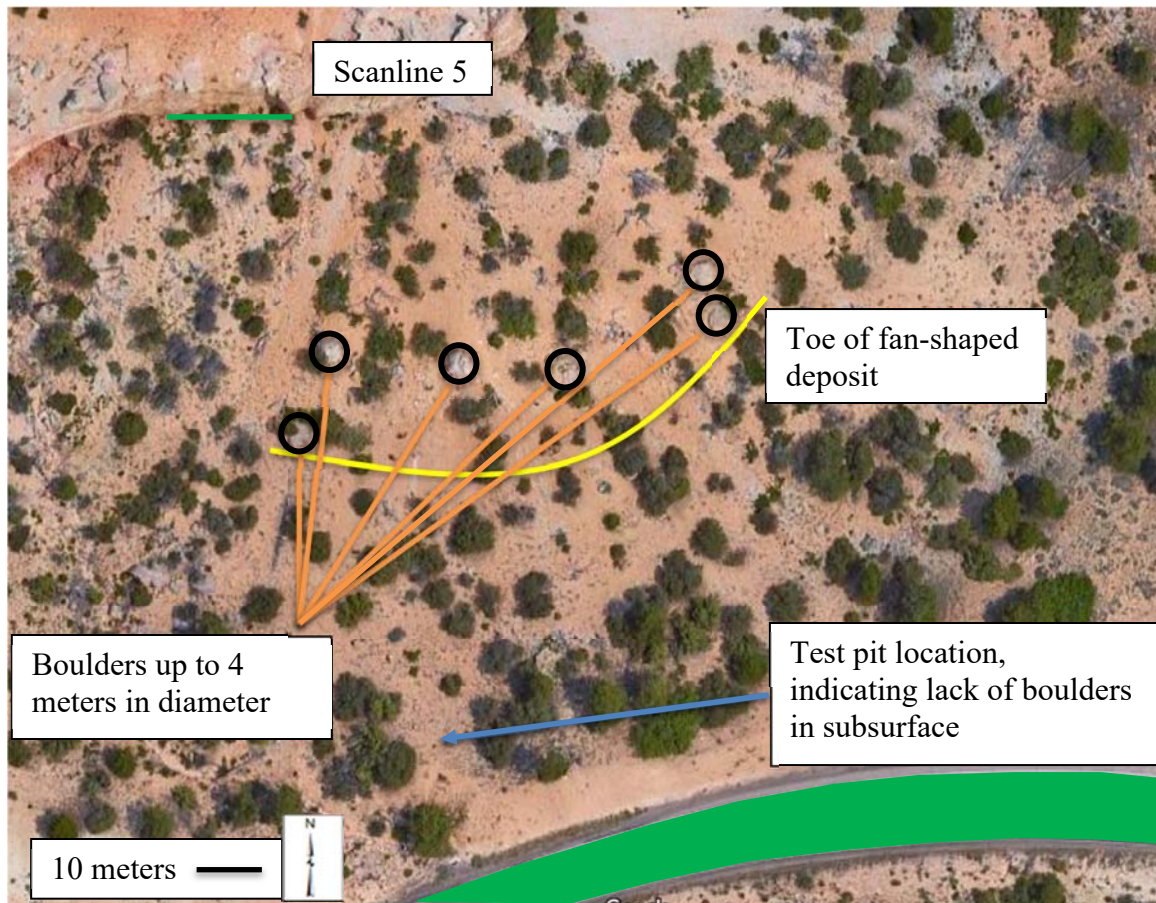
Figure 64 – Google Maps imagery of a fan-shaped deposit where boulders from the Scanline 5 cliffband appear to stop, well above the roadway. See Appendix C for test pit log, 19-TP-14. Green on roadway indicates this is an area of low rockfall hazard (Figure 63)

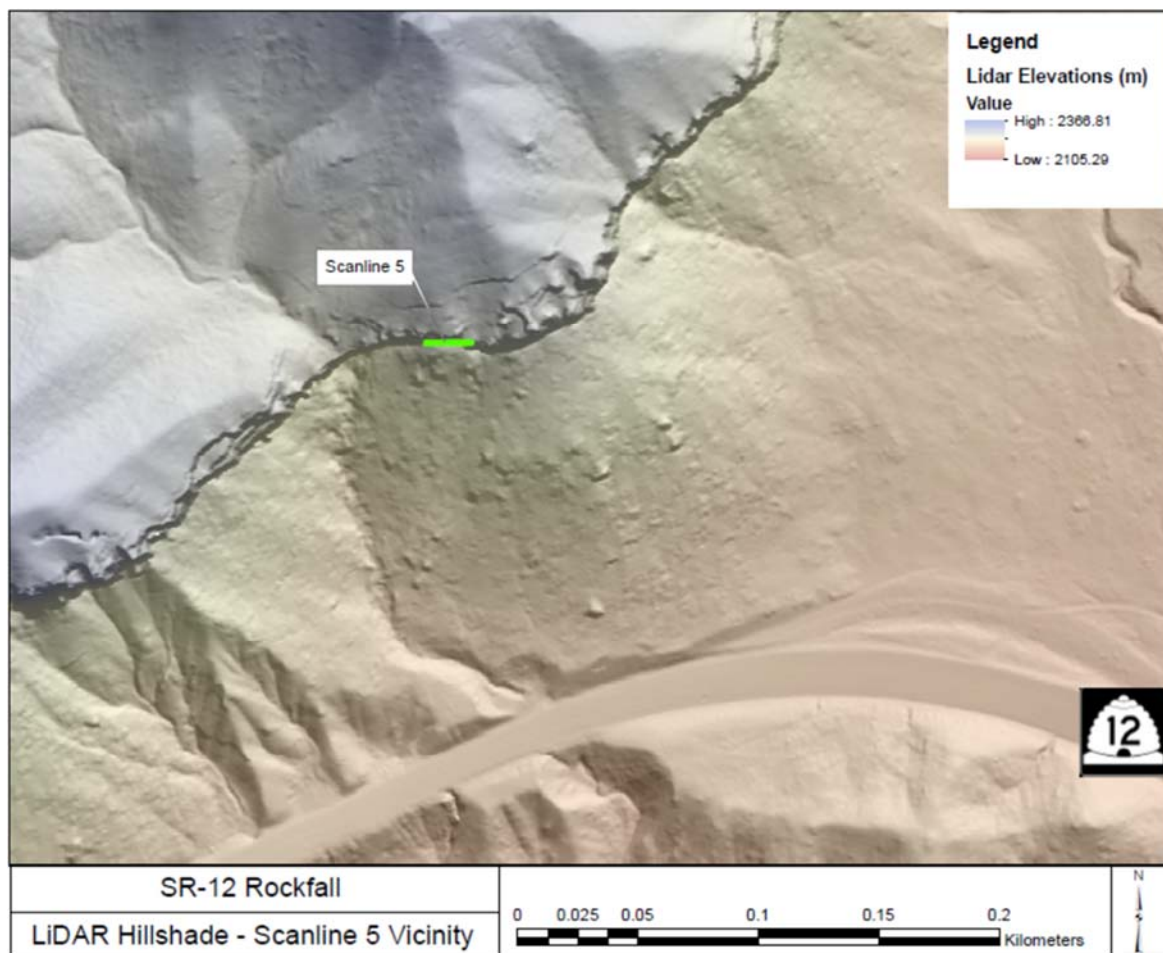
Figure 65 – LiDAR hillshade in the vicinity of Scanline 5, showing a fan-shaped deposit where boulders from the Scanline 5 cliffband appear to generally stop, well above the roadway.

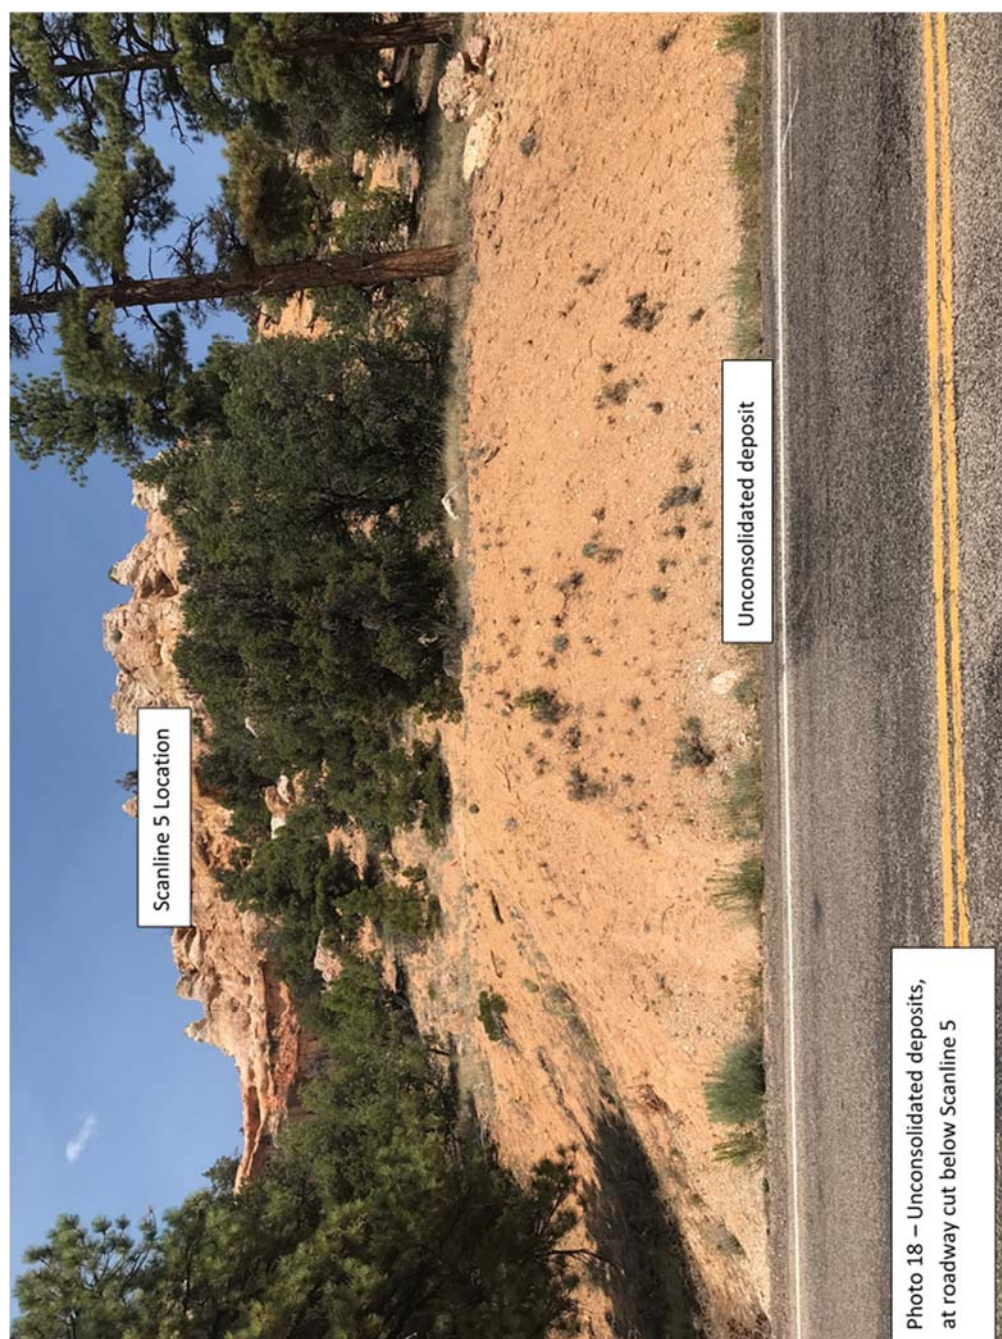
Figure A-20 – Photograph of unconsolidated deposit in roadway below Scanline 5

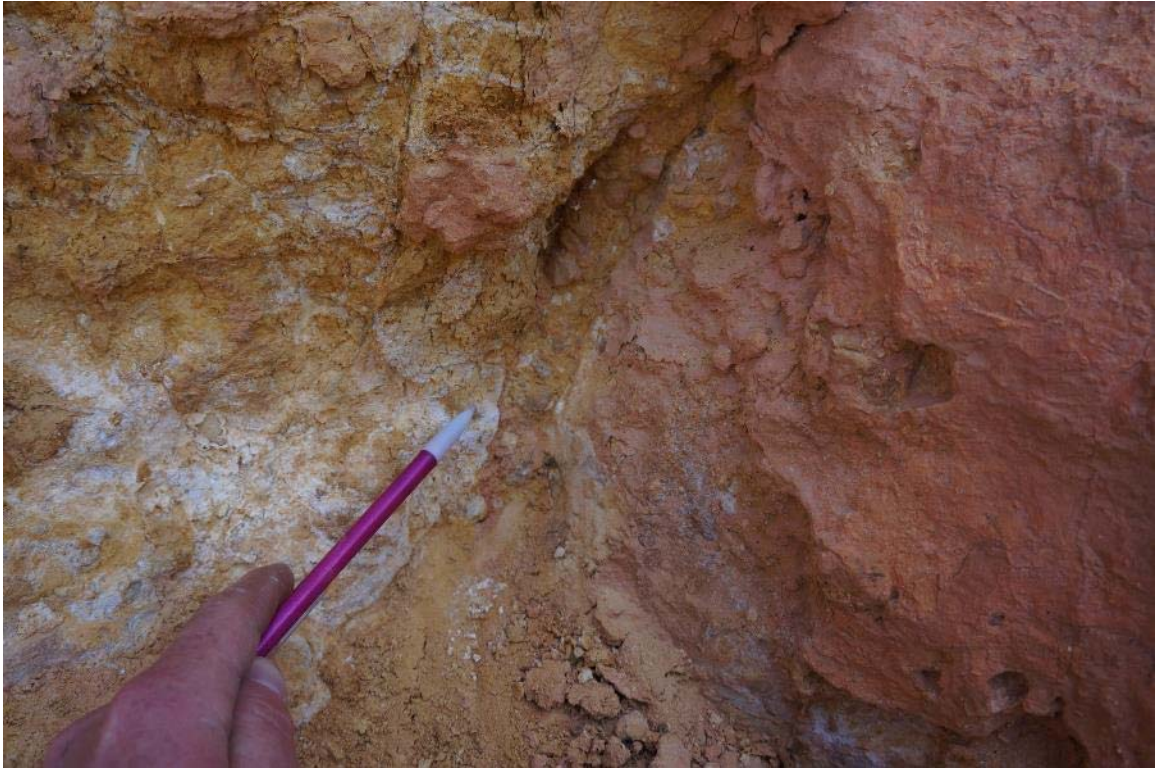
Figure A-23 - Altered unit near Scanline 1, pencil (15 cm. long) for scale. Pencil pointing to a possible fault zone, with what appear to be clasts of Pink Member of the Claron Formation mixed in with the yellowish brown sandy matrix.

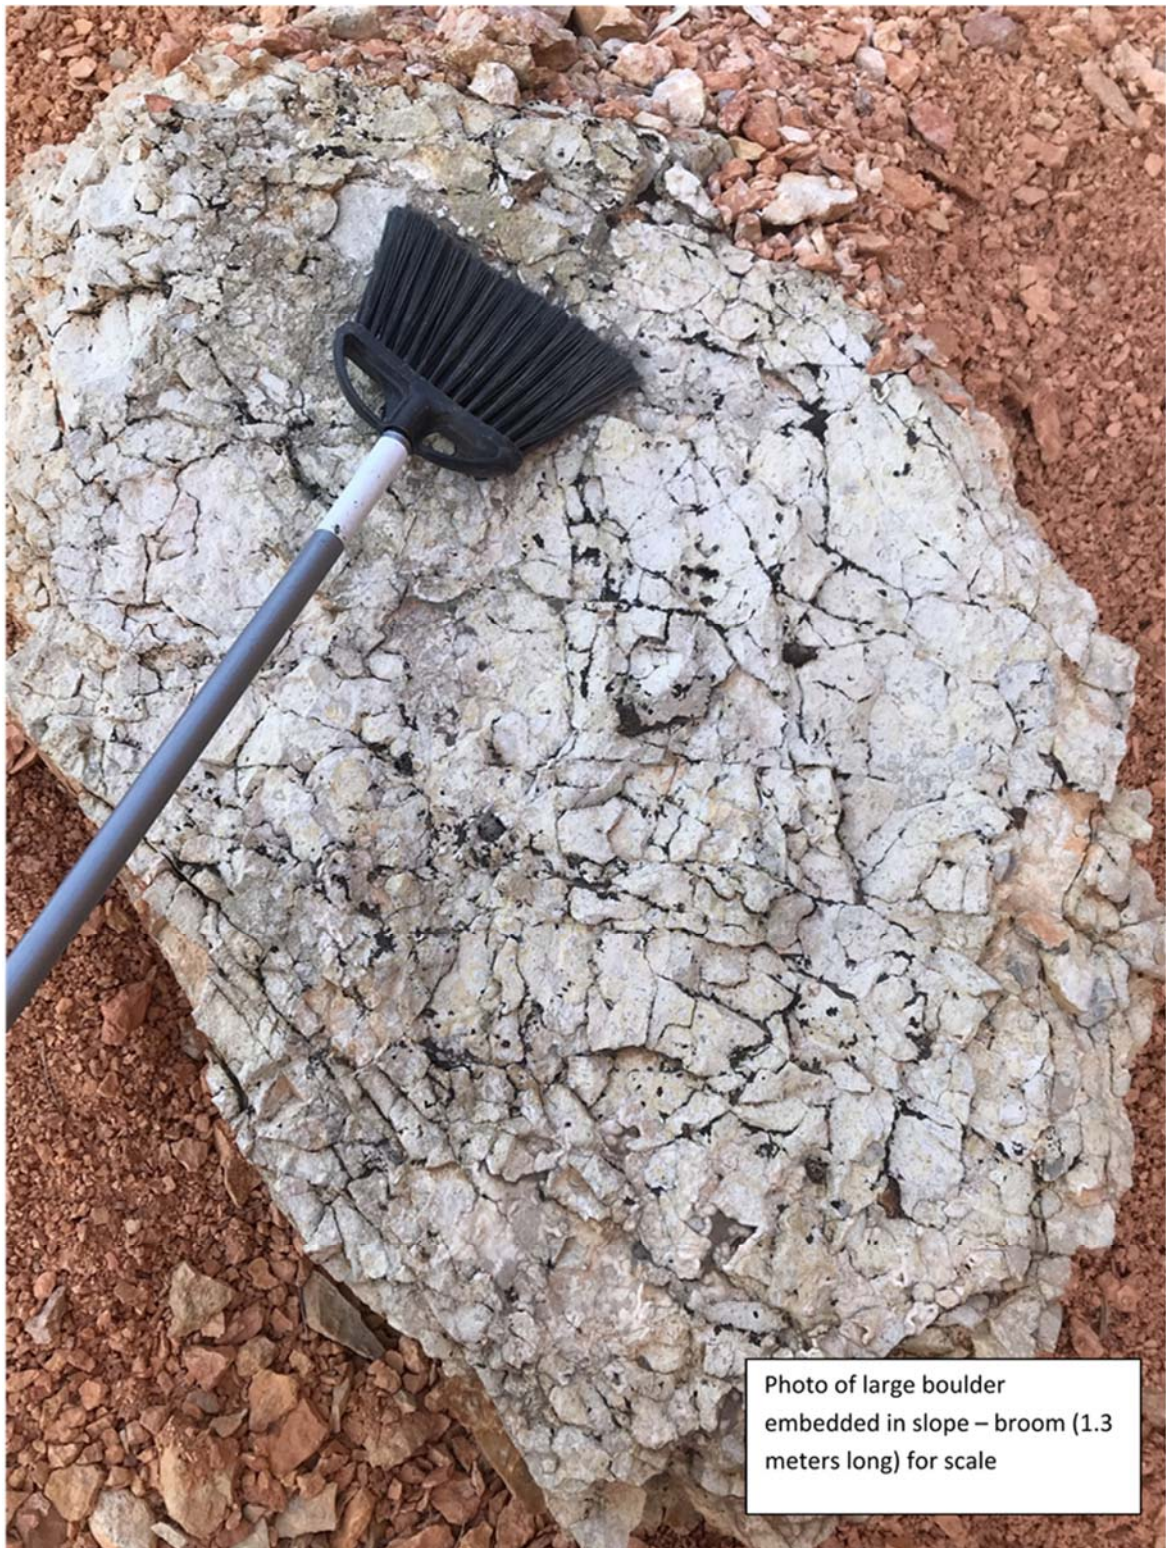
Figure C-3 – Photo of boulder found during field studies, indicating both the size of potential rockfall blocks and the potential for blocks with dissolution cleavage to still release in a larger mass

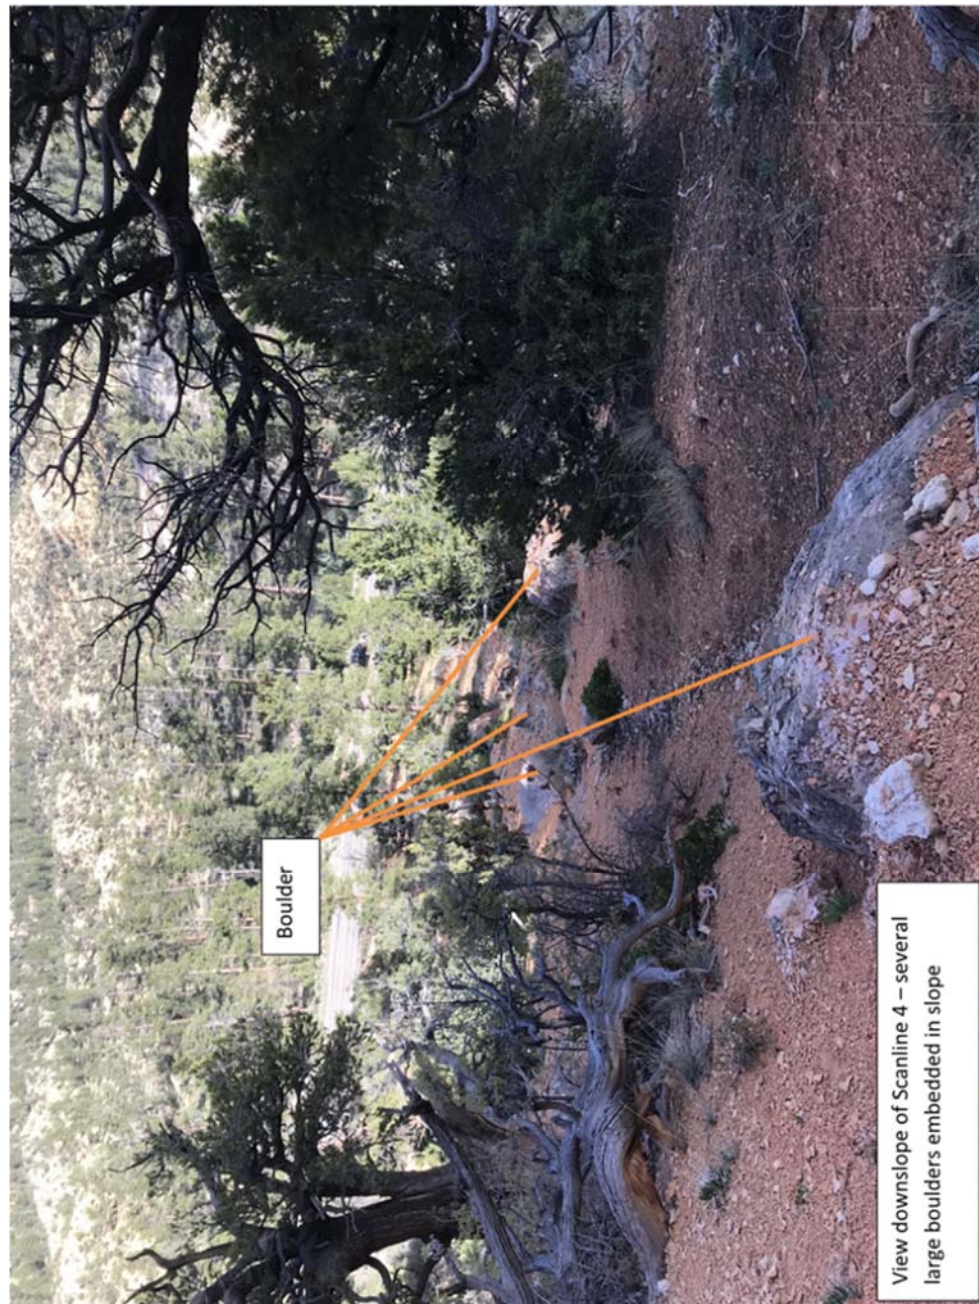
Figure C-4 – Large boulders partially embedded in the slope near Scanline 4

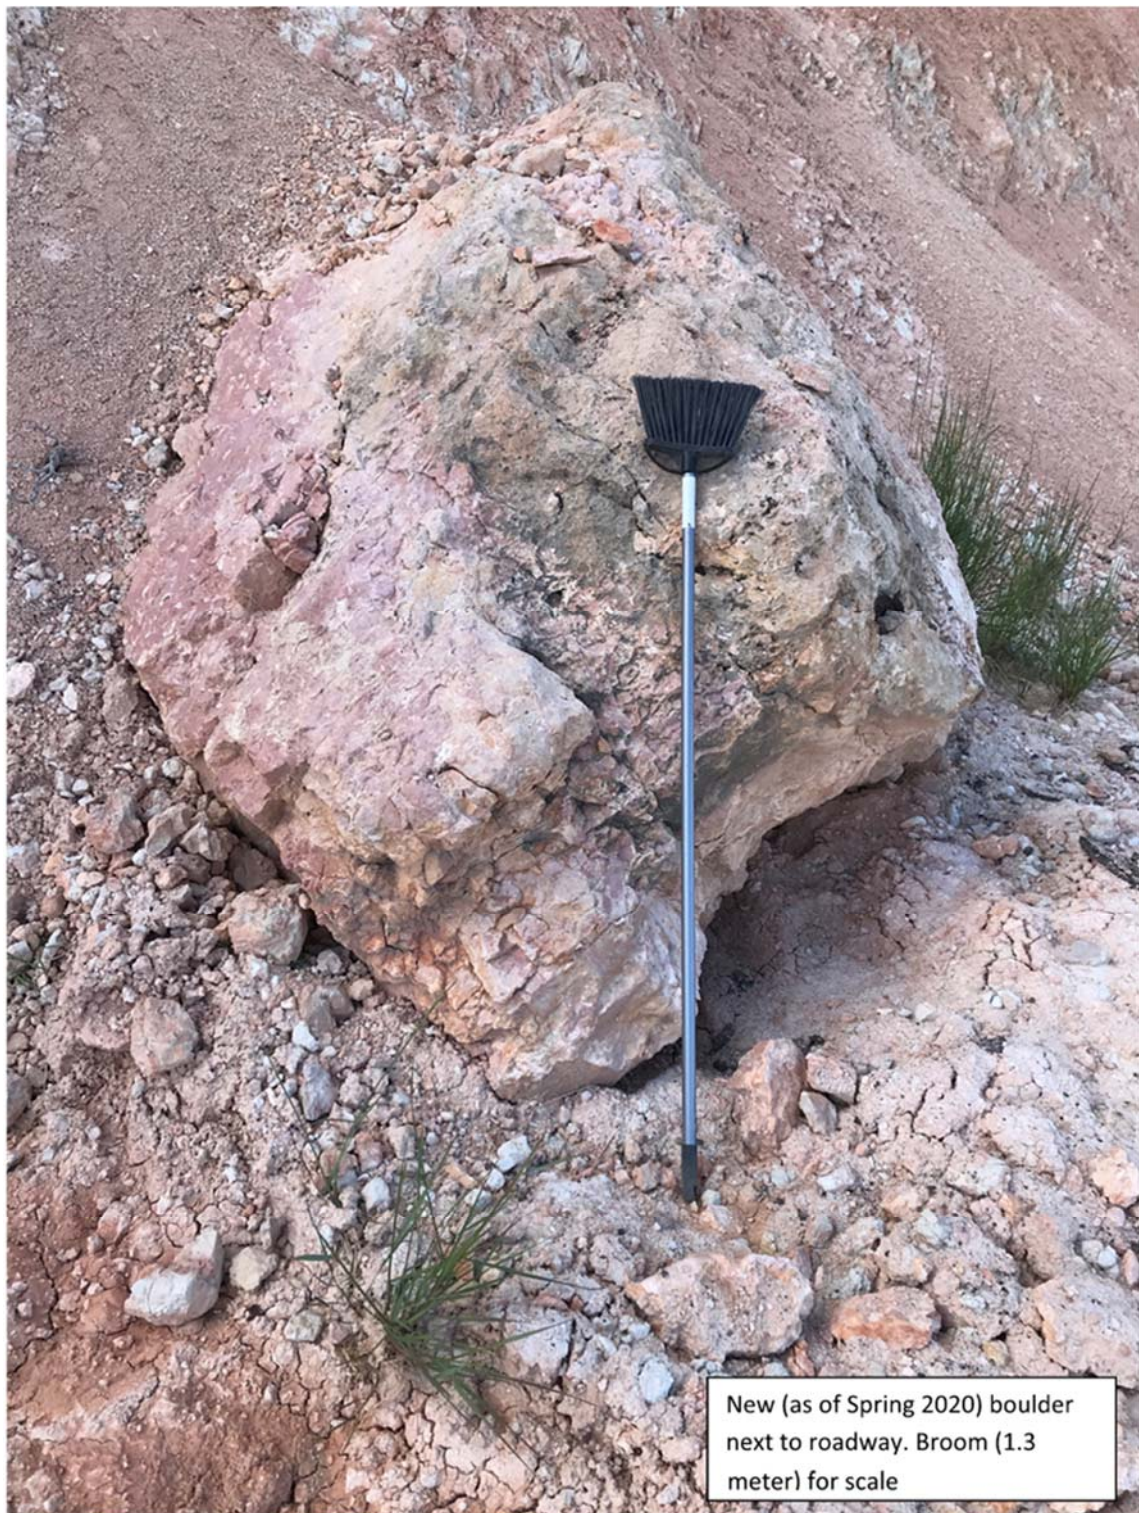
Figure C-7 – Large boulder at roadway level between Scanlines 2 and 3, new as of Spring 2020, appears to have been pushed off the road or shoulder

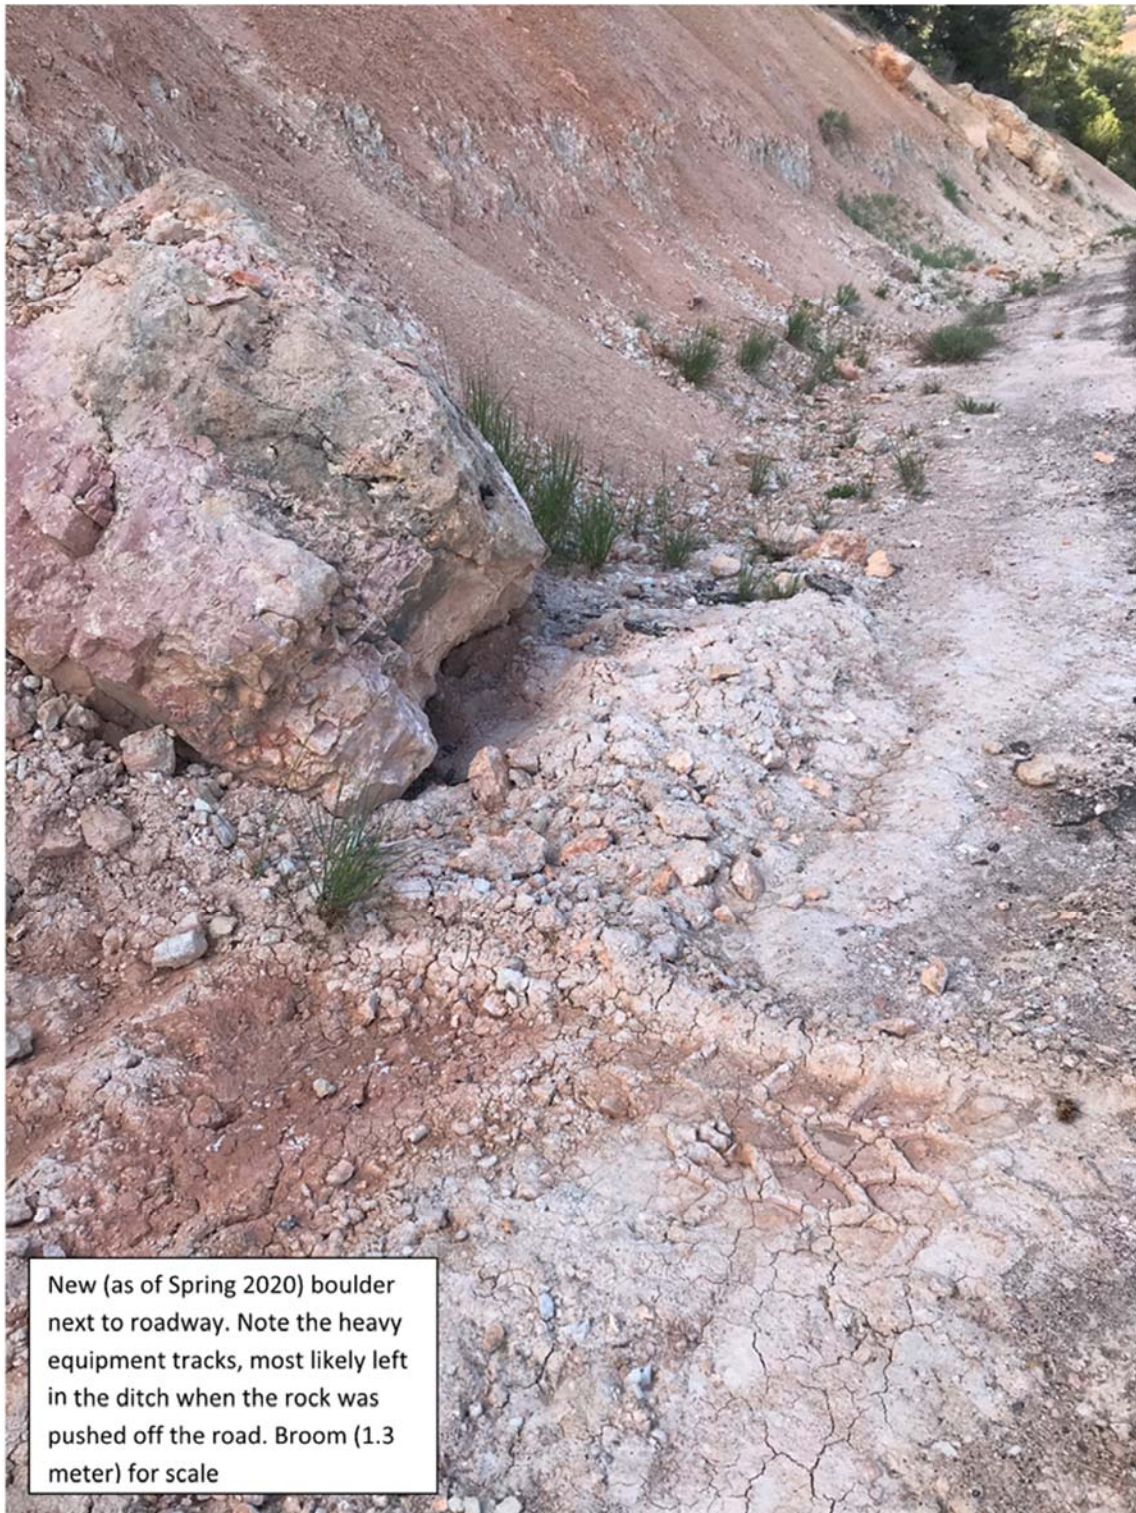
Figure C-8 – Additional photograph of the new boulder shown in C-7

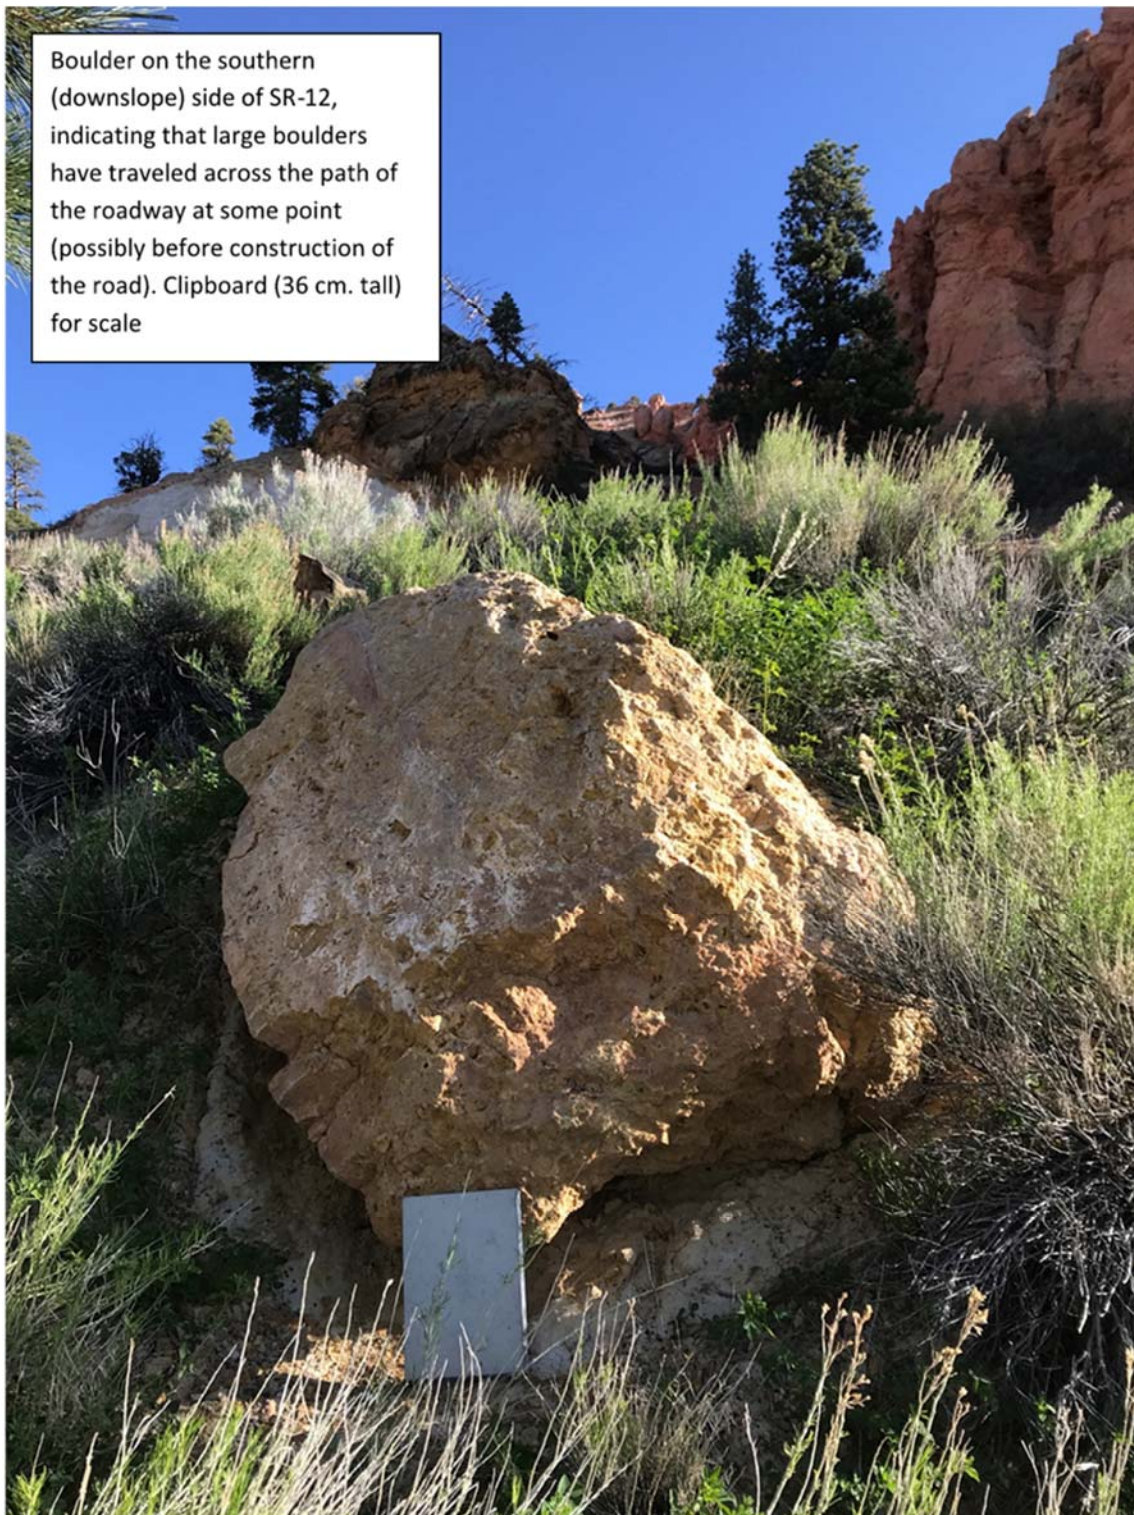
Figure C-9 – Photograph of boulder below highway level
