Dellingr: Reliability lessons learned from on-orbit

Larry Kepko, Luis Santos, Chuck Clagett, Behnam Azimi, Dean Chai, Alan Cudmore, Scott Starin, James Marshall,
John Lucas
NASA Goddard Space Flight Center
Space Weather Laboratory, Greenbelt, MD, 20771; 301-286-2728
Larry.kepko@nasa.gov

Table 1. Dellinger on-orbit event list

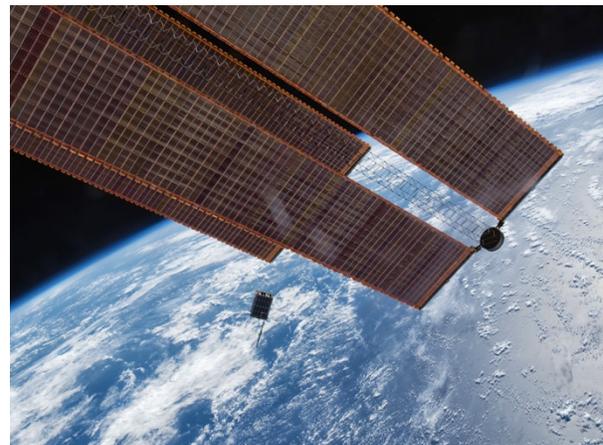
Even with the low resolution live feed it was quickly apparent that Dellinger had experienced the first anomaly of on-orbit operations, just seconds into the mission: The magnetometer boom and UHF antenna deployed immediately upon ejection, despite a 30-minute built-in delay timer. Figure 1 shows a high-resolution image of Dellinger deployment. The magnetometer boom is seen clearly pointed to the lower part of the picture, as are the UHF antenna.

Figure 1. Photographs of Dellinger’s deployment confirmed that both the magnetometer boom and the antenna deployed immediately upon ejection from the NanoRacks deployer.

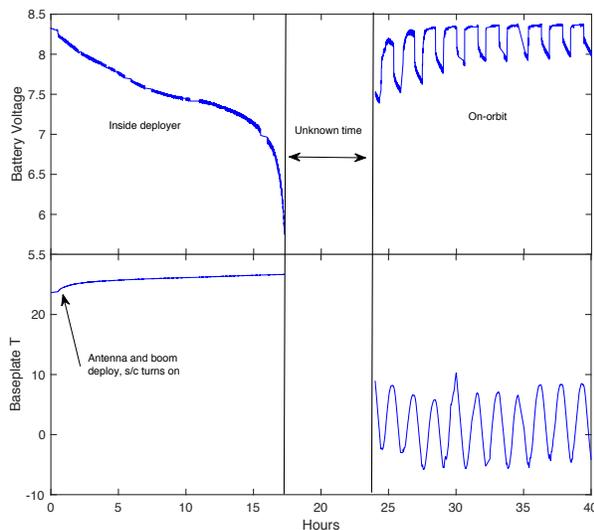
Analysis of the onboard data collected prior to deployment is consistent with the satellite having turned on while still inside the ISS. Figure 2 shows the battery voltage and temperature for the first hours of Dellinger’s mission and includes pre- and post-deployment data. The system clock booted into a default epoch, as it was intended to sync with GPS once deployed, so the initial time of the pre-deployment data is unknown. But we can infer the most likely scenario for when this initial deployment occurred.

system. The battery voltage depleted slowly over the course of 17 hours until the safety circuits, triggered off the low voltage, shut down the power system. At this point, the satellite was still inside the deployer with uncharged batteries. The satellite turned on again after deployment from the ISS (approximately hour 24 in Figure 2), once the batteries had recharged sufficiently via power from the solar panels. The time between the EPS shutoff due to low battery voltage and the turn-on once batteries were recharged is unknown, since the internal clock was reset. The 7-hour gap in Figure 2 is for illustration purposes only.

Figure 2. On-orbit battery voltage (top) and temperature (bottom) telemetry indicates that Delligr had turned on inside the deployer while onboard the ISS. After deployment the spacecraft tumbled until the batteries recharged sufficiently to turn the spacecraft back on, at which point it acquired the sun, and entered stable sun-point mode.

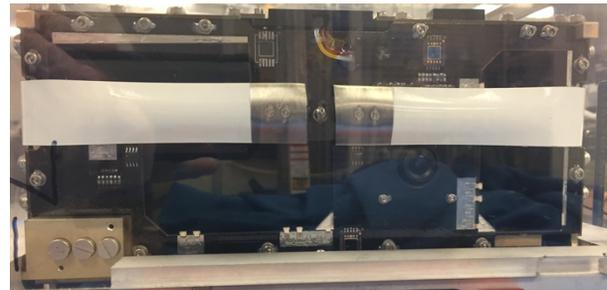
redundancy. The most likely timeframe is between removal of the deployer preload aboard ISS and robot arm operations. Our leading theory suggests that the clustering of the sensors on a small surface area of the spacecraft combined with the NanoRacks deployer geometry lead to an inadvertent release of the switches.

Figure 3 shows the location of the three Delligr separation switches, which are concentrated in a corner of the 2U face (bottom left). This side of the satellite rested against the deployer door. From delivery to pre-deployment, a static preload was applied to keep the satellite from moving during launch and handling. During ISS operations, the preload was removed by an astronaut, thereby removing pressure at the door, and causing the door to move 0.025". In principle, the pusher plate should have had enough force to depress the switches against the door and maintain the inhibit. It is believed that interactions between pusher plate, clearances on the rails, ganged switches, door movement, and friction caused a distribution of pusher plate force that was not sufficient to keep switches pressed down in the off position. We confirmed that the satellite waited 30 minutes after disengagement of the switches to deploy the boom and antenna (Figure 2).

Figure 3. Delligr's separation switches were located at the bottom left corner of a 2U face and depressed by pressure against the NanoRacks deployer door.

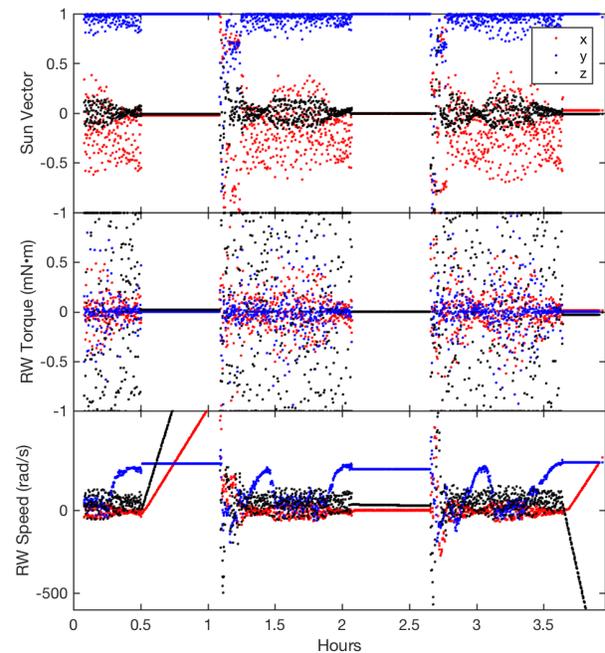
The effects of this noisy sun sensor data were twofold. First, the reaction wheel torque commands (Figure 4 middle panel) shows that the spacecraft was heavily torquing the wheels to respond to what it believed to be pointing errors, often to maximum torques and with rapid switches in direction. Second, the sensor noise made it impossible for the Kalman filter to converge on a good attitude solution to achieve eventual ram pointing for mass spectrometer science. Since this impacted INMS science operations, this issue halted the progression of the commissioning phase until the team could determine the source of the noise.

Another anomaly observed, shown in the bottom of Figure 4, is the occasional increase of reaction wheel speed to maximum values during eclipse. The speeding up of the wheels, which was later attributed to a software bug, by itself was not a major concern, as the small CubeSat wheels could not destabilize the spacecraft, and after exiting eclipse the spacecraft appeared to reacquire sun-point mode fairly quickly. Since it was not related to the pointing accuracy issue observed during sun pointing, and as it did not seem to adversely affect the system, we deferred further investigation of the wheel speed-up issue.

Figure 4. The ACS system exhibited noisy sun vector solutions (top panel), particularly in the x component, which resulted in heavy commanding of the reaction wheels (middle panel). Reaction wheel speed also exhibited unexpected behavior during eclipse. (bottom panel), sometimes accelerating to maximum value.

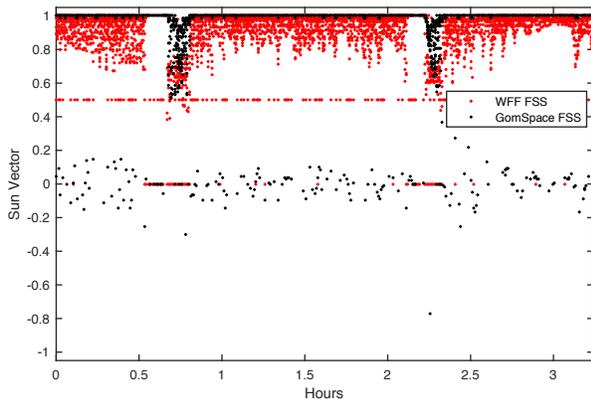
sensor was used, in an effort to reduce spacecraft bus telemetry size. The team commanded the spacecraft to retain individual sun sensor data to investigate sun sensor performance. Figure 5 shows simultaneously collected Y-axis (6U face, nominally pointed towards the sun) data from the in-house and GomSpace sun sensors. The figure shows the WFSS produced noisy and erroneous sun vector data, while the GomSpace accurately reported stable sun-pointing. Stable pointing was also confirmed by the energy entering the system from the solar panels. Erratic sun pointing such as the one reported by the in-house sun sensor would show non-constant power harvesting, but this was not observed. Despite a noisy FSS, stable sun-pointing was achieved since the control algorithm was designed such that random noise errors canceled. The resulting torque commands on the reaction wheels were a major concern, however, because they were driving the reaction wheels very hard and changing direction.

Figure 5. Delligr was commanded to send data from both sun sensors in an attempt to pinpoint the source of noisy sun vector data. Sun-pointing is indicated by a value of 1.

Diagnosing and solving the problem without a second sun sensor would have been difficult. The information in-hand indicated noisy in-house sun sensor data and the failure detection and correction on-board did not switch to the secondary sun sensor because noisy data was not considered a credible failure mode. The team switched off the in-house WFSS, to verify that the FDC would switch automatically to the backup GFSS. As expected, FDC performed as designed, and the sun vector data became very clean once the in-house WFSS was switched off, then noisy again immediately when the in-house WFSS was turned back on (Figure 6). Figure 6 also shows the reaction wheel torque, demonstrating a more stable control while utilizing the GomSpace sun sensor.

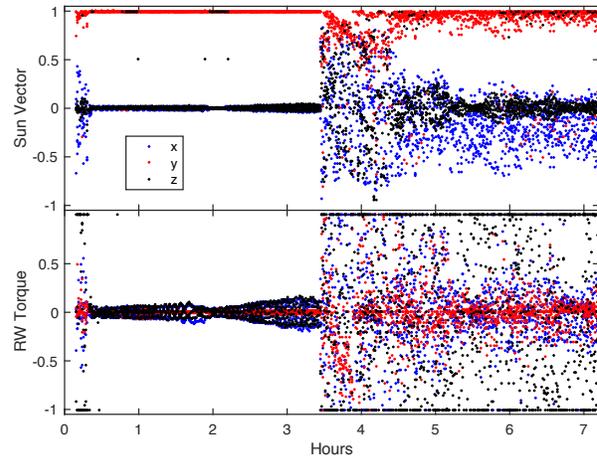
Figure 6. Delligr carried two fine sun sensors. From ~0.5-3.5 hours, the GomSpace FSS was active and indicates accurate sun pointing with Y-axis measuring 1 (pointed to sun), X and Z near 0 (perpendicular to sun) when sunlit. At hour ~3.5, we switched to the WFF FSS, and saw an immediate increase in the noise level. WFSS sun sensor data were the default for the first few months of the mission

to using the noisy WFSS. A permanent fix required a software change to prioritize the GomSpace sun sensor over the in-house sun sensor. While working on such patch other, higher priority, issues appeared and temporarily halted the sun sensor patch work.

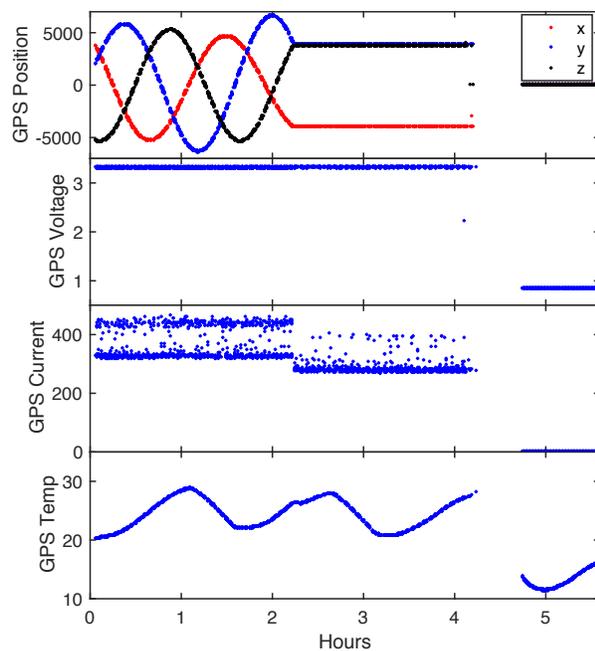
Dellinger carried a Novatel GPS (OEMV-1G) that failed on December 16, 2017, less than 1 month into the mission. The GPS telemetry shown in Figure 8 appears to show the moment the GPS failed. For the first 2 hours of the interval, the GPS reliably calculated the location of the spacecraft (top panel). During this time, it alternated between pulling ~327 mA and 440 mA; the majority of the telemetry was at 327 mA. Near 2:15, the telemetry showed a sudden change in the current draw, down to 280 mA, and a slight drop in temperature, suggesting a component failure on the GPS card. The next set of telemetry, just before hour 5, showed no current draw and zeros for the GPS-derived location.

The loss of the GPS was a major blow to the mission, as it eliminated the real-time ephemeris that was necessary for flying the spacecraft in a 3-axis, ram-pointed orientation. The best orientation for INMS science would have been to establish a fixed attitude relative to the local-vertical, local-horizontal (LVLH) frame with the INMS entrance aperture in the ram direction, and the Y-axis of the spacecraft (6U face) in a direction to optimize power production over the orbit (dependent on beta angle). Establishing an LVLH frame with no onboard capability to directly sense the Earth or the direction of nadir requires two computations. First, the FSW was designed to calculate the LVLH frame relative to inertial space using output from the GPS receiver. This would provide a target quaternion in the inertial frame.

Figure 8. Interval when the GPS failed.

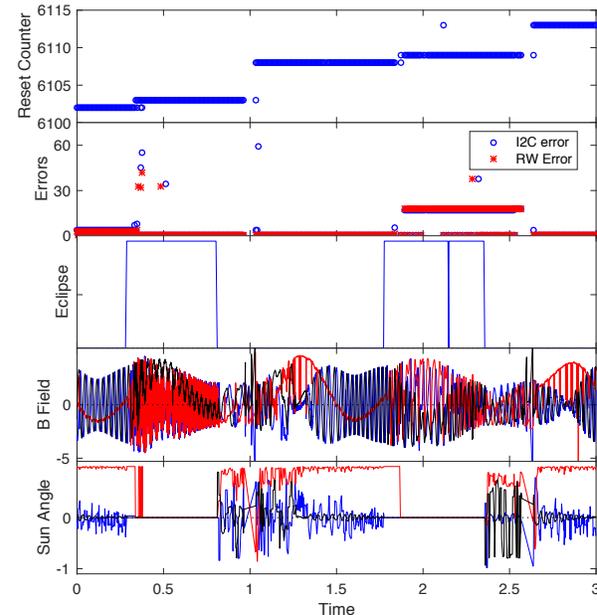
In the middle of January, the spacecraft started to show resets outside the expected daily reset. At first, the data showed a potentially thermal-related issue that caused multiple system resets a few minutes after entering eclipse, and then again a few minutes after exiting eclipse (Figure 9). Resets are indicated by an increase in the reset counter (top panel). The frequency of the resets rapidly increased to the point that by January 27th the spacecraft had entered a state of constant resets, once

Figure 9. Data from January 26, 2018, showing an example of resets and I2C errors seemingly associated with entering and exiting eclipse. Resets are indicated by increases by the reset counter.

In normal operation the flight computer sends data to the radio for later download. Furthermore, the radio is connected directly to the voltage busses without switches. Since we could not communicate through the flight computer, on January 31st the team sent commands directly to the radio to download data, to test if the reset was localized to the on-board computer or if the power system was resetting the entire satellite. During these ground passes, we were able to communicate to the radio without interruption, thus isolating the reset issue to the on-board computer, rather than the EPS. If the EPS had been triggering the resets, the spacecraft would have rebooted during the typically 5-7 minute duration of the passes. As the system booted up we noted that the FSW was sending limited telemetry to the radio – telemetry that included the boot-up logs. Review of this telemetry indicated that the flight computer crashed at the same point of the boot cycle, 63 seconds in, when it attempted to communicate with the I²C devices. We were able to reproduce the crash on the ground with the flatsat and isolated the issue to a bug in the I²C driver. The bug is in the code that is supposed to prevent simultaneous access to the I²C driver by different tasks in the FSW. If two or more tasks were trying access the I²C bus at the same time, one would gain access to the bus, and the others would wait with a 10 second timeout. If the task that had access was delayed due to I²C device errors, the waiting tasks would eventually timeout and access the bus

anyway, causing the crash. Correction of the device driver was found to be a simple one-line modification.

It worked. By constantly commanding the radio to reset the flight computer we had effectively jammed it and triggered an EPS watchdog reset. During the interval of constant resets, the team had theorized that the issue was high traffic on the I²C line. The current theory revolves around degraded components on the I²C line, making the line unstable. After recovering the spacecraft, the team immediately disabled the reaction wheels to decrease I²C traffic, as the reaction wheels are by far the worst offender on I²C traffic, with each of the 3 wheels communicating on the bus at 10 Hz.

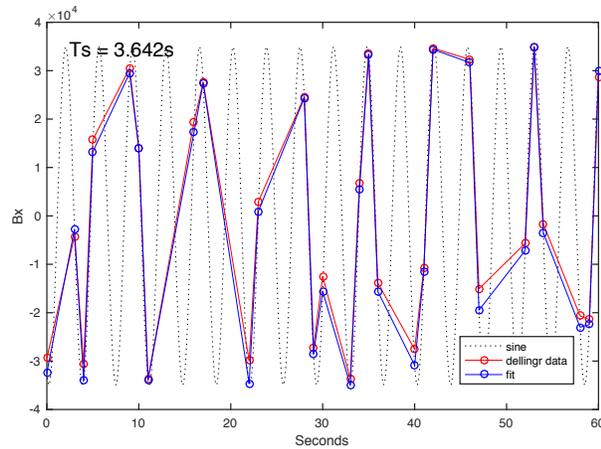
Yet it soon became clear that the ACS system was not keeping the 6U face pointed towards the sun and, in fact, the ACS system seemed to be having no effect on the attitude at all. On March 6th, 2018, by fitting a sinusoid to the science magnetometer data, we saw the first indication that Dellinger was in an uncontrolled, fast-spinning tumble (Figure 11). The maximum observed spin rate was about 105°/sec (17.5 RPM) primarily about the body-Y axis (6U face), and all the reaction wheels were saturated at maximum speed. The ACS system was designed to work at spin rates below about 5.0°/sec/axis, so Dellinger was operating well outside the design limits. The ACS system appeared unable to unload the spin

momentum. The tumbling rate faced some initial skepticism because it wasn't clear to the ACS engineers how Dellinger could have reached that high spin rate (about 20x Dellinger momentum capacity). Also, 17.5 RPM is just under the Nyquist frequency where one can deterministically assess rate based on the 1 Hz sampling rate. Between that and limited and noisy data, it seemed serendipitous for Dellinger to be in an uncontrolled yet observable state. Nonetheless, the de-tumbling effort soon commenced. Determining how the spacecraft entered the uncontrolled, rapid spin rate would have to wait.

Figure 11. Sine wave fits to the x component of the magnetic field data from March 6th provided accurate assessment of the spin rate, even with unevenly sampled data.

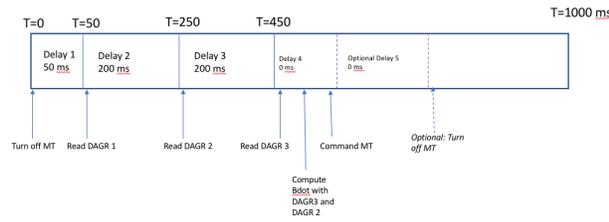
Figure 12. Timing diagram of the final B-dot algorithm.

The third and the final B-dot software patch had features to avoid race-condition with the science data acquisition application while also sampling the magnetometers three times within a 1-second period. It utilized the data from the last two queries that corresponds to time from the first two queries collected within the 1-second period. This final implantation is given by

Dellinger was successfully despun over the weekend of May 19-20, 2018.

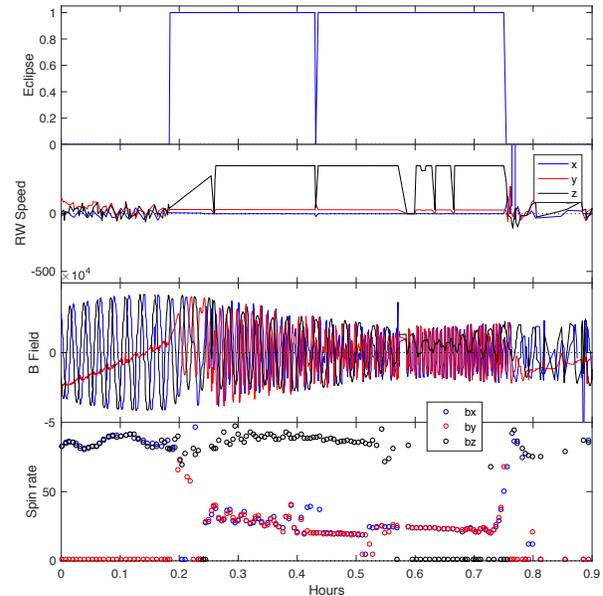
The leading theory to explain the root cause that brought Dellinger to the high-rate tumbling state appears to be a magnetic control software implementation error that occurs during eclipse. The Dellinger ACS was designed to send zeroed torque commands to the reaction wheel during eclipse while momentum unloading of the wheels continued. It was discovered during in-flight operations that the last reaction wheel command before eclipse entry was *effectively stuck* in the command queue and caused the wheel speeds to linearly increase till saturation (see Figure 4). At the same time, the magnetic control loop continuously attempted to unload the wheel momentum for a prolonged period. This continuous magnetotorquing spun up the spacecraft to a high spin rate.

Although we do not have data from the interval that spun up the spacecraft to the uncontrollable state, we have seen the effect throughout the mission. An example is shown below in Figure 13. Prior to eclipse the spacecraft was spinning about the y-axis, as indicated by the magnetic field measurements, with the x and z component seeing a quadrature magnetic field. Upon entering eclipse near 0.2 hours, reaction wheel Z (2U face) accelerated to maximum speed, and the spin orientation of the spacecraft changed. The spin period

(bottom panel) calculated via fits to the magnetic field observations tells the story. The z axis spin rate remained relatively constant at ~80 seconds, but the x and y axes saw an initial decrease to ~35 seconds (i.e., sped up), followed by a slow decrease that was due to the magnetotorquers attempting to unload wheel momentum. By the end of the eclipse, the spacecraft was spinning with a 20s spin period about the z axis, then recovered quickly once leaving eclipse.

Figure 13. Example of Dellinger body rate changes during eclipse. Spin fits of zero indicate a bad fit and should be ignored.

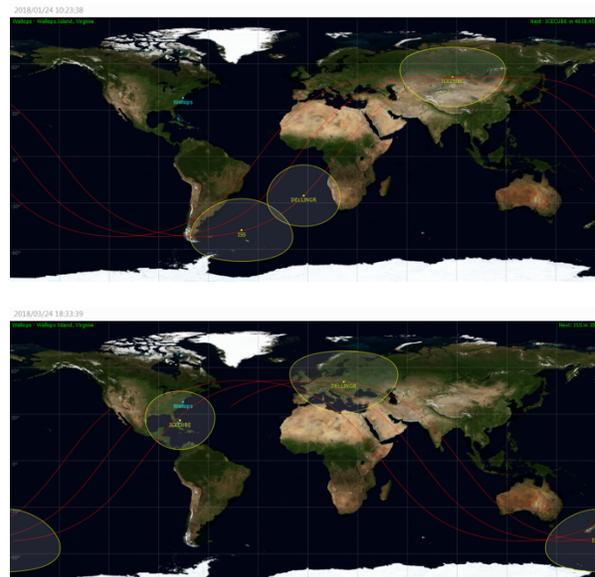
Dellinger's radio memory bank was deleted twice during the mission without an identifiable reason. In both cases the satellite was neither in the range of the WFF ground station nor in the same geographic location. The first incident occurred on January 24, 2018, around 10:23 am EST, losing approximately 650,000 packets of data. The location was estimated to be over the south Atlantic Ocean near South Africa and the South Atlantic Anomaly (SAA), as shown in Figure 14 (top). The second incident occurred on March 24, 2018 at 6:33 pm EST, losing around 700,000 packets. This incident

Figure 14. Approximate locations of the first (top) and second (bottom) data deletion events.

At this point in time we do not have a good explanation for the data deletion events. Direct command of the satellite by a UHF ground station seems unlikely since knowledge of Cadet radio operations is required since it will reject any commands not formatted correctly. While a single event upset is possible, particularly since the first event occurred near the SAA, we do not have an explanation for why an SEU would cause data deletion. An SEU does not seem likely for the second deletion event.
