Continuing Sediment Management at Mount St. Helens: Raising the Spillway of the Sediment Retention Structure

J.P. Britton, P.E., Ph.D.¹, C.J. Nygaard, P.E.¹, and S.J. Schlenker, P.E., Ph.D.¹ ¹U.S. Army Corps of Engineers Portland District Portland, OR 97204 USA E-mail: Jeremy.p.britton@usace.army.mil

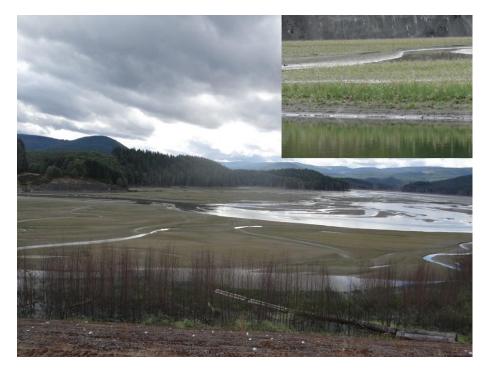
Figure 5. Conditions upstream of SRS spillway raise in summer 2013

terrace. Field evidence from the summer of 2013 (Figure 5) shows the development of proto floodplain and emergence of grasses. While encouraging for long-term revegetation and associated floodplain roughness in the sediment plain, grasses did not emerge in the summer of 2014 for unknown reasons. The USACE will continue to monitor the system for the primary performance metric but will also look for opportunities to improve basic designs like the weir crest shape.

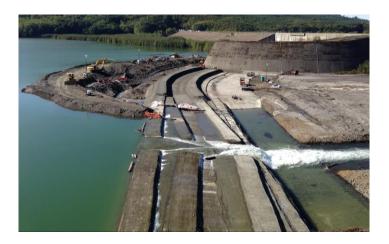
Figure 8. SRS spillway raise during construction

The spillway raise contract was awarded to LKE Corporation for \$4.5 million in July 2012. River diversion was accomplished in two phases. In phase one, the river was diverted to the left side of the existing spillway—through 10 culverts beneath a temporary access road—while the right side of the RCC structure was constructed behind a cofferdam. In phase two (Figure 8), the river was diverted through the low flow channel of the RCC structure while the left side of the RCC structure was constructed behind a cofferdam. The work was performed during late summer when flows in the river are at their lowest.

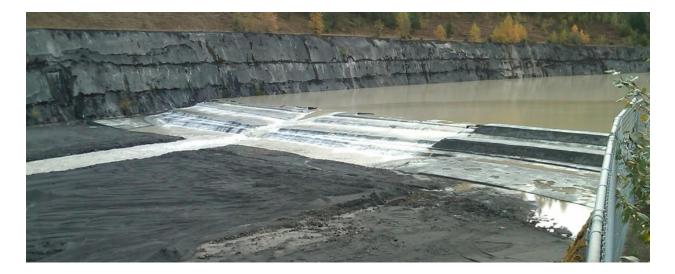
Figure 9. Completed spillway raise, 17 October 2012

The contractor placed a total of 8,700 cubic meters (11,400 cubic yards) of RCC on twelve days within a nineteen day period. The RCC 90-day strength was specified to be 31 MPa (4,500 psi) for durability against the erosive sediment-laden flows. Figure 9 shows the completed structure.
