Breakdown Analysis of Electrostatic Discharge

Materials Physics Group, USU Physics Department

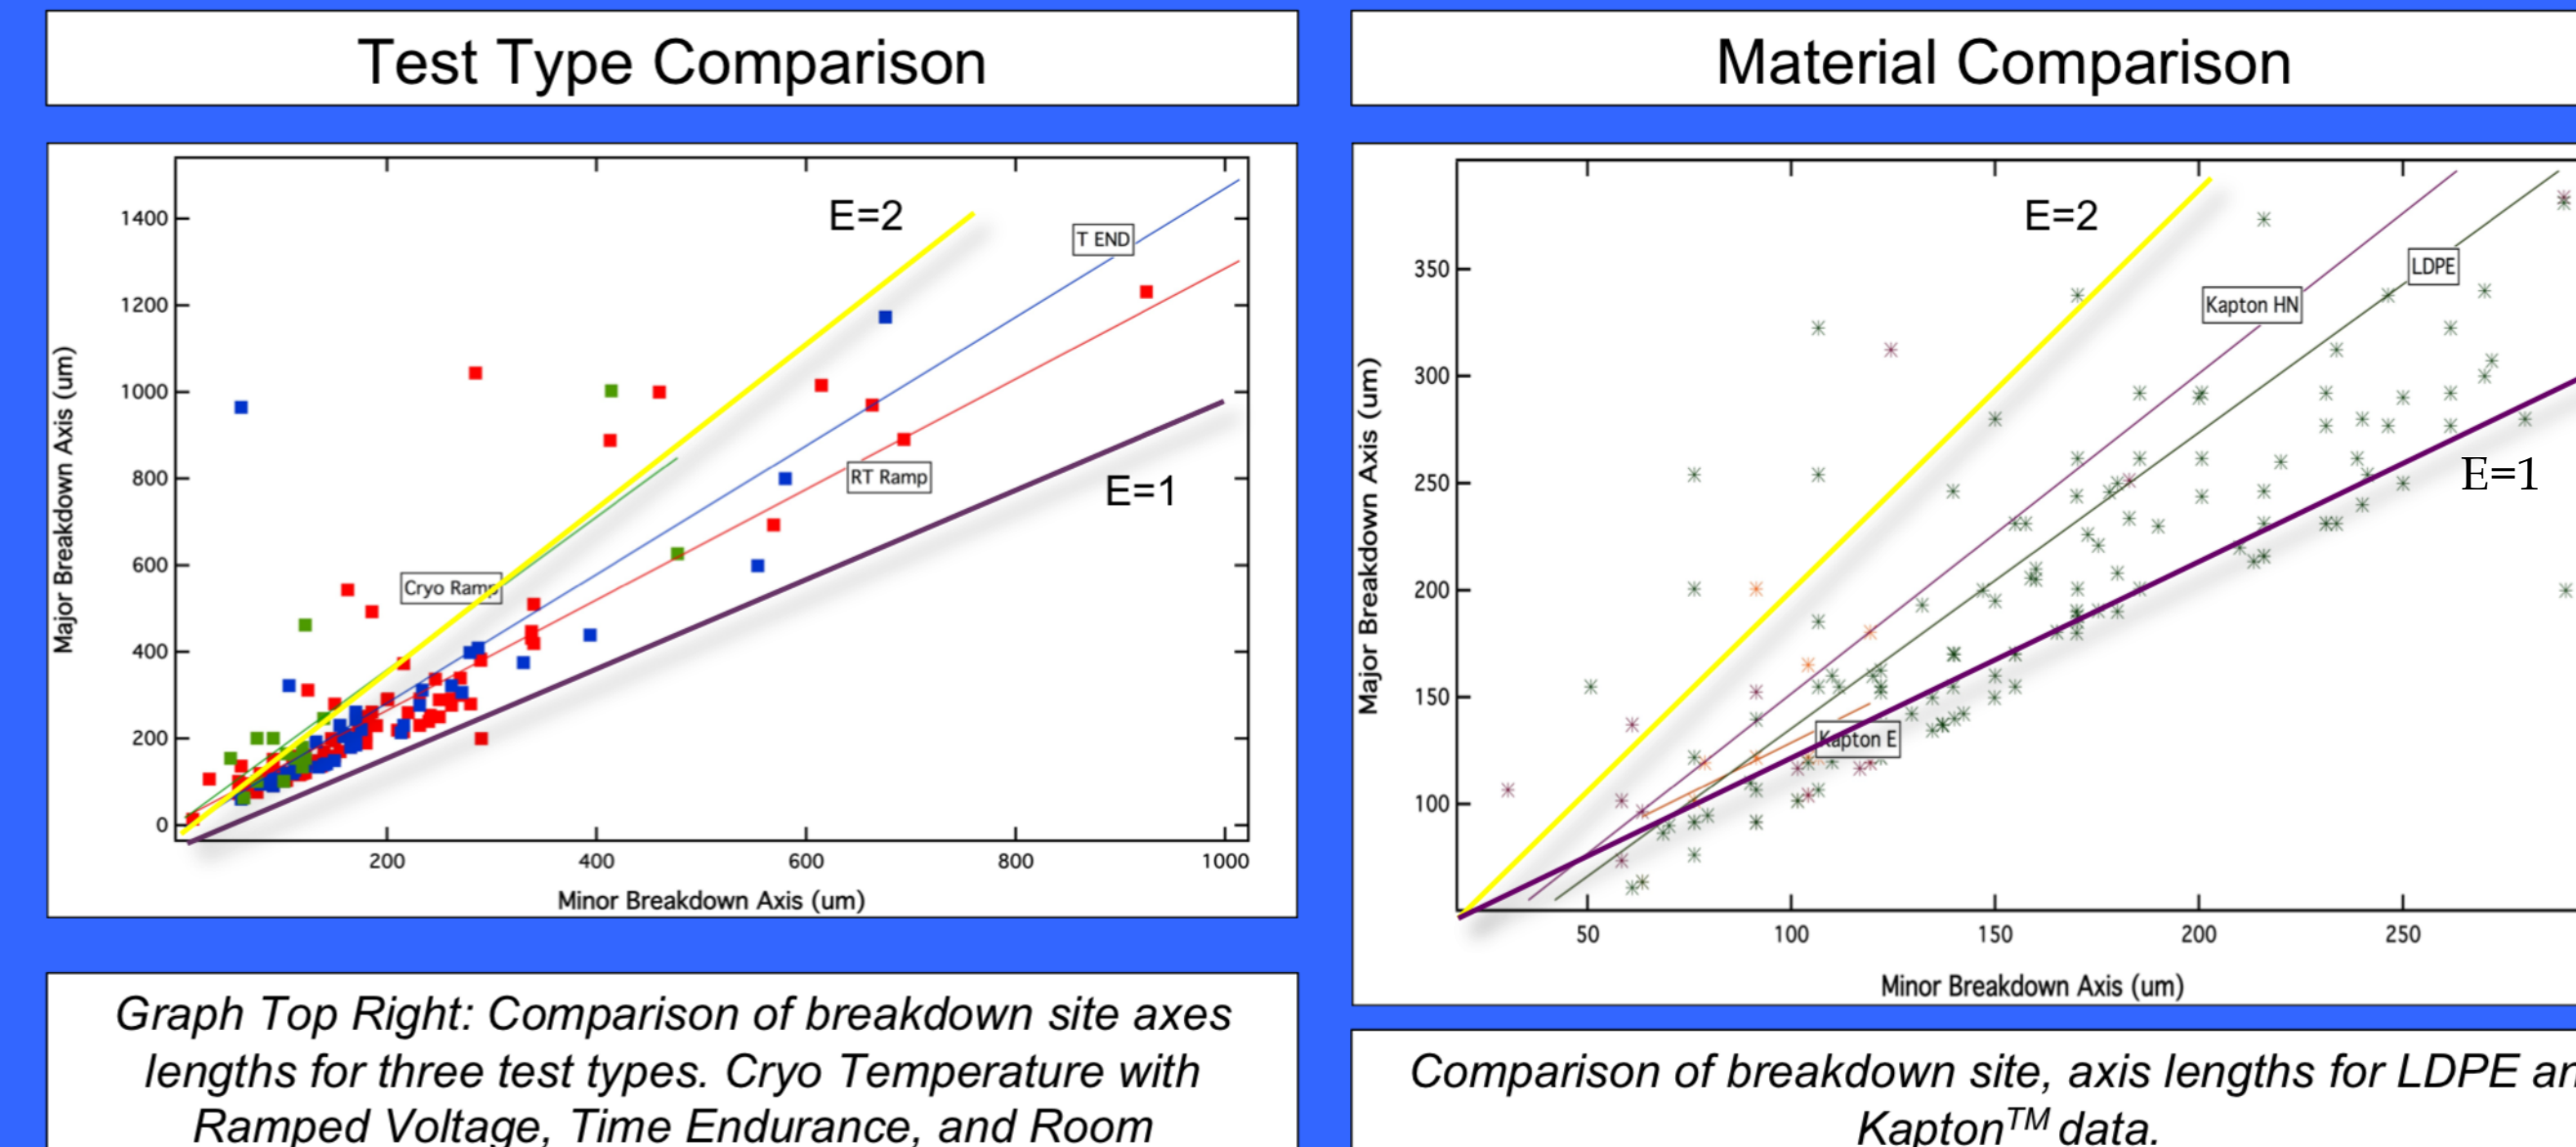
Breakdown Diameter Comparison

Graph Top Right: Comparison of breakdown site axes lengths for three test types. Cryo Temperature with Ramped Voltage, Time Endurance, and Room

Comparison of breakdown site, axis lengths for LDPE and Kapton™ data.
