# VIIRS On-orbit Optical Anomaly

Eugene Waluschka  
NASA/Goddard Space Flight Center/551.0

# Introduction

# Executive Summary

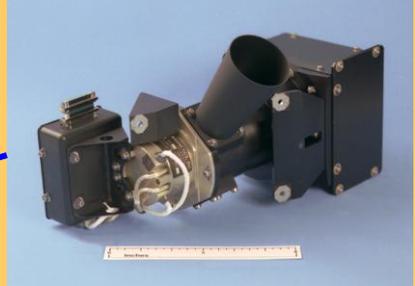
# VIIRS OMM and SDSM Solar Calibration Components

Cryoradiator  
FPIE

Rotating Telescope Aft Optics and Half-Angle Mirror

Cold FPA Dewar Assembly

Ratioing Radiometer (SDSM)

- Stability Monitor for Solar Diffuser
- Seven Wavelengths
