Cascade Garden

Design Workshop, Inc.

Cascade Garden Methodology for Landscape Performance Benefits

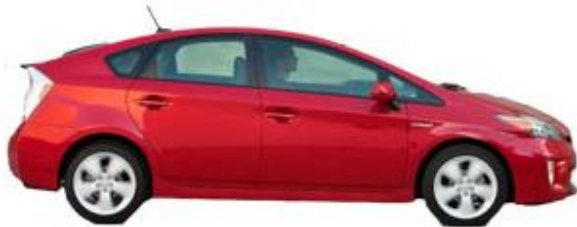
Figure 4. Color Overlay matching the Prius' outline

The photograph was imported into Adobe Photoshop where a color overlay was applied to give the car a solid color. The image was flipped vertically to match the direction of travel of the Prius in the panoramic photo (Figure 4). The image was resized in Photoshop to match the scale of the car as it appears in the photograph. The image of the car was then copied and pasted repeatedly to create a swath from one end of the property to the other that is representative of the total area the vehicle would occupy when traveling on the road (Figure 5). This is the visual area that would be occupied by a vehicle if no buffer were present between the viewer and the road.

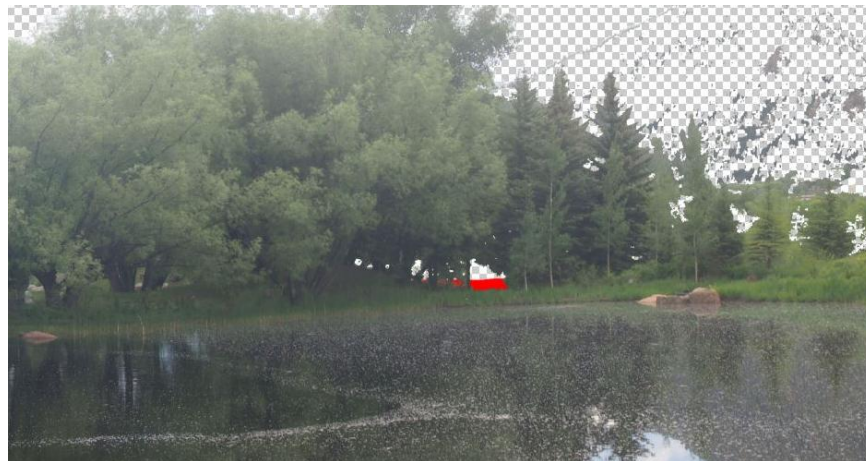
The swatch layer was moved underneath the panorama layer and the wand tool, set on a very low tolerance, was used to erase those parts of the panorama image that lie on the far side of the road (Figure 7). This revealed the swatch in just those areas that are not covered by berms, plantings, fences, or gates on the property.

Figure 7. Removing the background revealed the visible parts of the traffic swatch.

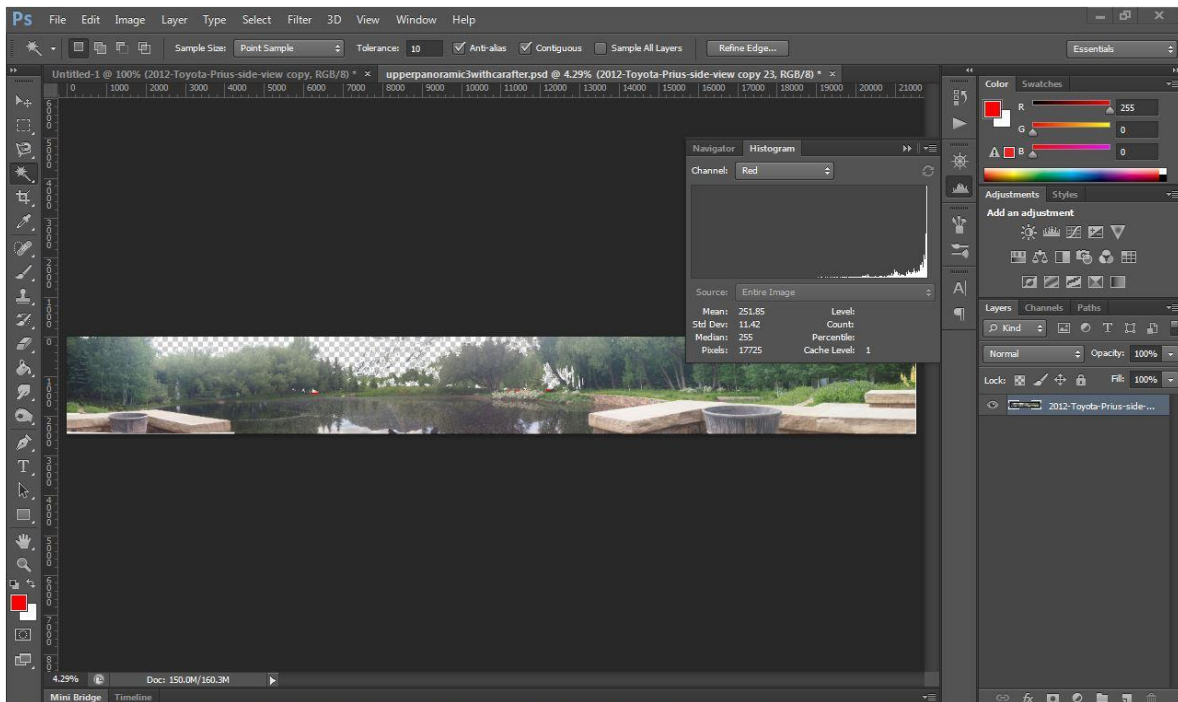
Finally, the layers were merged and the visible parts of the traffic swatch were selected. The histogram function was used again to determine how many visible pixels from the swatch remained (Figure 8).

Figure 8. The histogram reveals how many pixels are visible

A total of 17,725 pixels are visible.
 $17,725 / 796,196 = 0.02226$ or approximately 2.2%.
 $100\% - 2.2\% = 97.8\%$ of the view of traffic is blocked.
