Applications of Microscopy in the Paper Industry: Case Histories of the Mead Corporation

APPLICATIONS OF MICROSCOPY IN THE PAPER INDUSTRY:
CASE HISTORIES OF THE MEAD CORPORATION

A. J. Leonardi¹, B. A. Blakistone², and S. W. Kyryk²

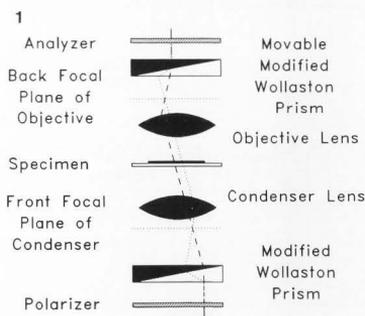
Figure 1. Schematic of a Nomarski differential interference contrast microscope.

Differential interference contrast (DIC) after Nomarski is the method of choice when the specimen of interest has inherent low contrast. The principles of Nomarski DIC optics are less well known and will be described here (see Figure 1). A beam of light passes first through a polarizer, converting the beam to one which is plane-polarized which then passes through a modified Wollaston prism (Figure 2) that splits the beam slightly and focuses this split beam in the front focal plane of the condenser. The plane-polarized, split beam continues through the condenser, specimen, into the objective, and then into a second modified Wollaston prism. This second prism recombines the split beam. The single plane-polarized beam is then passed through a second polarizing filter, the analyzer, which converts it into a fully polarized beam. At this point, the image is ready to be observed or recorded.

A key point in Nomarski DIC optics is that the split of the single beam is so minute that it is below the resolution of the objective lens used. This means that the image obtained is a differential, or three-dimensional, image. It is a false 3D image, and care must be taken in any interpretation of three-dimensionality in a Nomarski image.

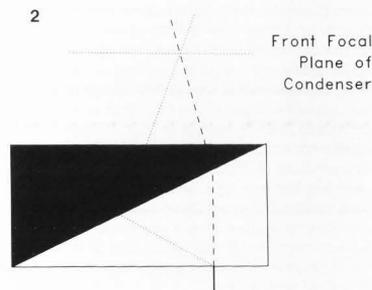
Figure 2. Schematic of a Modified Wollaston prism.

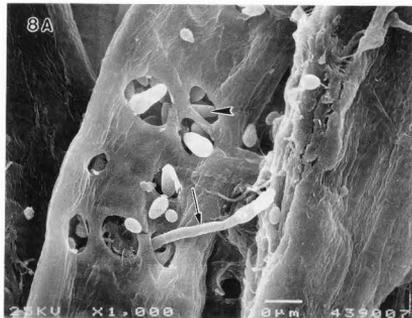
Figure 8. Using SEM, hyphae were seen penetrating pits (8A, arrow) of coated board as well as growing inside fibers (8A and B, arrowheads).

In the six week non-inoculated specimens, hyphal growth penetrated through pits and inside fibers (Figures 8 and 9) and the coating (Figure 10) creating decay troughs. Note also the outgrowth of native bacteria and their fine meshwork on the fibers (Figure 9B). These characteristic growth patterns have all been shown in the literature for wood (Eriksson et al, 1980;

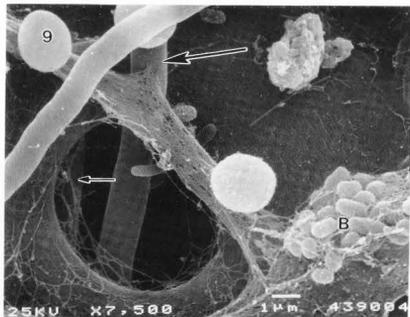
Figure 10. Hyphal growth has penetrated the coated side of the board, creating decay troughs (arrows) and holes.

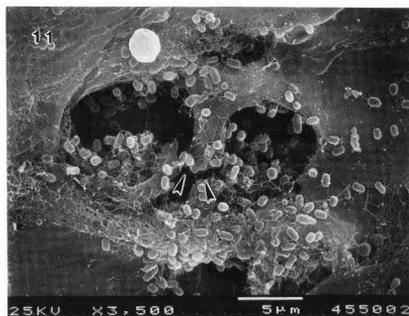
Figure 11. The SEM photomicrograph shows damage of fiber pits in coated board by bacteria including breaks in the walls of the pits (arrowheads).

Figure 12. PL microscopy of a coated board cross-section shows high birefringence of fibers in the control (A) but reduced birefringence (i.e. loss of fiber integrity) after 6 weeks of fungal growth (B).

Figure 11 shows fiber pits enlarged by outgrowth of native bacteria and breaks in the walls of the pits.

Perhaps the most interesting optical microscopy technique applied in this study was that of PL microscopy. Under PL microscopy fibers exhibit birefringence - a property of most crystalline substances. This property is well documented in the literature (Wilcox, 1965 and 1968; Greaves, 1969; Fengel and Wegener, 1984; Liese, 1970.) In any crystalline particle or fiber, if the crystalline state is disturbed or lost, so is the phenomenon of birefringence. This fact was instrumental in showing that bacteria and fungi do degrade wood fiber integrity (Figures 12A and B). At present there is no commonly accepted index of biodegradation. The studies herein reported are indicative of the potential for the use of birefringence as a qualitative index of degradation in environmental testing of wood-based products.

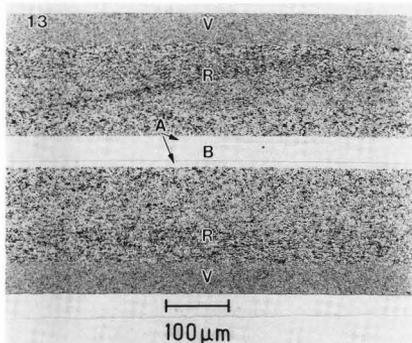
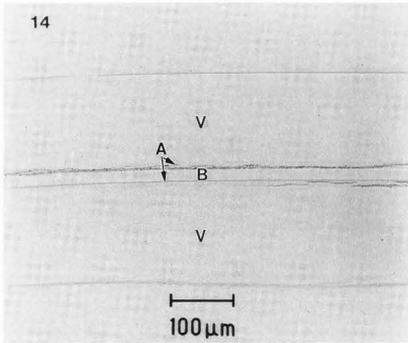
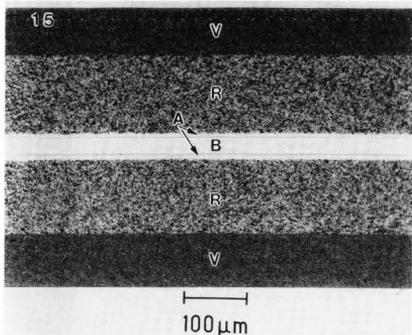
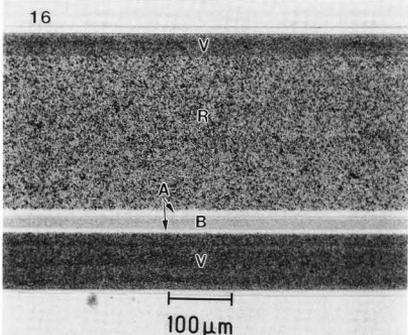
Figures 13-16. Köhler optical cross-sections of Rampart titanium-tinted (13) and clear (14), Ball (15), and James River (16) high barrier cup walls show virgin polypropylene (V), regrind (R), adhesive (A), and barrier (B) layers. Note that the clear Rampart cup has no regrind and the James River cup has an asymmetrical structure with the barrier being closer to the outside of the cup wall. In addition the barrier of the James River cup appears to be of a different composition from the rest.

EVOH layers can be seen with SEM, but observations can be made using optical microscopy. The differences among the constructions of the two Rampart cups (titanium-tinted and clear)(Figures 13 and 14), the Ball cup (Figure 15), and the James River cup (Figure 16) can be clearly seen in cup wall cross-sections. Titanium-tinted Rampart cups have the most regrind - a reflection of production demand. The clear Rampart cup has no regrind (Figure 14) for optimal clarity. Variations in wall thicknesses among the samples are a result of customer specification and are not a function of the manufacturing process. Comparing Figures 13, 14, and 15 with Figure 16, it may

be seen that Ball and Rampart cups have the same oxygen barrier: EVOH. The James River cup appears to have a different composition of EVOH from the other cups. The barrier position of the James River cup is a special construction for retorting. Such a position permits wicking out of moisture through the moisture sensitive barrier by mass action thus prolonging the oxygen barrier property of the material.

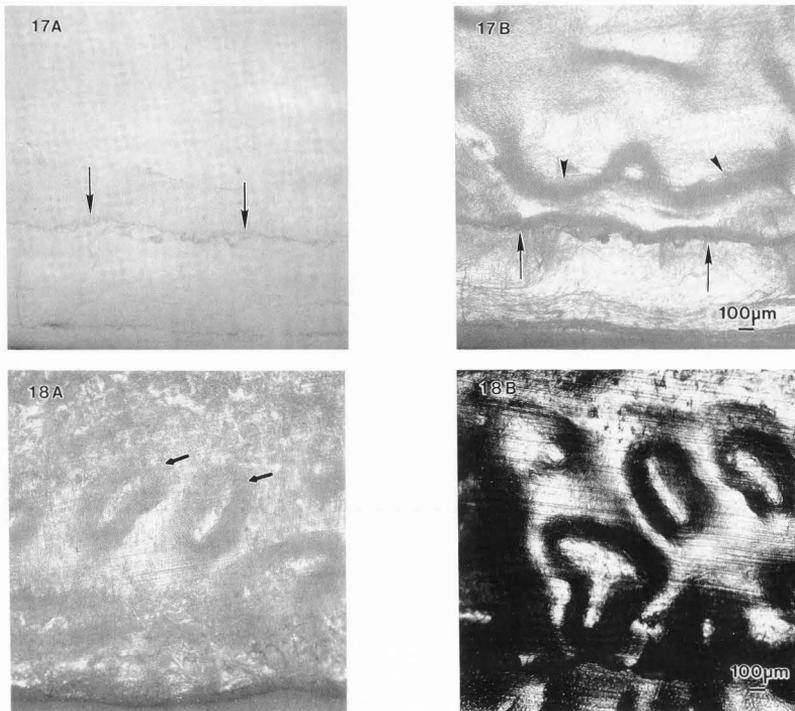
Figure 17. This figure illustrates the usefulness of Nomarski optics in observing cup seals. In normal brightfield microscopy, very little detail is observed (17A). The demarcation which indicates the edge of the seal is seen (arrows), but little other detail is noted. In DIC optics, more detail is evident (17B) such that the edge of the seal is now very obvious (arrows). Also, the pattern formed by the seal is visible (small arrowheads).

Nomarski DIC optics frequently offered an advantage over Köhler optics by providing a rapid and efficient procedure for distinguishing hard to visualize seal development areas of the cups. Figures 17 A and B compare Köhler and Nomarski microscopy on the clear Rampart cup sealed with a Morprime® lid. As illustrated it is quite difficult to see definition of the seal area on the flange using Köhler illumination. Using Nomarski optics seal development of the high barrier cups is much easier to assess. Important parameters in Morprime-sealed cups are the width of the seal, signs of oversealing/flange deformation, and transfer of the embossing pattern on the lid/sealant interface to the flange (Figure 18A). The underside of the lid appears as a smooth surface with Köhler optics, but a pattern can be distinguished with Nomarski (Figure 18B). Seal parameters of coextruded lids are lack of sealant residue on the flange but evidence of good seal width as judged by pressure in the area applied by the seal head and lack of stringing (Figures 19A and B). Stringing can occur in Morprime-sealed lids, but these are less temperature sensitive than the coextruded lids which tend

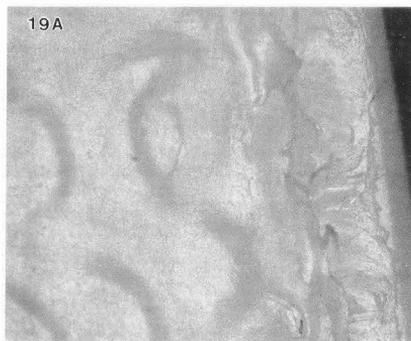
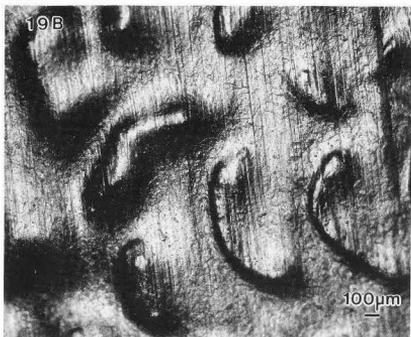
Figure 19. Using DIC optics, flange (19A) and lid (19B) seal activation patterns were visible on a cup sealed with a coextruded film type sealant.

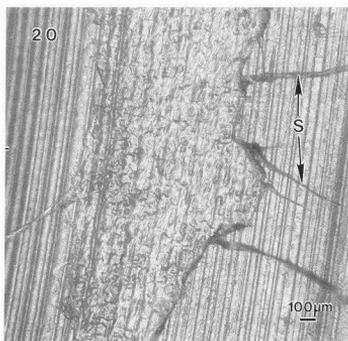
Figure 20. Cup flange with low contrast seal stringing (S) associated with coextruded film type sealant is shown using Nomarski optics.

to heat easily and release sealant and/or polypropylene in fine strands (Figure 20).

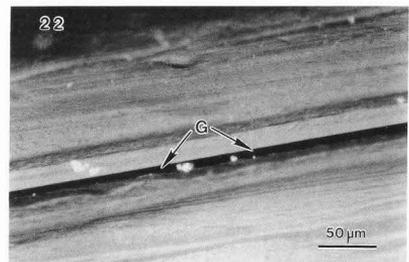
Figure 21. The SEM photomicrograph shows a gap (G) in the layers of a high barrier cup. Most gaps were found between the barrier and adhesive layers. See optical photomicrograph, Fig. 22.

Figure 22. Gaps are still seen after cross-sectioning cup wall and observing using Nomarski optics (G). By using Nomarski optics the possibility of the gap being an artifact of SEM preparation was eliminated.

Figure 21 illustrates the gap in the Rampart cup. Rampart rawstock prior to cup formation did not show gaps. A problem in interpretation was the fact that in preparing the cup cross-sections for SEM the cup cross-sections were twice subjected to vacuum: sputter coating with gold/palladium and the required vacuum for observation in the SEM. To precisely interpret the true or artifactual presence of gaps, samples were embedded, sectioned, and viewed using epi-illuminated DIC optics. The images aided in discerning the actual presence of the gaps as seen in Figure 22. A short article in *Plastics World* (Callari, 1990) confirmed that gaps are real not artifactual and are a problem in production, but the problem is being addressed. Gaps or any flaws are of concern in high barrier cups for use in extended shelf life packaging of food because of the possible effect on oxygen and moisture transmission. The gaps present in the barrier structure may have contributed to the graying of applesauce although gaps were probably not the sole source.
