## Geomorphic Changes Following Beaver Dam Failure and Abandonment

A plan B paper submitted in partial fulfillment  
of the requirements for the degree

Watershed Sciences

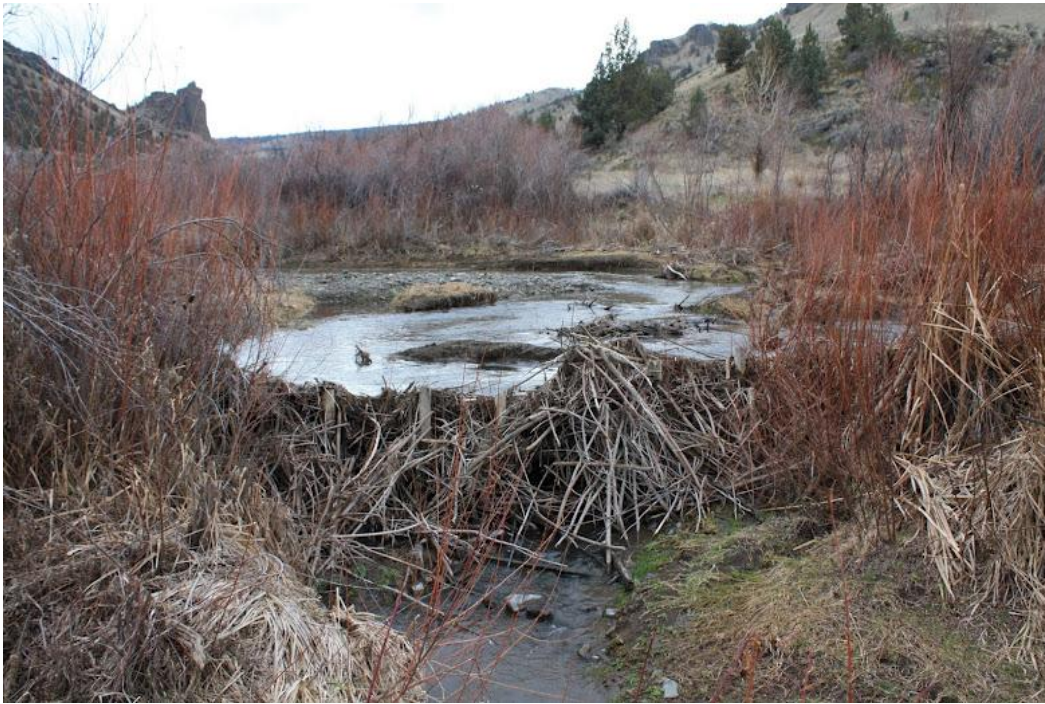
Figure 2: Beaver dam with beaver dam support structures at Upper Owens reach study site in November 2009, six months after the beaver dam was initially breached.

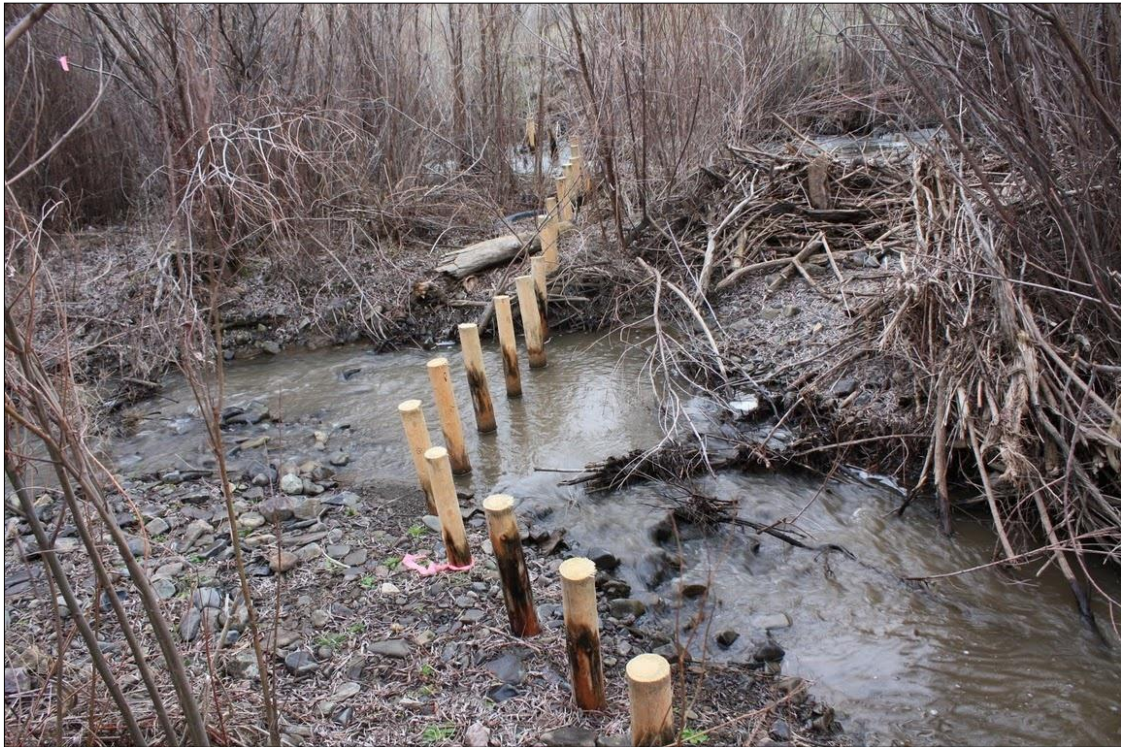
Figure 5: Newly installed Beaver Dam Support Structure on Bridge Creek, OR. Posts are 3 meters in length and pounded approximately 1.5 meters into the ground. Photo credit: Joe Wheaton, November 2010.

Upper Owens was a pilot treatment reach for the restoration project. The treatment includes providing structural support for the beaver dams in the form of beaver dam support structures (BDSS). BDSS are a series of 3 meter long pine posts that are hydraulically pounded 1.5 meters into the stream bed and adjacent banks creating a line, roughly the shape of a beaver dam, of posts spanning the stream and on occasion onto the active or abandoned floodplain (Figure 6). In this degraded system with low sinuosity, sparse riparian vegetation, and channel entrenchment there is very little flood attenuation. Additionally, there is very little large woody vegetation for the beaver to use in the construction of their dams. The result is that the high flows of this flashy system easily breach or even wash away dams constructed with small willow branches. At Upper Owens, Demmer and Beschta (unpublished data) documented the age of beaver dams at the time of failure from 1998 to 2005; during this time period more than half of the beaver dams failed within one year of construction (Figure 4). The structural supports provided to the dams by the BDSS allow the dams to persist longer than they may have otherwise in this degraded system.

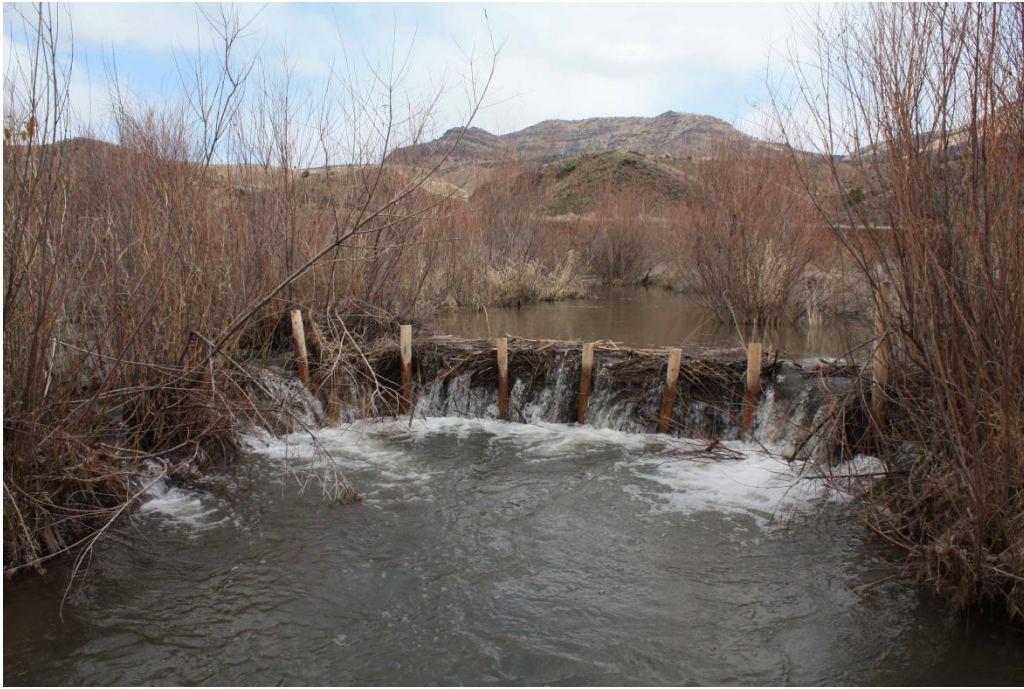
Figure 6: Example of a Beaver Dam Support Structure (BDSS) on Bridge Creek, OR, stabilizing a small willow branch weave and impounding the stream flow. Photo credit: Joe Wheaton, November 2010.

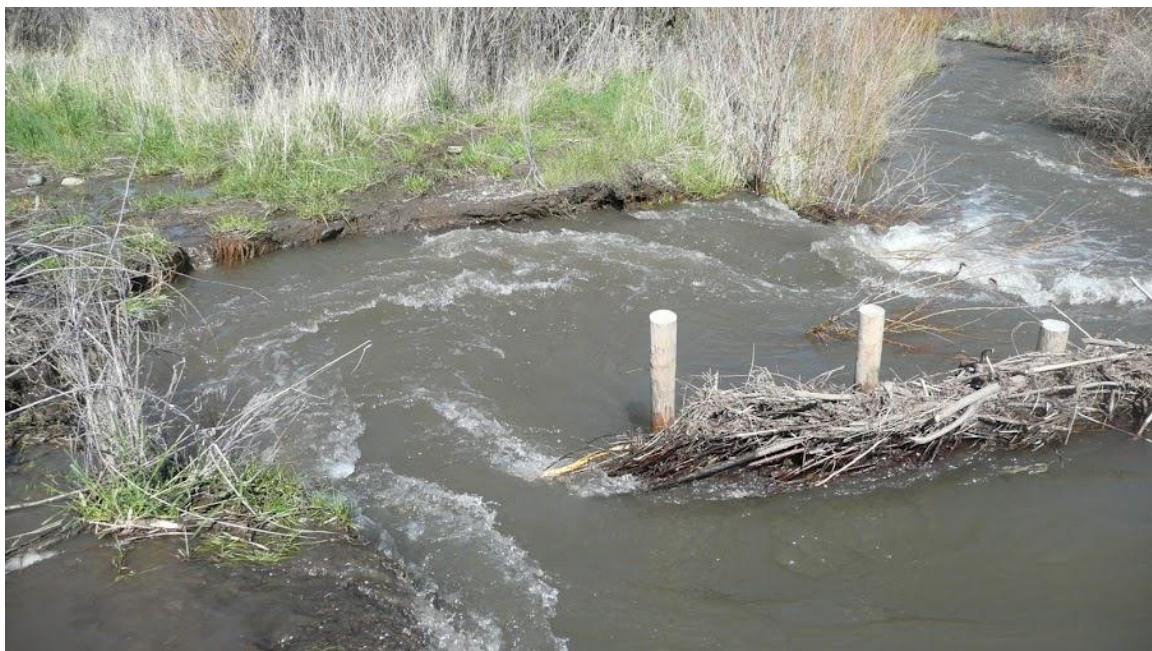
Figure 8: Photo of the beaver dam at Upper Owens in May 2009 during the initial breach.

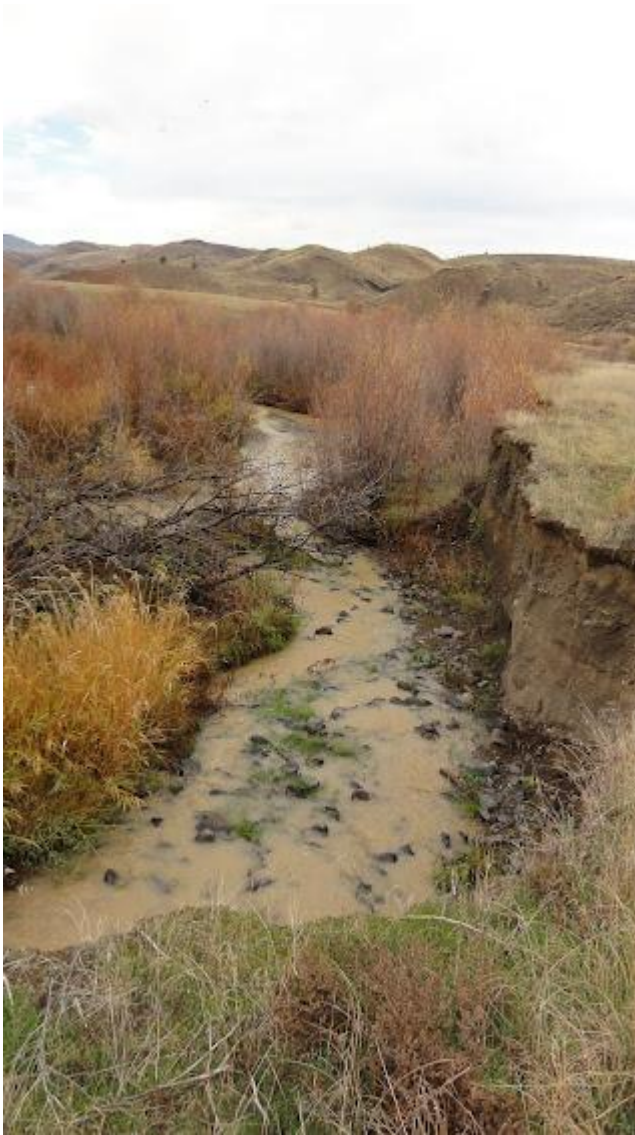
Figure 9: A portion of the Boundary reach showing the straight channel configuration and the alluvium the channel cuts through. Photo credit: Joe Wheaton, November 2010.

The Boundary stream reach is a control reach for the restoration project as it is reflective of the overall condition of Bridge Creek with a single-thread relatively straight and narrow channel entrenched in alluvium (Figure 9) with the 83.3% of the beaver dams

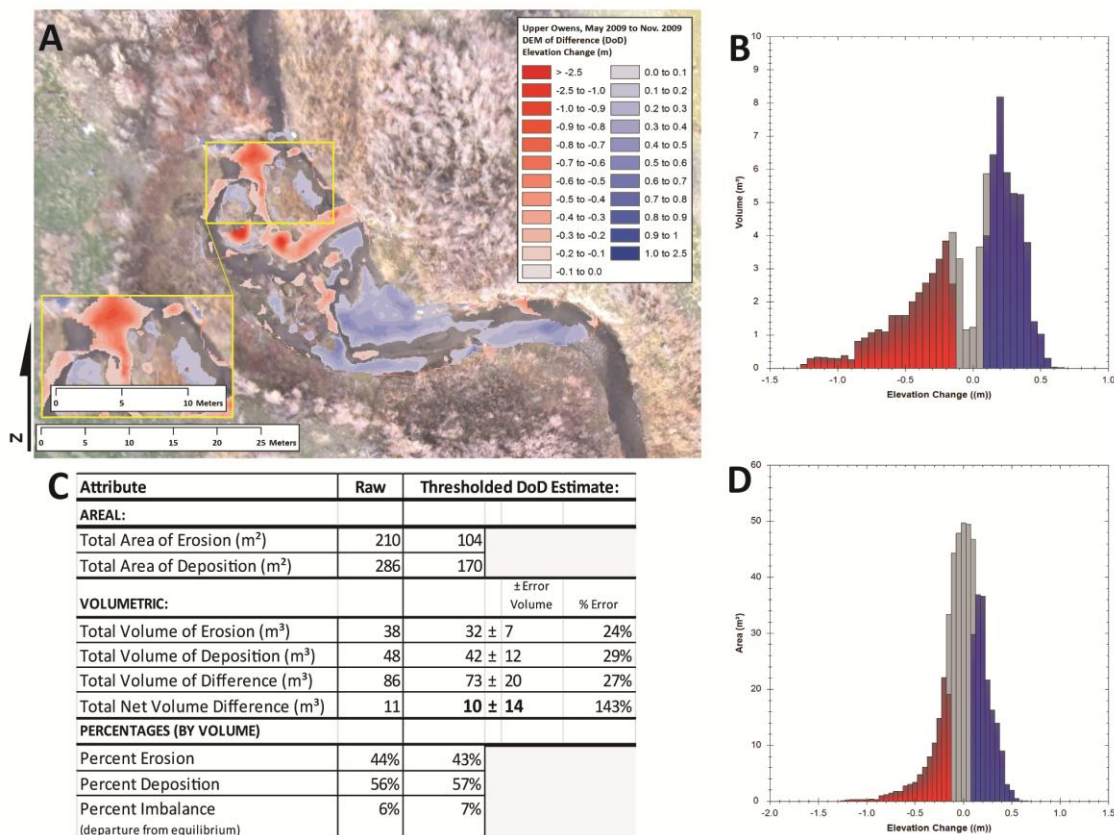
Figure 13: Upper Owens study site May 2009 to November 2009 Ground Change Detection results, 90% confidence interval, conducted in Arc GIS 10.0 using GCD 5.2 Ground Change Detection Uncertainty Analysis plug-in 10.A: Raster output showing elevational changes, i.e. erosion and deposition over November 2009 Blimp imagery. 10.B: Histogram showing the distribution of erosion and deposition by volume (m<sup>3</sup>). 10.C: Summary statistics. 10.D: Histogram showing the distribution of erosion and deposition by area (m<sup>2</sup>).

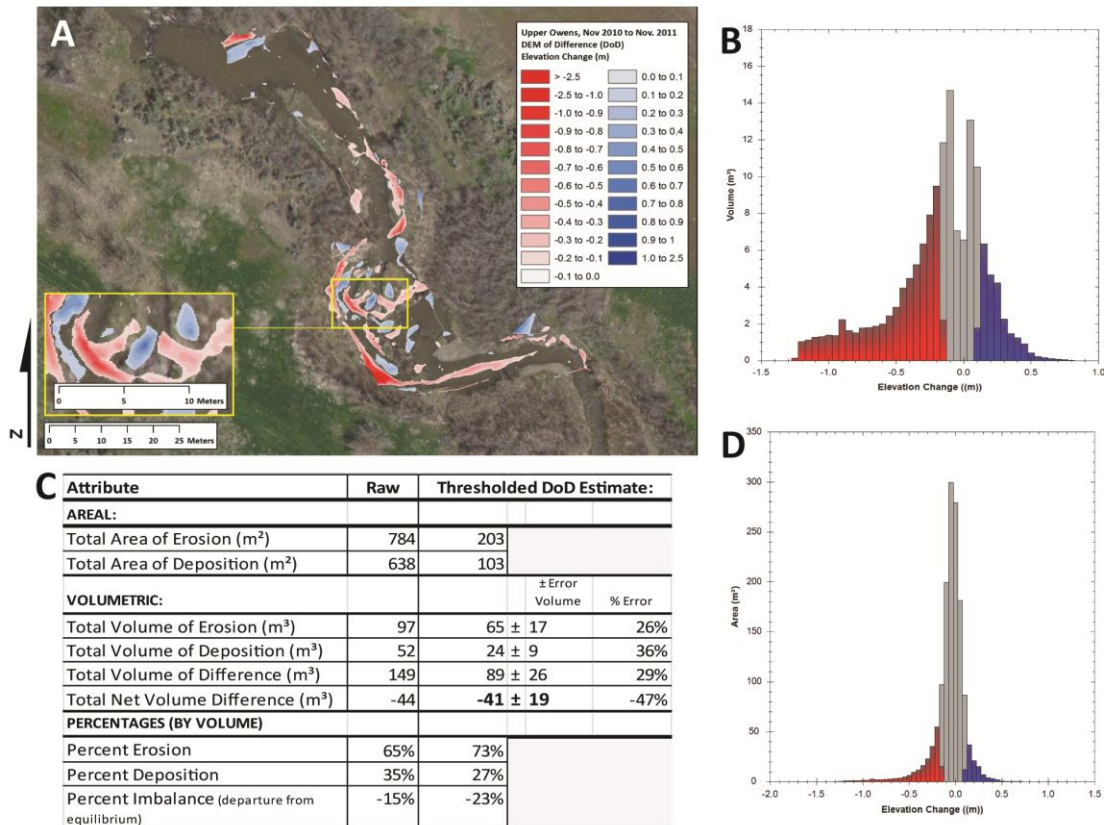
Figure 19: Upper Owens November 2010 to November 2011 Ground Change Detection results, 90% confidence interval. 10.A: Raster output showing elevational changes, i.e. erosion and deposition displayed over April 2010 UAV Drone imagery. 10.B: Histogram showing the distribution of erosion and deposition by volume (m³). 10.C: Summary statistics. 10.D: Histogram showing the distribution of erosion and deposition by area (m²).

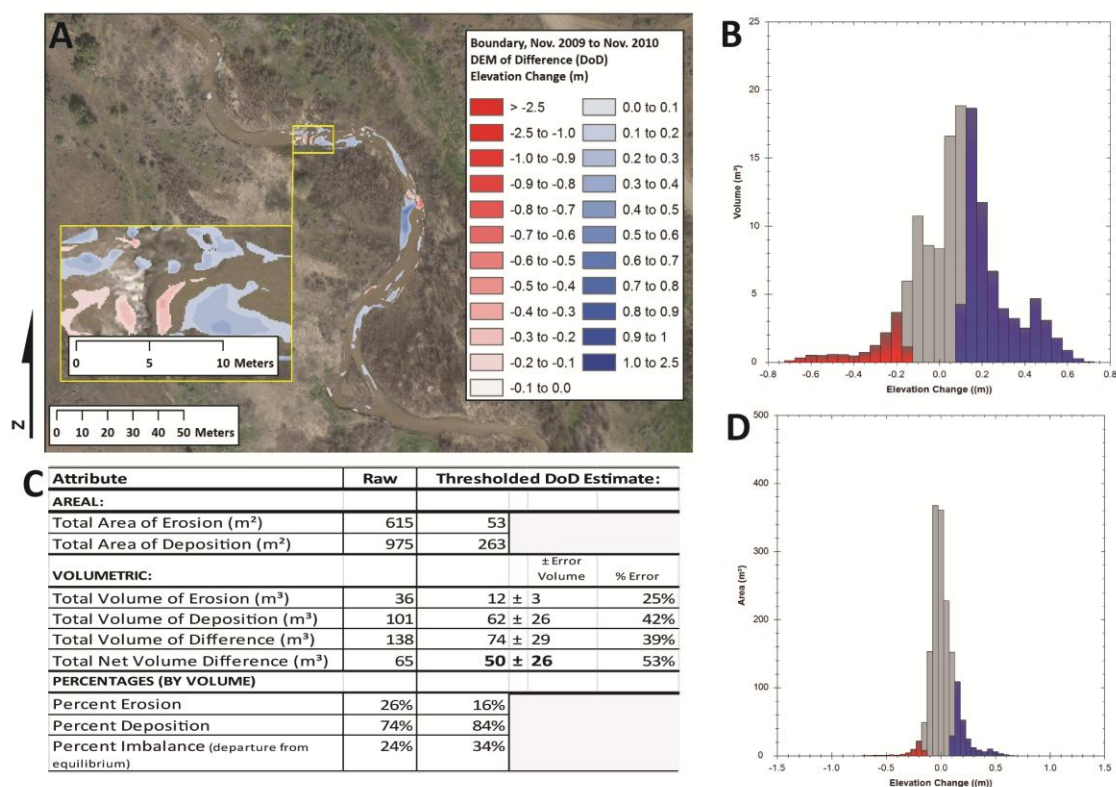
Figure 22: Boundary November 2009 to November 2010 Ground Change Detection results, 90% confidence interval. 10.A: Raster output showing elevational changes, i.e. erosion and deposition displayed over April 2010 UAV Drone imagery. 10.B: Histogram showing the distribution of erosion and deposition by volume ( $\text{m}^3$ ). 10.C: Summary statistics. 10.D: Histogram showing the distribution of erosion and deposition by area ( $\text{m}^2$ ).

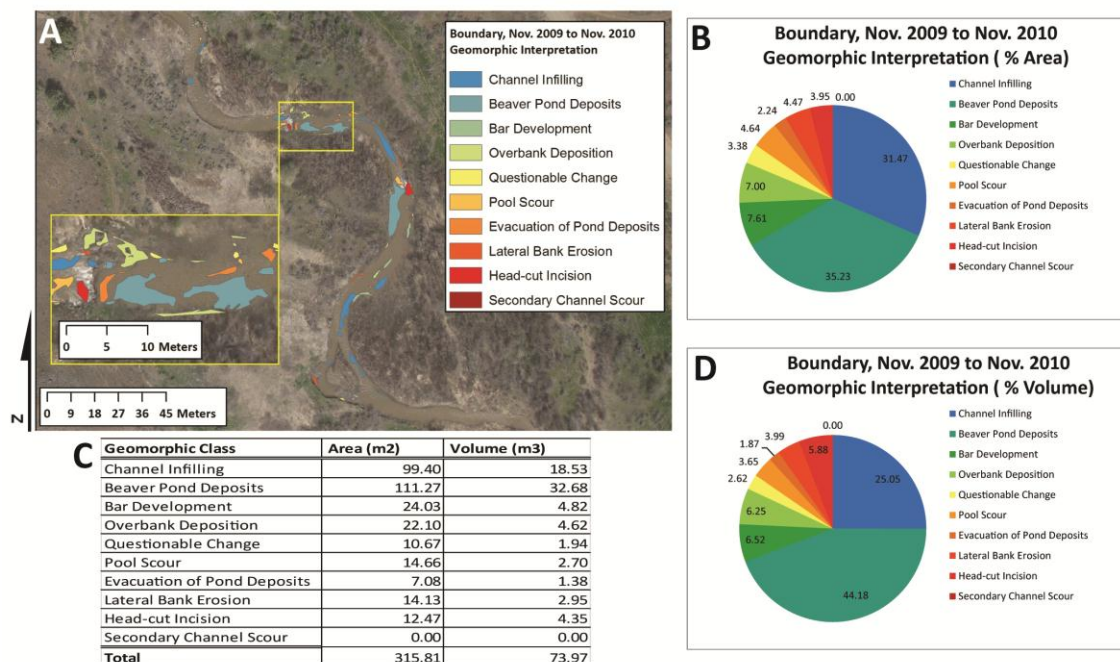
Figure 23: Geomorphic interpretation of in channel changes between November 2009 and November 2010, post beaver dam failure at preliminary study site on Boundary reach, Bridge Creek, OR. Conducted in Arc GIS 10.0 using GCD 5.2 Ground Change Detection Uncertainty Analysis plug-in. 14.A: Geomorphic interpretation output displayed over April 2010 UAV Drone imagery. 14.B: Pie chart showing percent area of each geomorphic class. 14.C: Summary of geomorphic classes by area (m<sup>2</sup>) and volume (m<sup>3</sup>). 14.D: Pie chart showing percent volume of each geomorphic class.

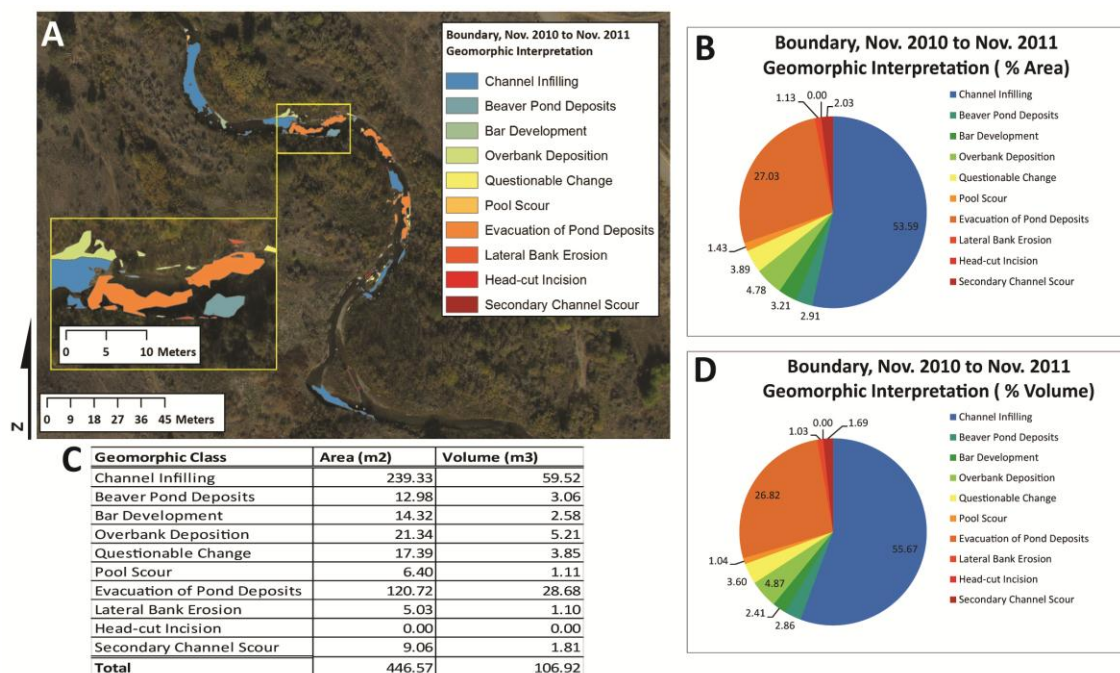
Figure 26: Geomorphic interpretation of in channel changes between November 2010 and November 2011, post beaver dam failure at preliminary study site on Boundary reach, Bridge Creek, OR. Conducted in Arc GIS 10.0 using GCD 5.2 Ground Change Detection Uncertainty Analysis plug-in. 14.A: Geomorphic interpretation output displayed over October 2010 UAV Drone imagery. 14.B: Pie chart showing percent area of each geomorphic class. 14.C: Summary of geomorphic classes by area (m<sup>2</sup>) and volume (m<sup>3</sup>). 14.D: Pie chart showing percent volume of each geomorphic class.
