Effects of Flooding and Tamarisk Removal on Habitat for Sensitive Fish Species in the San Rafael River, Utah: Implications for Furture Restoration Efforts

EFFECTS OF FLOODING AND TAMARISK REMOVAL ON HABITAT FOR SENSITIVE
FISH SPECIES IN THE SAN RAFAEL RIVER, UTAH:
IMPLICATIONS FOR FUTURE RESTORATION EFFORTS

MASTER OF NATURAL RESOURCES

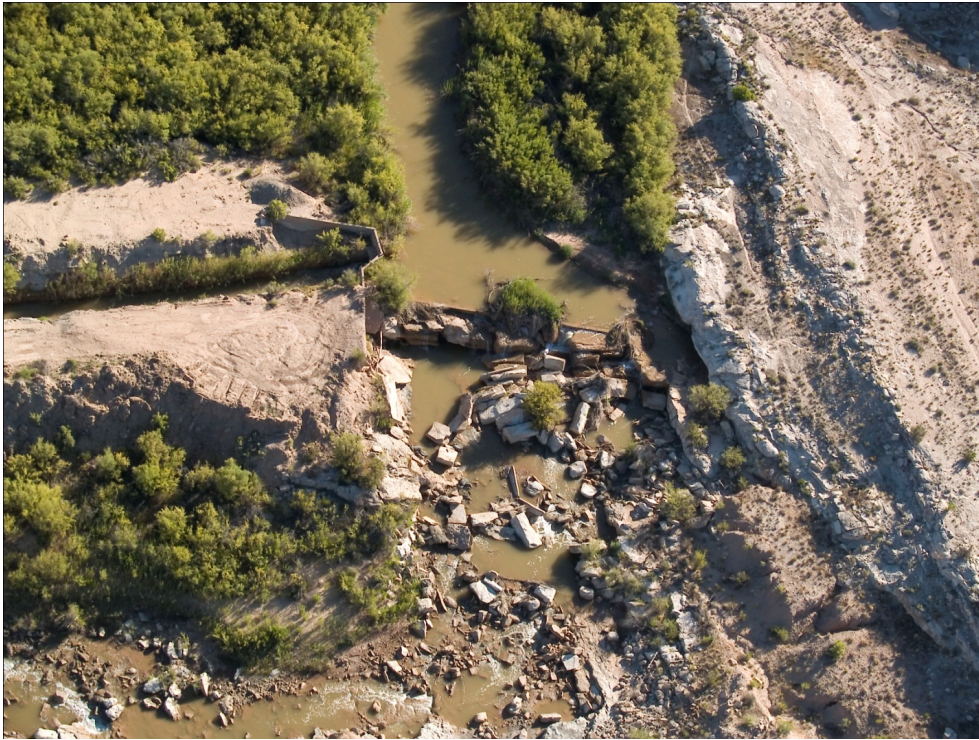
Figure 1. Aerial image of the Hatt's Ranch irrigation diversion (photo credit: Craig Walker) on the San Rafael River Utah. Most native fish occur above the diversion which is a complete barrier to upstream fish movement. The Diversion separates the lower and upper San Rafael River and prevents native fish from reaching higher quality habitat found in the upper San Rafael River; however, it has also kept non-native fish from colonizing the upper reaches where they would predate and compete with native fish. Providing passage around the diversion would benefit long migrating species such as flannelmouth sucker and Colorado pikeminnow, however this action would also open the upper river to invasion of non-native fish.

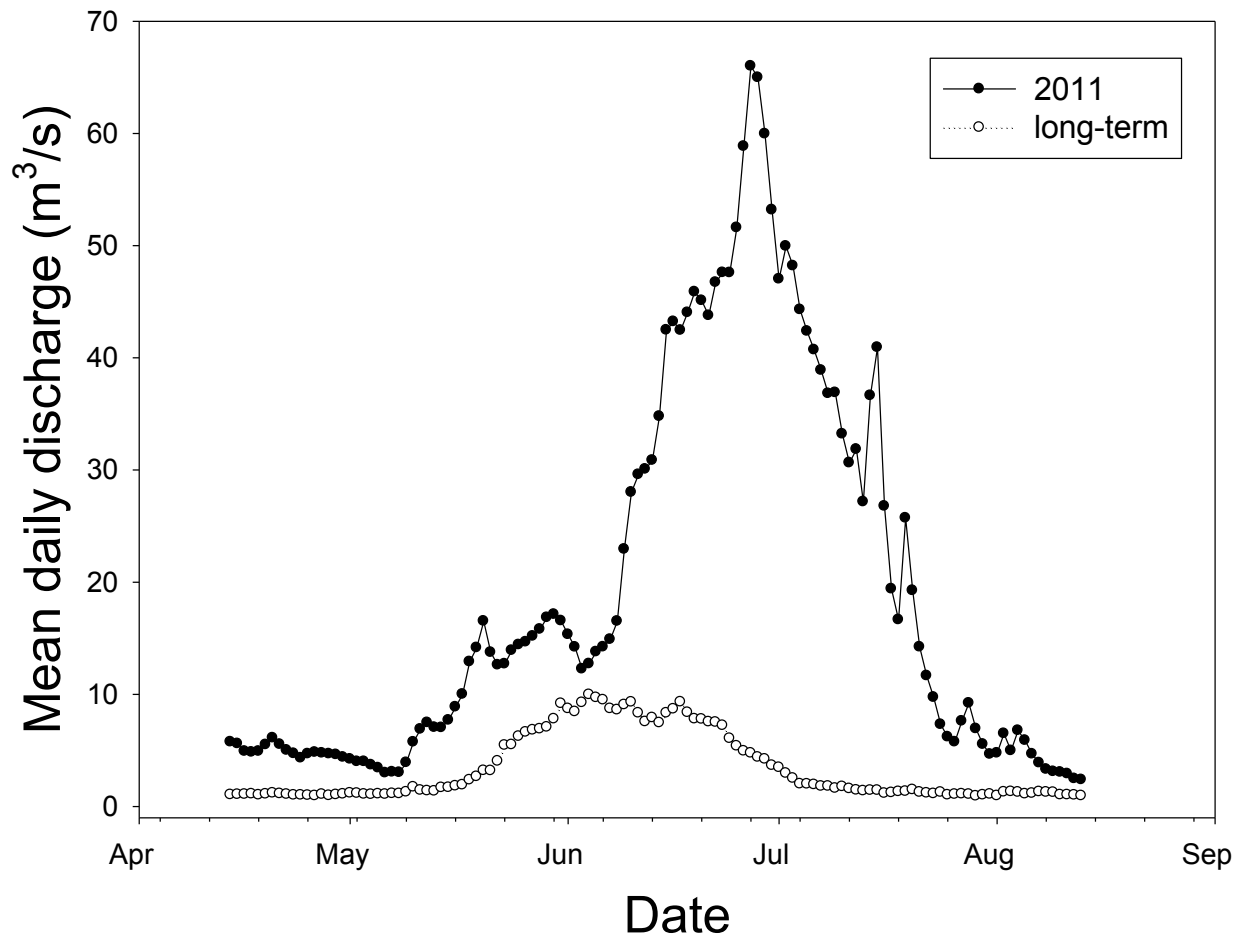
Figure 2. Measured discharge of the San Rafael River, Utah in 2011 (closed circles) compared to mean daily discharge over the period of record (1910-1918 and 1946-2012; open circles).

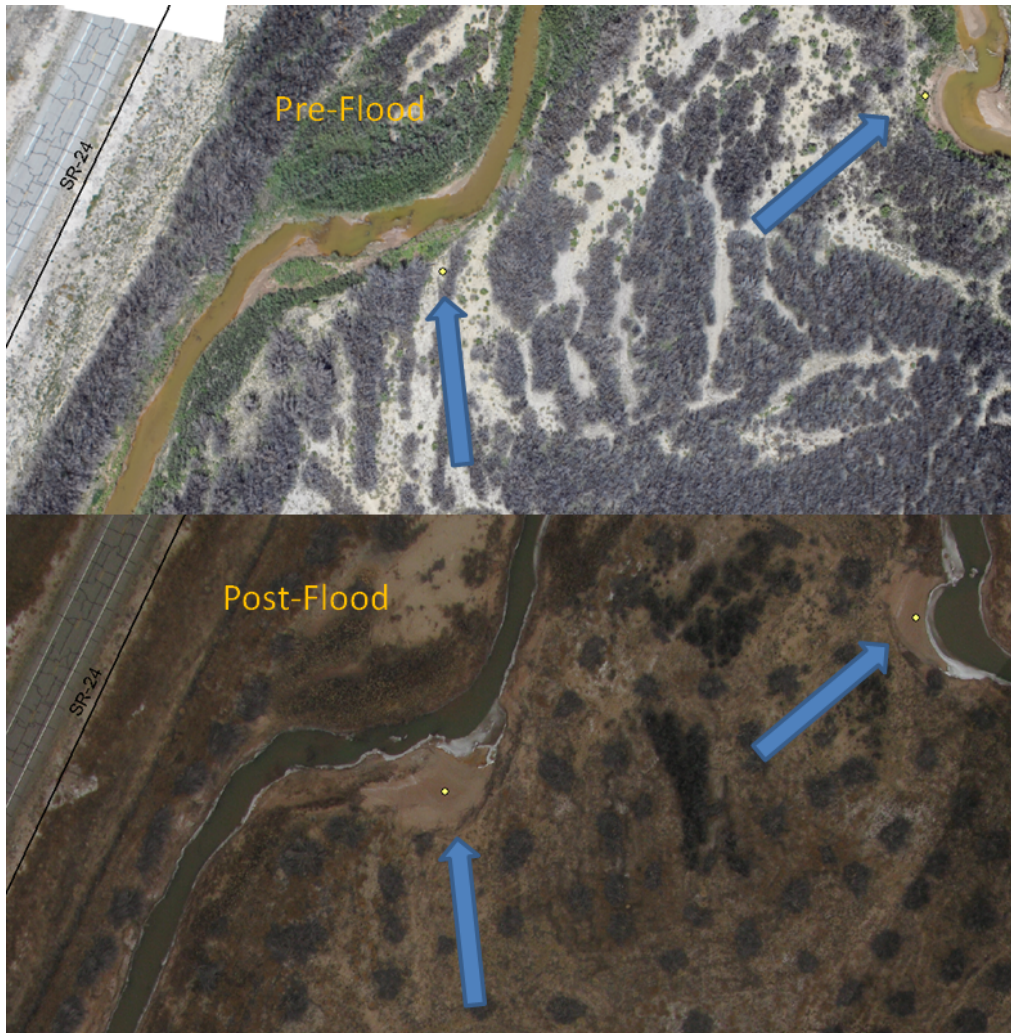
Figure 6. Before (above) and after imagery of the tamarisk removal treatment area. Yellow circles represent fixed coordinates, blue arrows indicate areas showing post-flooding lateral movement. Post-flood imagery shows the extensive tamarisk removal in this area (dark circles in bottom image are slash piles that were later burned).

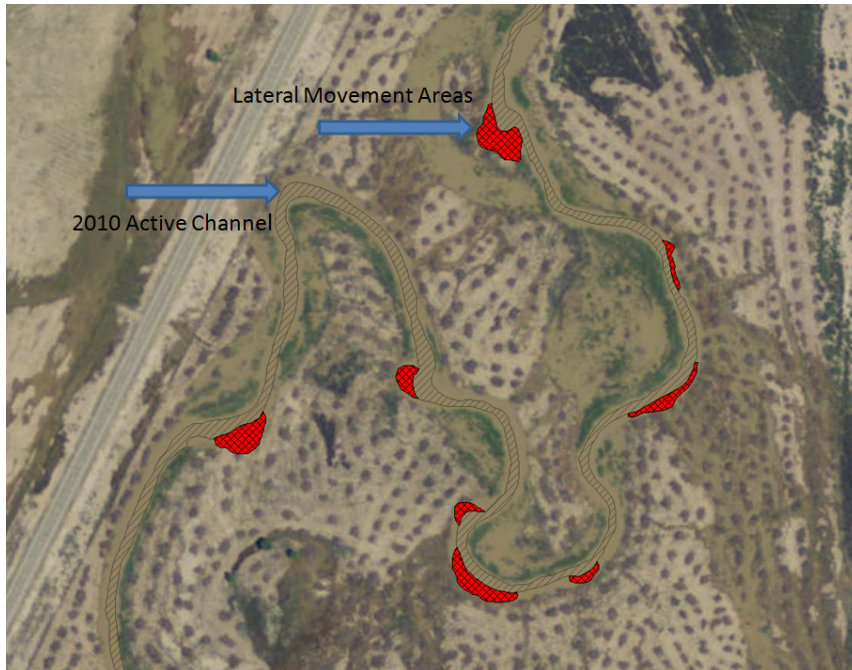
Figure 7. Lateral movement (red hatched) of San Rafael River Utah from 2011 flood; grey cross marked section indicates the 2010 active channel. GIS was used to calculate the area of lateral movement sites. The river was flooding when this imagery was captured (2011, National Agricultural Imagery Program, NAIP), and is not the aggie air (post flood) imagery used to delineate the lateral movement as seen in Figure 6.

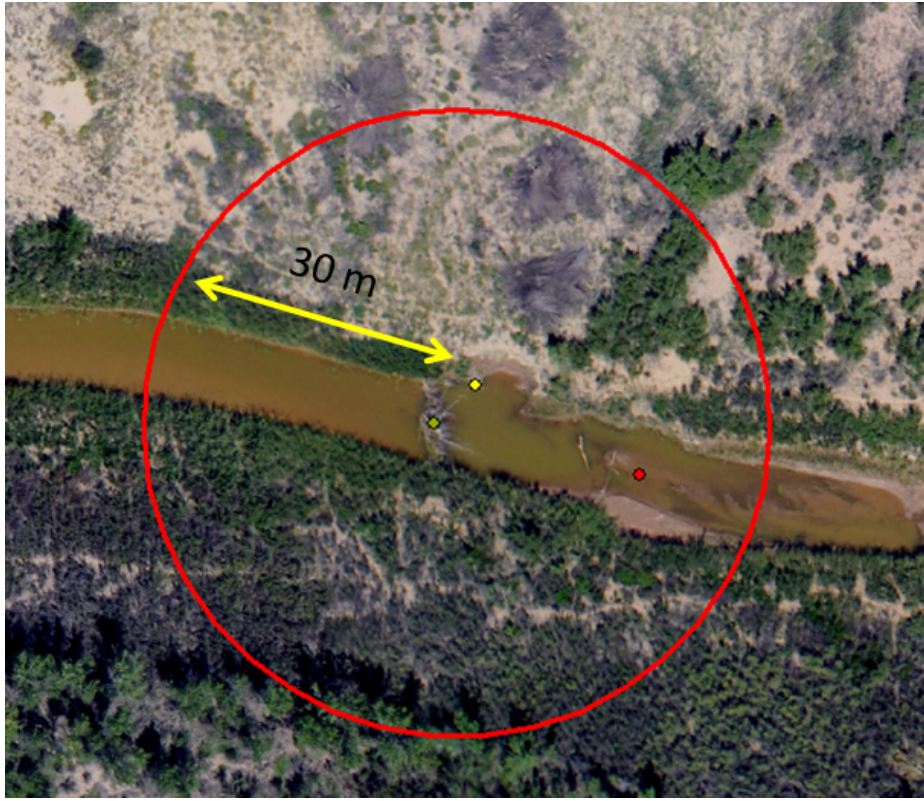
Figure 9. Close up view of a LWD pile buffer (red open circle) showing complex habitat features; yellow circle indicates a backwater, closed red circle is in riffle habitat and the green circle indicates the top of a pool. Buffers were used to select only the habitat near the large woody debris (LWD) pile (30 m upstream, and 30 m downstream) Type, number and area of features within buffers were summarized.

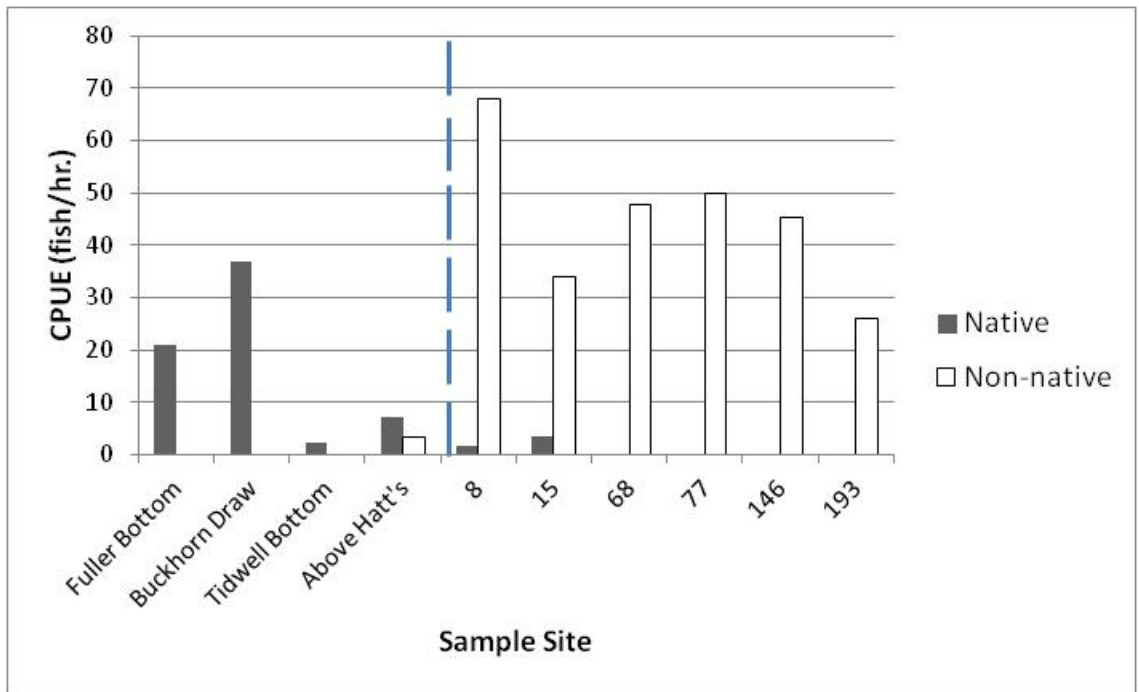
Figure 10. CPUE of fish captured during electrofishing surveys on the upper and lower San Rafael River Utah. The blue dotted line represents the location of the Hatt's diversion dam; upper San Rafael River sites are left of the line. Native fish were not captured below site 15.

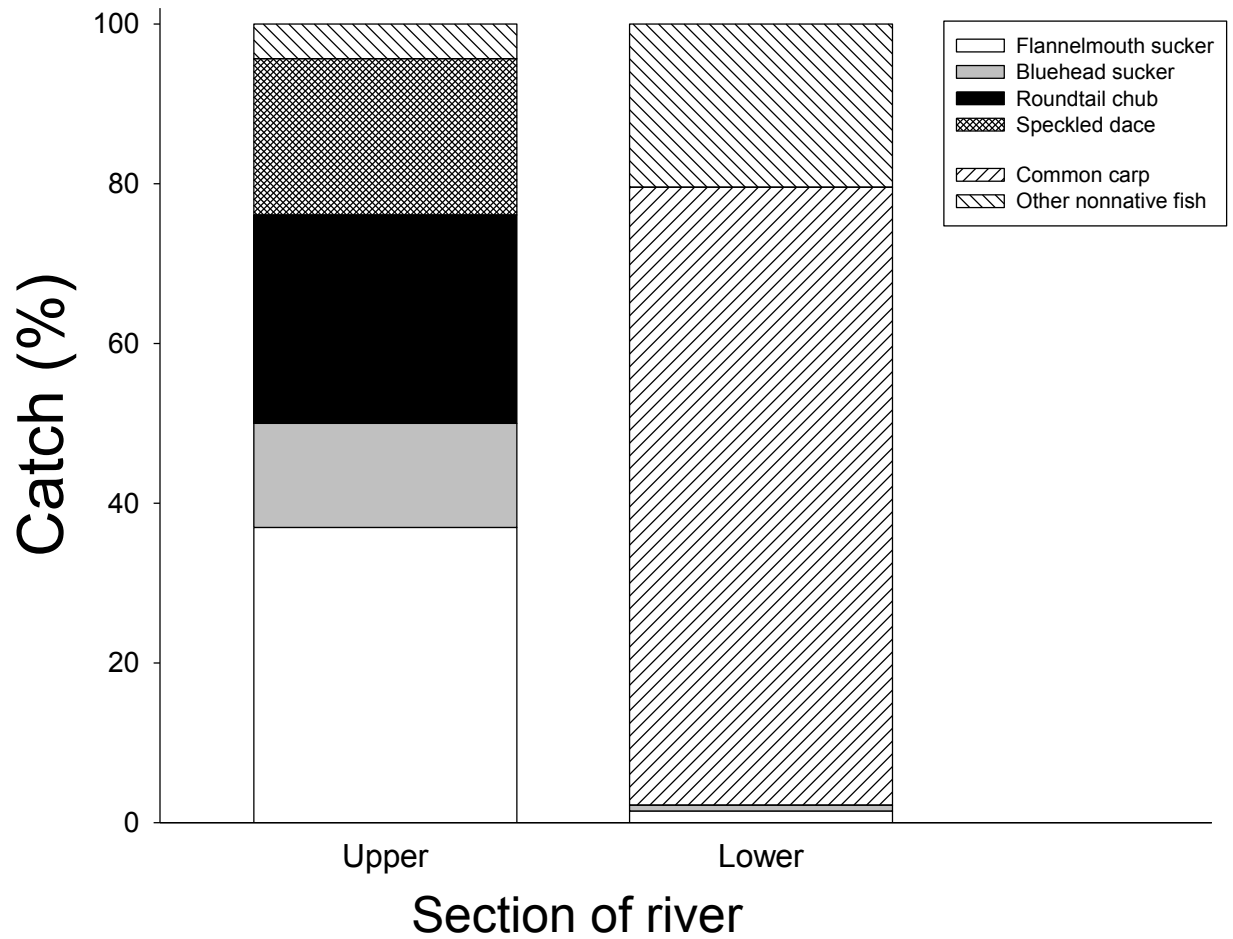
Figure 11. Percent catch of fish captured in the upper San Rafael River Utah (left) compared to the lower San Rafael River (right) during 2011 electrofishing surveys. The four native species: flannemouth sucker, bluehead sucker, roundtail chub, and speckled dace are shown individually. Non-native common carp are shown individually, and all other non-native fish are shown together.

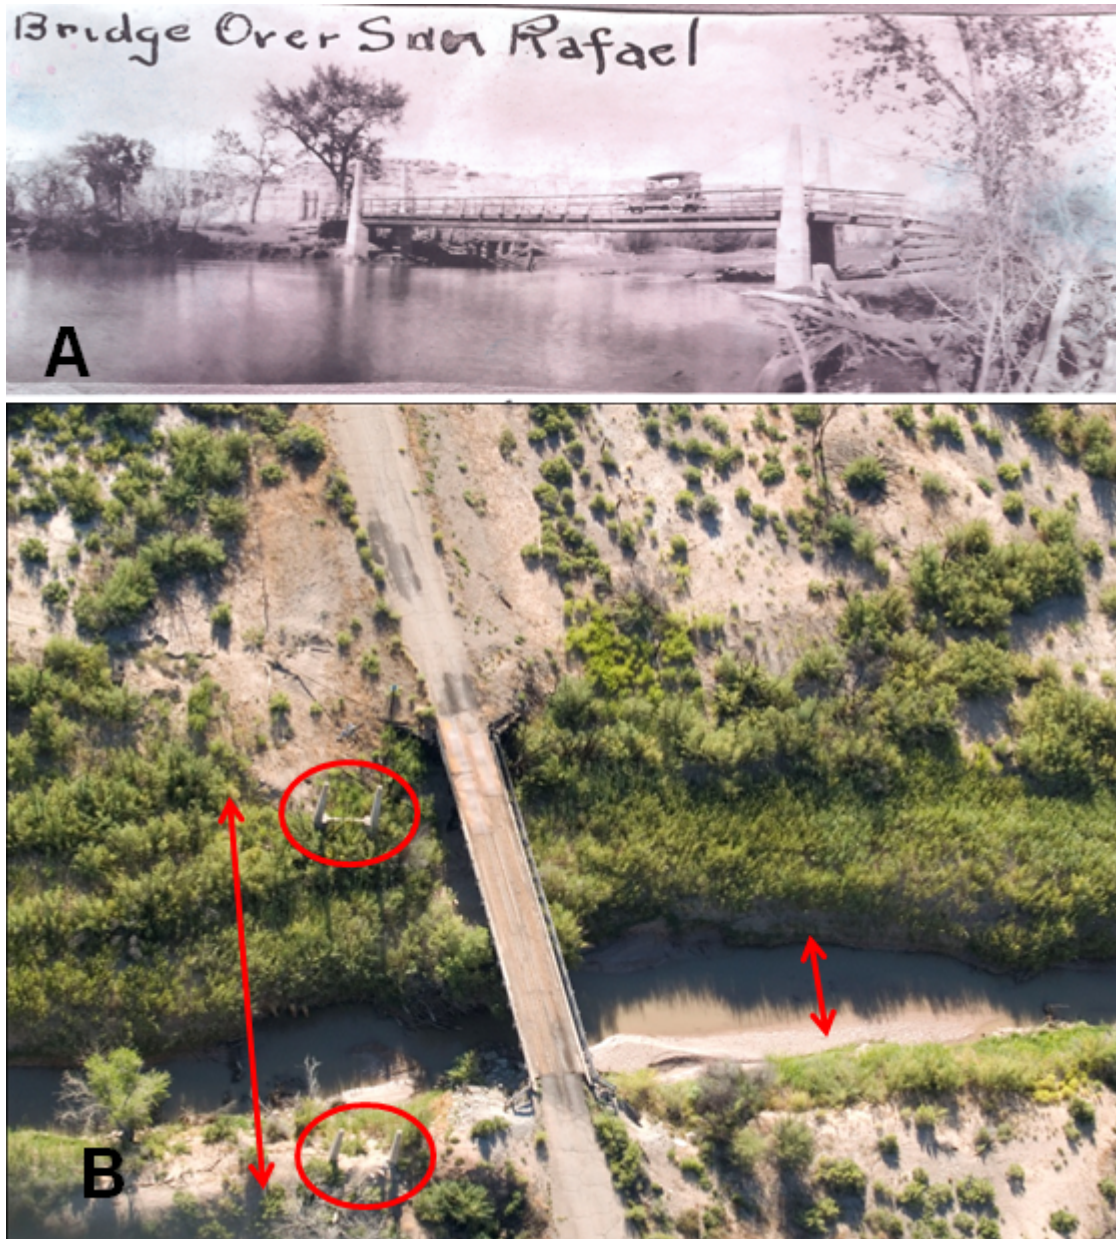
Figure 12. Photograph A. San Rafael River at the old Highway 24 bridge near Hatt's Ranch, depicting typical channel conditions in the early twentieth century (between 1921-1924, Credit: Floyd Kelly). This historical photo shows a wide and shallow channel with large woody debris collecting along the river bank. Photograph B. Illustrates the current river conditions on the San Rafael River. The red circles indicate the old vertical bridge supports that are present in photograph A. Notice that in photograph A the river extended out past these vertical supports. The red arrows indicate the historic (left) and current (right) active river channel.

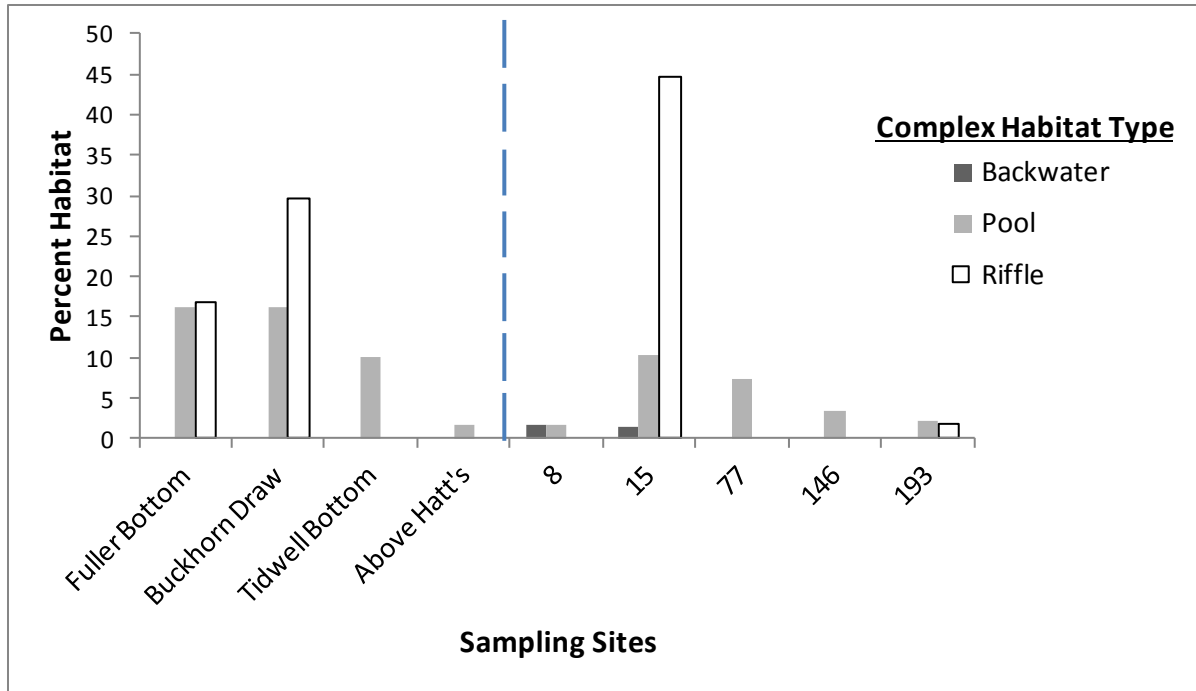
Figure 13. Complex habitat types at 9 sample sites on the San Rafael River Utah in 2011. Fuller Bottom is the furthest upstream site and 193 is the furthest downstream site, near the Green River. The blue line indicates location of Hatt's diversion dam and the division of the upper (left of the blue line) and lower river.

Sample sites in the upper San Rafael River were found to have a greater proportion of pool and riffle habitats. The Fuller Bottom site was comprised of 16.2 percent pool and 16.8 percent riffle habitat (Figure 13). The Buckhorn Draw site was comprised of 16.2 percent pool and 29.6 percent riffle habitat. Complex habitat is less available in the lower San Rafael River; however there are exceptions such as site 15 that was dominated by riffle habitat at 44.7 percent. Pools and backwaters were also present in site 15 (Figure 13). When comparing the percent habitat measured at our sites in 2011 to the data collected in years previous, we found that some sites changed very little while others, such as site 15, changed dramatically. Prior to the 2011 flood site 15 was devoid of both backwaters and riffles and held less than 1 percent pool habitat. After the 2011 flood this site shifted to predominately riffle habitat. Post flood, this site also provided pool and backwater habitat. Backwater habitat is the most limited complex habitat type in the lower San Rafael River. Backwater habitat was only found in two (sites 27, 173) of the 22 sites sampled by USU between 2007 and 2008 (Budy 2009). Due to the high run-off in 2011, backwaters were formed in sites 8 and 15 where they were not present before. Both sites 8 and 15 are within our tamarisk removal area.

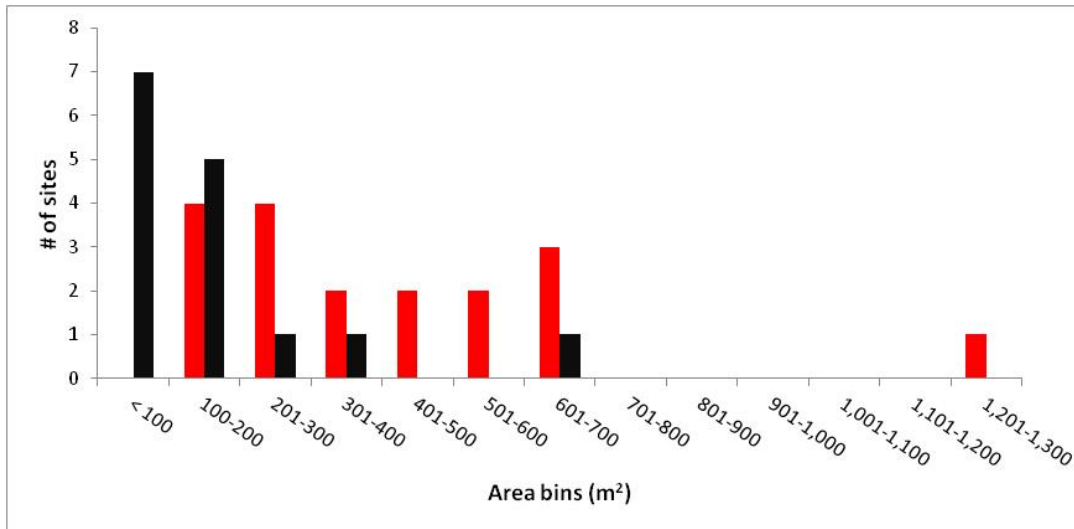
Figure 14. Sites showing lateral movement in response to 2011 flood on the San Rafael River Utah; red bars indicate treatment areas where tamarisk was removed, black bars indicate untreated areas. While the number of treated and untreated sites showing lateral movement were similar ($n=18$ treated, $n=15$ untreated) the area affected was significantly greater in the treatment (mean = 408 m^2 , SE = 66.7) compared to the untreated site (mean = 153 m^2 , SE = 42.9 , T-test $P = 0.003$).

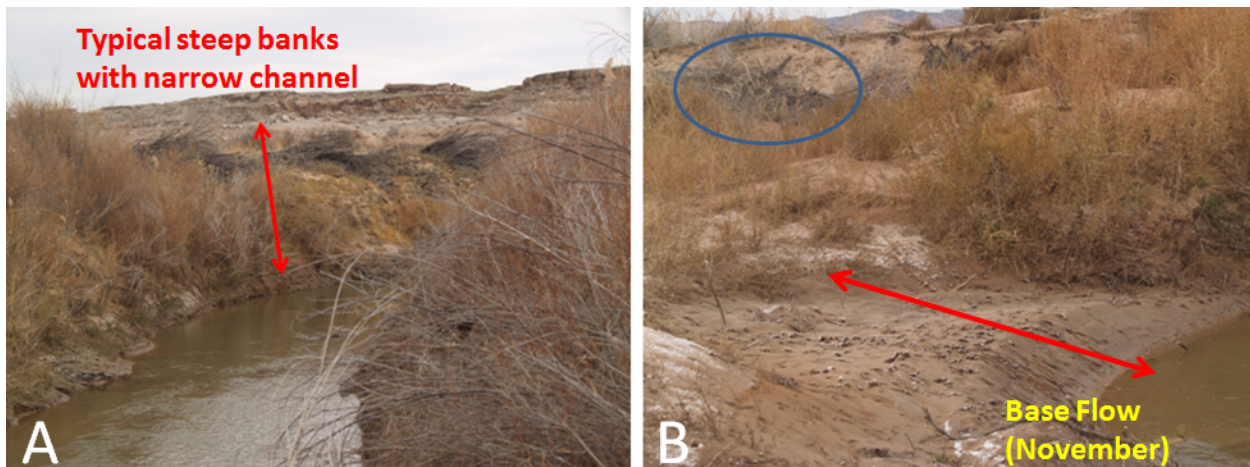
Figure 15. Lateral movement within our tamarisk treatment site on the lower San Rafael River Utah. Photograph A. Shows the typical steep banks and narrow channel that forms a ditch like river lacking habitat complexity. Photograph B. Shows a lateral movement site within our tamarisk treatment area. The blue oval shows a tamarisk pile falling into the channel that was a considerable distance away before the channel migration. The red arrow shows the river edge at base flows; when the river rises slightly this area will flood creating habitat complexity.

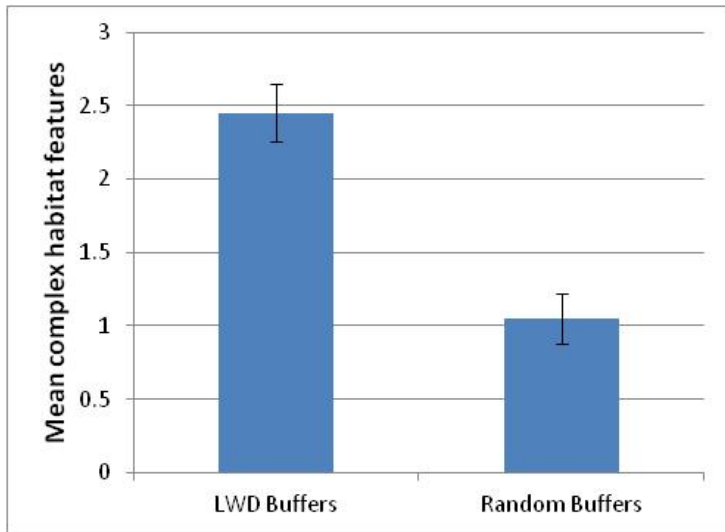
Figure 16. Mean number of complex habitat features (backwaters, riffles, pools) within LWD buffers (mean = 2.45, SE = 0.195) and random buffers (mean = 1.05, SE = 0.171). Standard error bars are displayed on graph (T-test, $P < 0.0001$).

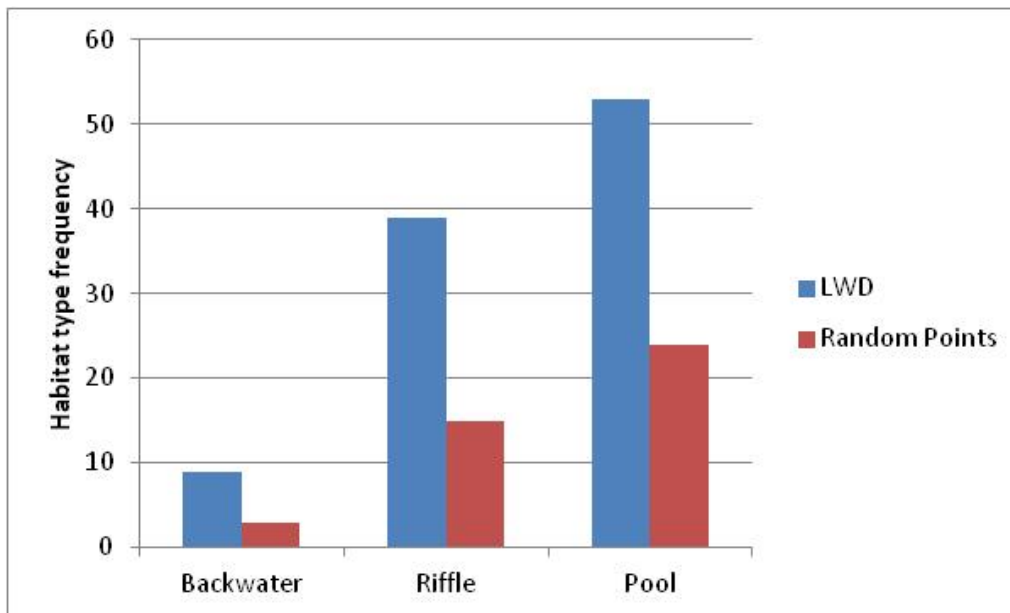
Figure 17. Number of complex habitat features sorted by type (backwater, riffle, pool) within LWD buffers (blue bars) and the random buffers (red bars) on the San Rafael River. All three habitat features occurred more frequently around LWD piles.

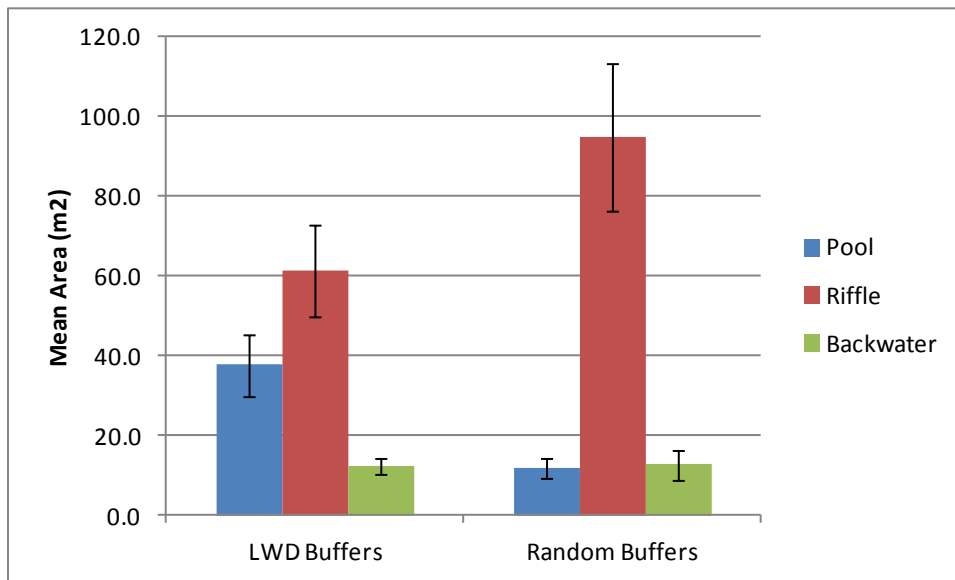
Figure 18. Mean area of complex habitat associated with LWD buffers and random buffers. The mean size of pools around LWD was significantly greater than at random sites (T-test $P = 0.002$). Mean size of riffle and backwater habitat was not significantly greater at random than LWD sites (T-test $P = 0.14$, $P = 0.94$ respectively). Standard error bars are displayed on graph.

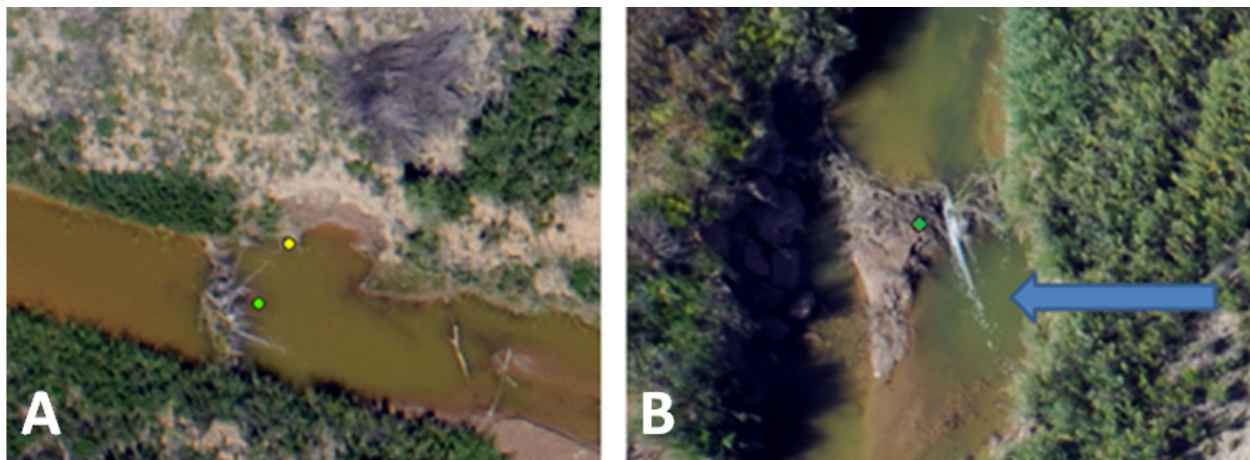
Figure 19. Creation of important fish habitat through the use of large woody debris (LWD) piles (green circles) on the San Rafael River, Utah. A. Demonstrates a backwater (yellow circle) created by a deflection of flow around a LWD pile (green circle). B. Illustrates a large scour pool (blue arrow) created by a LWD pile.

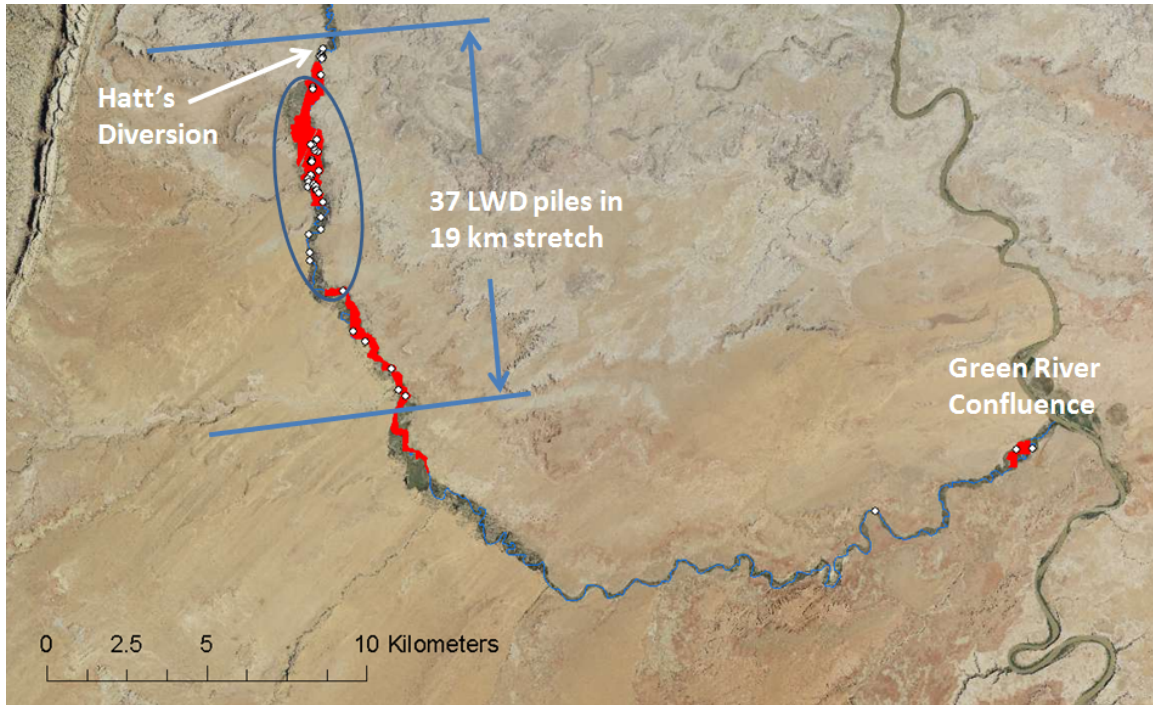
Figure 20. Distribution of LWD piles (white circles) on the lower San Rafael River Utah; the highest concentrations of LWD piles (37 of 40) occurred in a 19 km stretch below the Hatt's Ranch Diversion near tamarisk treatment areas (red) and high beaver activity (6 of 8 dams) found in 2010 (blue oval). The high concentration of LWD in 2011 was likely due to a combination of tamarisk piles flushing into the river and beaver activity.

An interesting pattern in LWD distribution is revealed when the piles are displayed on a map. Thirty-seven of the total 40 piles are found grouped together within a 19 km stretch around Hatt's Ranch (Figure 20). The 45 km below this aggregation is relatively devoid of LWD piles. Hatt's Ranch was the initial site selected for tamarisk removal in 2008 with removal being completed in 2009. Figure 21 shows a large quantity of wood piles stacked within the Hatt's Ranch during tamarisk removal. One explanation for the large concentration of woody debris around the Hatt's Ranch area is that tamarisk piles stacked within the floodplain were washed into the river during monsoonal flooding that occurred in the summer and fall of 2009. Figure 22 shows a lateral movement with tamarisk piles falling into the river as the banks erode around them. The imagery used to count the piles was captured during the summer of 2010, potentially detecting the washed in debris from the previous year.

river were noted to have beaver activity. Six of the 8 sites noted with beaver dams were between section 5 and 79, which completely overlaps the LWD concentration (Figure 20).

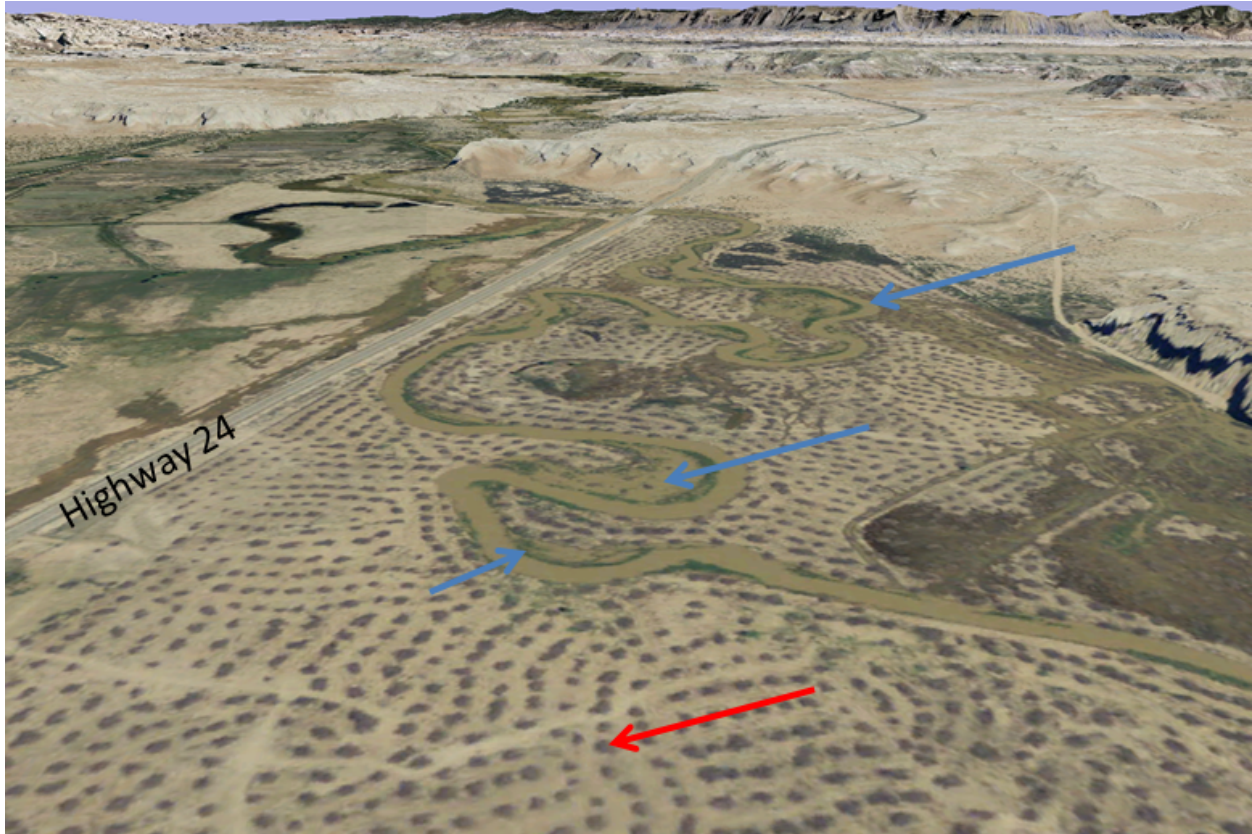
Figure 21. Imagery showing extent of the tamarisk removal project. This photo is only showing 48.5 hectares (120 acres) of removal, currently we have removed approximately 424.5 hectares (1,049 acres) of tamarisk. Note the areas of flooding that contain tamarisk piles (blue arrows). Flooding within our tamarisk treatment areas likely have contributed beneficial LWD to the river system. Red arrow points out one of the many tamarisk slash piles.

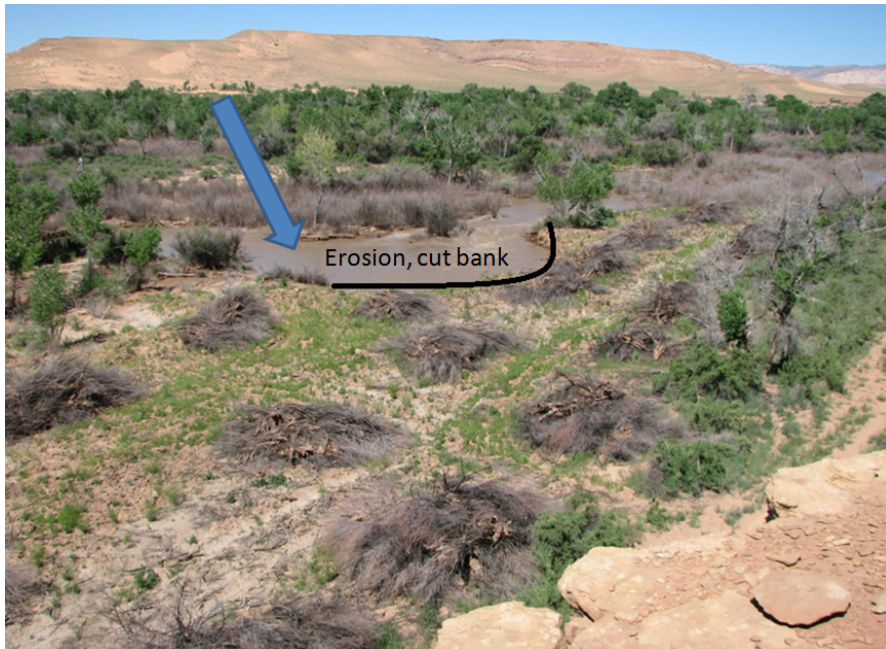
Figure 22. Photograph showing bank erosion and tamarisk piles (i.e., large woody debris) falling into the river (blue arrow); both are positive intended results of tamarisk treatments.

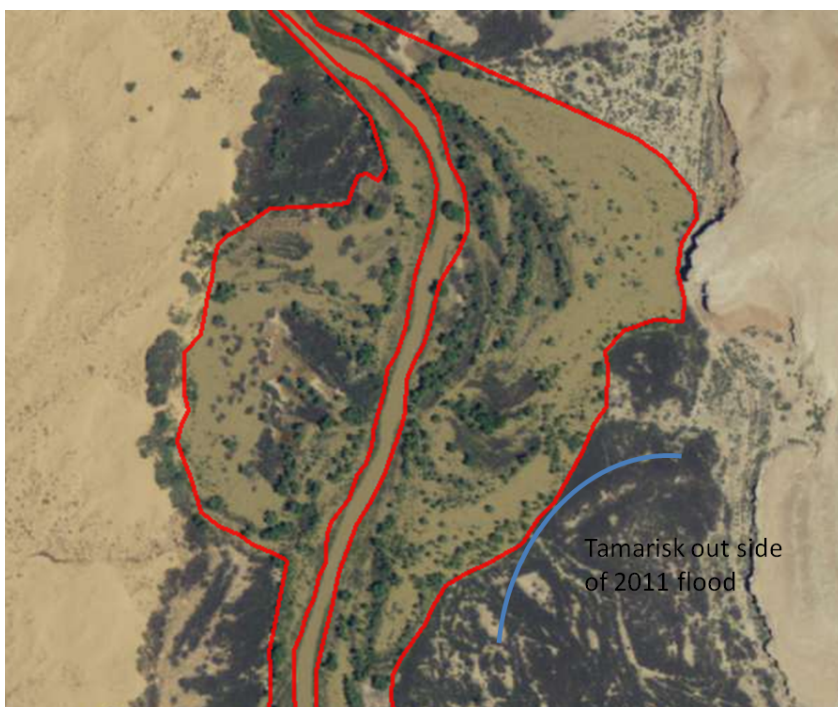
Figure 23. Example of the extent of 2011 flooding captured by the 2011 NAIP imagery. In this image the floodplain had been digitized (red lines).

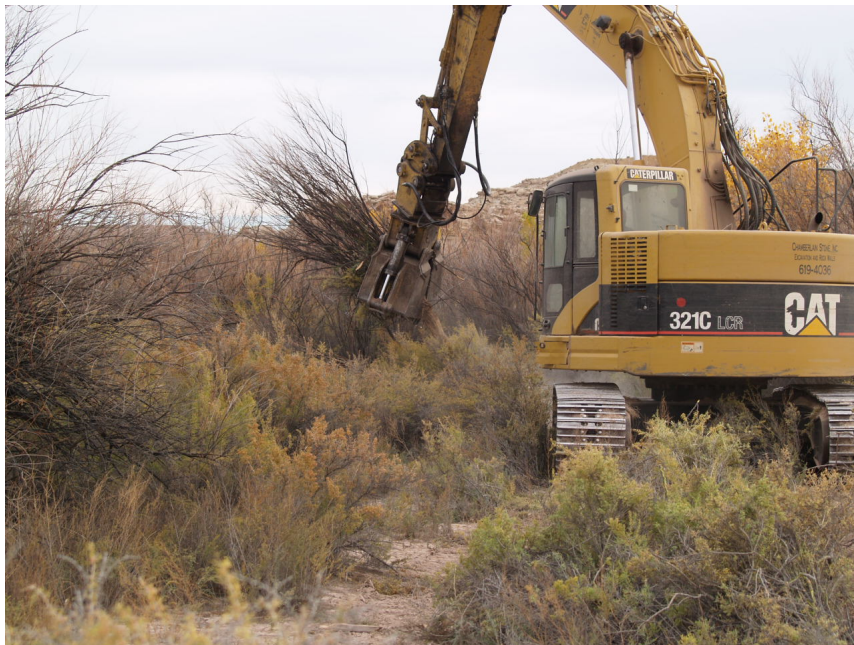
Figure 24. 321C excavator with rotary grapple attachment working to remove tamarisk at Hatt's Ranch, October 2008. This method allows individual tamarisk plants to be plucked while minimizing disturbance to surrounding native vegetation. Removal of the root ball from the soil minimizes the need for costly herbicide treatments.
