## Continuous Operation of Micro Plasma Thruster “Microwave Engine”

**Abstract.** A low-power, microwave-discharge type electrostatic thruster named “microwave engine” has been developed for applications to 50 kg-class satellites at Advanced Technology Institute Ltd. (ATI) in Hokkaido, Japan. A prototype of the engine was manufactured, and its performance and random vibration tests have been reported in previous papers. An endurance test followed, and showed no failure in the engine after 400 hours of operation.

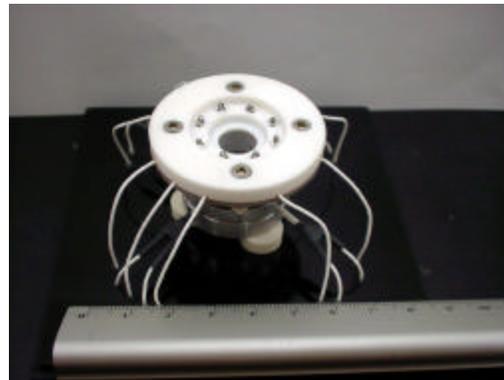
**Fig. 1 Microwave Engine Head**

been reported in previous papers.<sup>1,2,3</sup> A prototype engine generated a thrust of 0.36 mN with a specific impulse of 1250 seconds at a total power of 26.6 W. The random vibration test of the microwave engine showed no visible failure, and its tolerance on the mechanical environment was confirmed. The thermal analysis concluded that white paint should be applied to all surfaces of the microwave

engine assembly while using the engine mounting bracket as a radiator surface. This design gives a maximum on-orbit temperature of the engine head (including both magnets) of 86 °C, which is well below the maximum temperature limit of 110 °C.

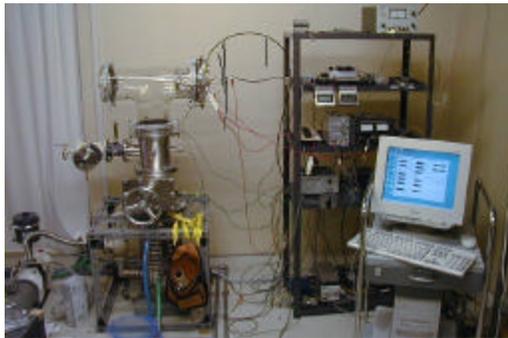
Continuous operation of the microwave engine was conducted as a test of its endurance. The test system consists of thruster system, vacuum chamber and pumps, recorder and PC. The experiment is automated using the PC. All data are stored in the PC's hard disk. The setup for the endurance test is shown in Fig. 2.

**Fig. 2 Setup for Endurance Test of Microwave Engine System**

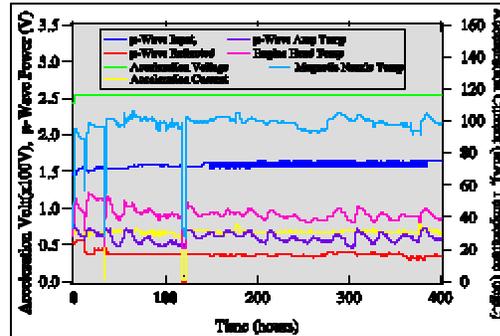
400 hours have passed so far, and the operation characteristics over that period are shown in Fig. 3. A brief shut down on the 34th hour was necessary for maintenance by the electric power company. There was another shut down on the 118th hour. Investigations revealed that the engine was shorted to the vacuum flange which was grounded and that the fuse on the acceleration voltage supply had been blown. The short between the engine and ground was

**Fig. 3 Endurance Test of Microwave Engine (400 hours so far and continuing)**

caused by the failure of the insulating sheet between the engine and the engine stand which is directly attached to the vacuum flange. The sheet was replaced, and the discontinuity between the engine and ground was verified before the endurance test was resumed. This failure was not related to the microwave transmission path or internal components of the engine. Therefore, operation and endurance of the microwave engine is considered to be in good condition. Figure 4 shows actual run time of the engine during the first 400 hours of the test. Small accumulation of sputtered materials was observed in the corner where the upstream end wall and side wall of the discharge chamber met. Analysis with a scanning electron microscope revealed that the sputtered

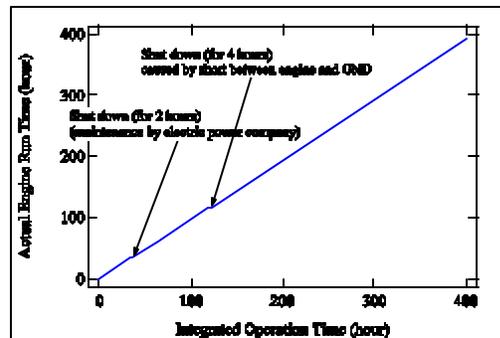
**Fig. 4 Actual run time of Microwave Engine during the endurance test**

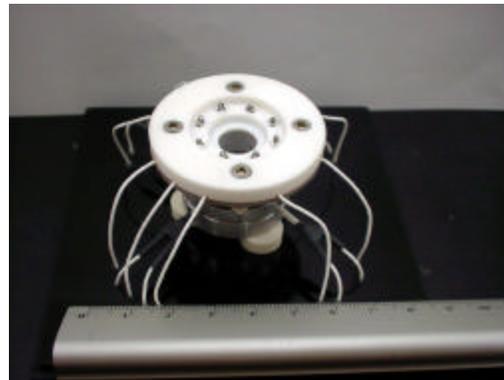
**Fig. 1 Microwave Engine Head**

been reported in previous papers.<sup>1,2,3</sup> A prototype engine generated a thrust of 0.36 mN with a specific impulse of 1250 seconds at a total power of 26.6 W. The random vibration test of the microwave engine showed no visible failure, and its tolerance on the mechanical environment was confirmed. The thermal analysis concluded that white paint should be applied to all surfaces of the microwave

engine assembly while using the engine mounting bracket as a radiator surface. This design gives a maximum on-orbit temperature of the engine head (including both magnets) of 86 °C, which is well below the maximum temperature limit of 110 °C.

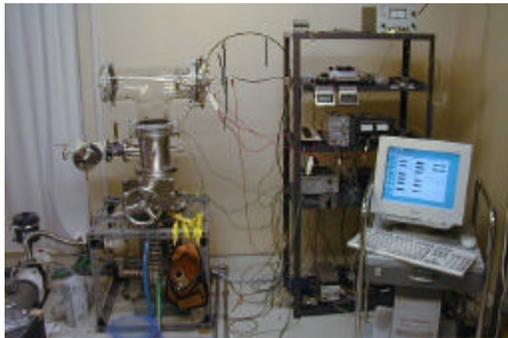
Continuous operation of the microwave engine was conducted as a test of its endurance. The test system consists of thruster system, vacuum chamber and pumps, recorder and PC. The experiment is automated using the PC. All data are stored in the PC's hard disk. The setup for the endurance test is shown in Fig. 2.

**Fig. 2 Setup for Endurance Test of Microwave Engine System**

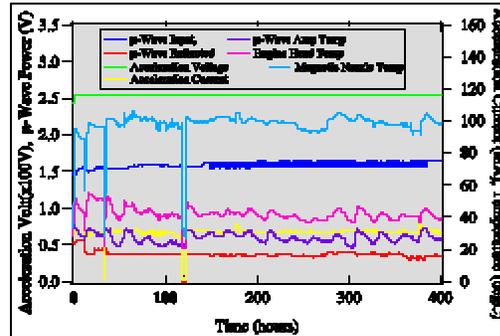
400 hours have passed so far, and the operation characteristics over that period are shown in Fig. 3. A brief shut down on the 34th hour was necessary for maintenance by the electric power company. There was another shut down on the 118th hour. Investigations revealed that the engine was shorted to the vacuum flange which was grounded and that the fuse on the acceleration voltage supply had been blown. The short between the engine and ground was

**Fig. 3 Endurance Test of Microwave Engine (400 hours so far and continuing)**

caused by the failure of the insulating sheet between the engine and the engine stand which is directly attached to the vacuum flange. The sheet was replaced, and the discontinuity between the engine and ground was verified before the endurance test was resumed. This failure was not related to the microwave transmission path or internal components of the engine. Therefore, operation and endurance of the microwave engine is considered to be in good condition. Figure 4 shows actual run time of the engine during the first 400 hours of the test. Small accumulation of sputtered materials was observed in the corner where the upstream end wall and side wall of the discharge chamber met. Analysis with a scanning electron microscope revealed that the sputtered

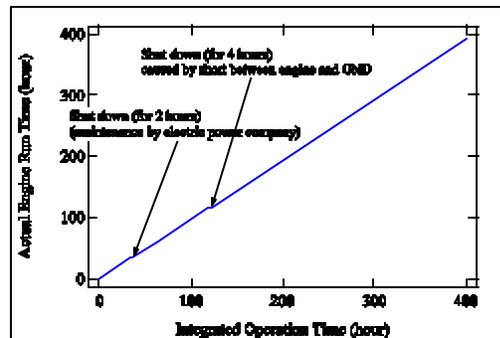
**Fig. 4 Actual run time of Microwave Engine during the endurance test**
