Electrostatic Breakdown Analysis

URCO Final Report

USU Materials Physics Group

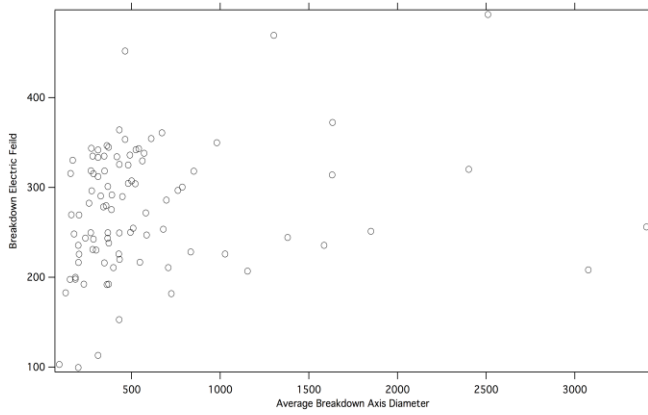
*Electric Field and Average Breakdown Diameter
Figure: 1.0*

Of interest at the start of the project was the relationship of destroyed material to the applied electric field. Larger areal damage was expected to positively correlate to an increased electric field since higher energies are capable of larger material displacement: $E=mc^2$. Our plotted data (figure 1.0) shows a typical range of electric field values for breakdown, however no correlation was found between this value (e-field) and breakdown axes. Worth noting is the process of determining the areal

damage. At the investigation start major and minor axis of displaced material was measured rather than entire damage zone. A more accurate indicator of damaged material resulting from expended energy may be to measure the associated damage melt area surrounding the displaced material (hole), in addition to the actual hole. I believe our graph did not show a correlation as a result of this oversight.

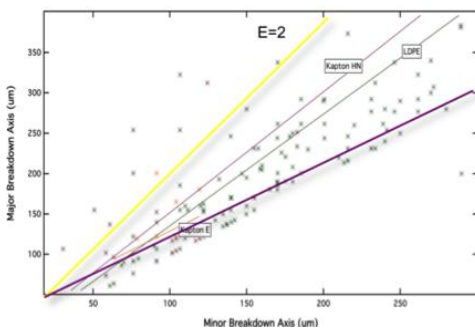
Material Eccentricity Figure 2.0

Breakdown eccentricity of each material flavor was examined graphically by plotting major and minor axis against each other (figure 2.0). This was performed for all material types, as well as the different test types performed on each material. Our work shows that breakdown were elliptical rather than perfectly circular. Eccentricity was measured by creating a ratio between the major and minor axis of each breakdown hole. Our sample group has an

average eccentricity of 1.38. The orientation of the ellipse axes was not noted during this investigation. In the future, this would be worth recording since

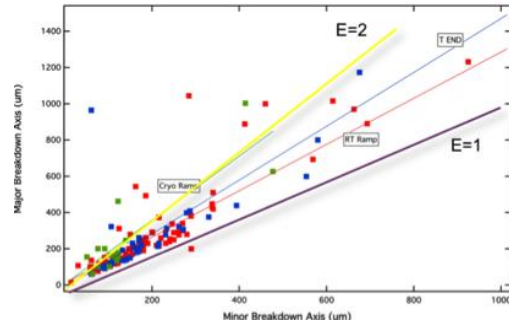
Test-Type Eccentricity Figure 3.0

Eccentricity of the different test types was looked at in a similar manner. Types of tests performed on samples included Cryo Ramp (increasing voltage at cold temperatures), RT Ramp (increased voltage at room temperature), and Time Endurance (constant voltage over a prolonged period of time). Cryo Ramping was thought to yield larger areal destruction than the other tests. It was thought that material; which was tested at space temperature (3° Kelvin), would be denser than at room temperature and more brittle. This change in material property was thought to cause damage to propagate further than at room temperature. A higher eccentricity value or a larger average breakdown value of these test types than other tests would lead us to believe breakdown at space temperatures propagate further, or are larger, than at room temperature. Eccentricity was examined in our major and minor axis graph comparison; Cryo Ramp test types did have a higher eccentricity value of nearly 2. Room temperature tests had an eccentricity of 1.4. When breakdown diameter averages for each group were compared, no relationship between average breakdown diameter and the test performed was noted. Our graph does demonstrate that breakdown eccentricity increased with breakdown size. Samples deviated from an eccentricity of 1 (circular) as their size increased.

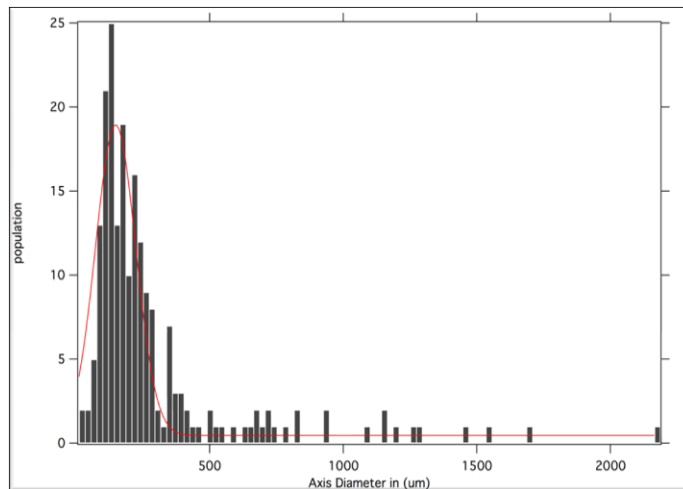
Complete Population and Average Breakdown Diameter Figure 4.0.

My comparisons were made using over 200 analyzed samples, the majority of which (78%) were Low Density Polyethylene samples of varying test types. These conclusions primarily apply to this sample type. Kapton E and Kapton HN were also included in our analysis but comprised fewer than 35 test pieces. Populations of each material test type were plotted in a histogram (figure 4.0) to compare breakdown diameter of the entire test group. This showed that there is a normal breakdown diameter. A histogram of multiple Kapton flavors (Figure 5.0) was

created to examine whether the predominantly LDPE material falsely represented the rest of our data. Initial trends within Kapton materials indicated that the average breakdown site diameter was in fact 200% +/- 4% smaller. Comparing the population of different materials (figures 4.0 and 5.0) allowed us to locate a potential trend in a materials susceptibility to break down. Our graph shows that this susceptibility is likely due to material type rather than testing differences. Since similar histograms showed no trend when sorted based upon test variations.

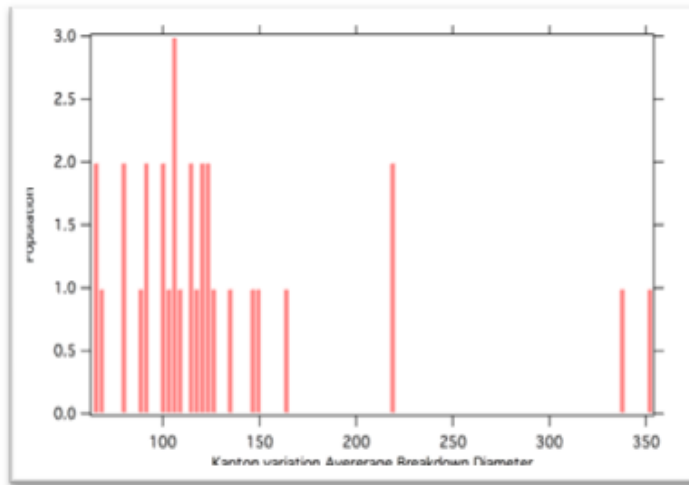
*Kapton Flavor Samples and Average Breakdown Diameter.
Figure 5.0*
