Electrostatic Discharge in Spacecraft Materials

ELECTROSTATIC DISCHARGE IN SPACECRAFT MATERIALS

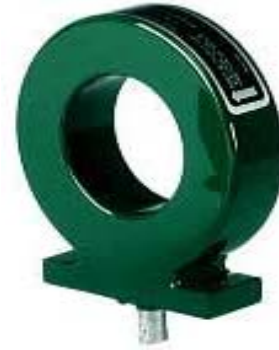
Fig 3.3: Pearson Electronics Current Monitor.

One of the current measurement methods uses a Pearson Electronics current monitor, also known as a current transformer or Pearson Coil. The sample current passes through the center of the Pearson Coil, which then outputs 0.1 V for every 1A of sample current. If the sample current detected by the Pearson Coil rises above a user-defined threshold a Tektronix TDS 2040 Digital Storage Oscilloscope records a user-defined time interval of data about the trigger event. The time between data points depends upon this user defined time-interval. For most experiments, the time between data points was 2 ns.

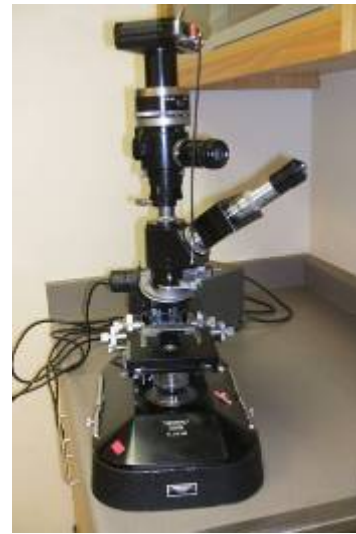
Fig 3.4: Zeiss Optical Microscope.

The images before and after are carefully reviewed and compared with one another, and notes are made of any differences between the two. Particular attention is devoted to detecting scorch marks and other physical signs that suggest the occurrence of an ESD event. The location and magnitude of these markings are recorded.

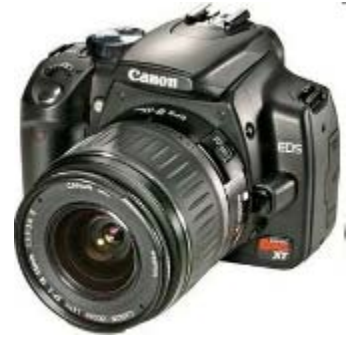
Fig 3.5: Canon Digital SLR Camera

Still photographs of each sample were taken during ESD testing using a Canon Rebel XT Digital SLR camera. As with the video camera, the still camera was placed outside of the vacuum chamber and focused on the sample through a quartz window. The camera shutter was opened to download the image for 30 seconds and closed for four seconds of reset time. This pattern was repeated for the duration of the experiment. For every experiment, photographs were converted to bitmap images and cropped identically. These images were analyzed using a MathCad program that determined the intensity of the red, green, and blue light as well as the total light intensity of each frame.

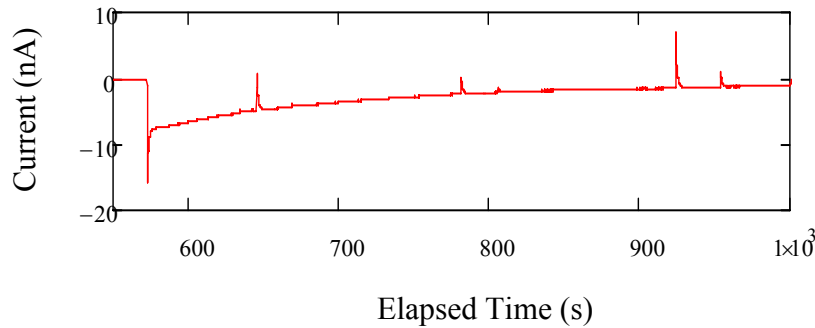
Fig 4.8: Graph of Electrometer Current versus time for Test 71.

The data recorded by the electrometer shows a sudden-onset, exponentially-decaying current similar to that seen in Test 70. Five arc events were also detected, the first of which appears to have happened either immediately before or simultaneously with the onset of the exponentially-decaying current. This arc occurred at 572 s, and is a spike in the negative current direction with a peak value of -15.75 nA from the base current. The other arcs (at 645, 781, 924, and 954 s) occur after the sudden-onset current, and are spikes in the direction of positive current.

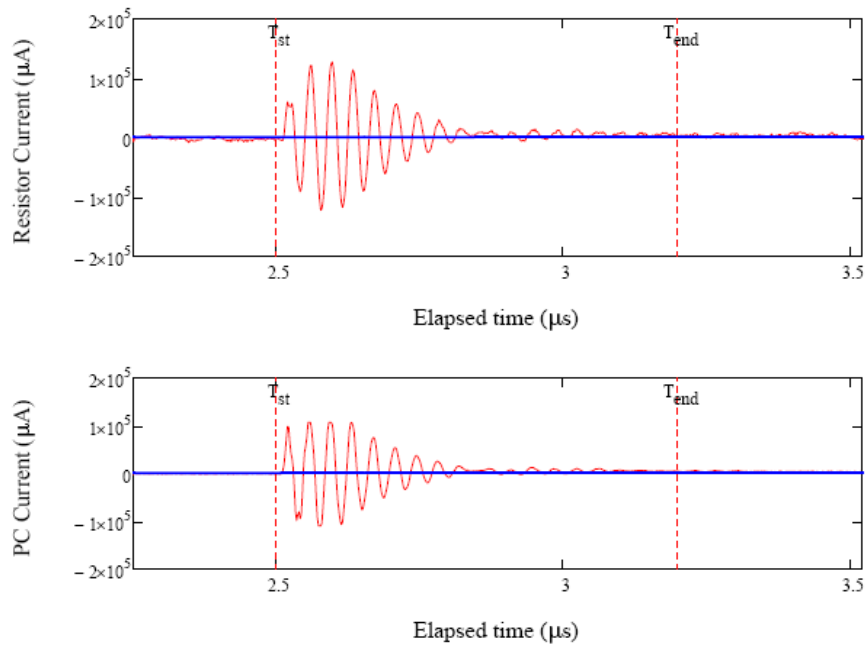
Fig 4.9: Graphs of Resistor and Pearson Coil (PC) current for Test 71 at **924 s**.

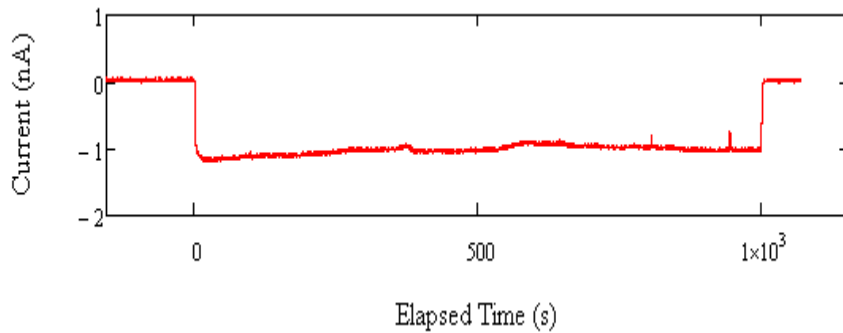
As for test 72, no exponentially-decaying currents appear in the electrometer data for Test 73. However, two small arc events were detected at $t = 804$ s and $t = 944$ s, which reached peak values of $I = 0.16$ nA and $I = 0.29$ nA, measured from the baseline current. (See Table 4.8 and Figure 4.18.)
