## UAV-Based Remote Sensing of Immediate Changes in Geomorphology Following a Glacial Lake Outburst Flood at the Zackenberg River, Northeast Greenland

# UAV-based remote sensing of immediate changes in geomorphology following a glacial lake outburst flood at the Zackenberg river, northeast Greenland

## ABSTRACT

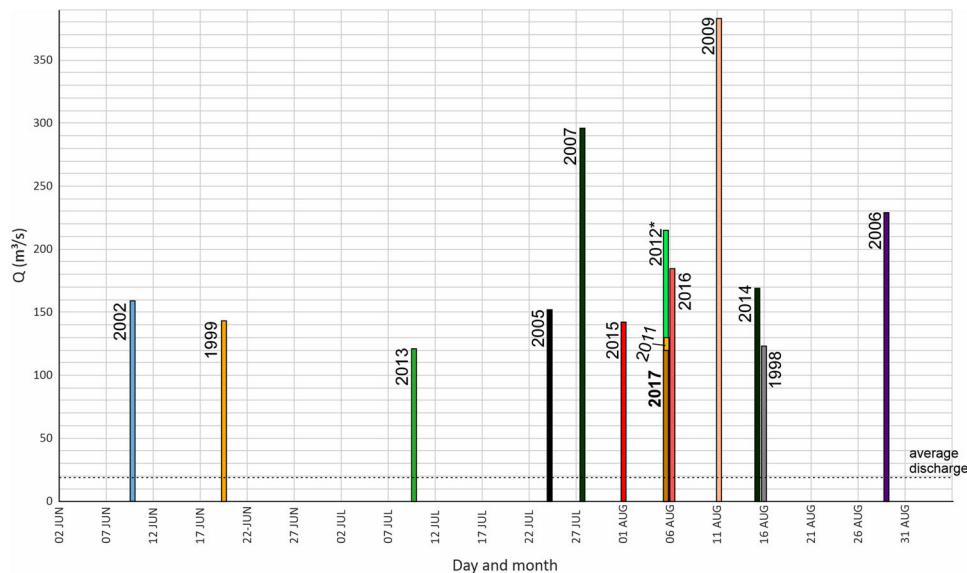
**Figure 2.** The average discharge (1996–2018) of the Zackenberg river and the maximum discharges for each year where a flood event was recorded. Data from the Greenland Ecosystem Monitoring Programme were provided by Asiaq – Greenland Survey, Nuuk, Greenland. Note: the flood in 2012 was so large that it destroyed the hydrological station; therefore, the provided discharge is underestimated.

The Zackenberg river catchment covers about 514 km<sup>2</sup>. The total annual discharges and associated total annual suspended sediment loads of the river in the years 1996–2015 varied from 132 to 338 million m<sup>3</sup> and from 16,129 to 162,622 t, respectively (Skov et al., 2017). The total discharge and suspended sediment were controlled for the most part by extreme events caused by the glacial lake outburst flood (GLOF), extreme rain event, rapid snowmelt, or a combination of these (Kroon et al., 2017). In the years 1996–2015, thirteen extreme events with discharges over 100 m<sup>3</sup> s<sup>−1</sup> were recorded at the Zackenberg river. Moreover, at least two additional extreme events occurred during the winter months (Kroon et al., 2017).

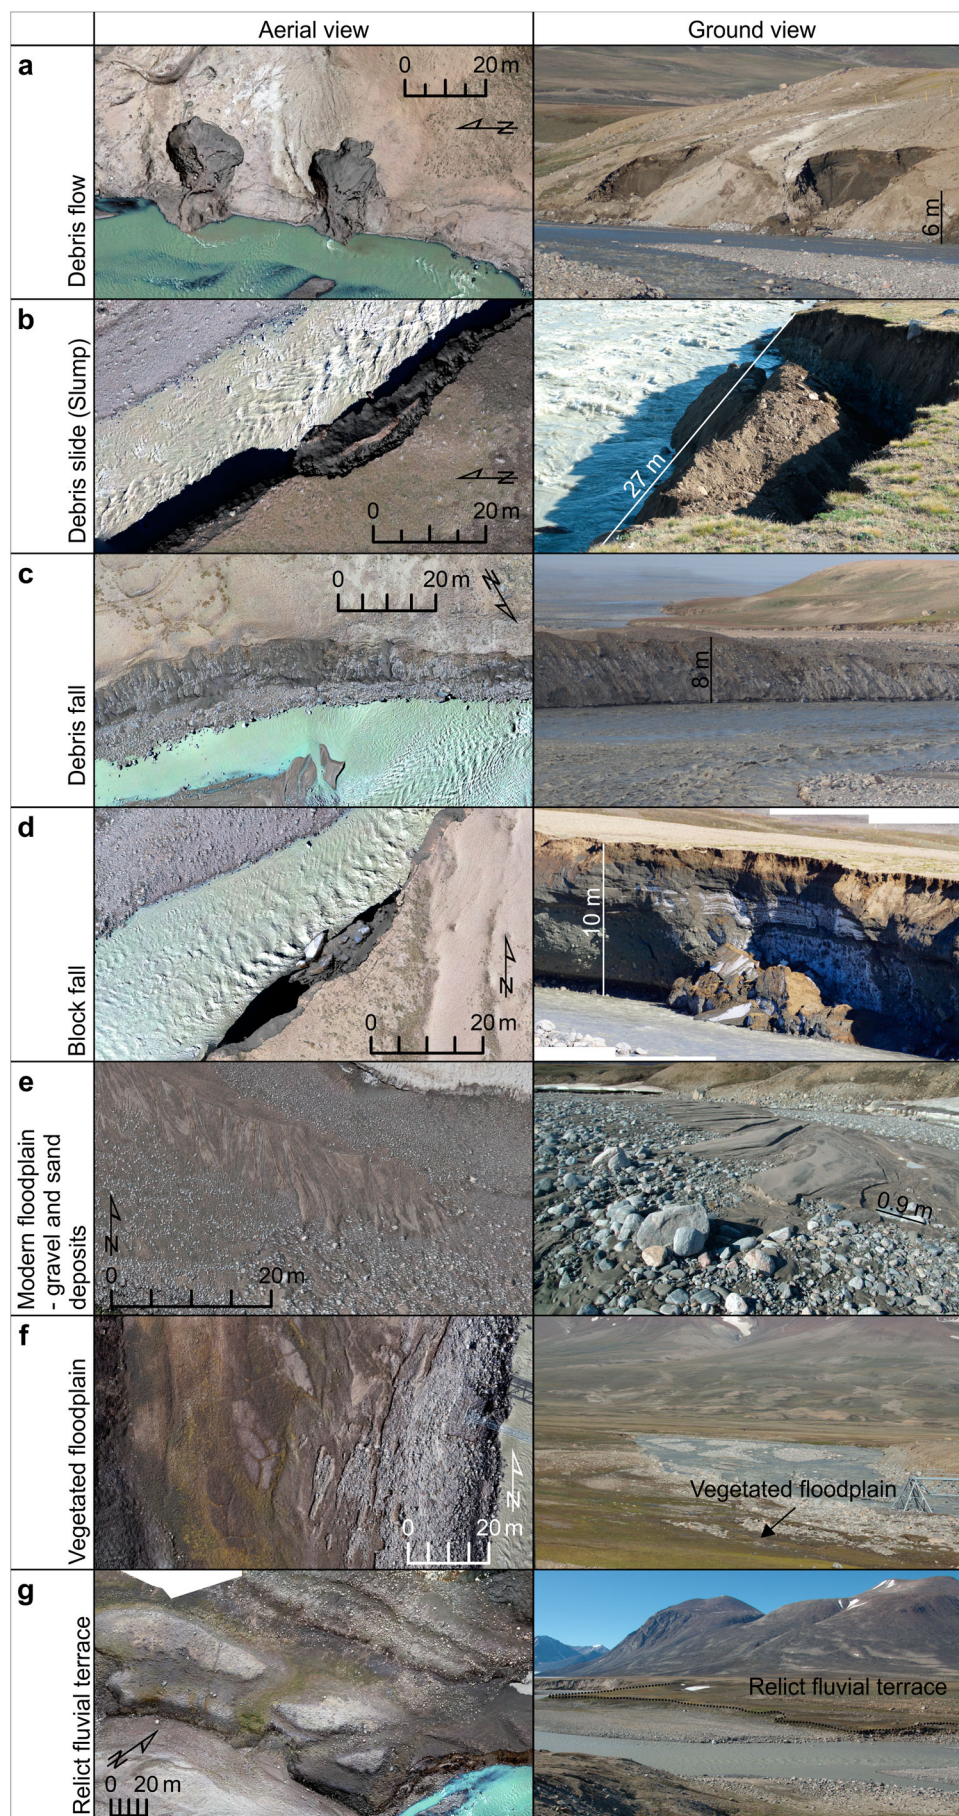
**Figure 3.** Geomorphological elements mapped in the studied river section. Further explanation in the text.

- (1) Geomorphological expression of different types of erosion and mass movement activity that modified the riverbanks (Figure 3(a-d, h)):
  - (a) Debris flows (Figure 3(a)) – there were two situations in which debris flows were observed. First, they developed along the steep sections of the riverbanks, as a result of debris removal by floodwater leading to slope instability and thawing of the permafrost (Main Map 2: 4A-4B). The second situation included debris flows which developed as a result of the melting of snow patches that survived until late summer in several locations.

- (b) Debris slides (slumps) (Figure 3(b)) were observed mainly in places where the thermo-erosion niches formed, and the riverbank was undercut. Whole blocks of material either slid or slumped as a result of gravitational forces. These processes were observed on slopes that were initially very steep or vertical but were subsequently undercut by the river.

- (c) Debris falls (Figure 3(c)) of single clasts or small cemented gravel blocks were observed along the sections of the banks which were characterised by a relatively high elevation (not necessarily high steepness). The debris fell as a result of lateral erosion and degradation of older segments of the cliffs.

- (d) Block fall was observed only in one section where a relatively high and steep slope occurred. Frozen blocks of material fell and developed small rockfall deposits in the river (Figure 3(d)).

- (e) Undercut banks (Figure 3(h)) were identified from orthomosaics and from the ground. Due to the presence of continuous permafrost, thermo-erosion niches formed as a result of thermal and mechanical activity of floodwater, even though the layer of frozen sediments located above was still stable for at least several days after the flood. The debris and water were constantly falling from these overhanging sections as the permafrost thawed. For that reason, the preservation potential of the

- (2) Fluvial geomorphological features (Figure 3(e, f, g, i)):
  - (a) The modern floodplain consists of recently deposited gravels, sands, and fines (Figure 3 (e)). This geomorphological unit included all non-vegetated surfaces built of unconsolidated sediments, which were located along the current river channel. Within this unit, fresh fluvial deposits were also observed and mapped separately (Main Map 1, Main Map 2), as they indicated the maximum extent of the flood.

- (b) Vegetated floodplains (Figure 3(f)) represented this part of the channel floor, which was vegetated by mosses and low plants. Such surface has not been subjected to regular flooding in previous years. However, in the northern section of the studied area, 2017 flood water also covered these vegetated surfaces, eroding some of the vegetation patches.

- (c) Relict fluvial terraces (Figure 3(g)) constitute areas that are higher than the contemporary channel (i.e. located at approximately 4–9 m higher than the current channel floor). Traces of the older channels and bars were clearly visible in the hillshade models and the orthomosaics; some of them were identifiable from the ground.

- (d) Small alluvial fans (Figure 3(i)) developed at the mouth of small gullies, where local drainage transported and deposited debris in the form of 18 small fan-shaped features (the largest is approximately 653 m<sup>2</sup>; 10 fans have an area smaller than 50 m<sup>2</sup>).

- (3) Features not related to fluvial activity: Permafrost-related features included thermal-erosion gullies (Figure 3(j)), i.e. the former thermal-contraction-cracks remodelled by the thawing of the permafrost and fluvial activity. Solifluction lobes (Figure 3 (k)) were associated with slow deformations of the surfaces toward the rivers. They were observed only in two places. Modern thermal-contraction-cracks were also clearly visible in the orthomosaic (Figure 3 l); however, due to the relatively narrow width, they were hard to identify from the ground.

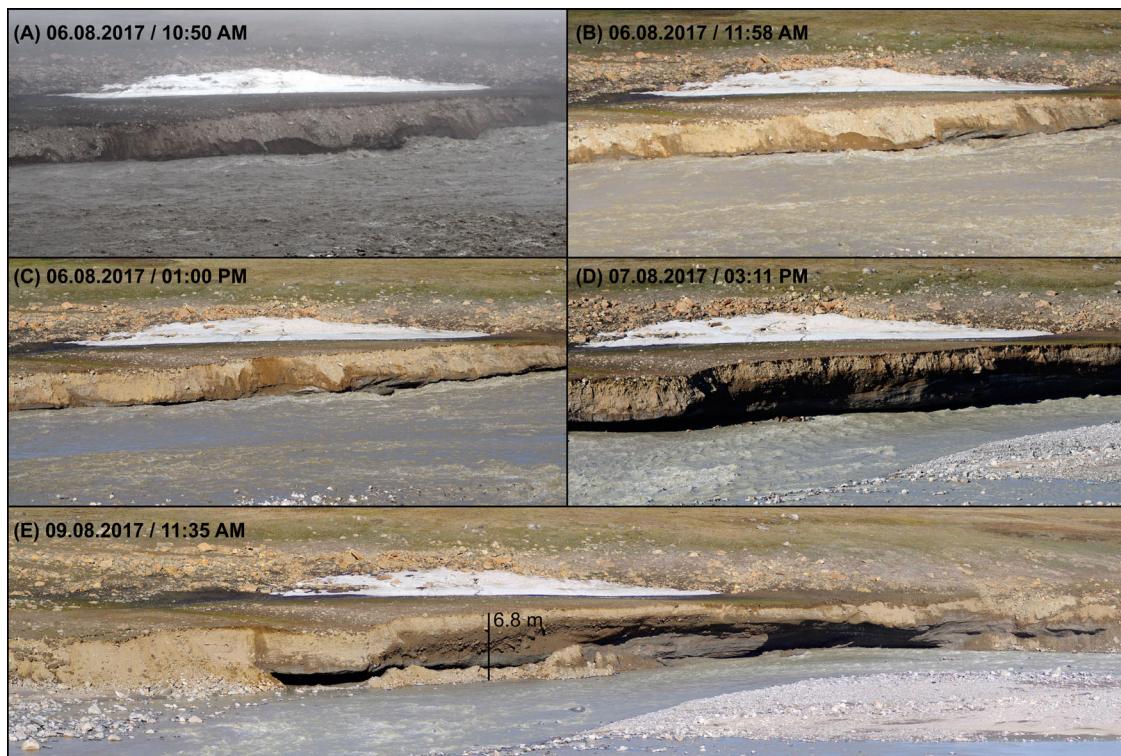
**Figure 4.** An example of the development of the overhanging section. Note that two days after the flood, some of the overhanging banks were still visible (in the central part of the bottom picture); whereas others have already collapsed (left part of the image).

Formation of the thermo-erosion niches was related to the presence of permafrost. The water undercut the banks by a combination of thermal and mechanical erosion, but the sediments above the water level were still frozen forming the overhanging sections of riverbanks (Figure 4). Such overhanging sections are likely transient features, which will collapse in the future (non-immediate response to the flood), thus contributing to a larger cumulative retreat of the riverbanks.

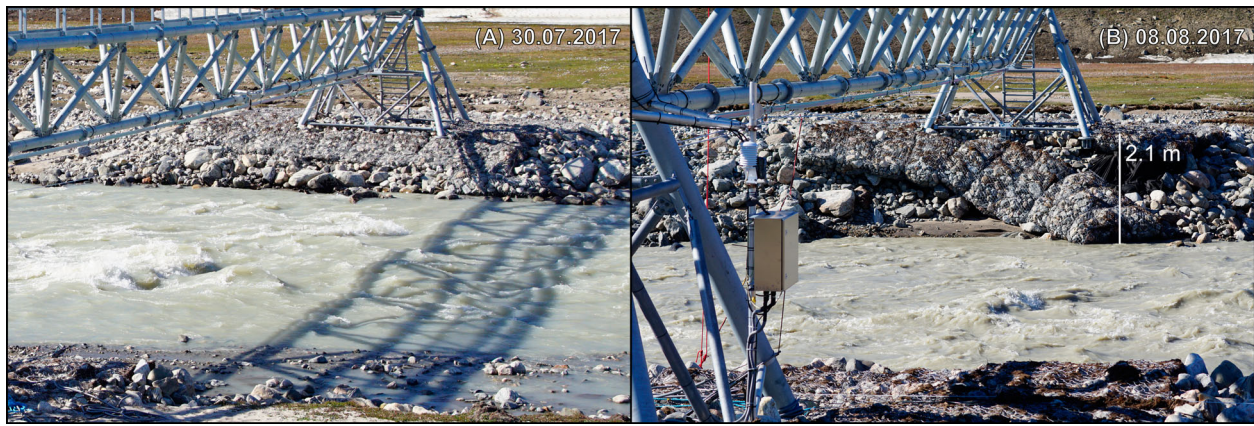
**Figure 5.** Pre- and post-flood image of artificial bank protection (metal nets filled with rocks). Note that water removed some of the nets.

- (5) The erosional power of the river was so great that it destroyed some of the artificial protection features (metal nets filled with boulders), which had been set up to protect the bridge (Figure 5).

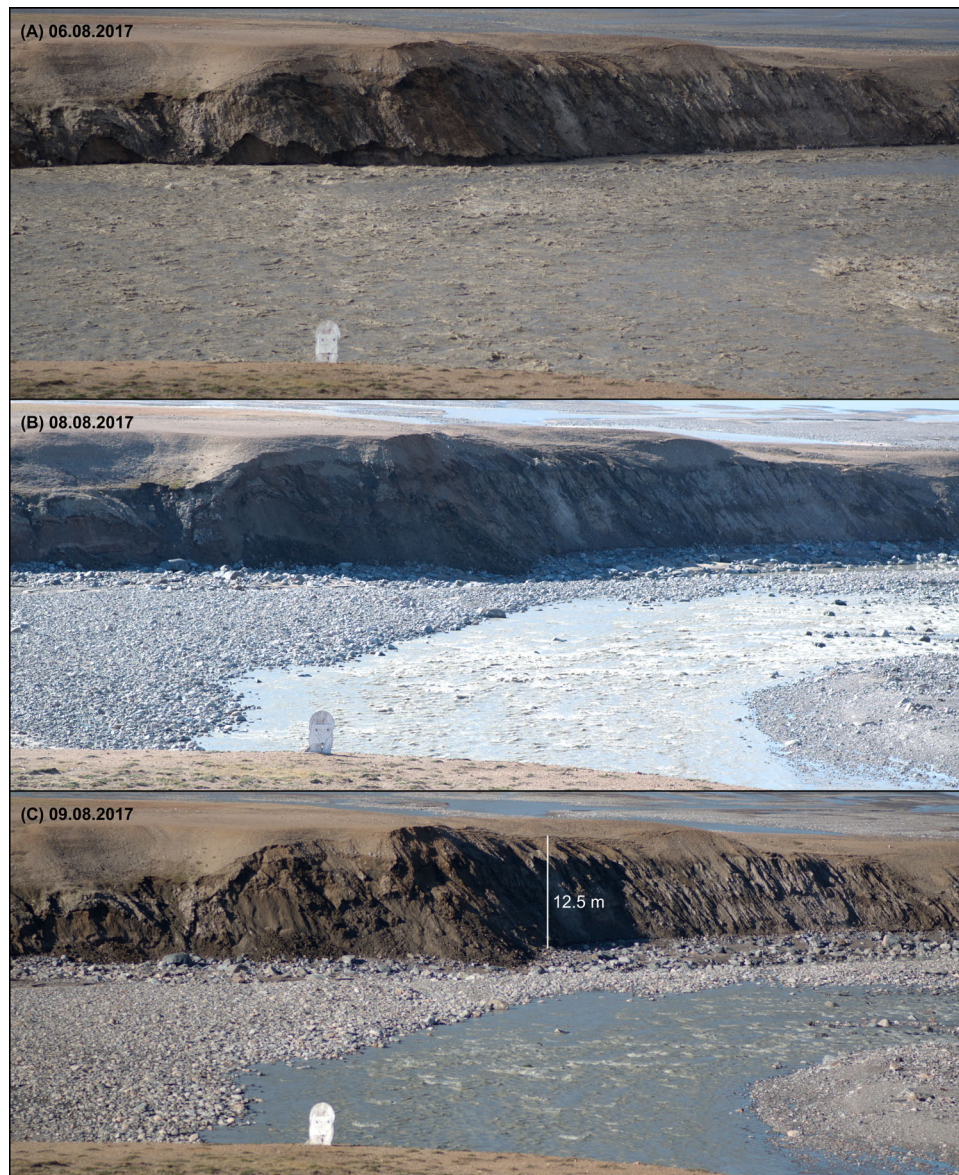
**Figure 6.** River section, where mass movement processes rapidly covered exposed sediments with new debris.

Map 1, Main Map 2), especially in later stages of the flood (Figure 6). These deposits originated from the upstream, as well as from adjacent banks. During the greatest extent of the flood (6 August 2017) lateral erosion removed loose sediments (mainly sands and gravels) and exposed steep sections of the banks. These exposed parts were still visible after the water level dropped (8

August 2017) (Figure 6(B)); however, rapidly developed debris falls from the upper sections of the riverbanks covered these exposed parts once again (Figure 6(C)). Most of the eroded deposits originated from diamicton therefore comprised wide variety of grain sizes – smaller fractions were removed by the water, while gravels remained at the foot of the banks; however, the debris was

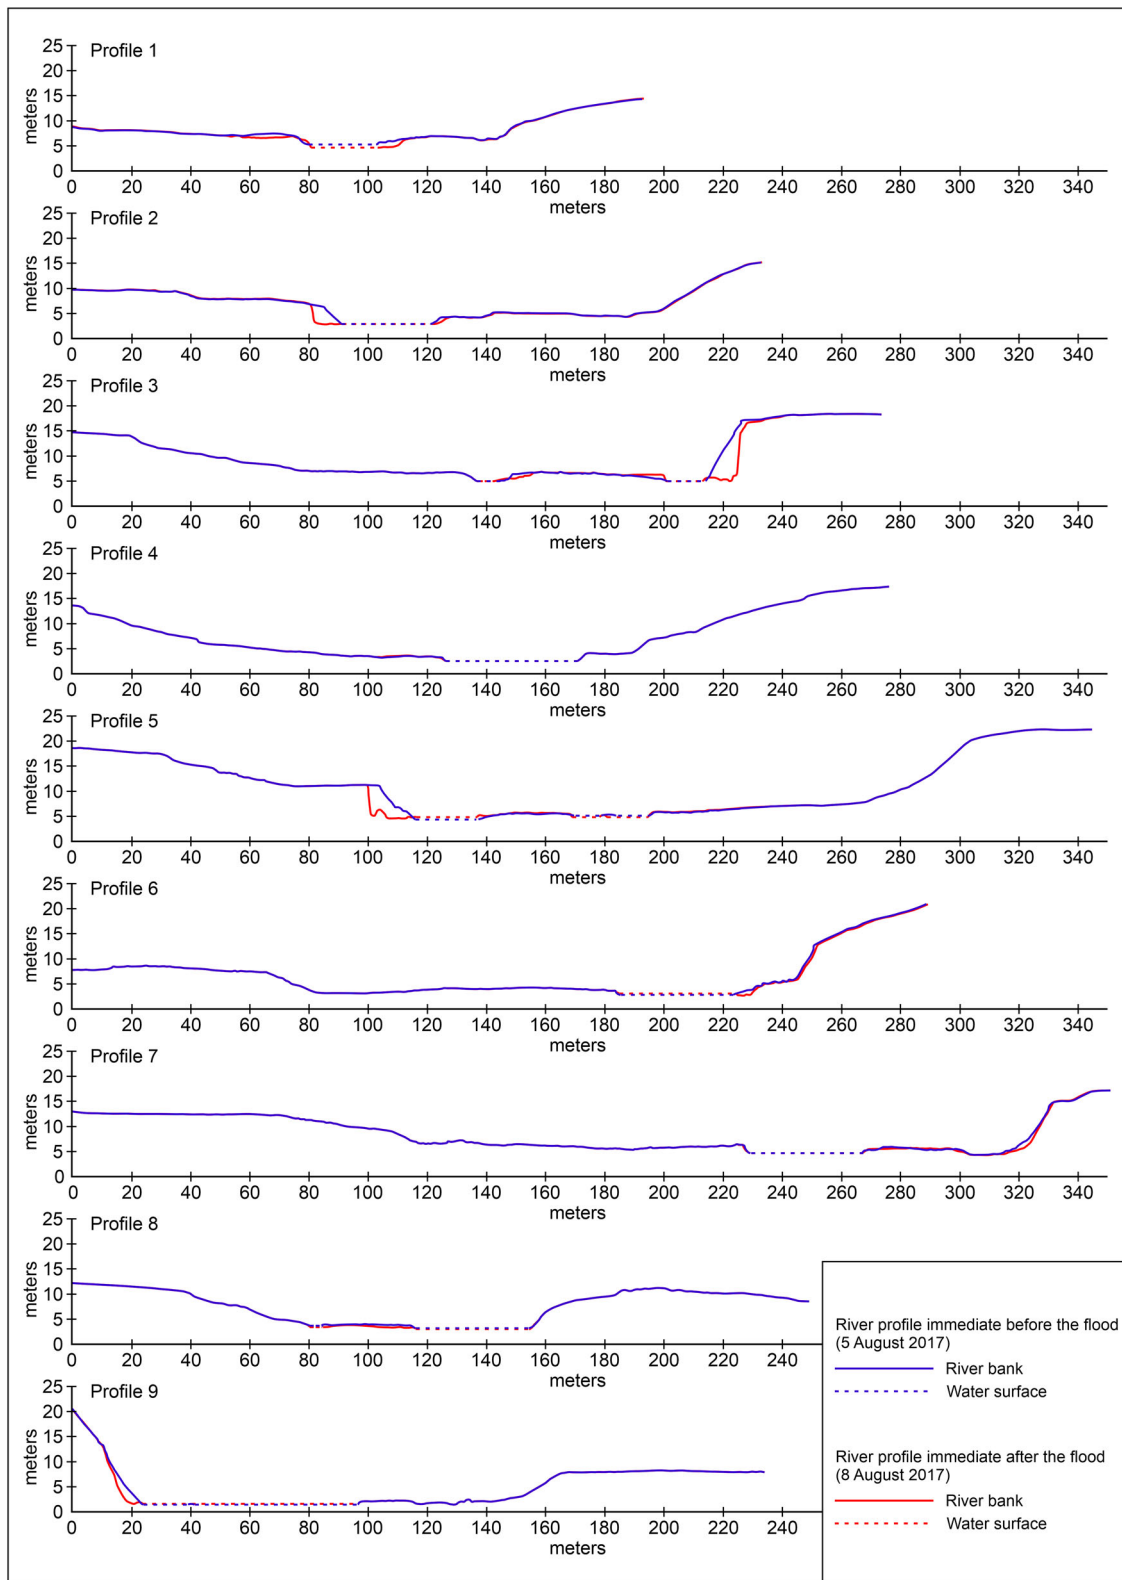
**Figure 7.** Changes in the channel and riverbanks morphology illustrating the short-term response to the flood event.

- (3) Several debris flows were observed along the riverbanks before the flood (Main Map 2: 4A). After the flood, debris flow processes intensified as water removed the older deposits and increased the steepness of the slopes (Main Map 2: 4B, Table 1, Figure 7).
