## The Effect of PEO Ratio on Degradation, Calcification and Bone Bonding of PEO/PBT Copolymer (Polyactive)

C.A. van Blitterswijk\*, J. v.d. Brink, H. Leenders, D. Bakker<sup>1</sup>

Laboratory for Otobiology and Biocompatibility,  
Biomaterials Research Group, University Hospital Leiden, The Netherlands,  
<sup>1</sup>HC Implants B.V., Zernikedreef 6, 2333 CK Leiden, The Netherlands

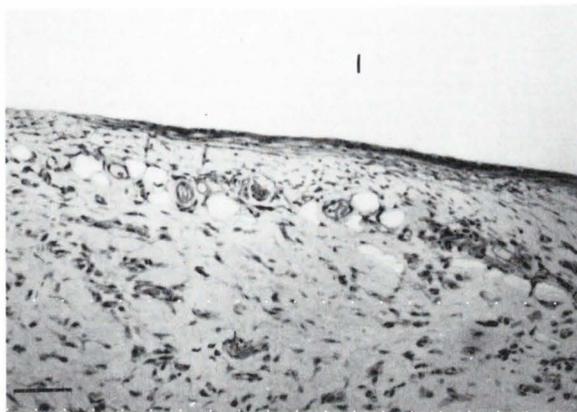
**Figure 1.** Light micrograph of a dense 70/30 PEO/PBT implant (I) after 6 weeks of subcutaneous implantation. Bar = 150  $\mu\text{m}$ .

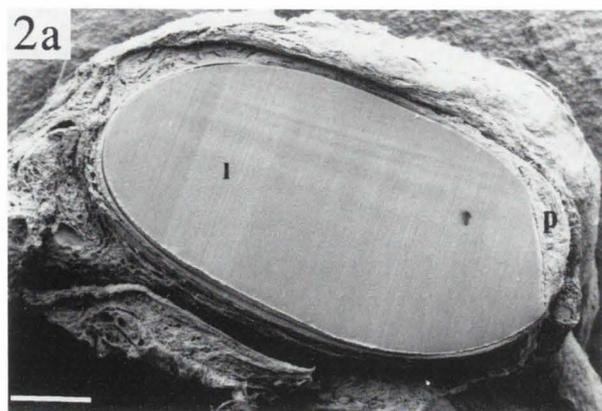
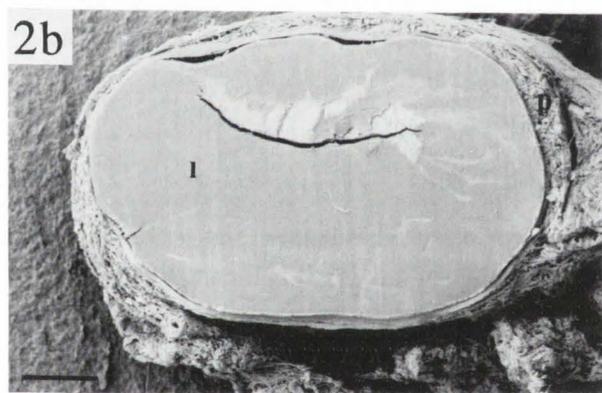
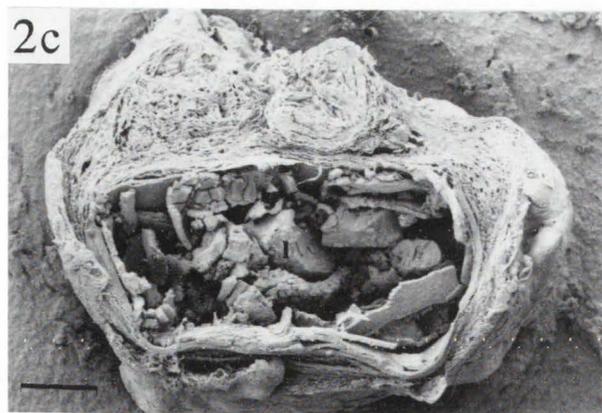
**Figure 2 (facing page, left).** Scanning electron micrographs of different dense PEO/PBT implants after subcutaneous implantation. Sometimes the porous film is also visible. I = dense implant, p = porous film. a) PEO/PBT 30/70, 1 year after implantation showing no noteworthy signs of degradation. Bar = 0.63 mm. b) PEO/PBT 40/60, only shows confined crack formation after 1 year of implantation. Bar = 0.56 mm. c) PEO/PBT 60/40 with prominent fragmentation, 1 year after implantation. Bar = 0.67 mm. d) PEO/PBT 70/30, characteristically showed extensive fragmentation and disappearance of bulk material, 6 months after implantation. Bar = 0.69 mm.

**Implant degradation:** The first indications of a change in implant structure were observed for the PEO/PBT 70/30 copolymer. This polymer already showed degradation into relatively large fragments three weeks following implantation, which was most clearly observed by scanning electron microscopy. Due to the relatively large size of the individual fragments most of the implant/tissue interface of this copolymer was still composed of a morphologically intact polymer surface. At 6 weeks the degradation of PEO/PBT 70/30 had progressed and PEO/PBT 60/40 showed the first signs of fragments detaching from its surface. All other PEO/PBT proportions were still generally intact, except for crack formation at their surface in a confined zone of approximately 10-100  $\mu\text{m}$  thickness. After 3 months, both the 70/30 and 60/40 proportion showed extensive fragmentation throughout and fibrous tissue had filled the interfragment space. At this point in time, the PEO/PBT 55/45 also showed extensive crack formation and detachment of fragments from the implant surface although the implant outline was still largely intact. Crack formation in the PEO/PBT 40/60 had proceeded but fragment detachment was not yet apparent. The PEO/PBT 30/70 did not reveal significant changes as compared to the 6 weeks period. In the 6 month and 1 year periods, fragmentation had continued for the PEO/PBT 70/30, 60/40 and 55/45 copolymer causing a smaller average particle size in the course of time. For the PEO/PBT 70/30 proportion, fragmentation was so extensive that the implants were difficult to retrieve after 1 year. The PEO/PBT 40/60 and 30/70 did not show a significant deviation from the 3 month period with exception of the occurrence of a single deep crack in one of the 40/60 implants after one year. Figures 2a-d show the situation for the various PEO/PBT proportions after long term implantation. With exception of the 1 year PEO/PBT 70/30, the original contours of the implants could still be observed despite the fact that tissue had grown into the interfragment space. This indicated that the disappearance of implant material from the actual implantation site, was either by cellular transport or actual resorption. Light microscopical surveys of general degradation are shown in Figures 3a-c.

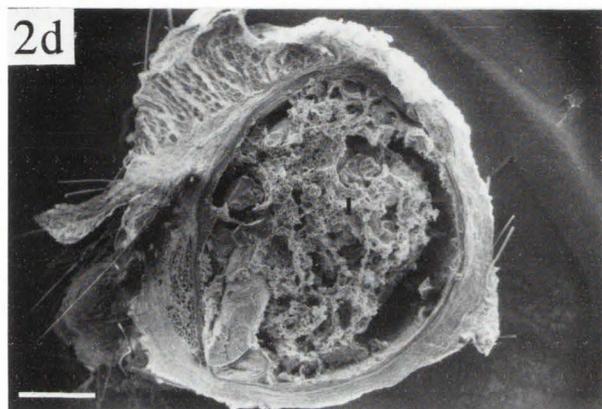
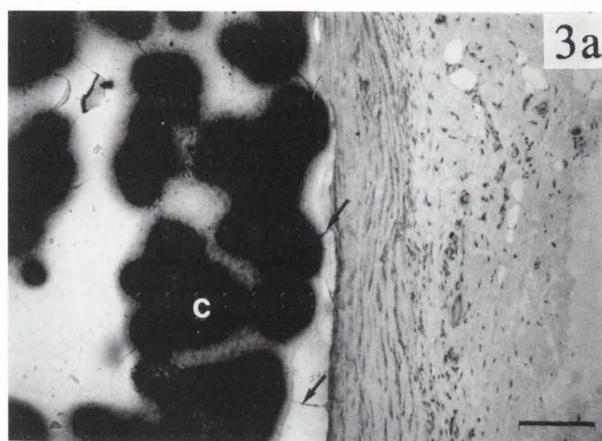
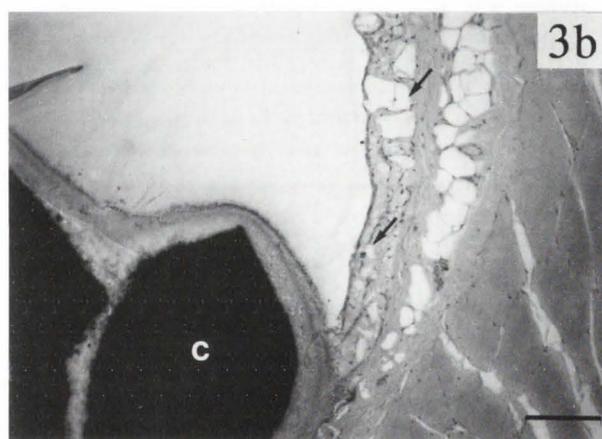
**Figure 3 (facing page right).** Light micrographs of increasing stages of fragmentation during subcutaneous implantation. C = calcified area (alizarin red staining). a) PEO/PBT 55/45 after 1 year of implantation. The first signs of fragmentation are seen in the form of crack formation of the interface (arrows). Bar = 300  $\mu\text{m}$ . b) PEO/PBT 60/40 implanted for 1 year showing the second stage of fragmentation, more extensive surface erosion leading to detachment of implant fragments (arrows). Bar = 300  $\mu\text{m}$ . c) PEO/PBT 70/30 after 1 year of implantation showing extensive fragmentation throughout the polymer. Bar = 300  $\mu\text{m}$ .

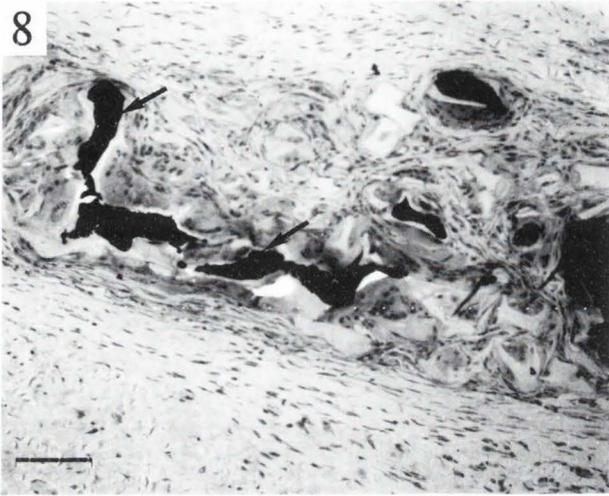
**Figure 8 (top left).** Light micrograph showing a porous PEO/PBT 60/40 film after 6 weeks of implantation. The major part of the implant fragments are calcified as indicated by the Alizarin red staining (arrows). Bar = 250  $\mu$ m.

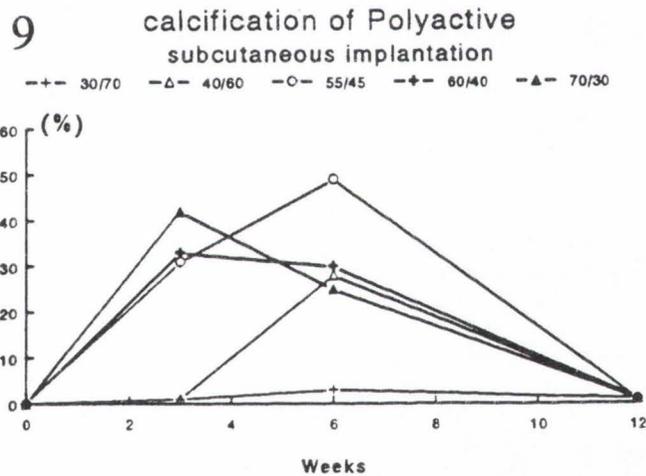
**Figure 9 (middle left).** Diagram showing the calcification in different PEO/PBT proportions as a percentage of total PEO/PBT surface.

difficult to perform, we decided to use the porous polymer films for quantitation. In general, the films showed an apparently faster degradation than the blocks. Due to this rapid degradation, it was no longer possible to retrieve the 70/30 films after periods longer than 3 months. The polymers were well recognized by sudan black staining and calcification was assessed by alizarin red staining (Fig. 8). The results, obtained after image analysis, are shown in Fig. 9

which indicates that more PEO will lead to increased calcification. This seems to suggest that an increase in PEO content will also lead to earlier calcification. In correspondence with the blocks, no calcification was found for the 30/70 copolymer. It was interesting to note that with the exception of the PEO/PBT 40/60 copolymer, none of the implanted films showed significant calcification at the 3 month period. In contrast, calcification could still be found with the blocks at this stage.

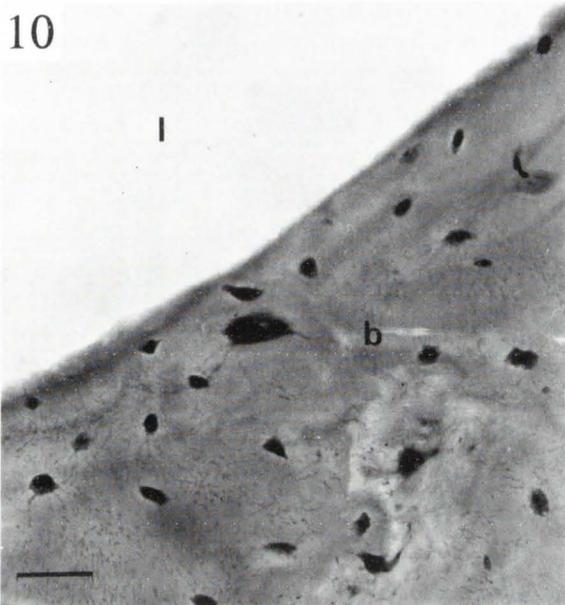
**Figure 10 (bottom left).** Light micrograph showing a general view of a decalcified PEO/PBT 60/40 interface with bone after 6 months. Bar = 60  $\mu$ m. I = implant, b = bone.

Light microscopical evaluation of the various PEO/PBT implants showed rather similar reactions. All implants were covered by fibrous tissue, bone marrow, and bone. The bone was of a lamellar type and after longer implantation times, large parts of the polymer were covered by this type of tissue (Fig. 10).

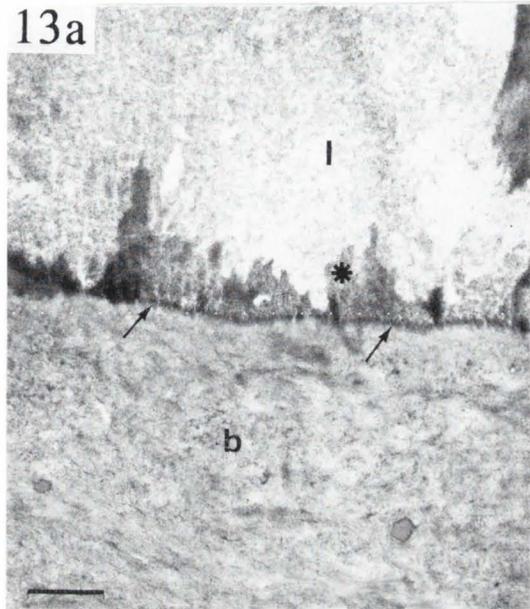
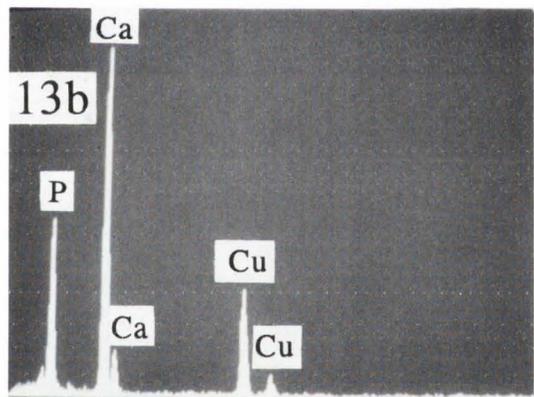
**Figure 13 (above).** a) Transmission electron micrograph of the non-decalcified PEO/PBT 60/40 interface with bone after 3 months. Note the presence of small needle-like crystals in both the bone (b) and the implant (I). Note the electron dense zone at the interface (arrows). Bar = 1.1  $\mu$ m. b) Spot analysis (at \*) shows the presence of Ca and P throughout the polymer. Copper peaks are from the grid.

**Evaluation of non-decalcified material:** Analysis of the bone/biomaterial interface by scanning and transmission electron microscopy and backscatter electron microscopy in combination with X-ray microanalysis showed that, with exception of the PEO/PBT 30/70 copolymer, all copolymers had areas of intimate bone contact. With PEO/PBT 30/70 areas of contact were present at the light microscopical level, but this observation was never confirmed by electron microscopy. Electron microscopy always showed areas of non-calcified tissue either composed of cellular or collagenous material. Concerning the other polymers, it should be emphasized that the data were suggestive of an increase in the incidence of intimate contact, in time and in quantity, with increasing PEO content. However, due to the relatively small number of implants investigated, this presumption could not be proven. The general appearance of the bone-polymer interface is illustrated by the use of back-scattered electron microscopy in Figures 11a-c (on color plate, at page 33) which shows a polished, non-decalcified, Spurr embedded PEO/PBT 60/40 implant, 3 months

after implantation. The X-ray maps provided in Fig. 11 demonstrated that the tissue surrounding the implant in the marrow cavity was indeed composed of bone, as indicated by the presence of calcium and phosphorus signals. A higher magnification of the area near the cortex, combined with X-ray map (Figures 12a-c; at color plate on page 33), showed that the bone was in continuity with what seemed to be calcified spots in the implant material. Analysis of these areas by transmission electron microscopy showed calcified areas throughout the polymer and near bone. Higher magnifications demonstrated that such spots were composed of needle-like crystals. The similarity between the crystals in the polymer and those in bone is stressed by Figures 13a and b, which show a calcified area in the polymer surface opposed to bone. Furthermore, an electron dense zone could sometimes be seen at the interface in these locations.

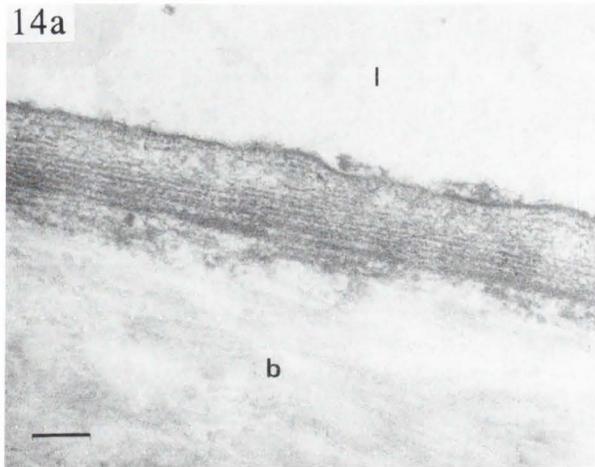
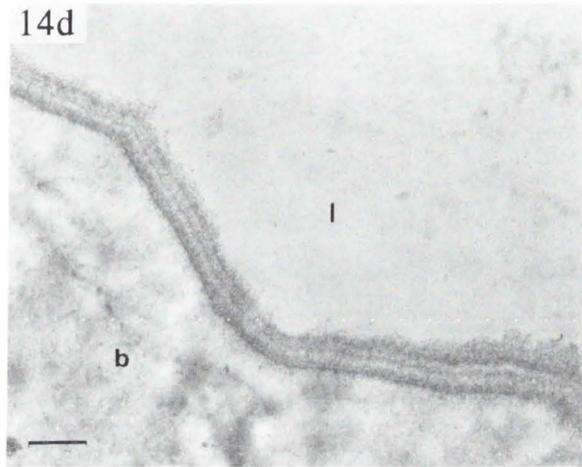
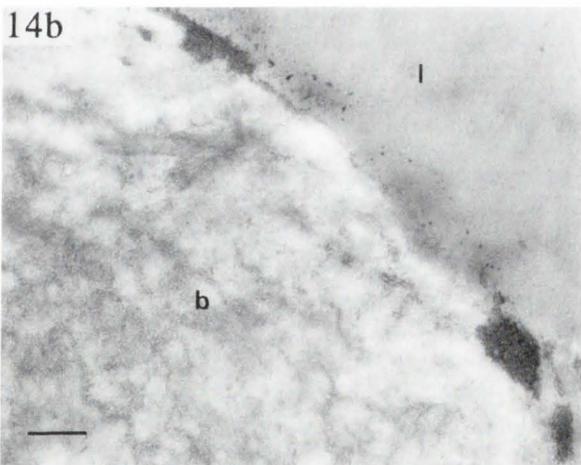
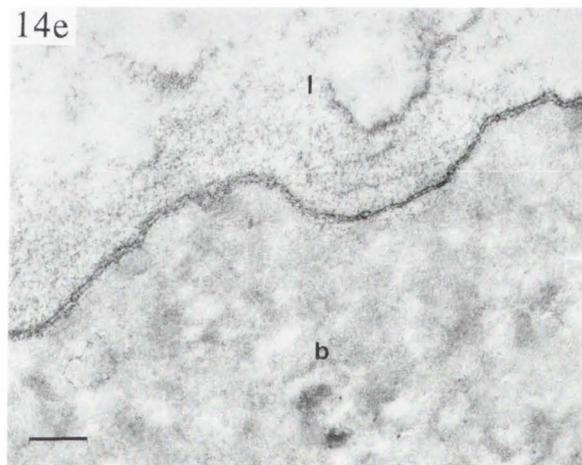
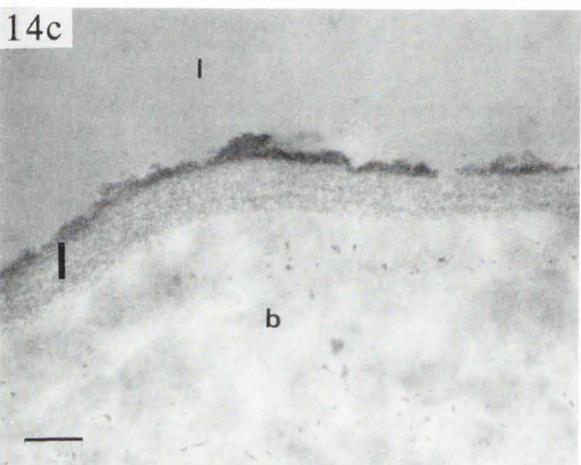
**Figure 14.** The interface between bone and different PEO/PBT proportions. All specimens were decalcified prior to embedding. Note the electron dense structure at the bone/PEO/PBT interface. An interposed fibrillar zone was always found between bone matrix and PEO/PBT 30/70. I = implant, b = bone.

- a) PEO/PBT 30/70, 6 months. Bar = 0.28  $\mu\text{m}$ .
- b) PEO/PBT 40/60, 6 weeks. Bar = 0.37  $\mu\text{m}$ .
- c) PEO/PBT 55/45, 6 weeks. Bar = 0.20  $\mu\text{m}$ .
- d) PEO/PBT 60/40, 6 weeks. Bar = 0.38  $\mu\text{m}$ .
- e) PEO/PBT 70/30, 6 weeks. Bar = 0.41  $\mu\text{m}$ .

**Analysis of decalcified material:** Study of the decalcified bone/PEO/PBT copolymer interface was predominantly performed with transmission electron microscopy. Although the morphology of the interface showed some variation, an interesting structure was seen at the interface of all materials except for the 30/70 PEO/PBT copolymer. This latter material never showed a clear contact with bone and sometimes a non-calcified lamellar structure was seen interposed between bone and the polymer (Fig. 14a). At the

bone/biomaterial interface of all materials with a PEO content of 40% per weight or more, an electron dense deposit was encountered. In the case of the PEO/PBT 40/60, this zone was composed of focal floccular material but it was unclear whether it was located on the surface or also in the implant material (Fig. 14b). A similar structure was found with the PEO/PBT 55/45 material, however, it was more continuous and frequently had a multilayered structure above (Fig. 14c). The PEO/PBT 60/40 mostly lacked the floccular deposit found with the 55/45 and 40/60 materials, here only a prominent multilayered structure was seen (Fig. 14d). A similar structure was observed with the PEO/PBT 70/30 copolymer (Fig. 14e). With the latter type of material, it was characteristic that part of the multilayered electron dense structure was located in the actual polymer. This latter phenomenon was never clearly demonstrated for the other PEO/PBT proportions.

The micrograph of the PEO/PBT 30/70 (Fig. 14a) deserves a special explanation. First of all this is from a sample after the 6 month evaluation period in contrast to the 6 weeks for the other PEO/PBT proportions shown in Figures 14b to 14e. This was so because, before this period, no interfacial contact was observed between the bone and the implant. Although at first sight, the structure seems rather similar to that seen for the PEO/PBT 60/40, it should be noted that it is composed of very distinct lamellar structures in comparison to the more granular appearance of the other structure. In addition, we never found a bone - PEO/PBT 30/70 contact with non-decalcified sections which indicates that this structure is most likely non-calcified.

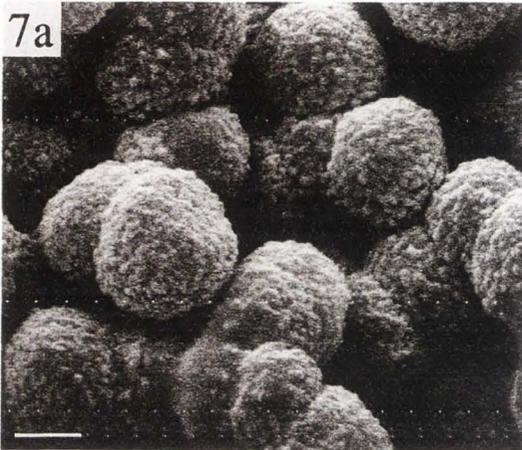
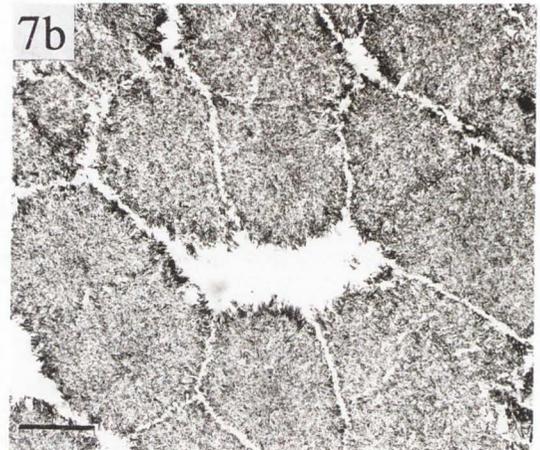
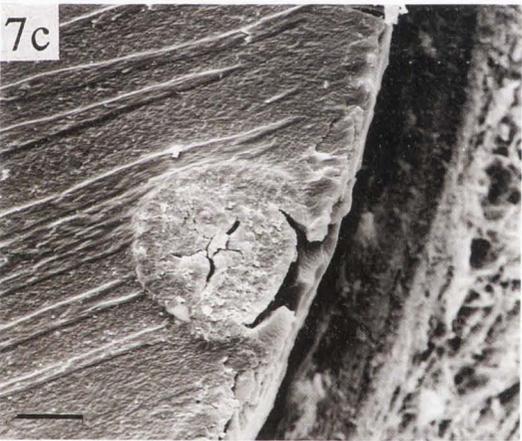
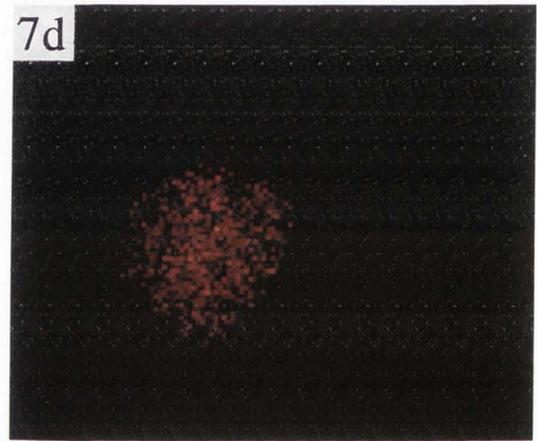
**Figure 7.** Ultrastructural analysis of PEO/PBT calcification. **a)** Calcified spots as seen by scanning electron microscopy at the surface of a PEO/PBT 70/30 fragment, 3 months after subcutaneous implantation. Bar = 2  $\mu\text{m}$ . **b)** A cross-section of spot-like calcified areas within PEO/PBT 60/40 after 1 year subcutaneously. Note the needle-like crystallites. Bar = 1.6  $\mu\text{m}$ . **c)** Back-scattered electron micrograph of a calcified spot (\*) within PEO/PBT 55/45 just below the surface after 3 months of subcutaneous implantation. Bar = 31.7  $\mu\text{m}$ . **d)** X-ray map indicating the presence of calcium in the structure shown in Figure 7c.

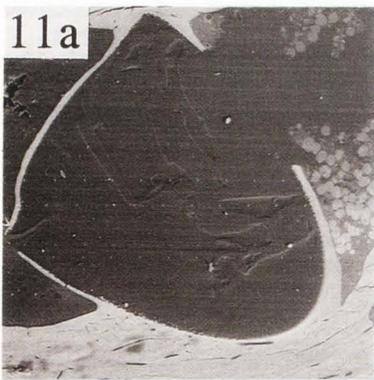
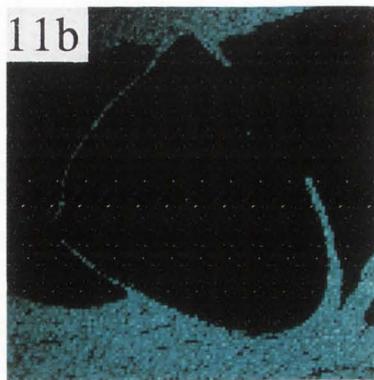
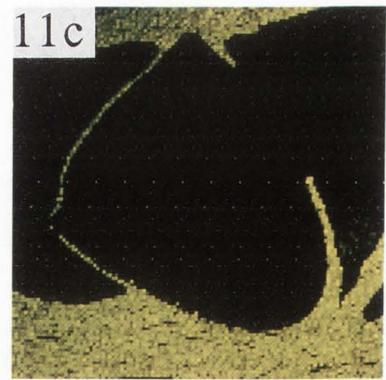
**Figure 11.** **a)** Back-scattered electron micrograph of an undecalcified PEO/PBT 60/40 after 3 months implantation. I = implant, b = bone. Bar = 0.6  $\mu\text{m}$ . **b and c)** X-ray maps indicating the presence of calcium (b) and phosphorus (c).

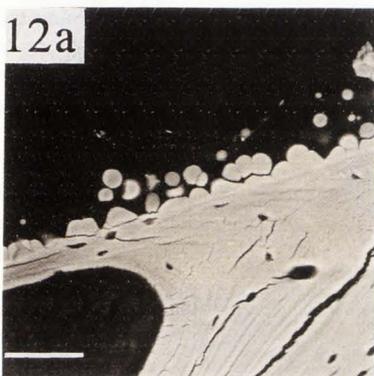
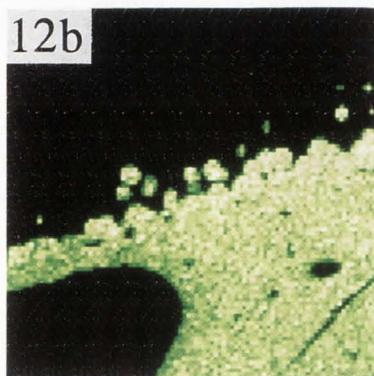
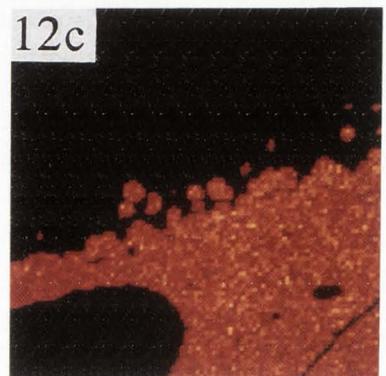
**Figure 12.** More detailed back-scattered electron micrograph. I = implant, b = bone. Bar = 52  $\mu\text{m}$ . **a)** undecalcified PEO/PBT 60/40 after 3 months. **b and c)** X-ray map indicating the presence of calcium (b) and phosphorus (c).
