A Comparative Study of the Interactions of Two Calcium Phosphates, PEO/PBT Copolymer (Polyactive) and a Silicone Rubber with Bone and Fibrous Tissue

C. A. van Blitterswijk
Leiden University

(Received for publication December 22, 1992, and in revised form March 31, 1993)

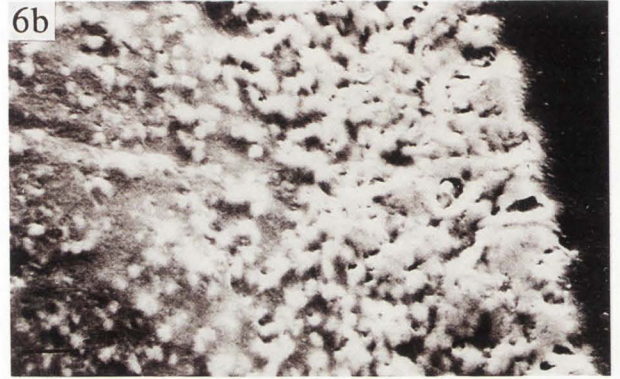
Figure 6 (facing page top). a) Light micrograph revealing the positive alizarin red staining for calcium within 55/45 PEO/PBT copolymer. Bar = 25 μm . b) Back-scattered electron micrograph of a light microscopical section of HPEO/PBT copolymer at its tissue interface. Note the white deposits. Bar = 5.9 μm . c) Line scan of the area shown in Fig. 6b revealing the presence of calcium. d) Similar linescan as in Fig. 6c revealing the presence of phosphorus.

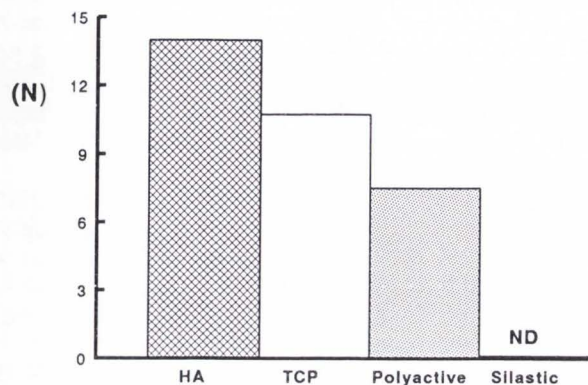
Figure 15. Pull-out values obtained for the different biomaterials at six weeks post-operation. ND = non-detectable.

The pull out experiment performed on the 6 week specimens is summarized in Figure 15 and essentially showed that no mechanically tight bonding was obtained with the silicone rubber while all other materials showed substantial bone-bonding. The pull-out forces, with exception of the silicon rubber, represent the values obtained at the point of implant failure i.e., the implant failed before it detached from its interface with bone (Fig. 14).
