## Channel Response to Flow Augmentation: Diamond Fork River, UT

A thesis submitted in partial fulfillment  
of the requirements for the degree

Watershed Science

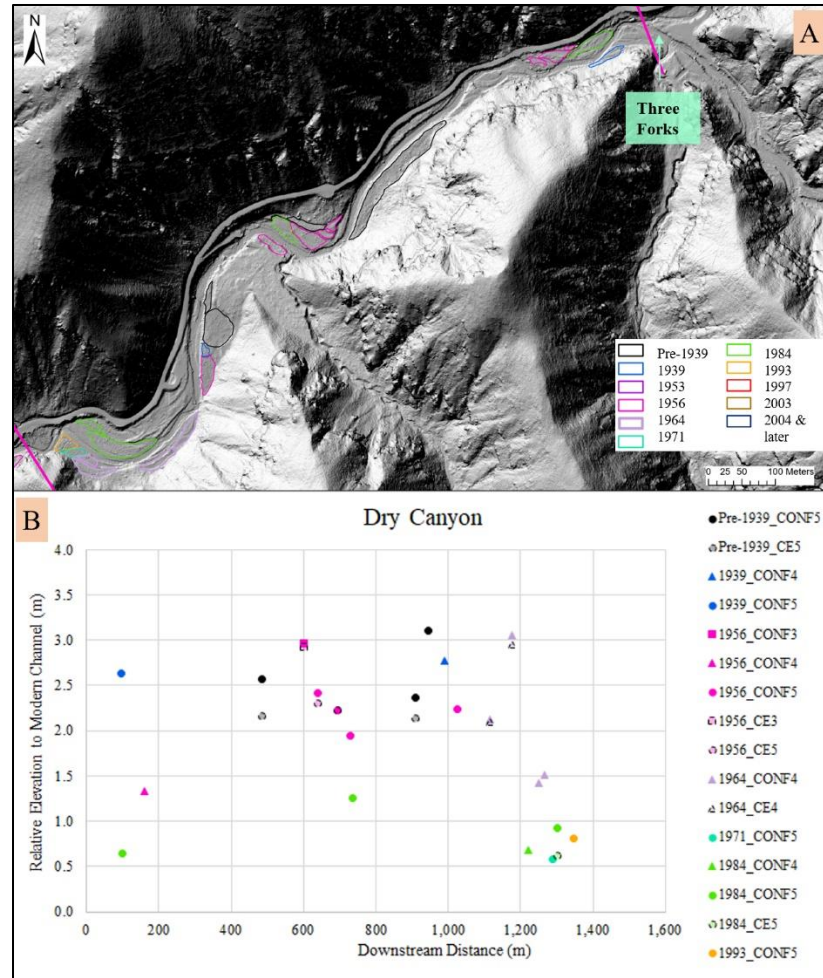
**Figure. 1.6.** Dry Canyon Reach: (A) DEM hillshade showing relict surfaces. (B) Relative elevation of relict surfaces with confidence mapping levels. CONF# = Mapping confidence level of surface. CE# = Corrected elevation of abandoned surface to account for thickness of fine mantle data collected in the field. Circle = Confidence Level 5, Triangle = Confidence Level 4, Square = Confidence Level 3. Although no 1939 surfaces were visited in this reach, it is estimated that the fine mantle thickness for these surfaces was around 0.2 m-0.3 m.

The river in the early decades of the project period apparently aggraded by several meters. There are accounts in the US Bureau of Reclamation annual reports of road repair required in the first several years of the project operation. Although there is little accommodation space in this narrow valley, several relict surfaces that pre-date the 1939 air photos are preserved 2.5 m to 3.1 m above the modern channel (Figure 1.6) and were already forested in the first air

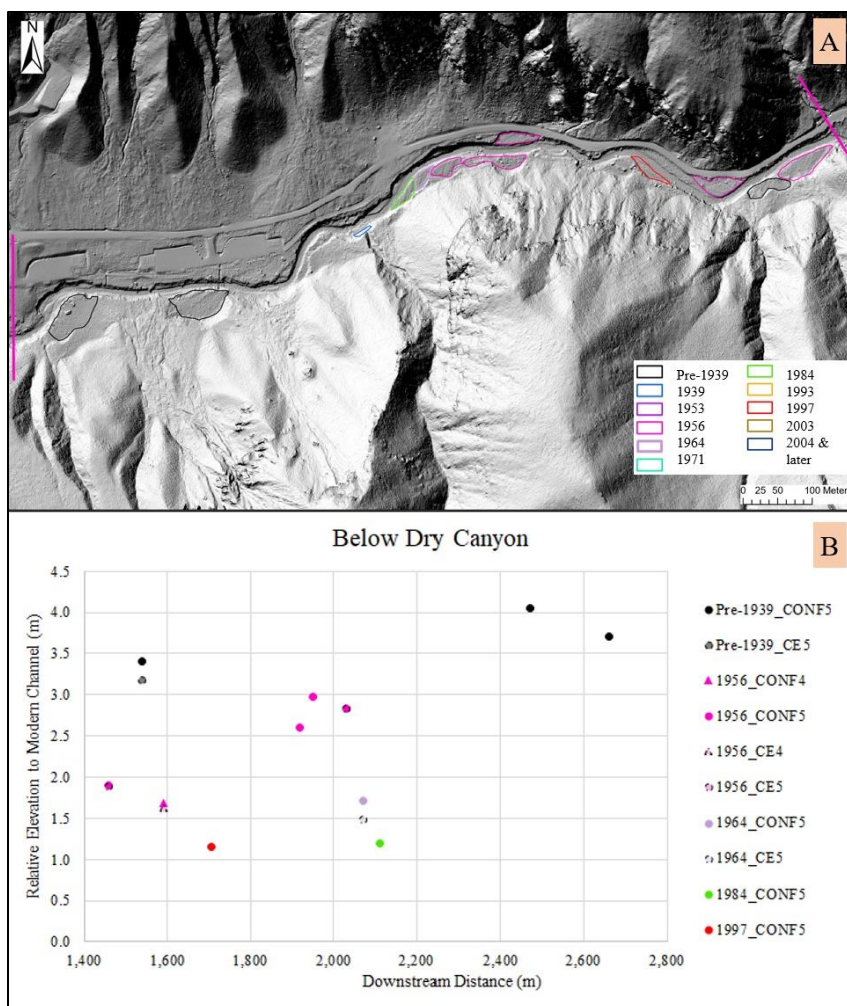
**Figure. 1.10.** Below Dry Canyon Reach: (A) DEM hillshade showing relict surfaces. (B) Relative elevation of relict surfaces with confidence mapping levels. CONF# = Mapping confidence level of surface. CE# = Corrected elevation of abandoned surface to account for thickness of fine mantle data collected in the field. Circle = Confidence Level 5, Triangle = Confidence Level 4.

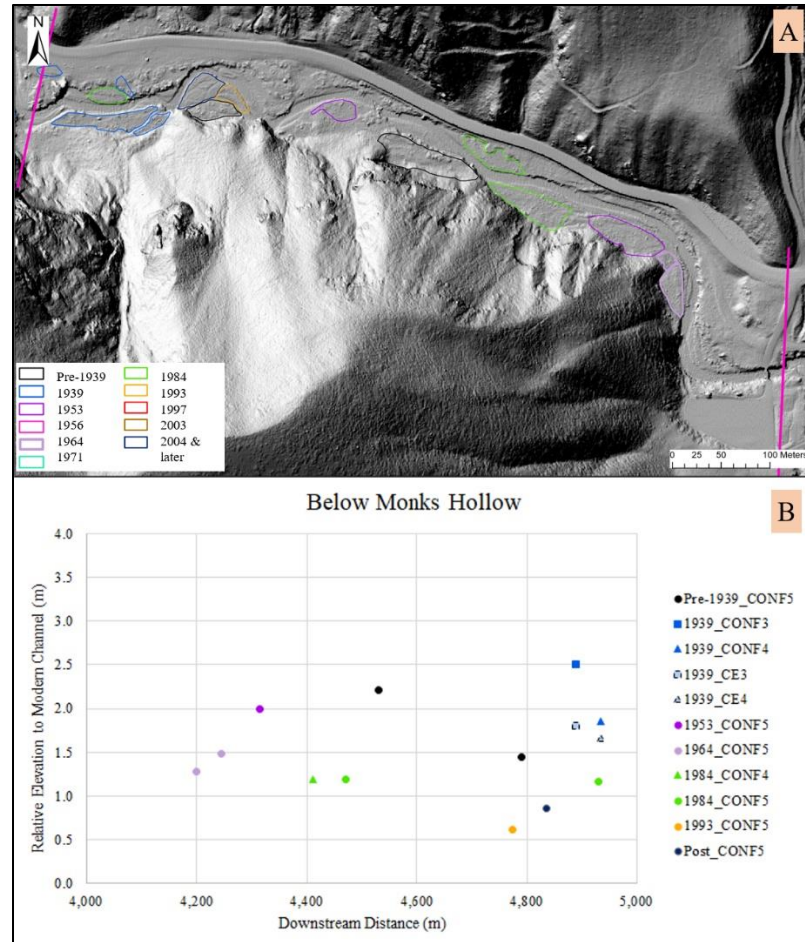
**Figure 1.17.** Below Monks Hollow Reach: (A) DEM hillshade showing relict surfaces. (B) Relative elevation of relict surfaces with confidence mapping levels. CONF# = Mapping confidence level of surface. CE# = Corrected elevation of abandoned surface to account for thickness of fine mantle data collected in the field. Circle = Confidence Level 5, Triangle = Confidence Level 4, Square = Confidence Level 3.

The 1952 flood caused the widest sections of the channel to widen further, although the median channel width decreased by 3.0 m (Figure 1.19). The channel shifted and gravel bars were deposited in the wider sections of the channel which caused an increase in the active channel width. One relict surface remains from 1953 at 2.0 m above the modern channel, which is similar in elevation to those left by the 1939 channel (Figure 1.17).

The 1984 flood eliminated some of the vegetation around the channel, again widening the wider sections of the channel (Figure 1.19). A small bend cut off occurred in the upstream portion of the reach (Figure 1.20). This flood caused the channel to cut down slightly and left it just over 1.0 m above the modern channel (Figure 1.17).

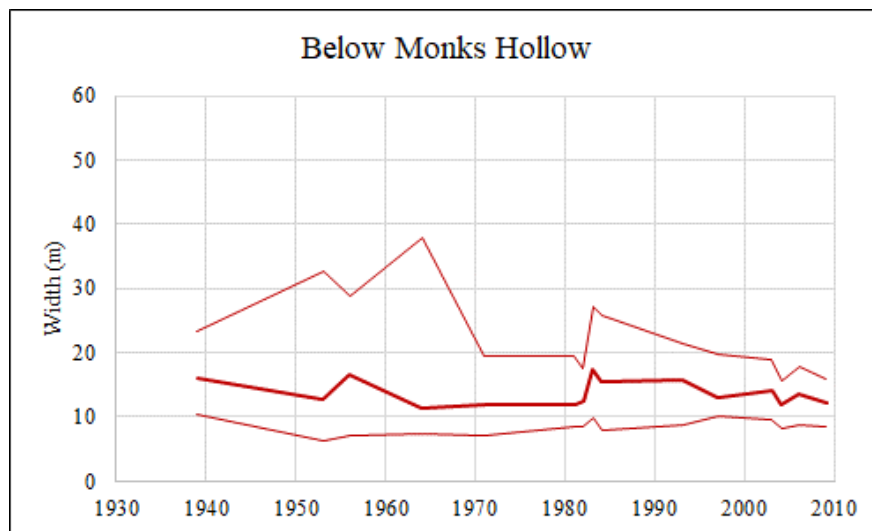
**Figure 1.19.** 10<sup>th</sup> percentile, median, and 90<sup>th</sup> percentile widths of Below Monks Hollow reach from 1939-2009. Increases in width in 1952 and 1984 were due to the two large natural floods during these years.

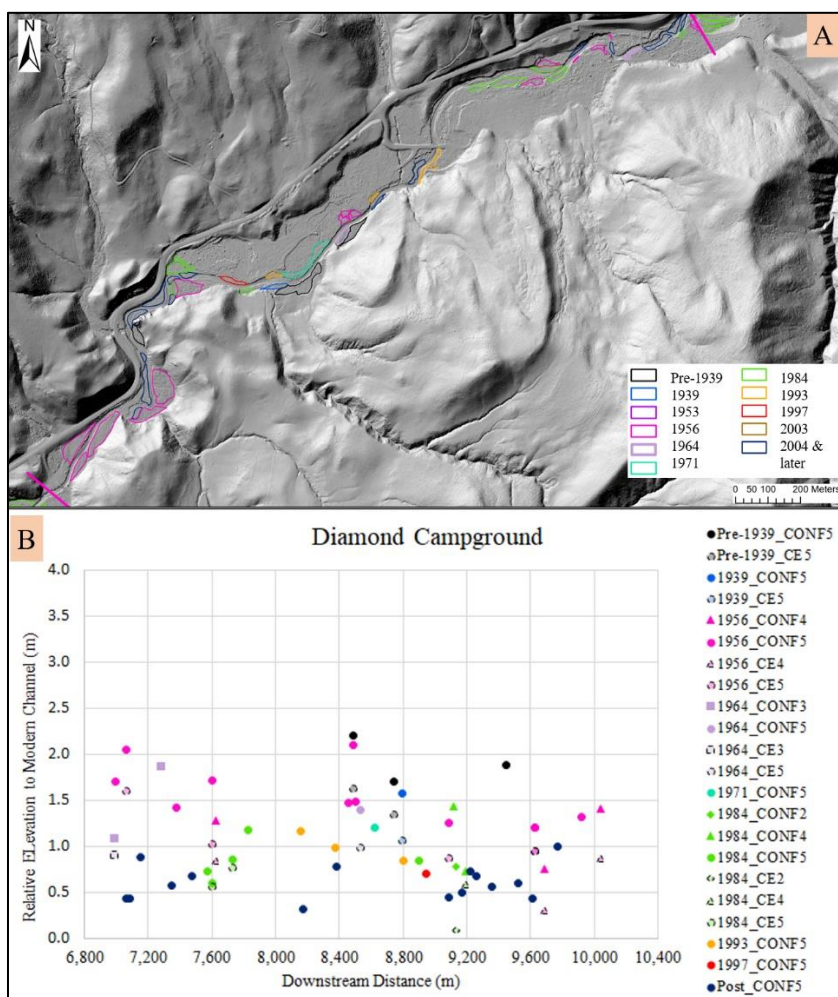
**Figure 1.25.** Diamond Campground Reach: (A) DEM hillshade showing relict surfaces. (B) Relative elevation of relict surfaces with confidence mapping levels. CONF# = Mapping confidence level of surface. CE# = Corrected elevation of abandoned surface to account for thickness of fine mantle data collected in the field. Circle = Confidence Level 5, Triangle = Confidence Level 4, Square = Confidence Level 3.

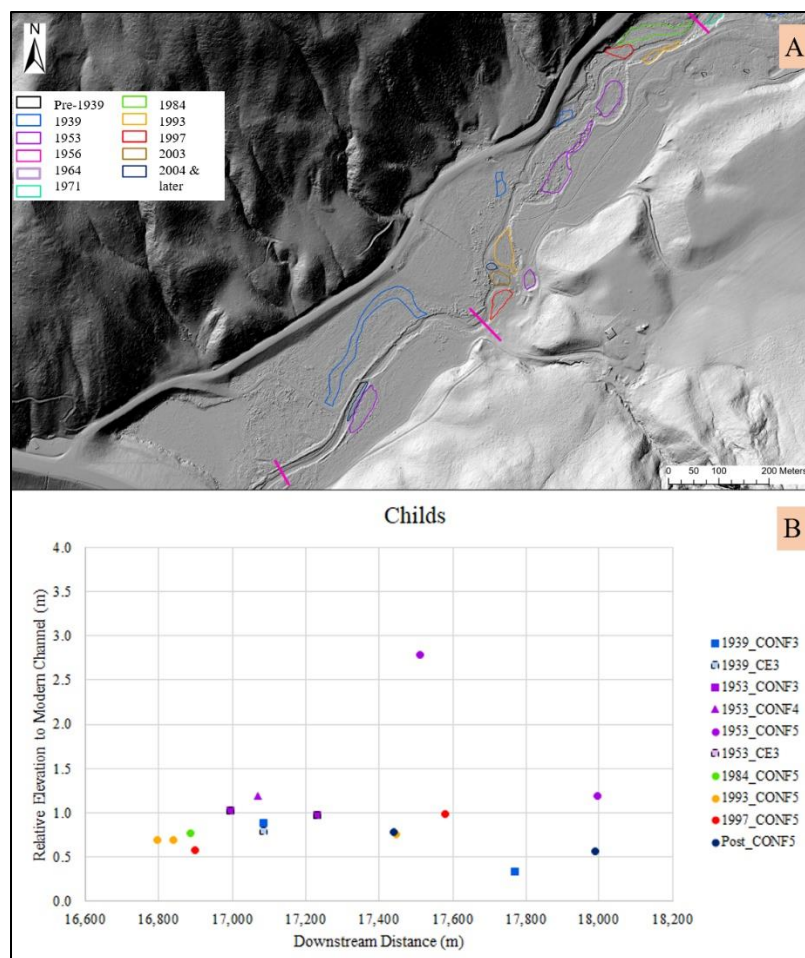
**Figure 1.49.** Upper and Lower Childs Reach: (A) DEM hillshade showing relict surfaces. (B) Relative elevation of relict surfaces with confidence mapping levels. CONF# = Mapping confidence level of surface. CE# = Corrected elevation of abandoned surface to account for thickness of fine mantle data collected in the field. Circle = Confidence Level 5, Triangle = Confidence Level 4, Square = Confidence Level 3.

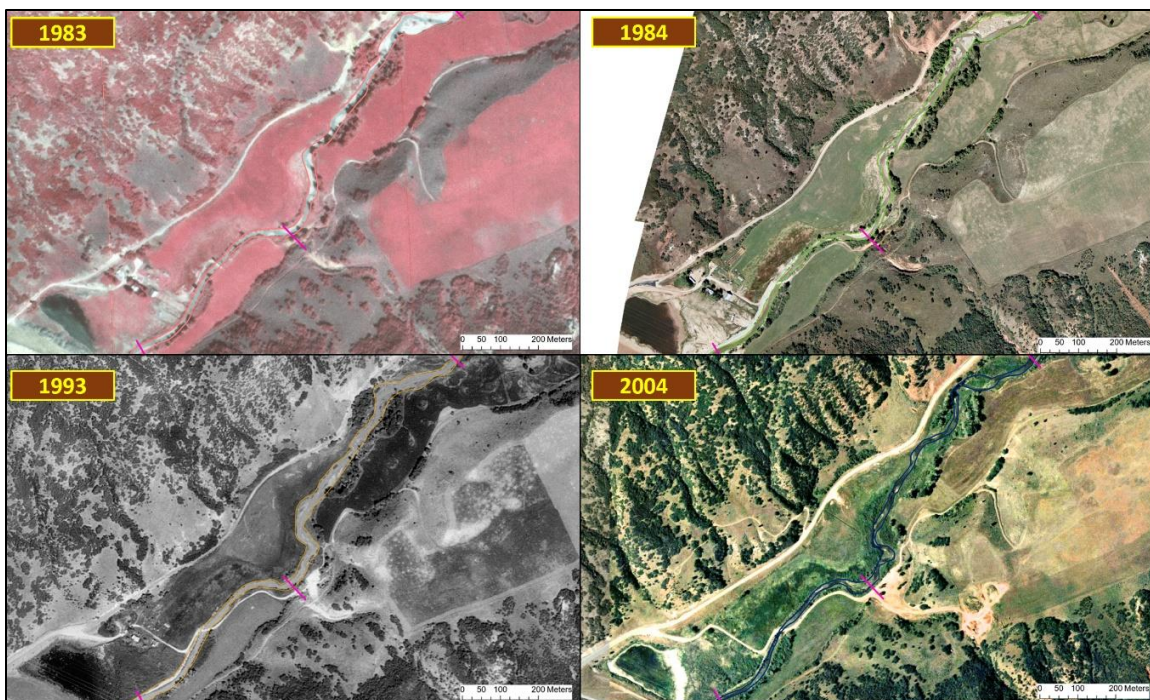
**Figure 1.52.** Air photos of CH Reach: 1983-2004. The 1983 and 1984 floods removed some riparian vegetation, producing an apparent widening of the channel in locations. Lines depict active channel boundaries.

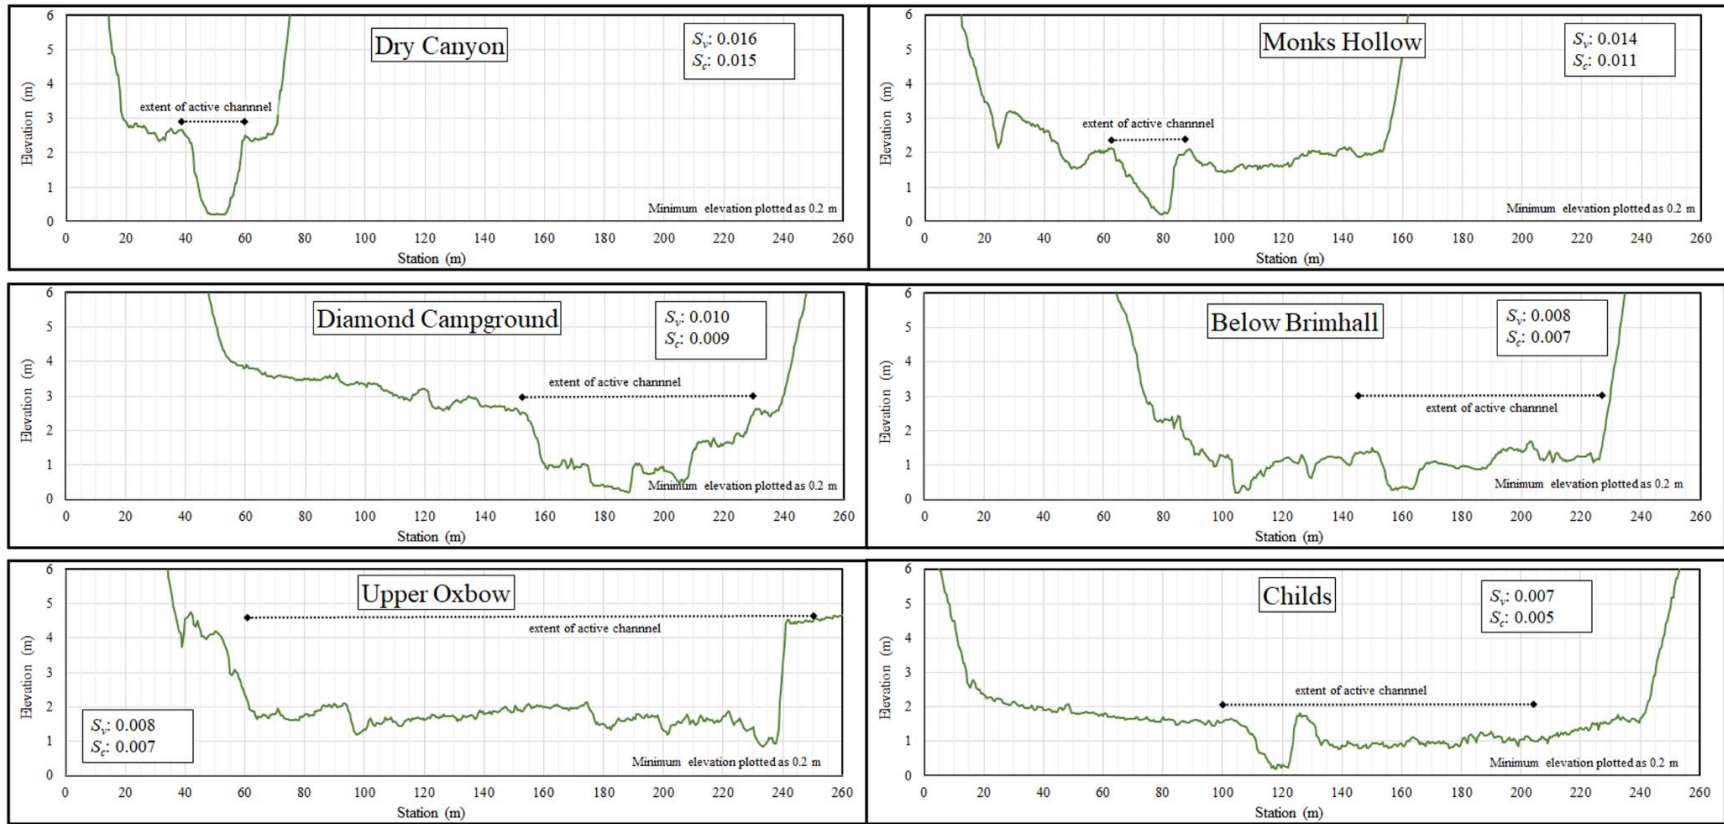
Figure 1.56. Selected cross section profiles depicting channel width going from upstream to downstream.

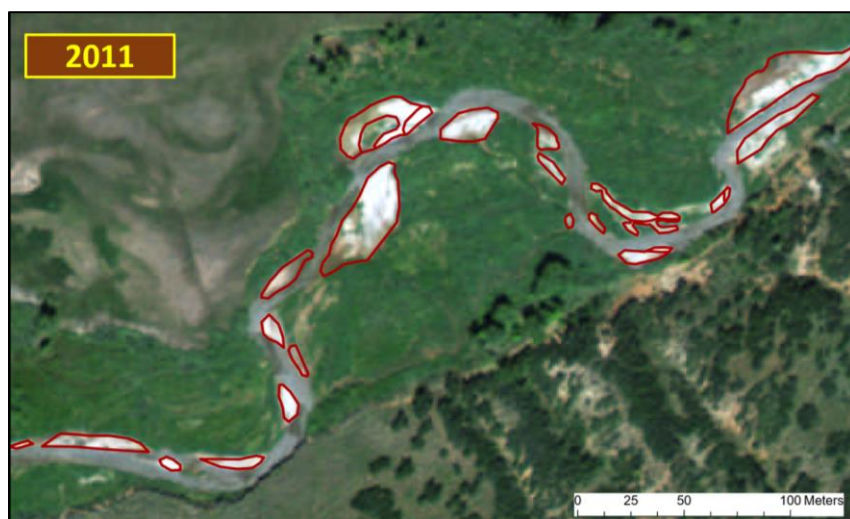
**Figure 2.1.** Example of delineated surfaces that became unvegetated due to the 2011 flood on 2011 NAIP imagery.

The flows of the 2011 flood scoured vegetation and fine sediment cover along the banks, causing the exposure of underlying gravel. This presented the opportunity to evaluate which surfaces subsequently revegetated and the role of revegetation in channel change. Bare surfaces were delineated on the 2011 photographs and those locations were then examined on the 2018 air photos to determine whether the bare spots had become revegetated (Table 2.1). The 2018 photographs were used because they are closest in time to the 2017 LiDAR DEM, allowing determination of the elevation of the surfaces relative to the 2017 channel. This LiDAR topography flown October 3-6, 2017 by the National Center for Airborne Laser Mapping (Jones, 2018).

Bare surfaces visible in the 2011 imagery were classified in 2018 as bare, partly vegetated, vegetated, or water (integrated into the wetted channel) (Figure 2.1, Figure 2.2). Surfaces classified as vegetated contained roughly 80%-100% vegetation, partly vegetated if they

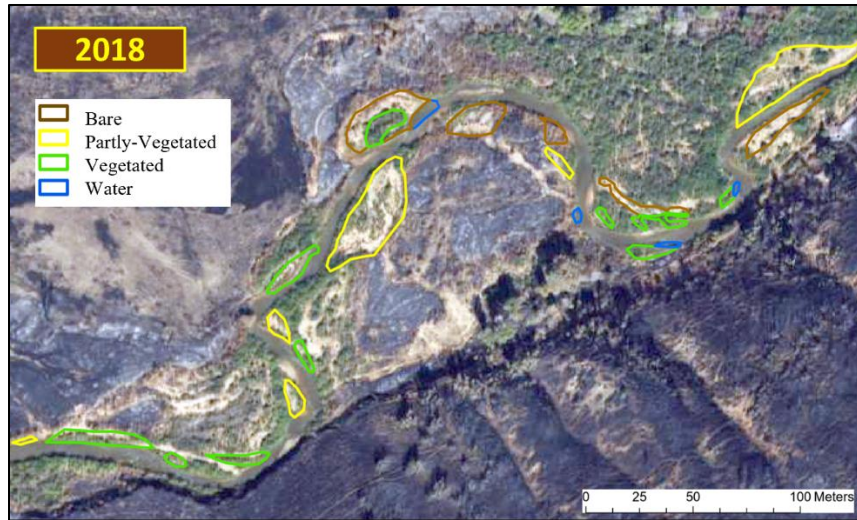
**Figure 2.2.** Example of what became of the delineated 2011 unvegetated surfaces on 2018 NAIP imagery. The color of the polygons represents their vegetation classification in 2018.

contained roughly 20%-80% vegetation, and bare if no vegetation was present. No attempt was made to describe their vegetation type, but willow is the dominant shrub growing in the near-channel bare spots. The 2018 imagery was taken after the Pole Creek fire that sparked on September 6, 2018, and passed through the Lower Diamond Fork area from September 15 - 18, 2018.

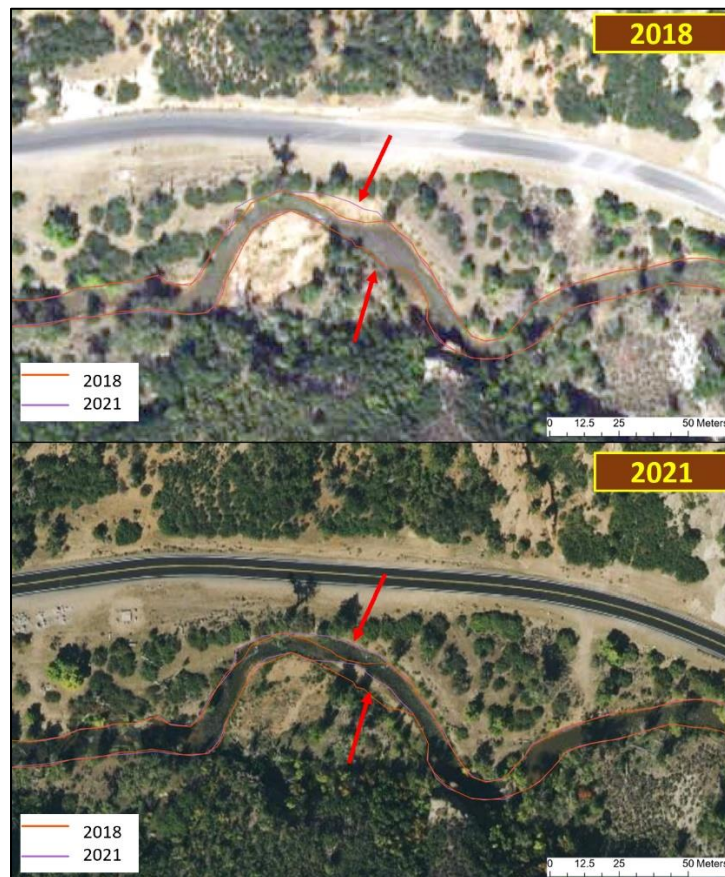
**Figure 2.18.** Point bar deposition and outer bank erosion in Below Monks Hollow reach at RM 4,800.

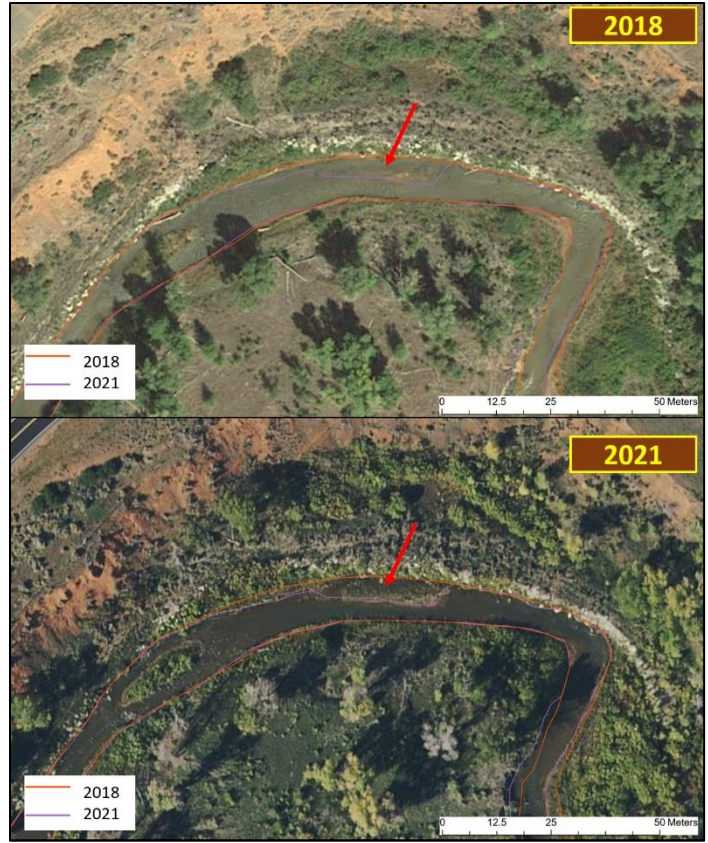
**Figure 2.47.** Bar deposition between 2018 and 2021 in the lower Oxbow reach.

At RM 16,300, point bar deposition and outer bank erosion from 2016-2021 caused a relatively smaller bend to narrow and elongate. This bar was vegetated by 2021. A large bend in this reach (around 16,400 m downstream) narrowed and shifted (Figure 2.46) due to bar deposition between 2018 and 2021 (Figure 2.47) causing this section of the reach to be almost 5 m narrower in 2021 than in 2018. This bar was vegetated by 2021.

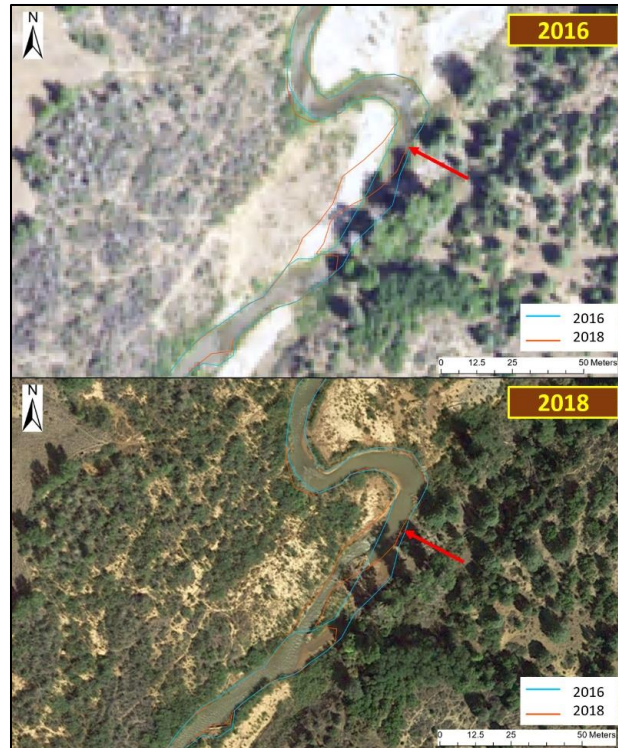
**Figure 2.55.** Example of bar cutting and bar deposition from 2016-2018 in the Levee reach.

The third mechanism was bar cutting with associated deposition of a new bar downstream. The wetted channel cut through a bar on one side of the river to then deposit another bar on the opposite side of the river. This caused the river to shift from one side of the river to the other (Figure 2.55). This was the least frequent mechanism of channel change on the lower Diamond Fork River from 2011-2021 as it only occurred twice—once from 2016-2018 in the Levee reach and once from 2018-2021 in the Childs reach. The fourth channel change mechanism is driven by the occurrence of channel spanning wood jams (Figure 2.56). Three wood jams were observed on the LDFK—one in the Dry Canyon reach and two in the Monks Hollow reach—all in the upstream section of the river. Flooding above these wood jams forced the flow to one side, causing large channel shifts in two locations in 2021 and one location in 2018. Both bar cutting wood jams produced a large, localized channel change, but were the least frequent mechanisms

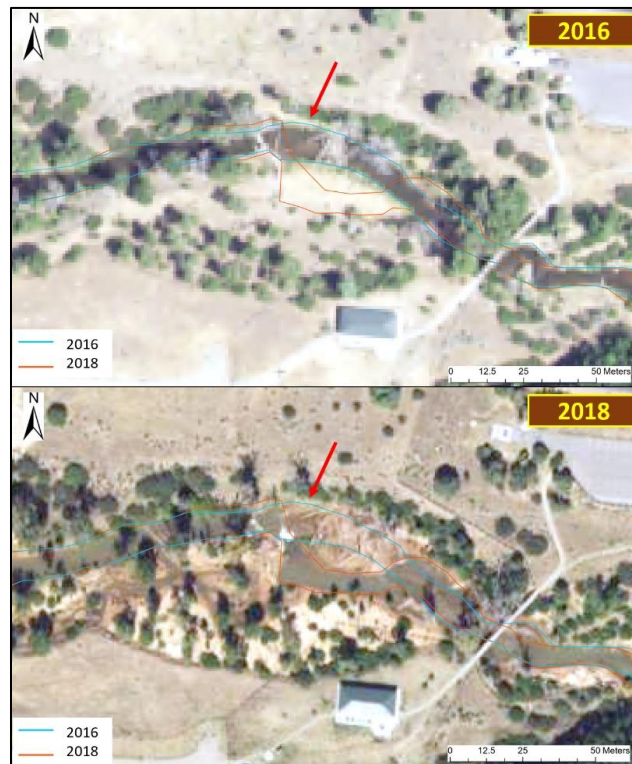
**Figure 2.56.** Example of a wood jam from 2016-2018 in the Monks Hollow reach.

Channel change occurred from 2016-2018 due to a large wood jam about 300 meters downstream of the Monks Hollow Outlet. The jam caused a backwater extending approximately 60 meters upstream, driving a local avulsion of the channel to the left. The wood jam caused the channel to shift 9.2 m/yr for 2016-2018 and a further shift of 2 m/yr for 2018-2021 (Figure 2.13). This is by far the largest wood jam observed anywhere on LDFK during the study period and the jam was sufficient to withstand all high flows from 2016 on.

observed. Even though these wood jams shifted the river flow and aquatic habitat (Vaz et al., 2013), more channel change occurred without the influence of wood.

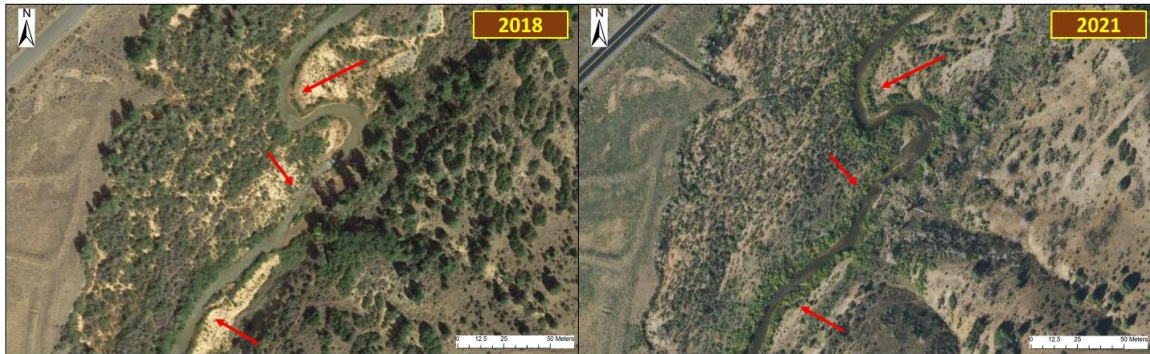
**Figure 2.61.** Example of the increase in vegetation density from 2018 to 2021 in the Levee reach. Red arrows display locations to focus on.

2021 than 2018 (Figure 2.61, Figure 2.62), specifically from Diamond Campground downstream to Childs. The downstream portion of the LDFK (Diamond Campground to Childs) appeared to contain denser vegetation than the upstream section (Dry Canyon to Red Ledges). This could be due to finer grain sizes in the downstream section compared to the upstream section. This is further discussed in section 4.3.

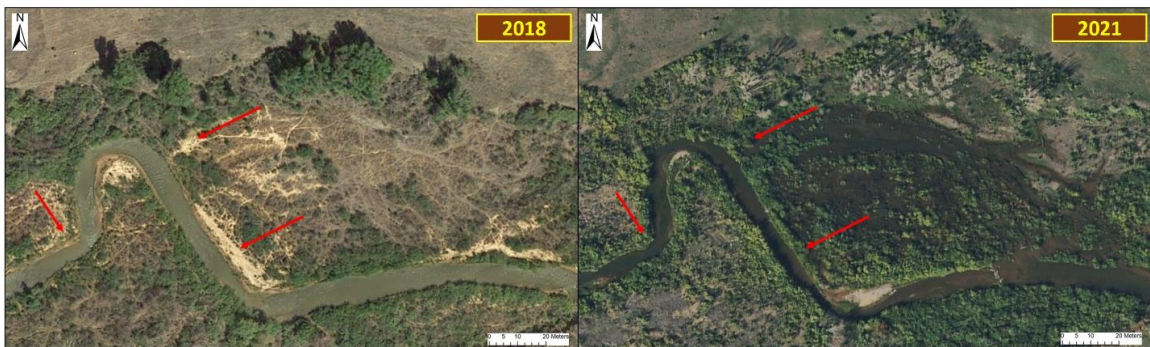
**Figure 2.62.** Example of the increase in vegetation density from 2018 to 2021 in the Motherlode reach. Red arrows display locations to focus on.
