Implantation Failure of Peritoneal Dialysis Catheters: A Scanning Electron Microscopical Study

IMPLANTATION FAILURE OF PERITONEAL DIALYSIS CATHETERS:
A SCANNING ELECTRON MICROSCOPICAL STUDY

Abstract

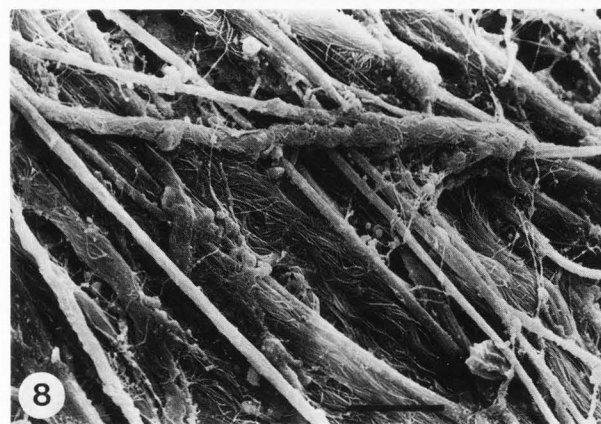
Figs. 5-8. Inwards-facing surface of flange of successful catheter. Fig.5 (bar = 100 μ m) is a radial profile through the entire 'GORE-TEX' layer showing overlying layers of connective tissue (A), collagen fibrils (C) penetrating the pores between nodes of PTFE (*), and the underlying silicone rubber (S). Fig. 6 (bar = 5 μ m) is a higher magnification profile of the overlying connective tissue layers showing collagen fibre bundles. Fig.7 (bar = 100 μ m) is a surface view showing the mat of collagen fibre bundles whose fibrillar construction is clearly visible at the higher magnification of Fig.8 (bar = 10 μ m).

Fig.5 shows a radial profile through the entire 'GORE-TEX' layer on the inwards-facing surface of the flange (see Fig.1) of this successful catheter. Here layers of connective tissue can be seen overlying the 'GORE-TEX', with collagen fibrils penetrating the pores. At a higher magnification (Fig.6) the collagen fibre bundles in the overlying layers are clearly seen. A surface view of this inwards-facing surface of the flange is shown in Fig.7 and at a higher magnification (Fig.8) bundles of collagen fibres characteristic of dense irregular connective tissue (Kessel and Kardon, 1979) are clearly visible.

The most extensive tissue infiltration occurred around the cuff (see Fig.1) of this successful catheter. Pieces of cuff were mounted to enable both surface views and longitudinal profiles of the 'GORE-TEX' layer and adherent tissue to be examined. A longitudinal profile at one side of the cuff looked rather similar to Fig.5 but showed the 'GORE-TEX' layer to be overlain by approx. 1mm thickness of connective tissue, the surface appearance of which was like that shown in Fig.7.

The successful peritoneal dialysis catheter examined in this study showed a collagenous infiltration of pores in the expanded PTFE, sometimes linking to surrounding muscle fibres (Figs. 5 and 9). This finding is very similar to that described by Goldfarb et al. (1977) who showed expanded PTFE vascular grafts firmly incorporated into surrounding tissues by integration with periprosthetic dense collagen which extended directly into

the internodal spaces of the PTFE lattice structure. The layering of the collagenous tissue (seen clearly in Fig.6) may reflect the succession of collagenous laminae produced during wound healing as described by Baur et al. (1981).
