Application of Scanning Electron Microscopy and X-ray Microanalysis to Investigate Corrosion Problems In Plain and Enamelled Three Piece Welded Food Cans

James E. Charbonneau

National Food Processors Association
1401 New York Avenue, NW
Washington, D.C. 20005

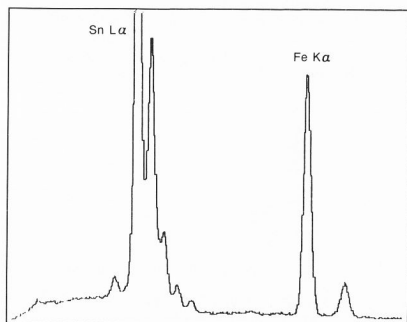
**Figure 1.** EDS Spectrum of $0.25 \text{ lb/basis box}$ (2.8 g/m^2) tin coating.

An EDS spectrum was acquired for the unknown sample and each of the standards under identical conditions of specimen tilt (34°), working distance (12 mm), emission current ($150 \mu\text{a}$), and acceleration voltage (20 kV). The count rate was held at $3,000 \text{ cps}$ to avoid the $2 \times \text{Si}$ sum peak (Winstanley, 1986). The Kevex detector was operated in the Beryllium window mode. Figure 1 shows a typical EDS Spectrum for 0.25 pounds/basis box (2.8 g/m^2) tin coating.

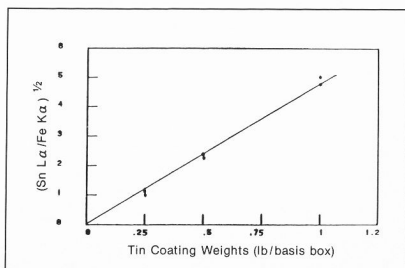
**Figure 2.** Standard Curve—
Tin coating weight vs. $(\text{Sn } L\alpha / \text{Fe } K\alpha)^{1/2}$.

For the sample and each standard, the peak intensities of the tin $L\alpha$ and iron $K\alpha$ peaks including background acquired in 300 seconds was measured. A standard curve was constructed by plotting $(\text{Sn } L\alpha / \text{Fe } K\alpha)^{1/2}$ vs. standard values of tin coating weight. The concentration of the unknown was determined from the standard curve. Figure 2 shows a typical standard curve. The standard curve has good linearity.

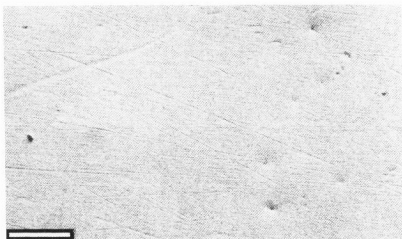
Figure 3. Smooth continuous tin coverage on 1.00 lb/basis box (11.2 g/m²) tin coating. Bar=100 μ m.

If the surface of the tinplate is smooth as in Figure 3, the determination of tin coating weight can be made at varying magnifications. However, if the surface is not smooth as in Figure 4, a magnification must be chosen to represent the entire surface. In Figure 4 areas like (0.15) are lightly tinned areas. A tin coating weight of 0.15 pounds/basis box (1.7 g/m²) was found at area 0.15. At area (0.92) the tin coating weight was found to be 0.92 pounds/basis box (10.3 g/m²). At 100 \times magnification a tin coating weight of 0.5 pounds/basis box (5.6 g/m²) was found, which agrees with the known tin coating weight. Working at 100 \times magnification appears to be a good choice for the samples that have been examined using SEM-EDS.

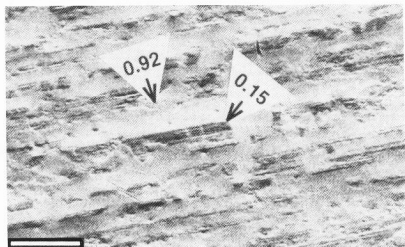
Figure 4. Areas of light and heavy tin coverage on 0.50 lb/basis box (5.6 g/m²) tin coating. Bar=100 μ m.

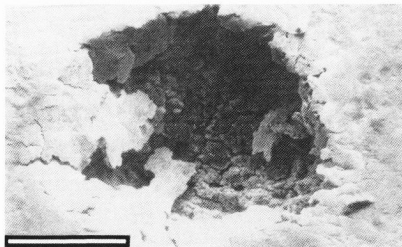
Figure 8. A typical corrosion pit on the inside body bead of a plain tinplate container undergoing early failure by pitting corrosion. Bar = 100 μ m.

Figure 8 shows an SEM photo of a typical corrosion pit. At the corrosion pits, iron dissolves into the product and hydrogen evolves into the can headspace.

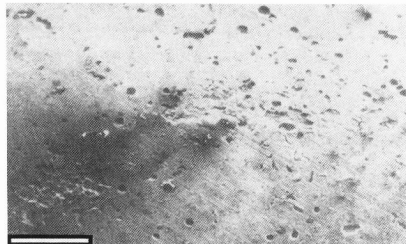
Figure 9. A typical pitted and stained area on the headspace walls of a can that contained apple sauce. Bar=1,000 μ m.

The cans were examined for corrosion using an optical microscope. Most of the pitting was characterized by a few deep pits on the body beads. These pits would have eventually pinholed through the container. Some of the code lots from the New York canning plant had multiple corrosion pits on the walls of the can in the can headspace. These pits occurred in clusters some of which were associated with partial detinning and black colored staining of the tinplate. Figure 9 shows a typical cluster of corrosion pits.

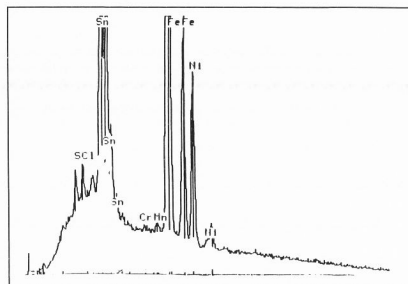
Figure 10. EDS spectrum of the corroded area in Figure 9.

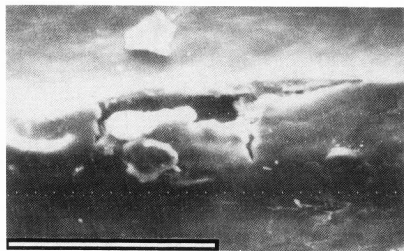
Figure 11. A pitted area on an enamelled tin free steel end that was in contact with apple sauce. Bar=100 μ m.

Tinplate samples were analyzed using SEM-EDS. The corrosion pits below the product line were mostly empty of corrosion deposits. Trace levels of sulfur and chloride were found in and around the pits. In contrast corrosion pits in the black stained areas in the can headspace were high in nickel. Figure 10 shows an EDS spectrum of the one of stained areas. Traces of nickel were also detected in corrosion pits on the enamelled tin free steel ends in complaint samples from both packing locations. Figure 11 shows a pitted area on one of the tin free steel ends.

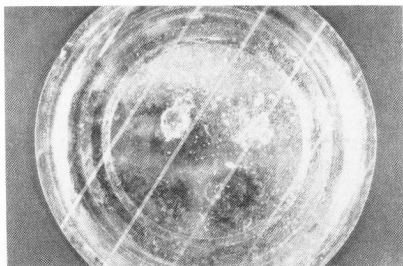
Figure 12 shows rust on one of the tinplate lids. The rust covered a major portion of the lid surface. The pronounced parallel lines in Figure 12 are normal identification marks for differential tin coating weights. Figure 13 shows a rust stained area. Figure 14 shows the area with the rust removed. The site of rusting appears to be ridges in the tinplate that are lightly coated with tin compared to surrounding areas. (See Figure 4). The EDS spectrum of the stained area contained a major oxygen peak and trace levels of sodium, phosphorus, and chloride besides iron and tin from the tinplate. The source of these elemental components is the food product.

Figure 12. Rust deposits on the inside surface of a tinplate can end after contact with mushrooms for one month.

which attacked the tinplate. The point of attack was the lightly tinned ridges of the plate. The problem can be prevented by using enamelled tin free steel instead of tinplate and taking steps during canning to reduce oxygen.

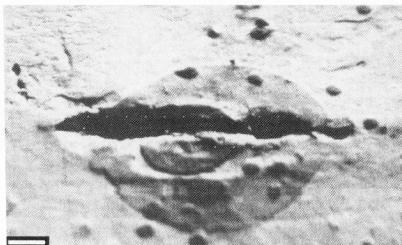
Figure 13. A rust stained ridge area in Figure 12. Bar = 10 μ m.

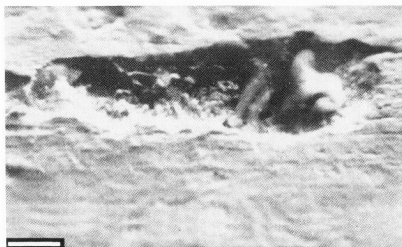
Figure 14. A corrosion pit under the rust in Figure 13. Bar = 10 μ m.

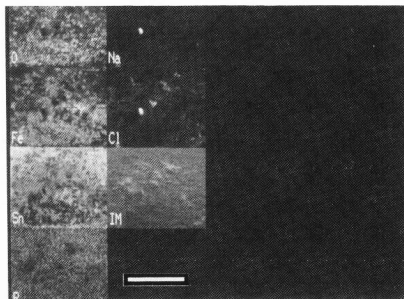
Figure 15 shows X-ray maps for a rusted area. The presence of white areas indicates the presence of a particular element. Oxygen, tin, and iron (many white areas) are distributed over the rusted surface, whereas sodium and chloride are localized in the rust (few white areas). Phosphorus is present at a low level and the phosphorus map is mostly background. The X-ray map in Figure 16 shows the distribution of oxygen (indicated by black rectangles) over the rusted surface. This internal rusting problem appears to be due to an excess level of oxygen in the can

Figure 15. X-ray maps for oxygen, iron, tin, phosphorus sodium, chloride and the image at a typical rusted ridge in Figure 13. Bar = 100 μ m.

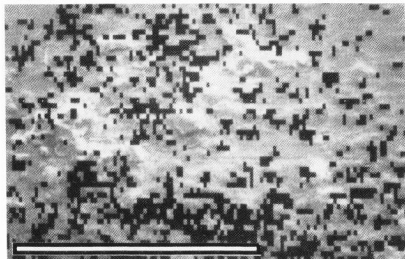
Figure 16. X-ray map for oxygen from Figure 15. Bar = 100 μ m.

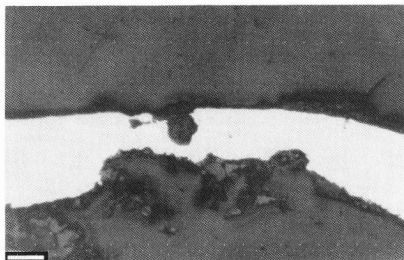
Figure 17. Cross section of a corroded section near the side seam weld of a can that contained carrots. Bar=100 μ m.

Figure 17 shows a cross section of a corroded section near the weld. Figures 18–21 show the types of metal exposure present at the weld and along the beads on unused cans. Figure

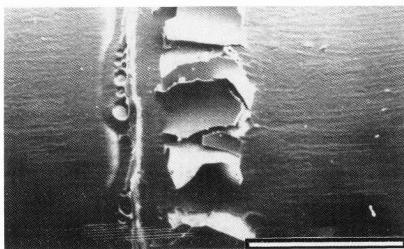
Figure 18. Fractured Enamel at a typical weld area. Bar=1,000 μ m.

18 shows fractured enamel at the weld. Figure 19 is a backscattered electron image showing metal exposure at the weld. The backscatter detector is very useful for locating metal exposed areas. Figure 20 shows enamel blistering and metal exposure along the weld. Figure 21 shows metal exposure on the can body.

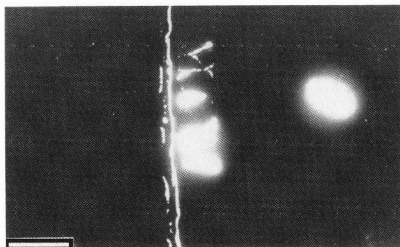
Figure 19. Backscattered electron image showing metal exposure at a typical weld area. Bar=1,000 μ m.

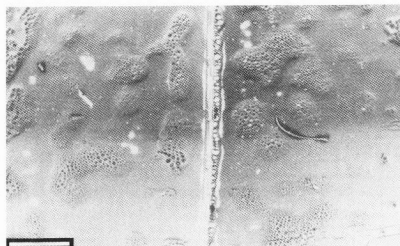
Figure 20. Backscattered electron image showing enamel blistering and metal exposure at a typical weld area. Bar=1,000 μ m.

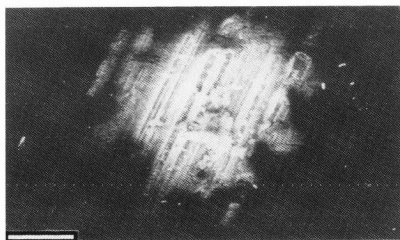
Figure 21. Backscattered electron image showing metal exposure at a typical area on the body. Bar=100 μ m.

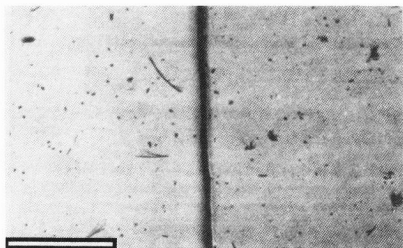
Figure 22. Backscattered electron image showing good metal coverage at a typical weld area. Bar=1,000 μm .

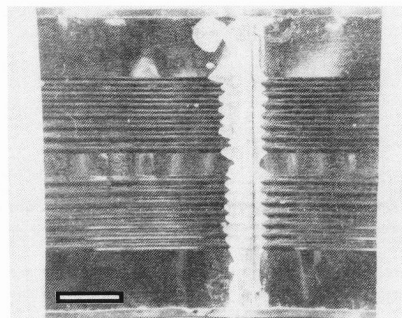
Figure 24. Enamel lifting and underenamel corrosion at the side seam of a No. 303 (8.1 cm in diameter) tinplate can that contained a vegetable product. Bar=20 mm.

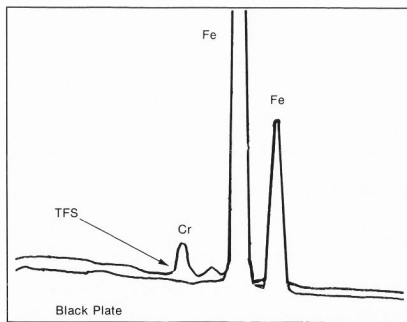
Figure 25. EDS spectrum of black plate (no chromium) lids that corroded in contact with canned pet food. TFS lids with chromium passivation gave good performance.

the defective lids. The chromium X-ray peak which is characteristic of chromium coated tin free steel is present in the control sample. The problem sample had no chromium. The failed lids are enamelled black plate which gives good performance with dry products but should not be used with aqueous foods because of its borderline corrosion resistance. A brown appearance forms during enamel baking of this material.

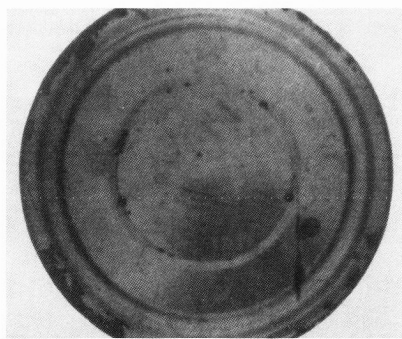
Figure 26. Sulfide black on a No. 10 tinplate lid (15.7 cm in diameter) from a can that contained peas.

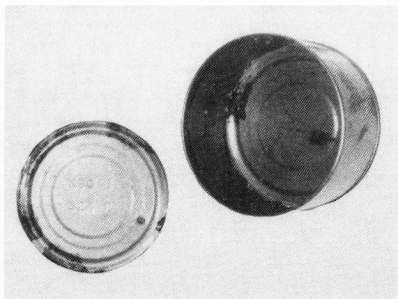
Figure 27. Sulfide black deposits in a 307x113 (8.7 cm in diameter) tinplate can that contained shrimp.

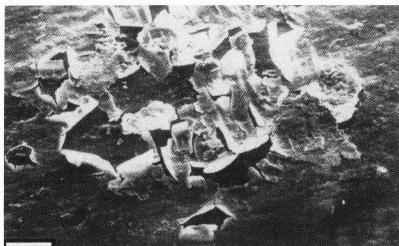
Figure 28 shows the presence of black deposits at an area on the profile ring. The enamel was fractured at this point.

Figure 28. Sulfide black deposits at an area on the profile rings of a lid from a can that contained minced clams. Bar = 100 μ m.

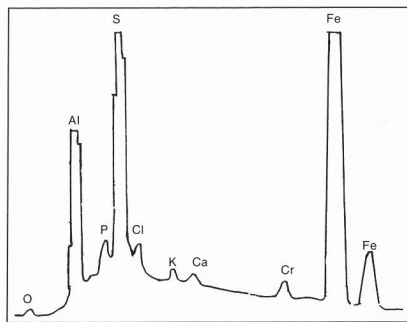
Figure 29. EDS spectrum of sulfide black deposits in canned minced clams.

Figure 29 is an EDS spectrum of the black deposits. The deposits contain mainly iron and sulfur and trace levels of oxygen, phosphorus, chloride, potassium and calcium and chro-

mium. The iron and chromium are from the tin free steel lid. The aluminum is from the organic coating. The other elements are from the product. Sulfides, oxides and phosphates of iron have been identified in sulfide black deposits. The elemental profile of the deposits in the clam cans is consistent with this composition. Black deposits sometimes contain no sulfide. The name "sulfide black" is somewhat of a misnomer, but this type of corrosion has been around since the beginning of canning and this was name given at that time. The composition of the deposits appears to vary probably depending on what anions are available to iron when the corrosion starts during processing and cooling of the canned product.

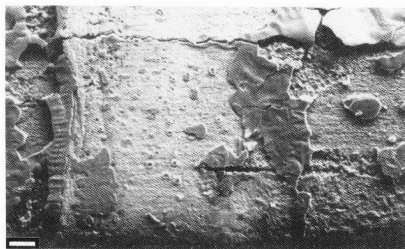
Figure 30. Stress corrosion cracks at the weld on the inside of a can that contained pet food. Bar=100 μm .

Figure 30 shows a S.C.C. at the weld viewed from the in-

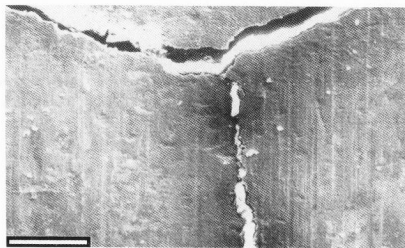
Figure 31. Stress corrosion crack near the weld on the outside of a can that contained pet food. Bar=100 μm .

side of the can. Figure 31 shows a part of the crack with corrosion deposits viewed from the outside of the can near the weld.

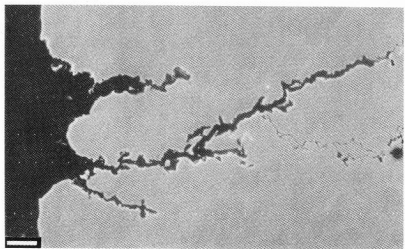
Figure 32. Branched stress corrosion crack in the cross section of a tin free steel lid from a can that contained potatoes. Bar=10 μm .

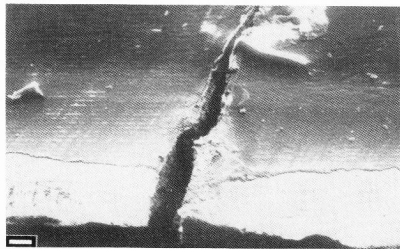
Figure 33. Stress corrosion crack on a tin free steel lid from a can that contained pet food. Bar=100 μm .
