# Revegetation of Reconstructed Reaches of the Provo River, Heber Valley, Utah

John A. Rice

In: Riley, L. E.; Dumroese, R. K.; Landis, T. D., tech. coords. 2006. National Proceedings: Forest and Conservation Nursery Associations—2005. Proc. RMRS-P-43. Fort Collins, CO: U.S. Department of Agriculture, Forest Service, Rocky Mountain Research Station. 160 p. Available at: <http://www.rngr.net/nurseries/publications/proceedings>

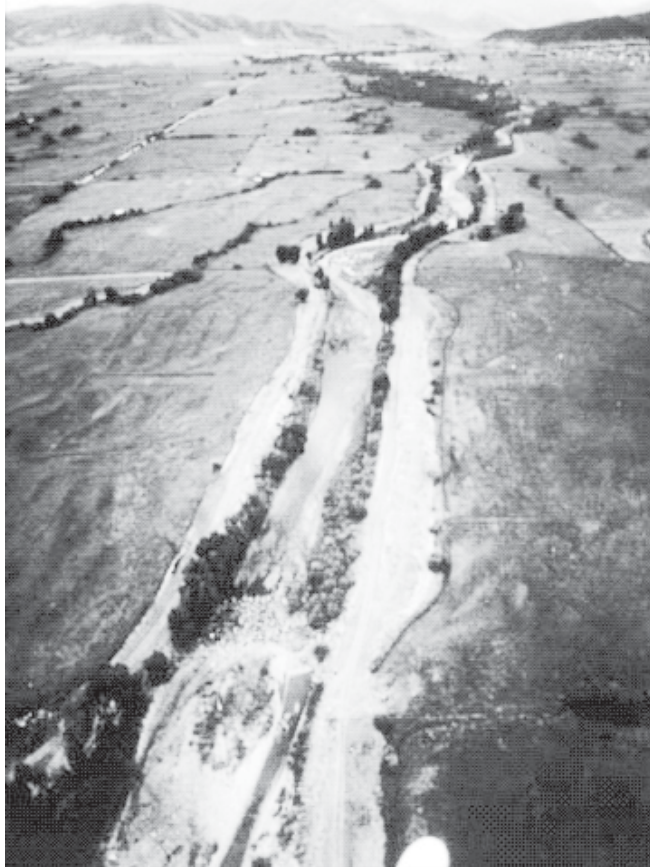
**Figure 1**—Provo River in Heber Valley before restoration.

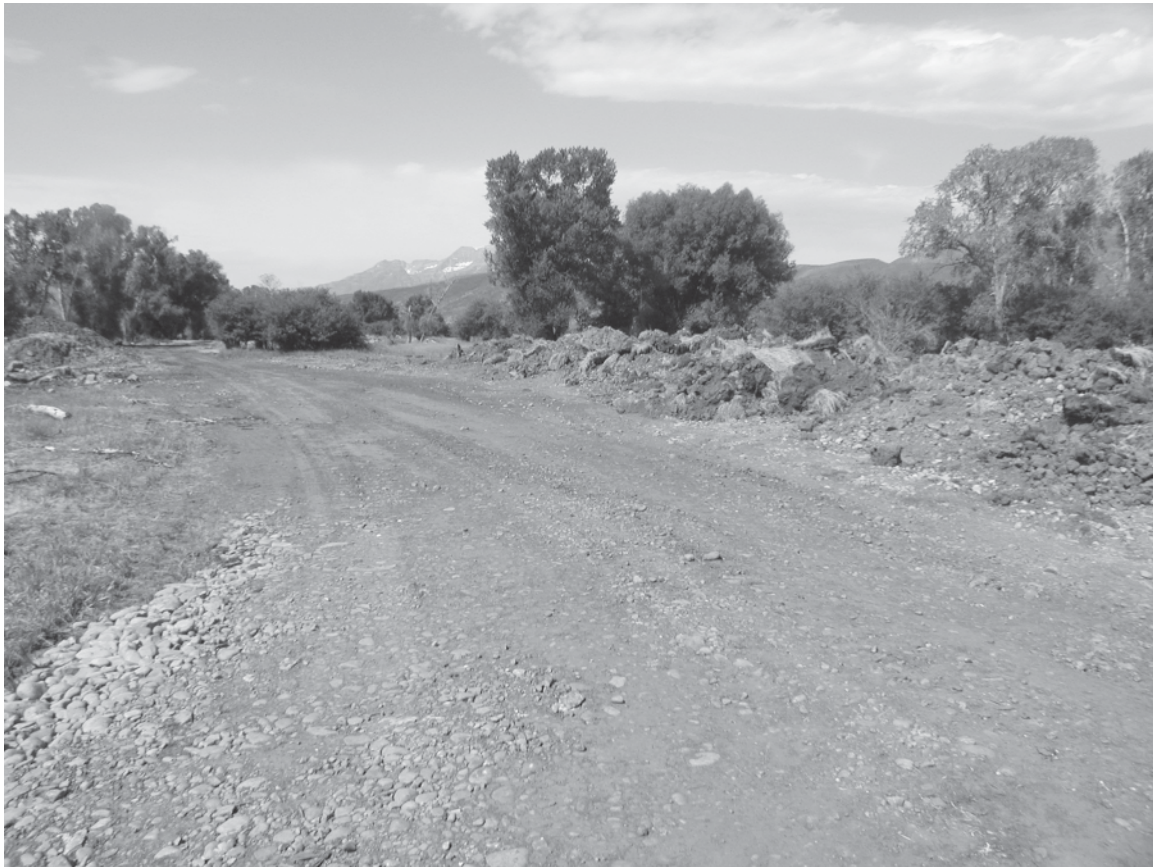
**Figure 2**—PRRP haul route. Note that the top foot of soil, which contains plant roots and seeds, has been stockpiled to the right of the road. This minimizes handling of the topsoil. Decommissioning of the route would follow the sequence of removing any road fill, grading to establish proper contour, ripping (if necessary), and replacement of topsoil.

Haul routes were minimized, and, to the maximum extent practicable, did not cross wetlands, wet areas, or constructed features. If crossing a constructed feature became necessary, compacted areas were ripped prior to topsoiling. No crossing was permissible on topsoiled areas (figure 2).

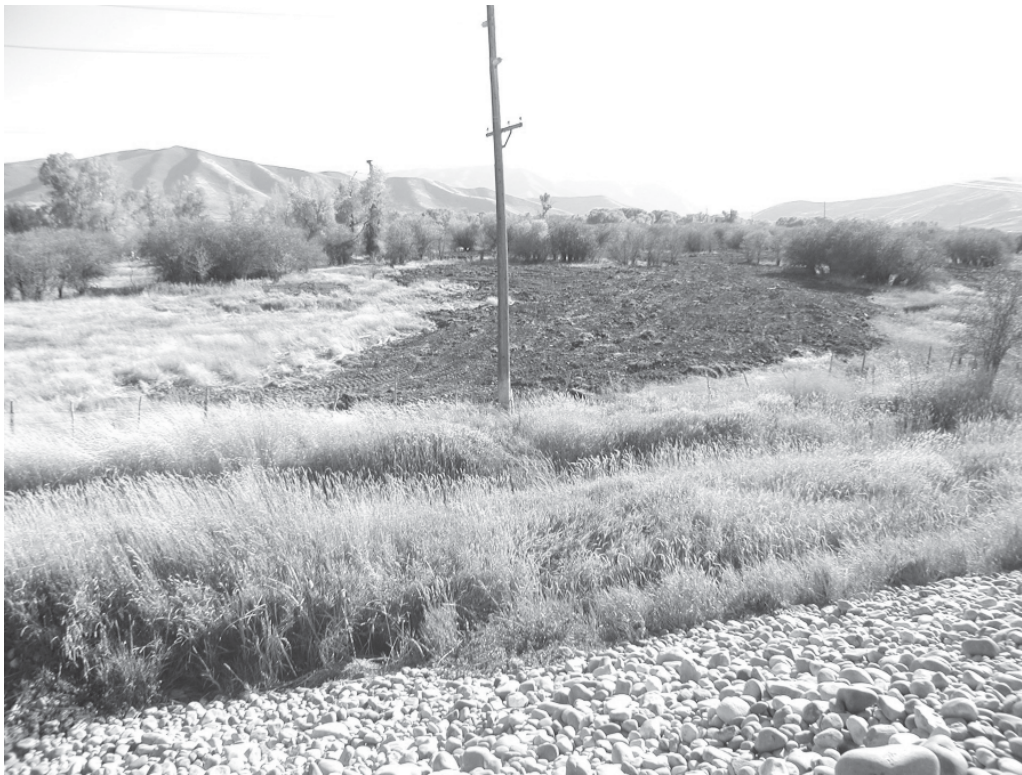
**Figure 3**—Small mammal refuge created by onsite disposal of excess material.

Onsite disposal of excess material can cause site impacts by disturbing additional area and possibly covering productive habitat. However, careful dispersal of excess material onsite will not only avoid transportation costs, but can reclaim disturbed habitats. For example, PRRP small mammal studies indicated that upland habitat for small mammals might be in short supply during high water events associated with periodic floods. For this reason, excess material has been used to raise the elevation of uplands in several areas in order to provide a refuge during high water events (figure 3).

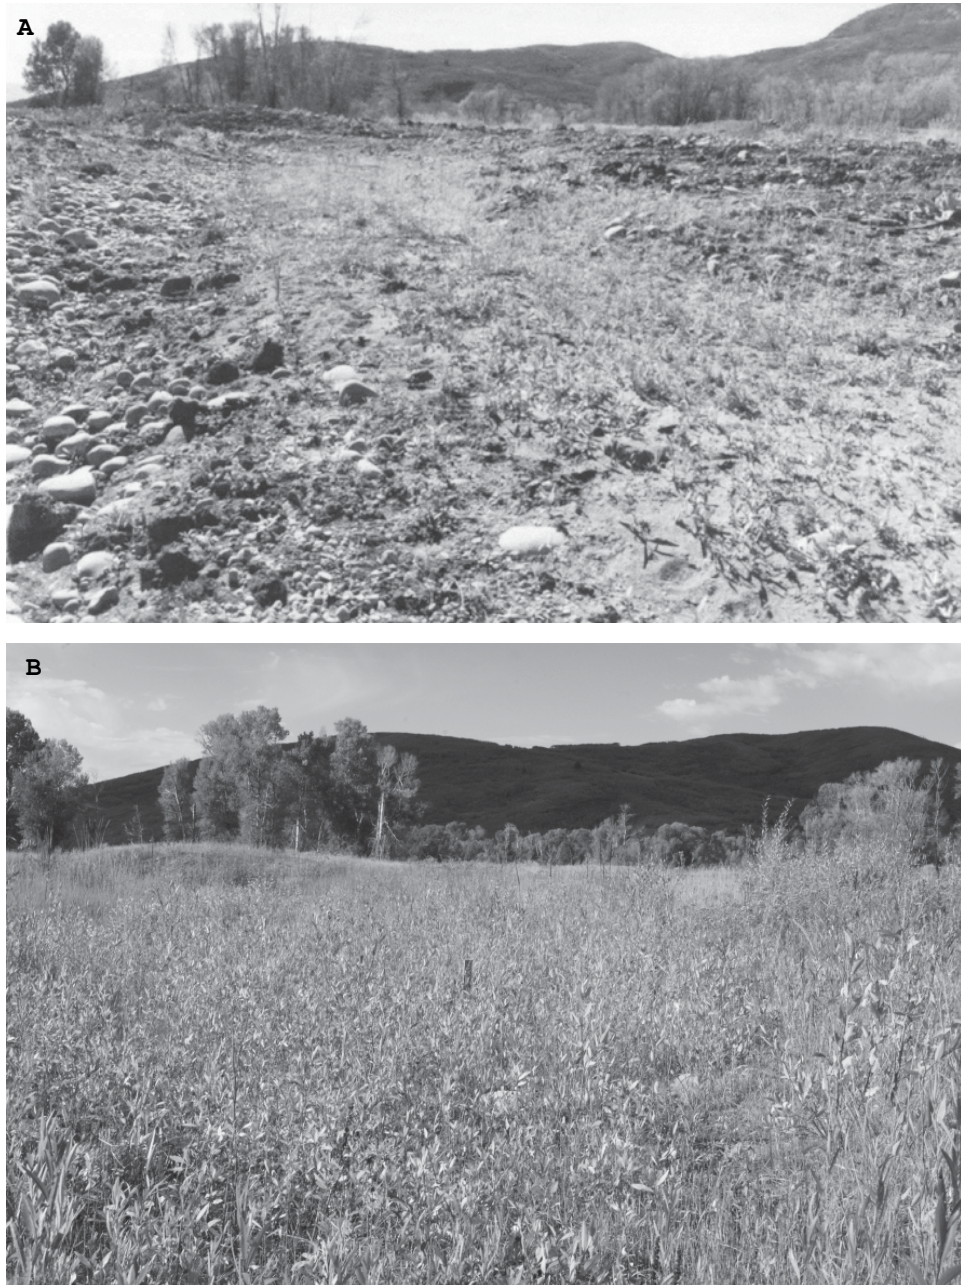
**Figure 4**—High flow channel one flood event after construction (A) and three flood events following construction (B). Note that no trees or shrubs have been installed at this location. Natural recruitment accounts for the many hundreds of seedlings.

Wherever possible, it was important to work with the natural disturbance regime of the river. Figure 4a shows the natural recruitment of hundreds of seedlings within a high flow channel following a single flood event, and figure 4b the natural recruitment of hundreds, if not thousands, of seedlings following three flood events. No trees or shrubs were

installed at this location, yet several cohorts of willow and cottonwood have successfully established because the natural disturbance regime of the river has been reestablished.
