# Water Main Break Rates in the USA and Canada: A Comprehensive Study

December 2023

A Resource to Support Asset Management,  
Pipeline Renewal, and Replacement

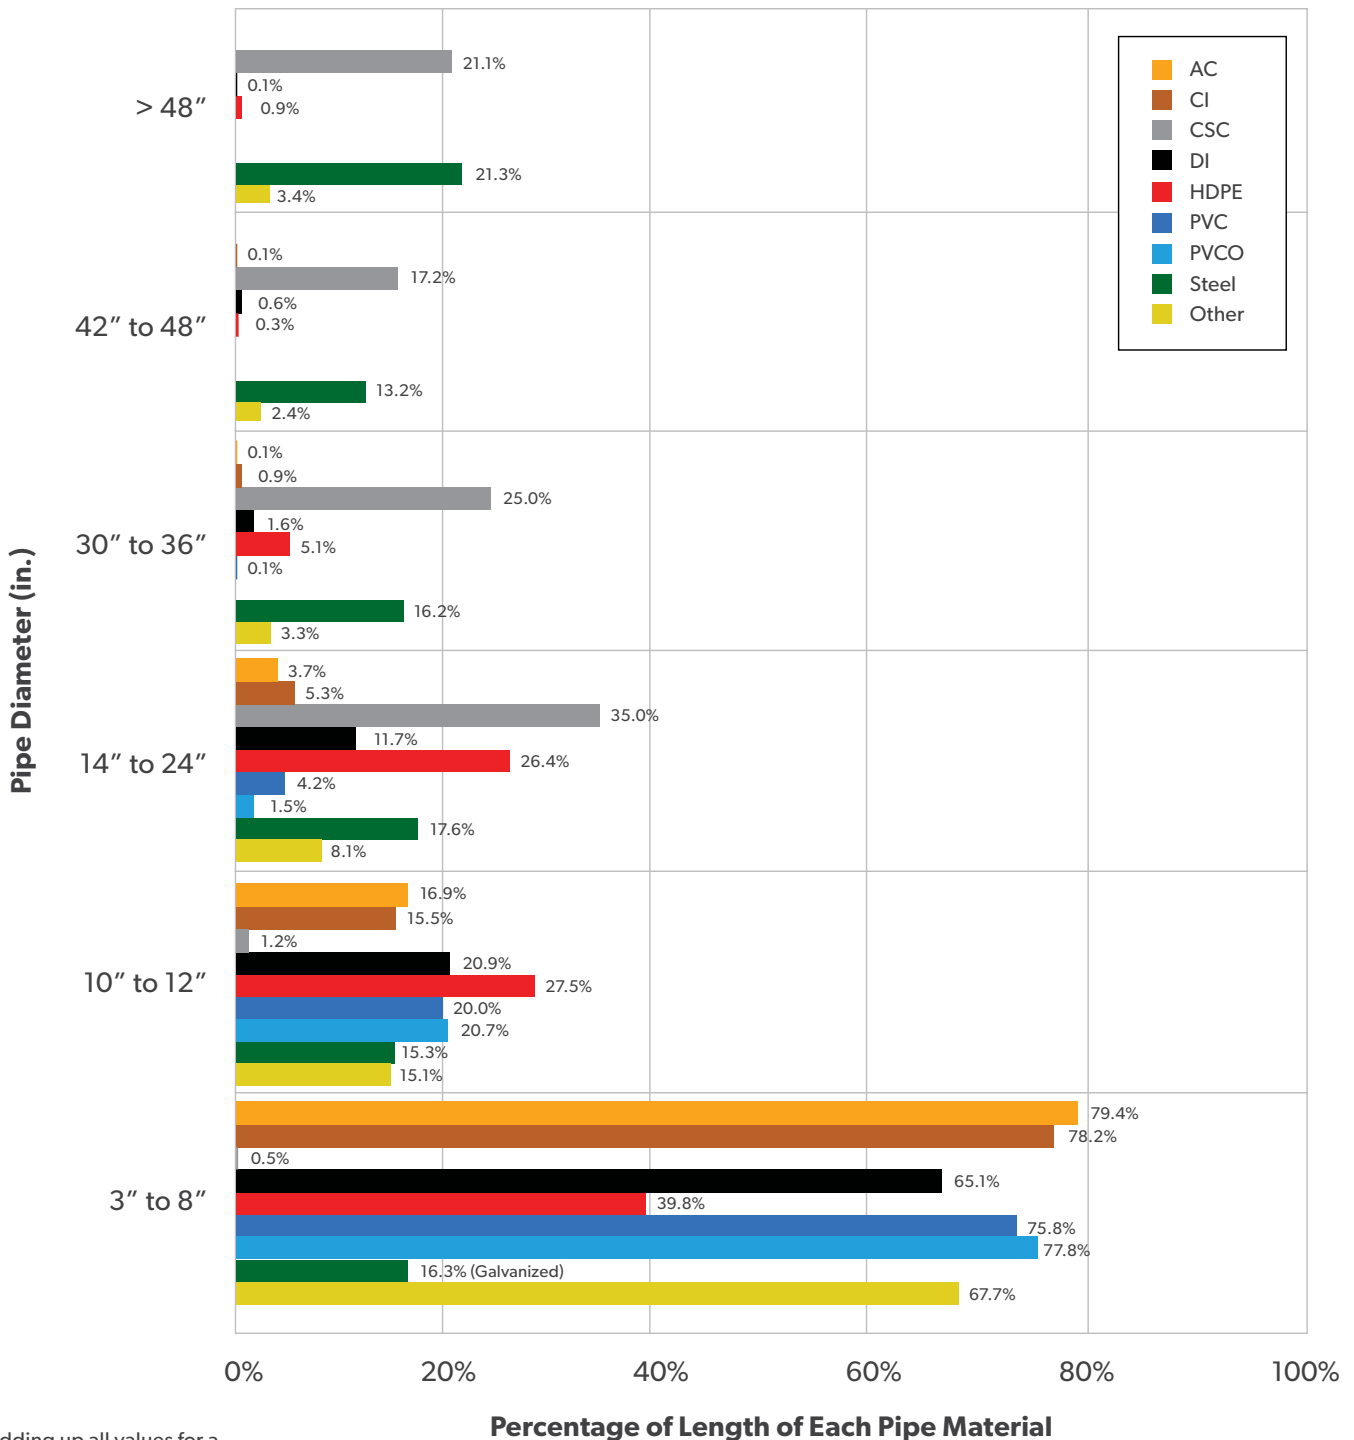
**FIGURE 24: PIPE DIAMETER DISTRIBUTION BY MATERIAL TYPE (DETAILED SURVEY)**

Figure 24 illustrates the diameter distribution for each material type as reported from the detailed survey. The figure shows that most large diameter pipes (14-inch and larger) are predominantly steel and CSC, with each material having more than 21% of their length in sizes larger than 48-inch. More than 98% of the CSC pipe was in sizes 14-inch and larger. The figure also shows that over 75% of all AC, CI, PVC and PVCO pipe, respectively, is 8-inch or smaller.

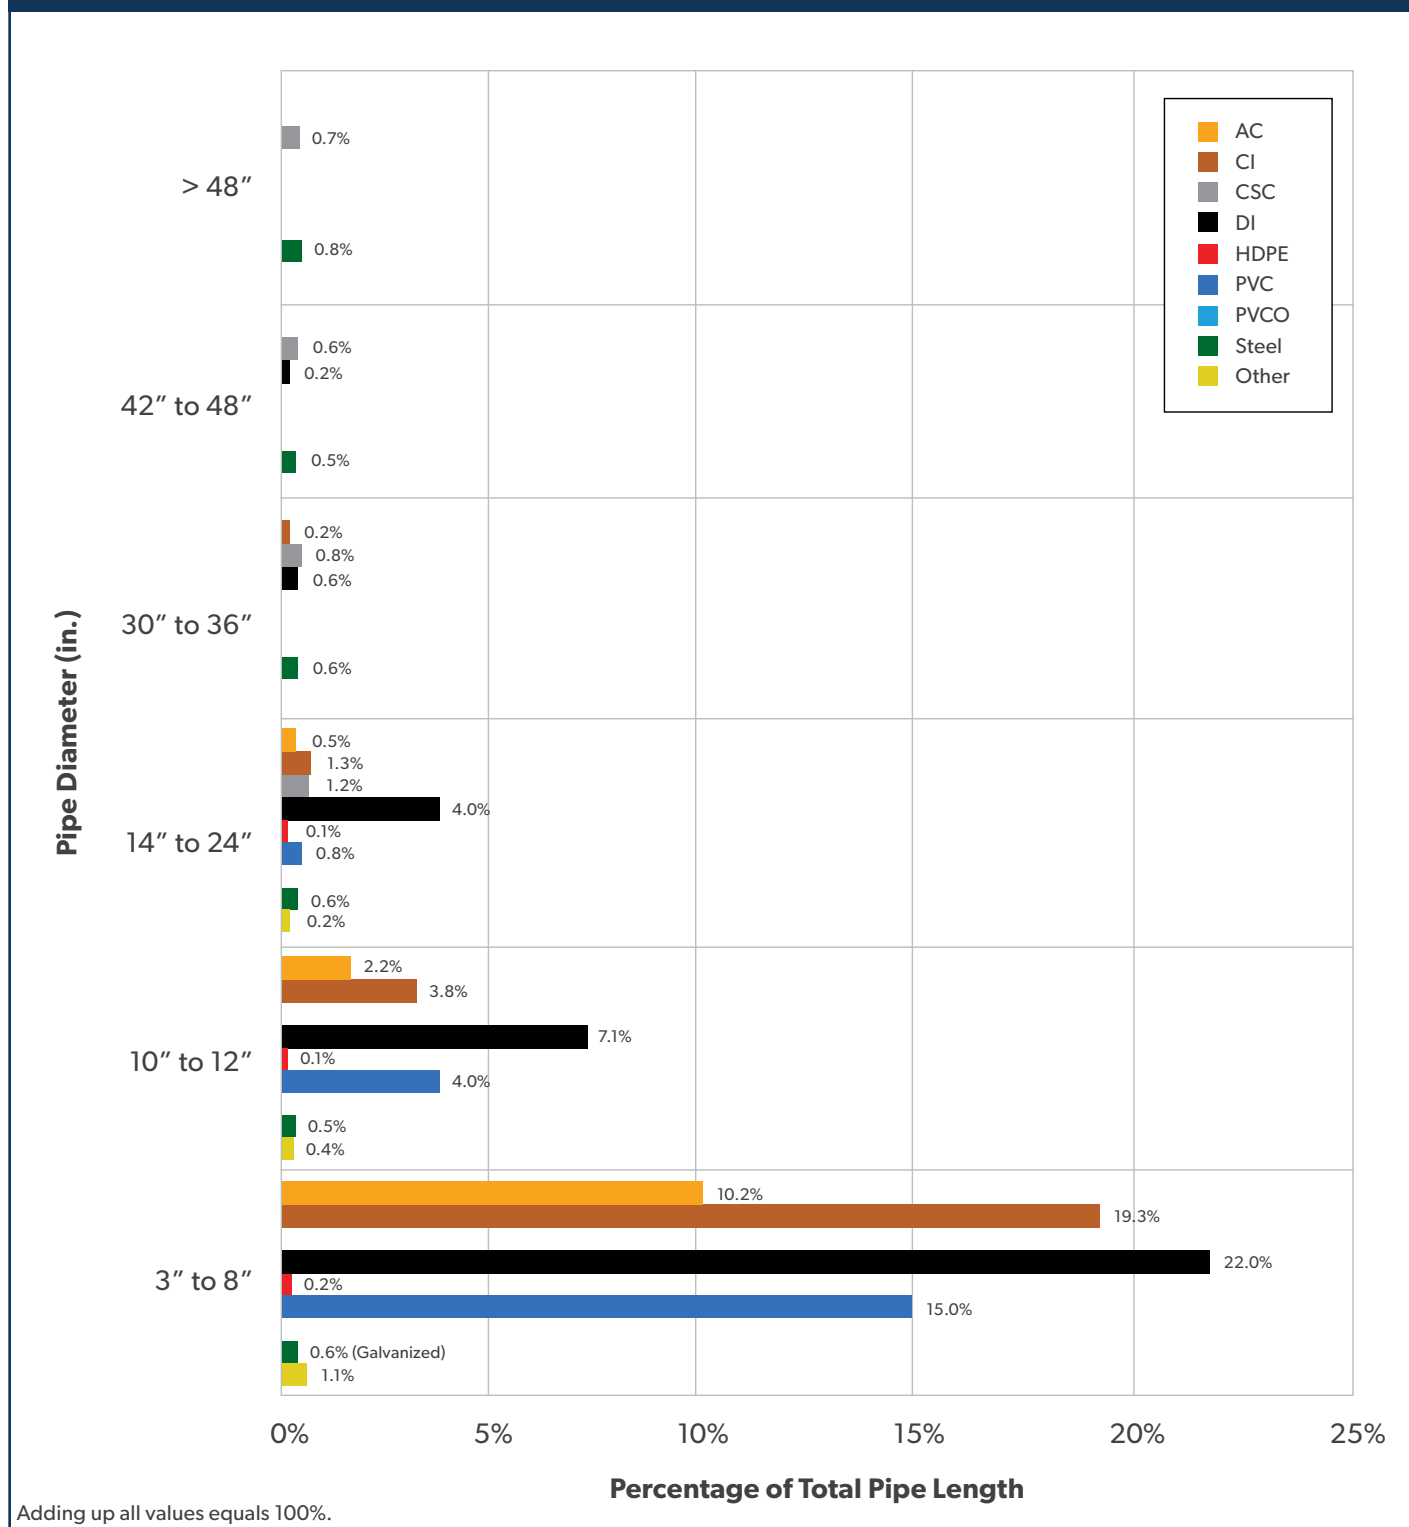
**FIGURE 25: PERCENTAGE OF TOTAL PIPE LENGTH BY DIAMETER AND MATERIAL TYPE (DETAILED SURVEY)**

Figure 25 illustrates for each pipe material the percent of total length by material type and diameter. It shows that DI and PVC pipe from 3 to 8 inches in diameter represent over 22% and 15%, respectively, of all installed pipe as reported from the detailed survey. Steel pipe less than 14-inch in diameter is most likely galvanized steel, while larger diameter steel is typically carbon steel. As discussed previously, the pipe mileage data from the detailed survey differs from the data collected in the basic survey due to the difference in sample size.

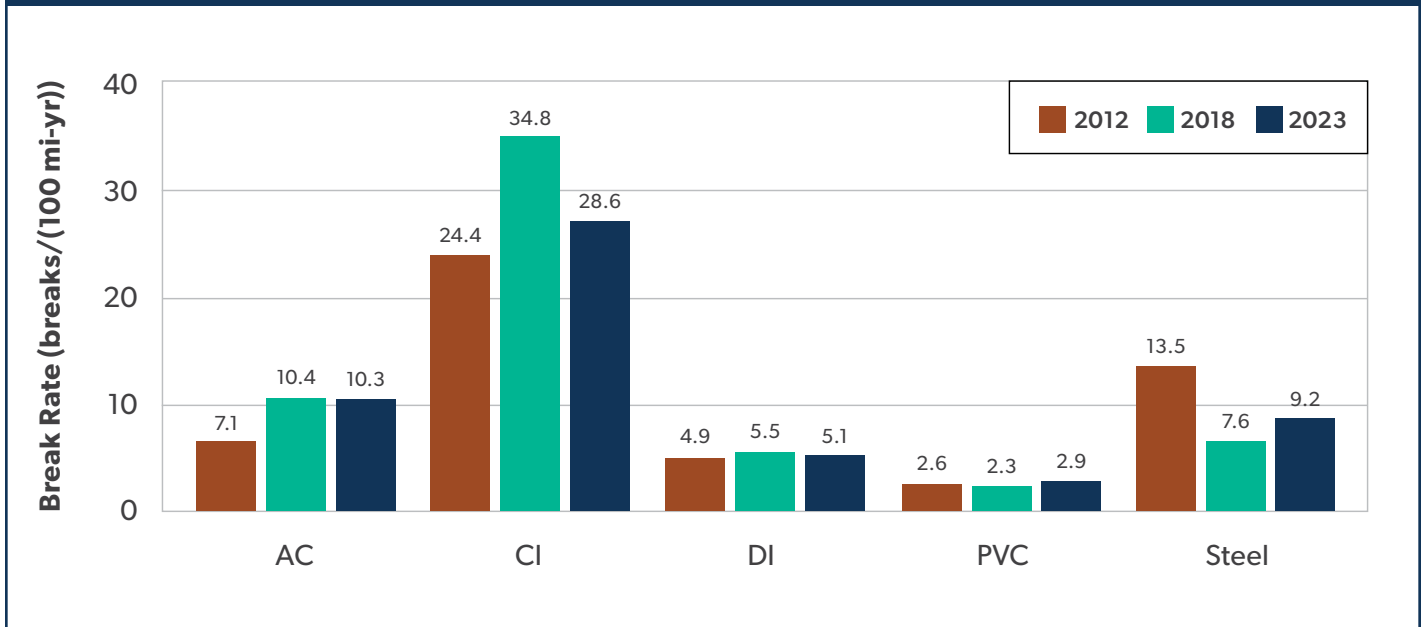
**FIGURE 31: COMPARISON OF BREAK RATES FROM THE 2012, 2018, AND 2023 BASIC SURVEYS**

Figure 31 compares the break rates of common water pipe materials from the 2012, 2018, and 2023 USU surveys. The consistent break rates across the three studies help to validate the accuracy of the data. Small variations can be assumed to be data scatter. Since about 90% of installed pipe consists of AC, CI, DI, and PVC, the break rates for these materials are the most accurate, which avoids inaccurate calculations for pipe materials with low reported mileage. Figure 31 shows an insignificant break rate change over time for PVC and DI pipe.
