Analysis of Significance & Integrity Orson B. Adams Farmstead Historic American Landscape Survey

Analysis of Significance & Integrity

Orson B. Adams Farmstead Historic American Landscape Survey

Prepared by
Ladd Schiess
Utah State University
Logan, Utah

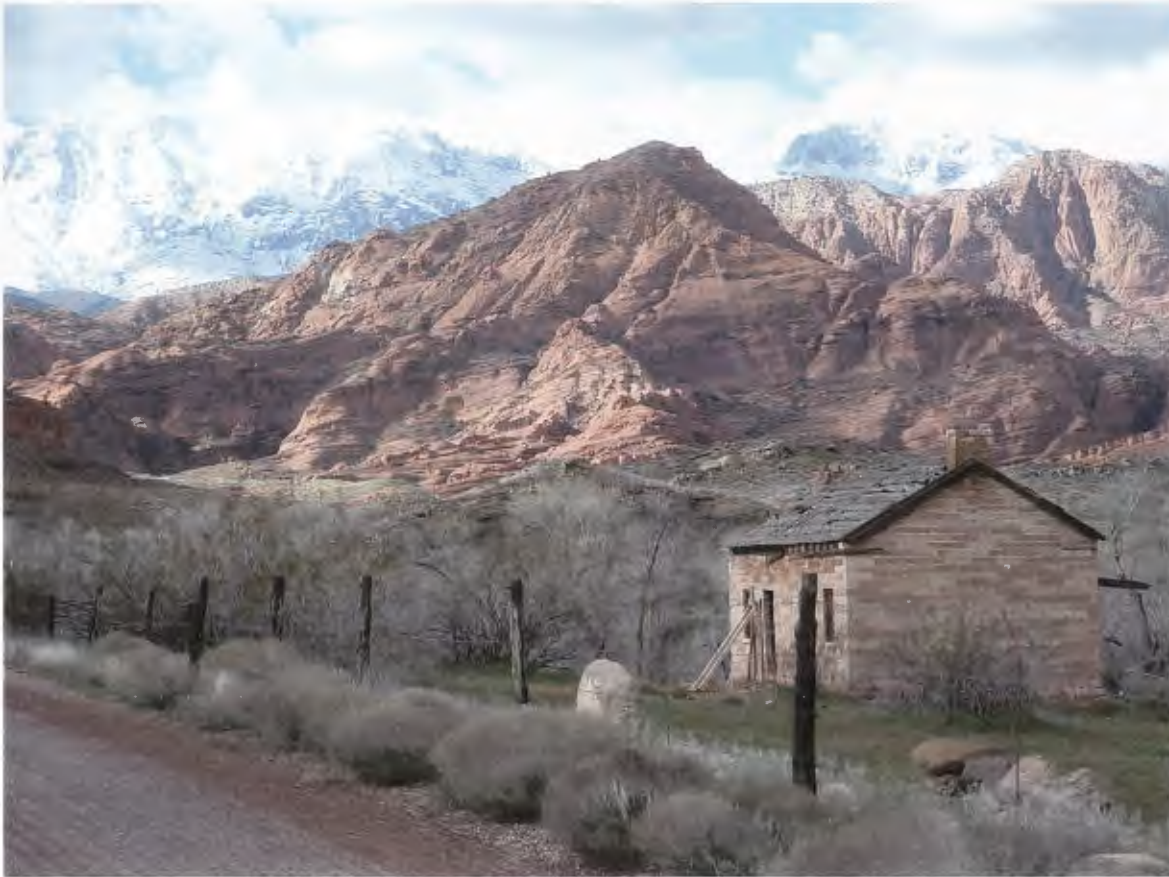
Figure 2 Photo showing the house with the Red Cliffs and Pine Valley Mountains in the background.

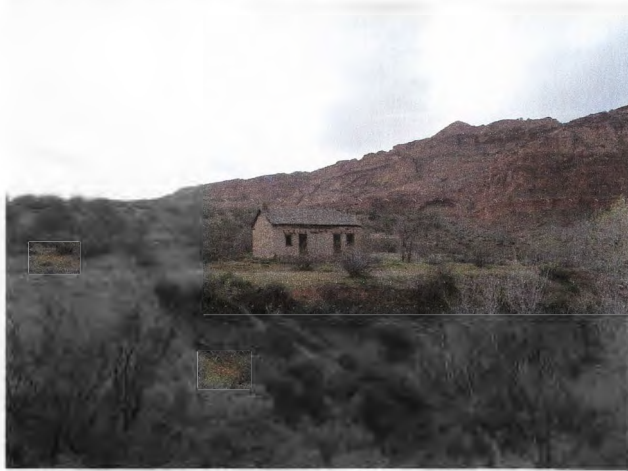
Figure 2 Photo showing the relationship between the house and the bluff.

The location of the home on a small bluff above Quail Creek also created natural barriers to hold cattle and horses beneath the bluff in pasture separated from the grain fields, vegetable gardens, and orchards in the upper field. The north aspect of the bluff's slope also created a cooler micro climate that allowed for wetter soils for orchards and vineyards.

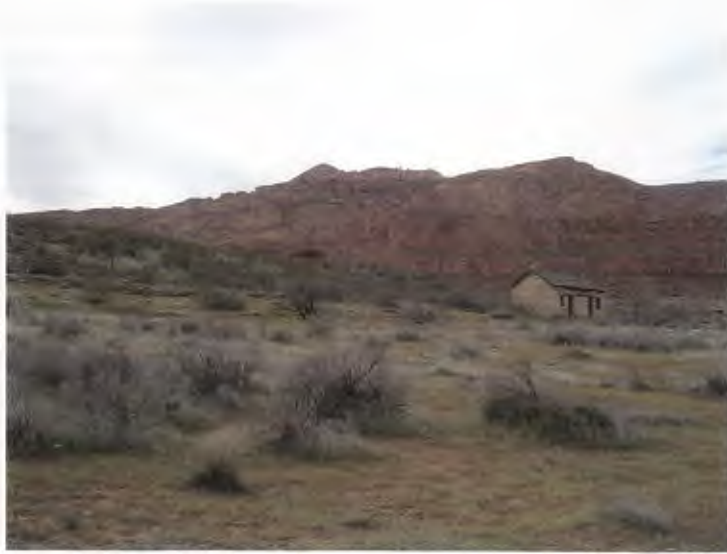
Figure 3 The upper field is still flat and sparsely vegetated.

Today, the upper field remains smooth, the bluff's grape terraces are still intact, and the lower pasture land is still delineated. There are few trees remaining and no sign of the grapes. The smooth fields and the irrigation ditch show signs of their former use.

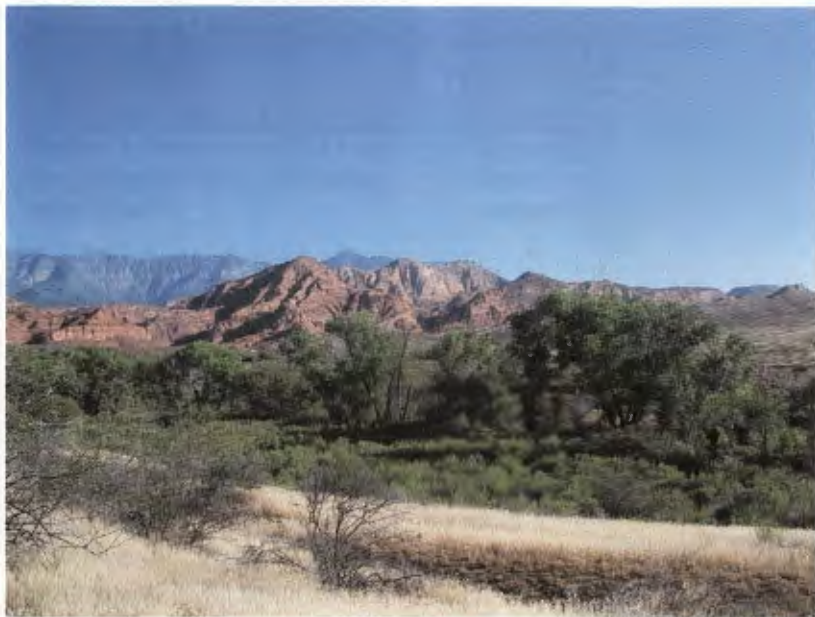
Figure 4 The lower north field has become filled with rubber rabbit brush due to the high water table. The riparian area contrasts with the dry area around it.

The Mojave Desert has reclaimed much of the once irrigated fields with creosote and other desert plants suited for the harsh conditions of southern Utah. Only a few exotic species remain in the area. In stark contrast, the riparian vegetation along the creek is green and lush. It is a cotton wood forest similar to what existed at the time of occupancy.

most likely after the period of significance, include a pistachio tree, a pear tree, two locust trees, and a few pepper trees. There are many dead trees on the slopes as well as a dead fruit tree in the terraces. These most likely died when the ditch no longer carried water.

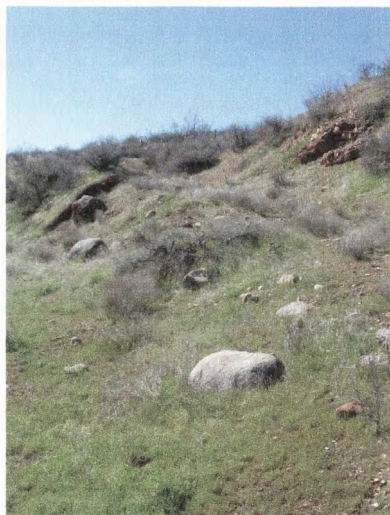
Figure 5 The remnants of a road connecting the lower fields to the upper field.

The alignment of two earlier access roads on the property is still readily apparent. The road directly below the house shows access to and from the lower pastures and the upper field, while the road on the east side provides access from the lower pastures to the carriageway and continues up the hillside to the top above the carriageway. The roads remain in their original width and character and contribute to the sites integrity.

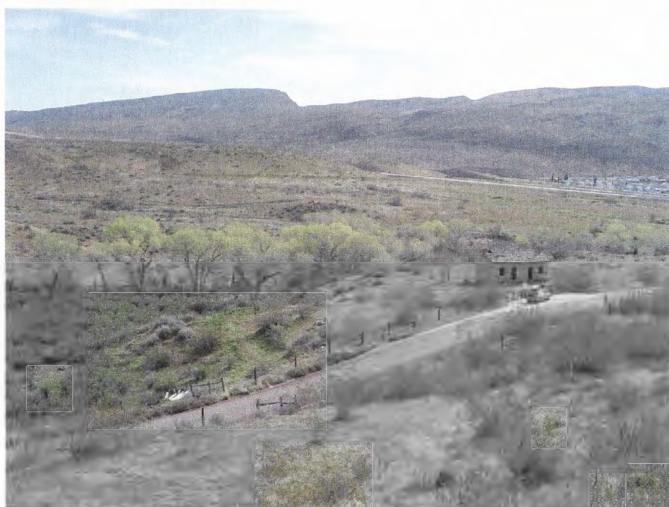
The carriageway route is still intact, although widened considerably, allowing the original circulation to and from the farm to function as it did during the period of significance.

Figure 6 Although paved and widened, the current road through the site follows the same alignment as the original carriageway.

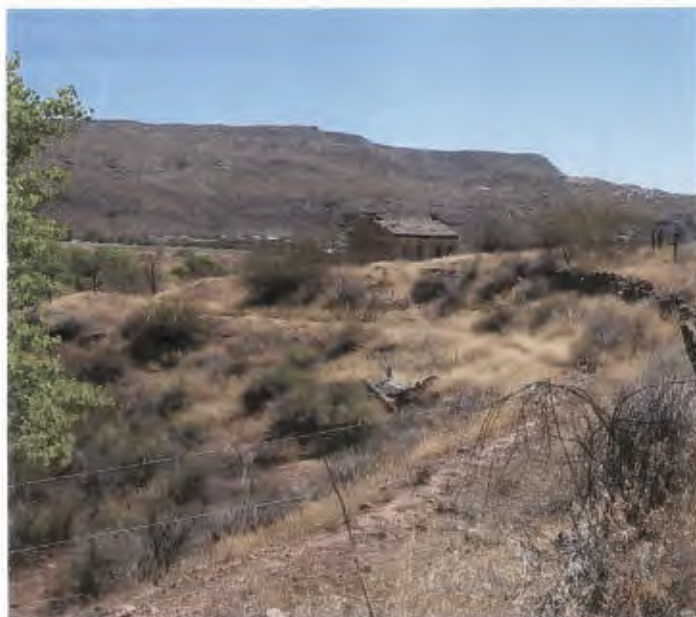
Figure 7 The ditch for the farmstead went around the house and supplied water to the upper field.

A major contributing feature is the main irrigation ditch through the farmstead. The ditch appears largely undisturbed from its diversion out of Quail Creek to where it disappears into the landscape on the east of the farm. Changes along the ditch start where the diversion reservoir has washed out and continue where a few gullies have formed along the way. The formerly wooden flume, that carried the water over a gully on the western edge of the farm, has been replaced by corrugated steel in more recent times. That too is now dysfunctional due to washouts.

farm, the ditch has retained its integrity despite years of abandonment.

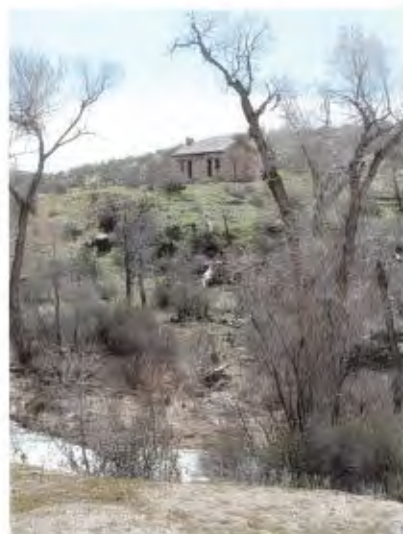
Figure 8 The house sits on a bluff above Quail Creek.

The most significant structure remaining of the town of Harrisburg is the Adams Home. It was built, along with the surrounding area from 1862-1864. The house was likely built by a local stone mason, Willard G. McMullin. The home is built with cut white and pink sandstone that is unique, compared to other homes built by McMullin, which are usually made of a different type of stone. The Adams home has two rooms that are

connected by a door through the interior wall. Each room has a fireplace at opposite ends and a door and window opening on the north and south side of each room. Most of the roof and floor were still intact at the start of the site study. Unfortunately, a rear room and cellar have collapsed.

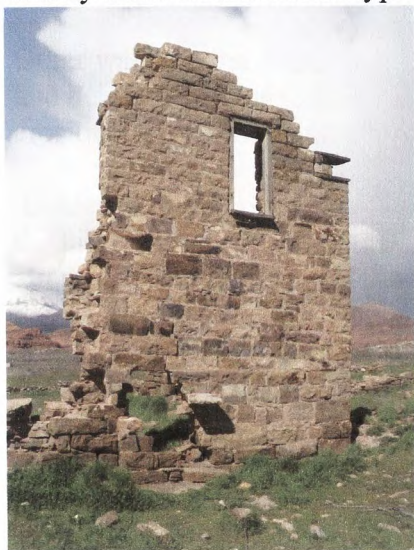
Figure 9 The McMullin house remaining wall.

In the Harrisburg area, there are also foundations remaining. The only other intact or partially intact buildings are two houses in the RV resort and the ruins of the McMullin house and smoke house. The McMullin house was one of only three two-story

buildings in the town. Currently, one wall remains of the house up to the second story window and most of the smoke house.

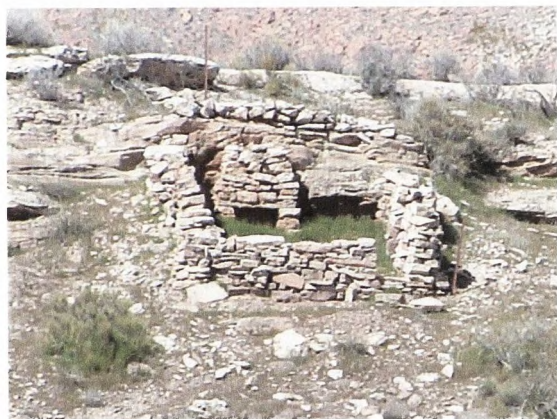
Figure 10 Mining claim shelter on Silver Reef.

Another notable structure is near the top of silver reef where a ruined mining shelter stands. Although small, it appears to have been a miner's claim shelter as it is located near many small mining remnants and rock cairns along the reef.

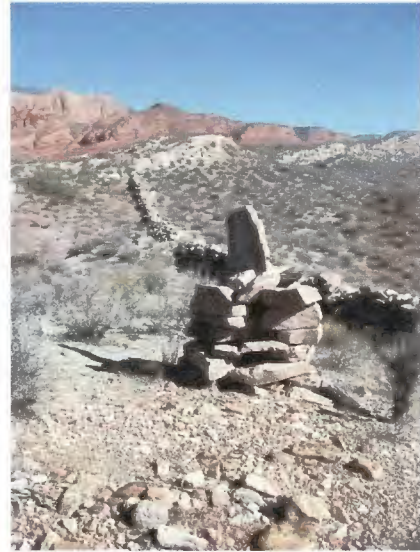
Evidence of the mining operations on silver reef and in the hill south of the farmstead are dotted with holes of attempted mining and rock cairns, rock piles used to denote a miners claim.

Figure 11 Rock cairn and wall

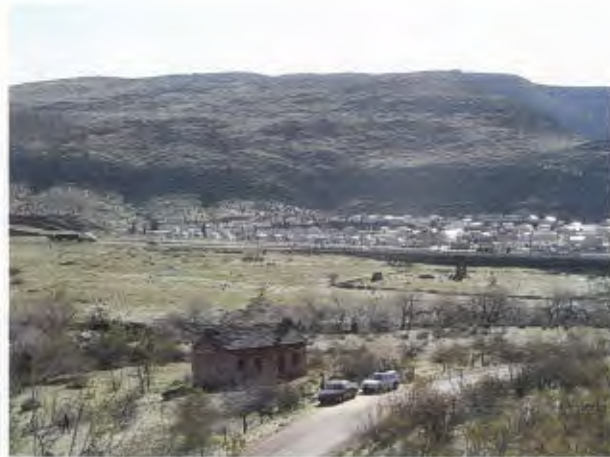
Unfortunately, views to the south east have been intruded upon by Interstate 15, constructed in the 1960s, which also introduces element of traffic sound, incongruous with the formerly silent quality of the site.

Figure 13 The biggest changes for the area have been the construction of Interstate 15 and the Harrisburg RV Resort.
