## Orson B. Adams Farmstead Existing Conditions Survey

**ORSON B. ADAMS FARMSTEAD  
EXISTING CONDITIONS SURVEY**

Mandie Zollinger  
Utah State University  
Landscape Architecture and Environmental Planning  
Thesis Advisor: Professor Michael Timmons

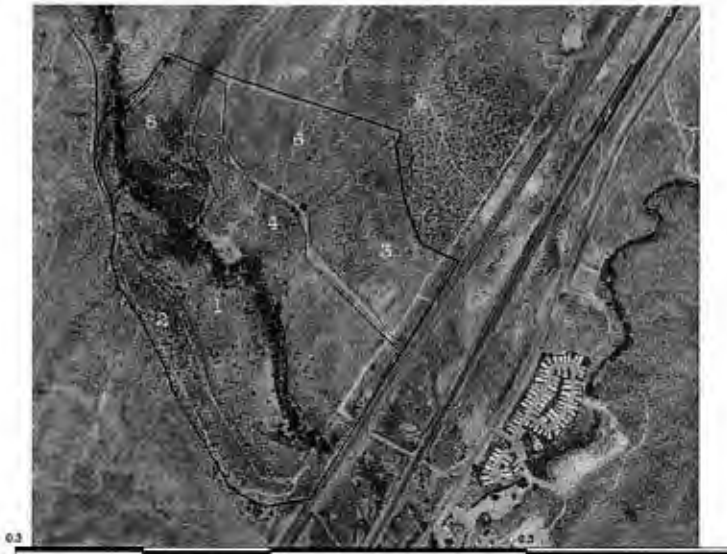
**Figure 1.1 - Project Area Divisions**

HALS can be submitted at three different levels, Level I Exhaustive, Level II Thorough, and Level III Limited. The project area has been divided into five areas (see Figure 1.1) with two levels of recordation. Area one, which includes the Orson Adams home, will be a level II while the other areas are level III. This document divides the existing conditions information according to these two levels.

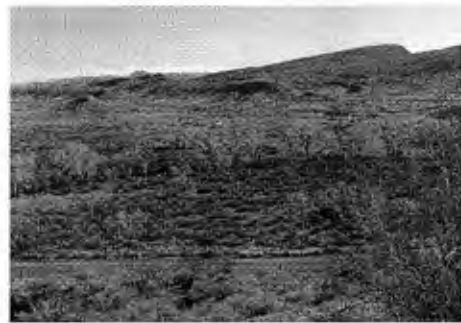
Figure 2.1 – Lower North Field

The lower north field is now completely full of Rubber Rabbitbrush with Cottonwood trees and other riparian vegetation along Quail Creek. The abundance and success of Rabbitbrush in this area are indicators of a high water table that the plants have tapped into (see Figure 2.1). North of the field, near the flume bridge that passes over the wash, a nut tree is growing in the wash, most likely Pistachio according to Rick Heflebower, the USU Horticulture Extension Agent. Heflebower also identified a Pear tree on the west edge of the field near a cluster of Cottonwood and Mesquite trees.

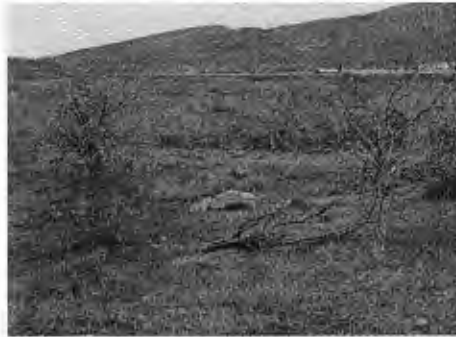
Figure 2.2 – Pepper Trees

There is only speculation as to what was grown on the upper field during Orson Adam's time. Parent believes it may have been a small grain crop such as wheat, oat, or barley because that was highly used and in demand at the time. Idonna Emmett remembers corn, melons, and cantaloupe grown in this area during William Emmett's time. Vaunda Emmett more specifically remembers the corn grown in the west part of the field just below the ditch. The upper fields around the house are now mostly covered in grasses and small forbs scattered with Creosote. There is a community of dead Saltbrush to the northeast, most likely victims of the recent drought. There are 1 dead standing and 3 live Pepper trees at the south end of the field (see Figure 2.2), and one large dead Cottonwood tree on the northeast side at the top of the retaining wall that has fallen down the hill(see Figure 2.3).

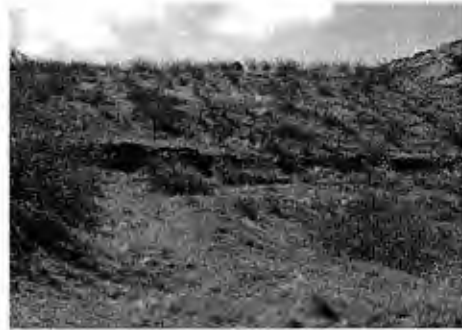
Figure 2.4 - Irrigation Ditch

The irrigation ditch has not been used for many years, but can still be seen on the property (see Figure 2.4) and followed to its source further up Quail Creek. A dam and small reservoir provided water for the ditch and it wound through the riparian plant community until it entered a flume on the north edge of the farm. The flume currently in place is a metal culvert held up by metal tubes on concrete bases (see Figure 2.5). The original flume was made of wood and was replaced sometime after William Emmett's death in the 1944. The ditch follows the retaining wall and edge of the west slope until it nears the house at the terraces. It then flows around the house to the east, then gradually winds its way back to the west side of the upper field. It eventually fades away at the southern edge of the property.

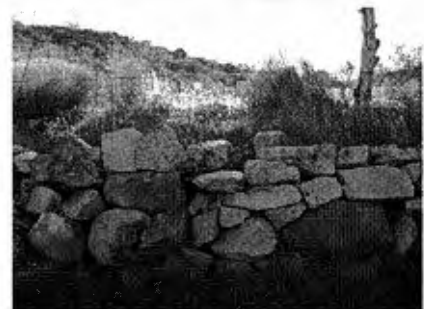
Figure 2.10 - Rock Retaining Wall

There is a rock retaining wall that runs along the west edge of the property (see Figure 2.10), stopping before it reaches the Adam's house, and continuing again on the other side of the house. It is approximately two feet wide and is made of a mix of sandstone rocks. See Figure 2.11 for a detailed sketch of this wall.

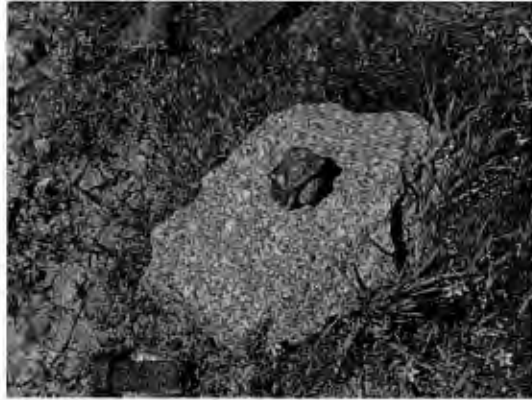
**Figure 2.12 - Metal Screws**

A pile of crudely made metal screws and bolts (see Figure 2.12) was found on the site at the southern end of the upper field. There is only speculation as to their creation and placement.

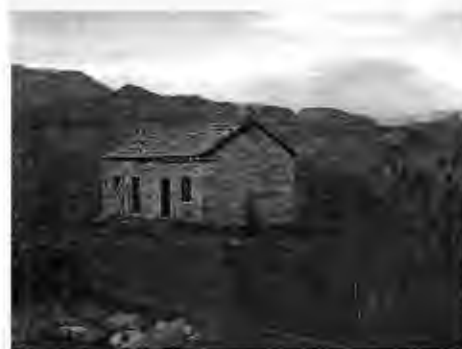
**Figure 2.14 – Orson Adams Home**

The Orson Adams home is the only standing structure on the site and is currently undergoing restoration. The home was built at the top of a bluff overlooking Quail Creek, the town of Harrisburg, the Red Cliffs, and Silver Reef. Vandalism of the home is apparent by graffiti covering the inside walls. Pieces of wood shingles and tin can lids formerly used as roof flashing and patching are scattered throughout the site. A detailed account of the home can be found in the *Historic Structure Condition Assessment*, by S. Kardas and E. Larrabee.

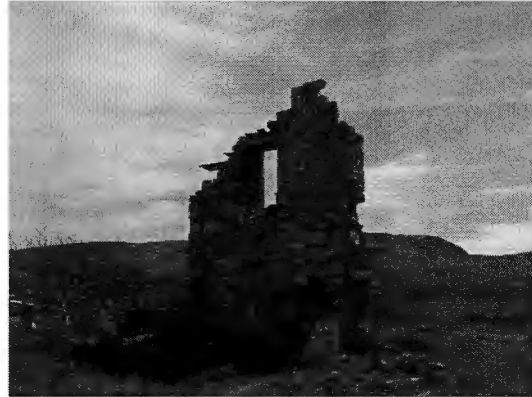
Figure 3.1 - McMullin Home

The remaining property within the study area has long been abandoned, but traces of old Harrisburg can still be found throughout the site, including Harrisburg ditch, other irrigation ditches, house foundations, rock wall remnants, mounds, and piles of rocks. The best preserved feature is the ruin of the McMullin home. Part of the south wall is still standing and the remains of a smokehouse and the perimeter walls are semi-intact (see Figure 3.1).

The McMullin house may be the most visited feature on the property. As mentioned earlier, part of the south wall is still standing along with the remains of a smokehouse and perimeter walls. The structure is not in good condition and it is recommended that efforts be made to preserve it.

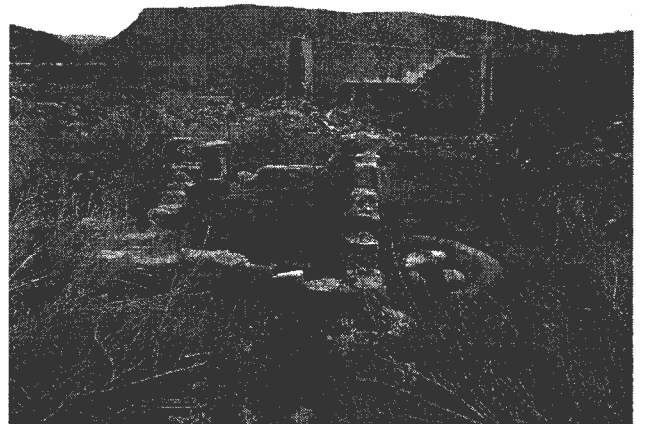
Figure 3.2 - Movie Set Remains

The movie set consists mostly of rubble with one corner wall remaining (See Figure 3.2, upper right). The walls were made of stucco and chicken wire to create a set resembling a Spanish mission. Most of the rubble is featureless, except for a concrete curbing and walls of a Spanish style fountain in the center (See Figure 3.2, left center). Existence of the movie set on the site is said to have increased the property value as “improved land” and the owner, not wanting to pay the increased taxes, encouraged people to ruin the movie set so the property value would decrease.

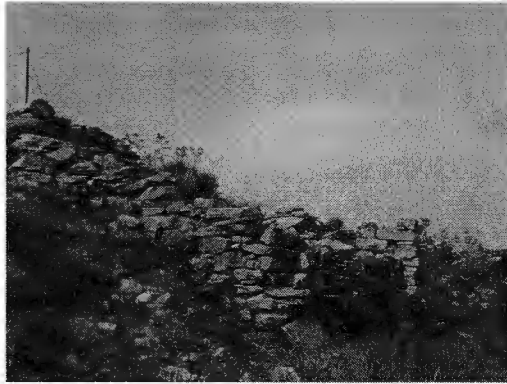
Figure 3.3 – Dwelling Remnants

The remains of an old dwelling or lookout can be found across the rock wall on northeast part of the property (See Figure 3.3). There is a fireplace in the fort that appears to be in fairly good condition (See Figure 3.4), but the walls appear fragile. It is speculated that this may have been the dwelling of a miner because there is an entrance to a mining shaft northeast of the fort, marked by a rock cairn.
