## Comparison of Backscattered Scanning Electron Microscopy and Microradiography of Secondary Caries

Grayson W. Marshall Jr.  
*University of California, San Francisco*

### Abstract

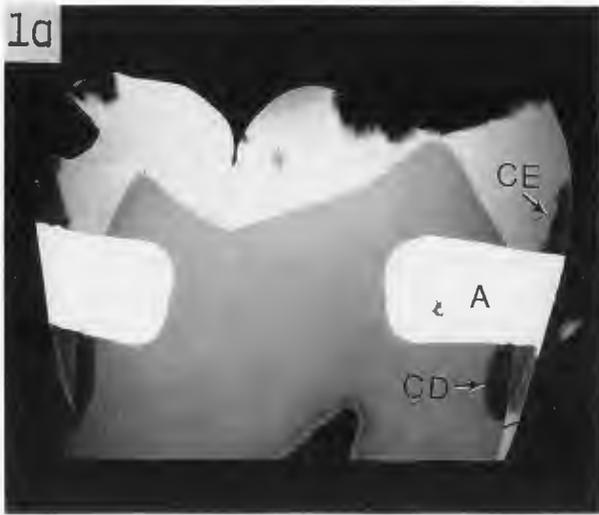
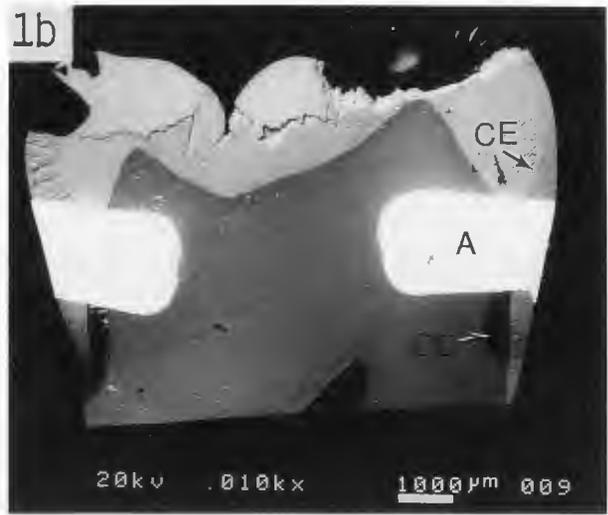
Figure 1. Microradiograph (a) and BSEM (b) of same section at low magnification. CE = carious enamel lesion; CD = carious lesion that penetrated through enamel into dentin; A = amalgam restoration.

Fig. 1 shows a low magnification view of the microradiograph and backscattered electron micrograph of a typical section. At the occlusal aspect of each restoration, the carious lesion can be seen as a broad dark band in the microradiograph and as a lighter band of the same shape in the BSEM micrograph. The lesion at the gingival aspect of the restorations (lower region) also has the same shape in each method of viewing. However, the lesion has penetrated through the enamel and spread to include a larger portion of the dentin. This penetration into dentin was seen in all cases for the lower lesion, a result of the much thinner band of enamel covering the dentin at this site compared to the more occlusally located lesion that always remained in enamel. The portion of the lesion that extended into the dentin had essentially the same appearance in the microradiograph and BSEM micrograph. This can be seen in Fig. 2, a comparison of the microradiograph and BSEM micrograph at higher magnification. The dentin lesion is very dark, seen with either method, while the lesion in the enamel portion is only a slightly darker shade than the surrounding sound enamel in the BSEM. The lesion confined to enamel-only is shown in Fig. 3, as seen by microradiograph and BSEM. Again, the shape and size of the lesions appear to be identical, although the lesion appears much darker in the microradiograph.

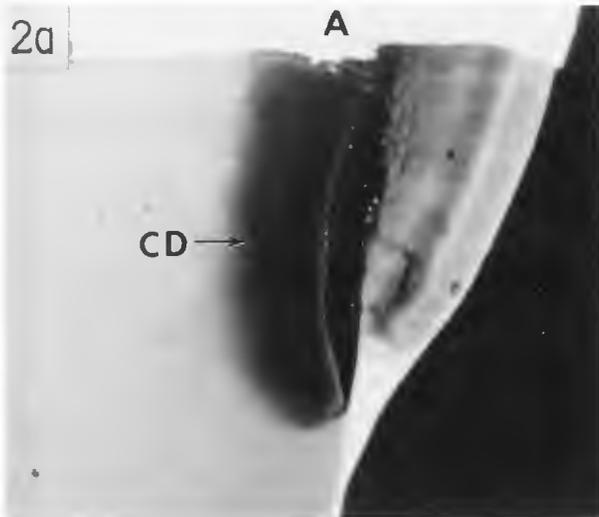
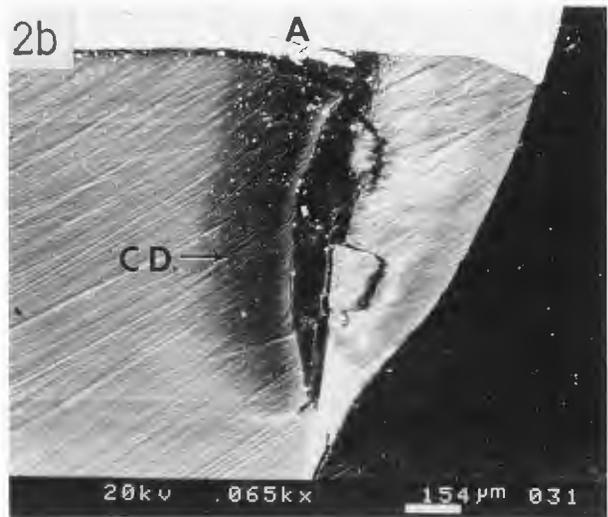
Figure 2. Comparison of microradiograph (a) BSEM (b) of an artificial carious lesion in dentin. Shape of lesion is the same. Cracks and scratches are apparent in BSEM, but not microradiograph.

There were some minor differences in the appearance of the lesions as seen by microradiography and the backscattered electrons. The carious enamel lesion induced along the tooth-amalgam interface appeared to have the same size and shape in the microradiographs and BSEM photomicrographs, but was darker and more distinct in microradiographs. This effect is due, in part, to the relatively low accelerating voltage of 15-20 kV used initially in this study, and to the fact that the samples were not highly polished. At higher accelerating voltages, the enamel lesion becomes more distinct, as shown by Pearce and Nelson (1989). They estimated that the optimum accelerating voltage for enamel carious lesions was about 30 kV. This effect is shown in Figures 4-6. However the lower accelerating voltage was used in part of this study to optimize the appearance of the dentin lesions. In addition, the microradiographic sections were not initially polished because they were extremely fragile and we wished to avoid any additional artifacts that might be introduced by further handling. This limited polishing until measurements were completed and, when viewed by BSEM, left the samples with clear evidence of the grinding scratches that had been introduced during the wet grinding procedure. Such scratches and other defects are not discernible in the microradiographs. In addition, the BSEM micrographs demonstrated many cracks and

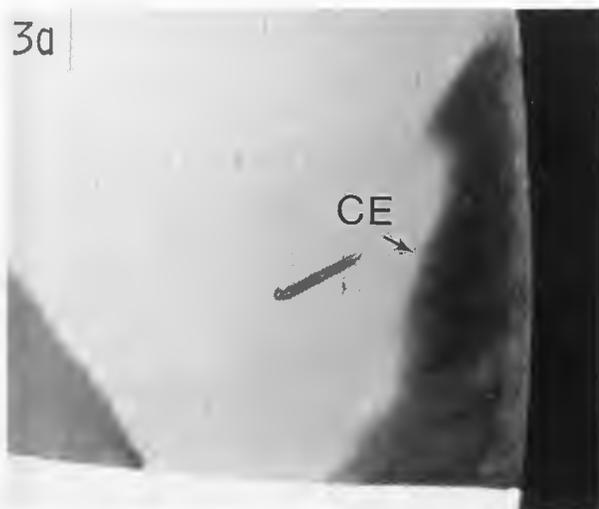
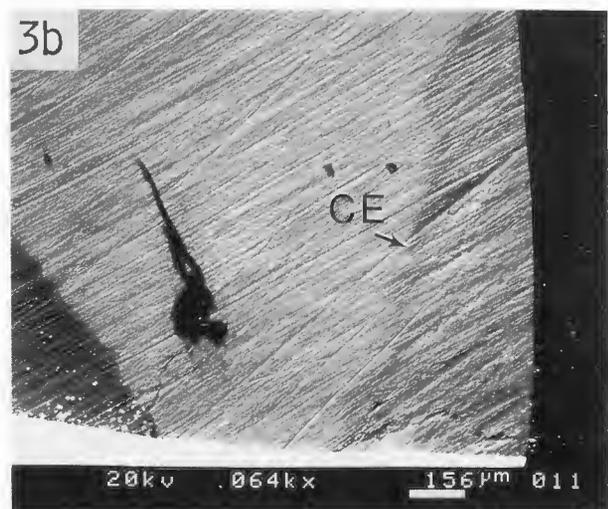
Figure 3. Artificial carious lesion in enamel. Size and shape of lesion is the same in microradiograph (a) and BSEM (b). Enamel lesion is much lighter in BSEM and grinding scratches are seen.

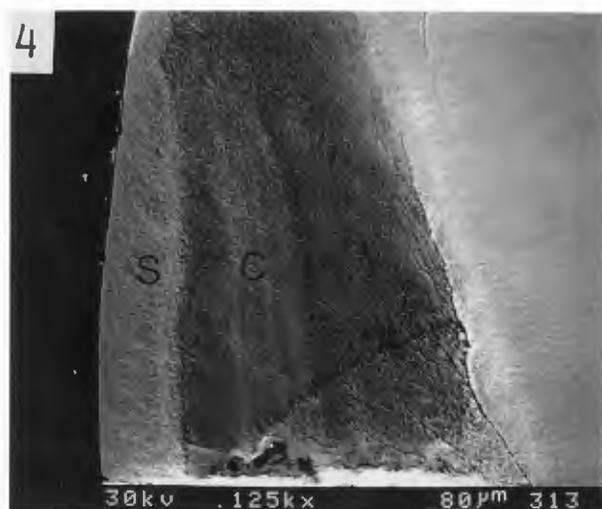
Figure 4. Low magnification BSEM view of artificial carious lesion in enamel after polishing. Intact surface zone (S) and cariou zone (C) of the subsurface lesion are seen.

Figure 4 demonstrates the appearance of the lesion at low magnification, after polishing. After removal of the scratches caused by grinding the classic subsurface appearance of the lesion was readily apparent. At higher magnification (Fig. 5) the transition from the relatively intact surface to the carious lesion can be seen. Cross striations along the enamel rods were apparent just outside the obvious dark zone of demineralization, and hypermineralized prism peripheries (bright areas) were also seen. The cross striations continue into the dark region as shown in Figure 6.

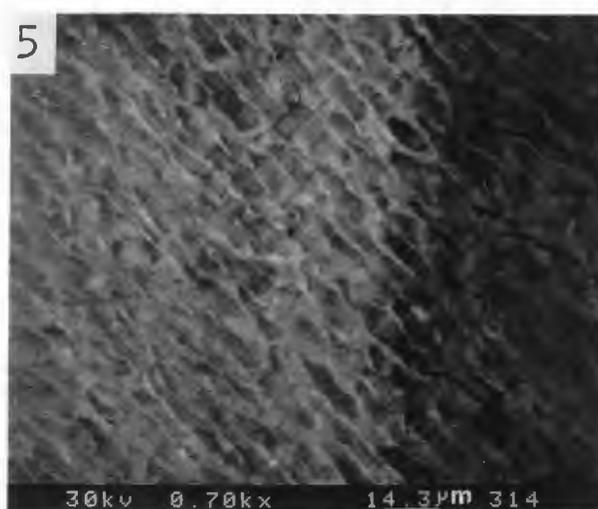
Figure 5. At higher magnification the transition region between relatively intact and carious zone of enamel; cross striations along the enamel rods, some of which appear to have hypermineralized peripheries.

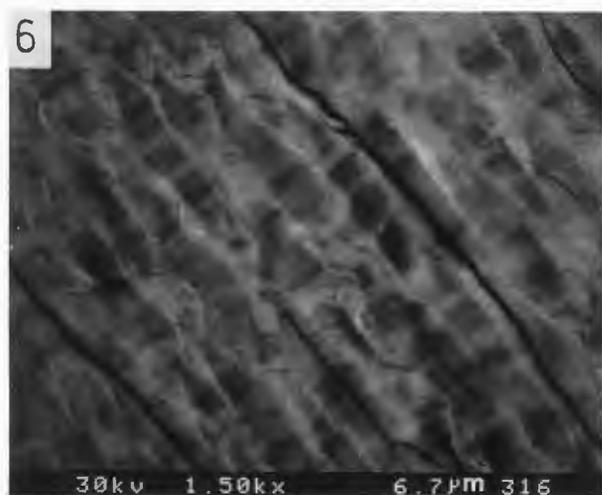
Figure 6. Details of the cross striations in the enamel rods of the carious zone are shown.

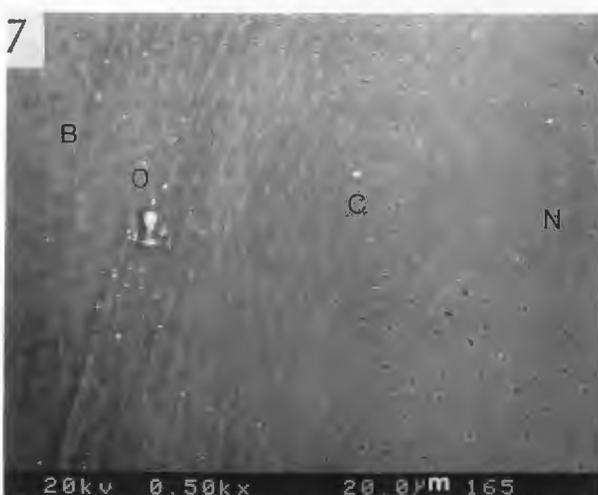
Figure 7. Various zones associated with artificial secondary carious dentin lesion. Body of lesion shows loss of dentin tubules (B); occluded tubules (O) in less affected zone; tubules with clefts (C) and normal tubules (N) in advance of the lesion.

After polishing, the lesions in dentin demonstrated several distinct zones as shown in Figure 7. In the most demineralized portion of the dentin lesion (left side) the tubular structure was lost. In advance of this zone, tubules appeared to be occluded. Proceeding toward more normal dentin, a thin zone of tubules showing clefts and partial flattening could be seen. Finally, a region of normal appearing tubules occurred (right side).

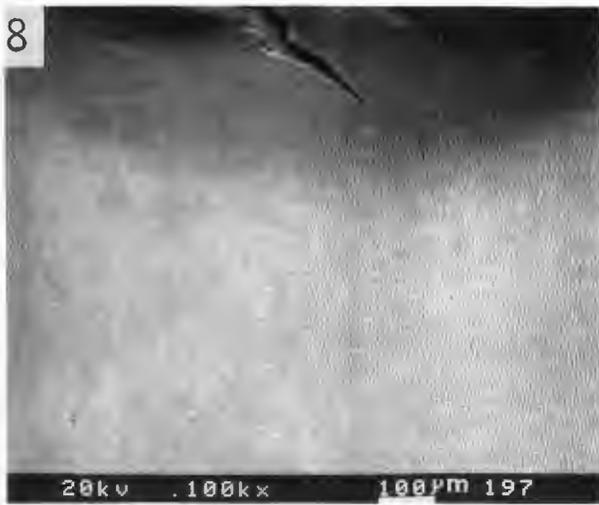
Figure 8. Transition zone between carious dark region (top) and transparent dentin in a longitudinally sectioned tooth with a natural carious lesion.

Since the sections prepared for microradiography were very fragile, additional observations of the carious features were observed in samples with natural caries. In contrast with the artificial carious sample, the lesions studied generally showed a broad region of transparent hypermineralized dentin, indicating the slow progression of the lesion. These regions appeared as roughly triangular or as a series of triangular regions with the base along the carious dentino-enamel junction (DEJ) and the apex toward the pulp chamber. Just below the zone of obvious destruction, preceding the transparent zone, was a dark zone of demineralization representing the carious front. Figure 8 shows this region of transition. Tubular structure can be seen in both zones. Figure 9 shows the dark zone at higher magnification, demonstrating a structure consisting largely of the remaining collagen matrix with much of the mineral removed. In Figure 10 the features of the lighter transparent zone, in which the majority of the tubules are occluded, are seen. Figure 11 shows the structures in the normal dentin well away from the lesion for comparison. Figure 12 shows the transition between transparent dentin (center right) and surrounding dentin in another sample. Interestingly, the several zones seen here contrasted roughly with the occluded and clefted zones seen on a much more limited scale in the artificial lesions.

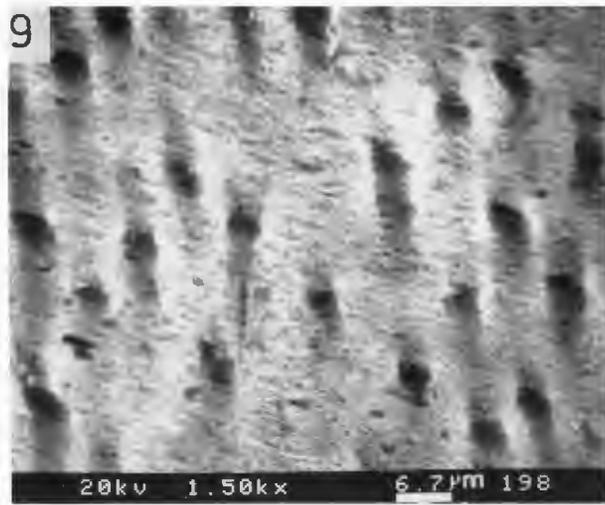
Figure 9. Higher magnification of dark zone showing demineralized matrix of the dentin tubules.

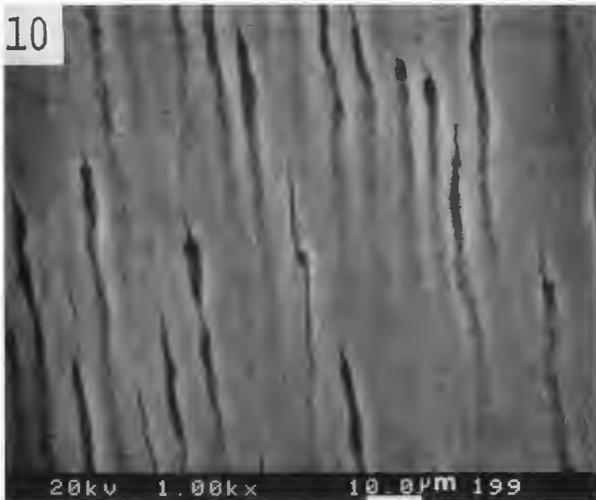
Figure 10. The transparent zone at high magnification showing partial occlusion of tubules.

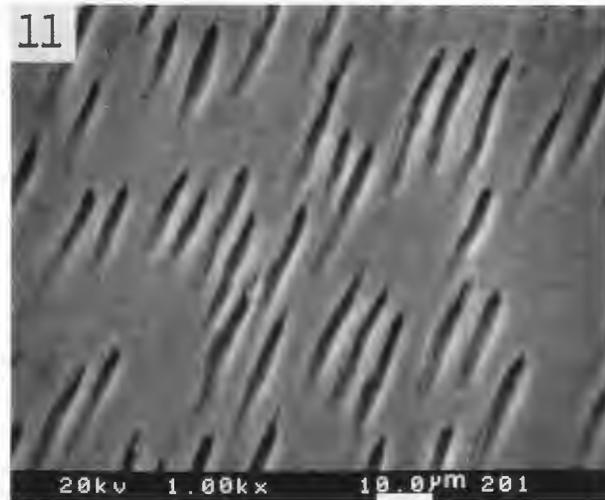
Figure 11. Normal dentin.

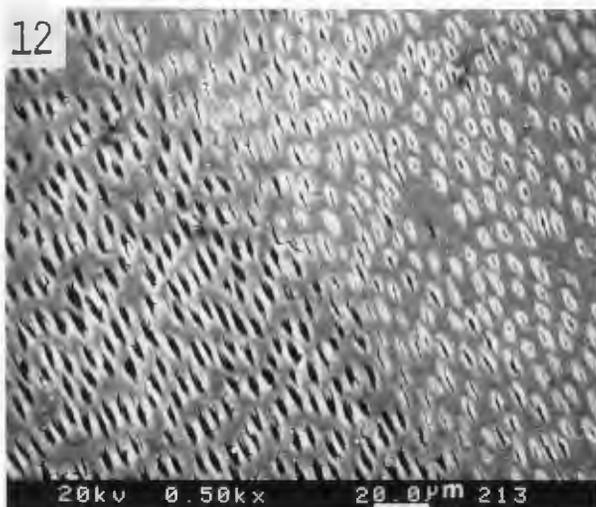
Figure 12. Transition zone between transparent dentin (top right) and surrounding dentin from a tooth with natural caries. Surrounding dentin was less mineralized and exhibited clefts in tubules.

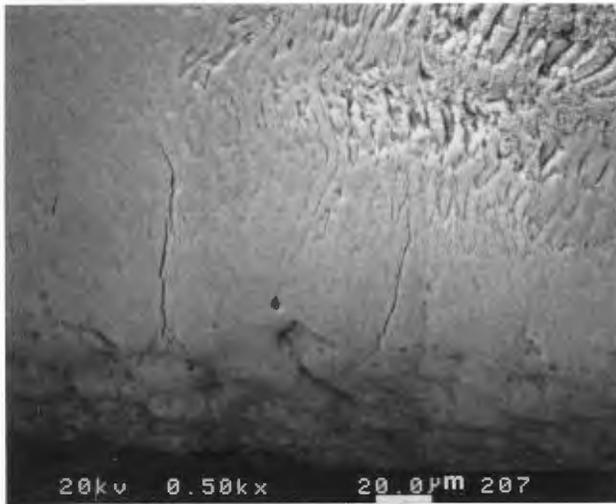
Figure 13. Sectioned tooth showing the enamel side of the naturally carious DEJ as well as cross striations in enamel rods.

The enamel side of another carious lesion is shown in Figure 13 and, once again, cross striations of enamel rods and openings between rods can be seen at this and higher magnifications (Figure 14).

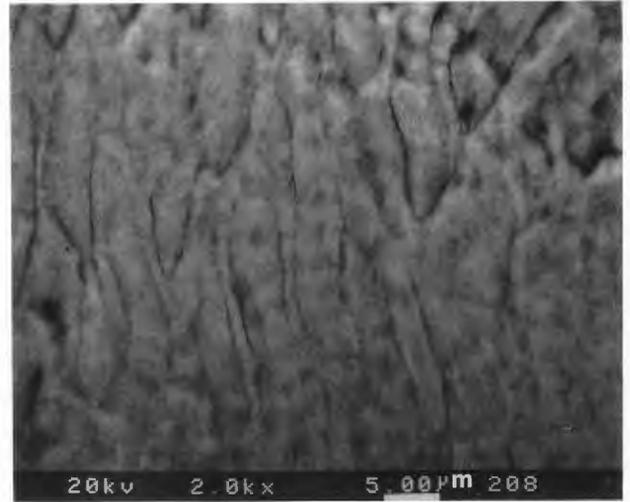
Figure 14. Higher magnification of polished enamel rods showing cross striations and openings between some of the rods.
