# After the Fire and Flood:

Tracking wood recruitment in the Strawberry River watershed  
after the Dollar Ridge Fire

Watershed Sciences

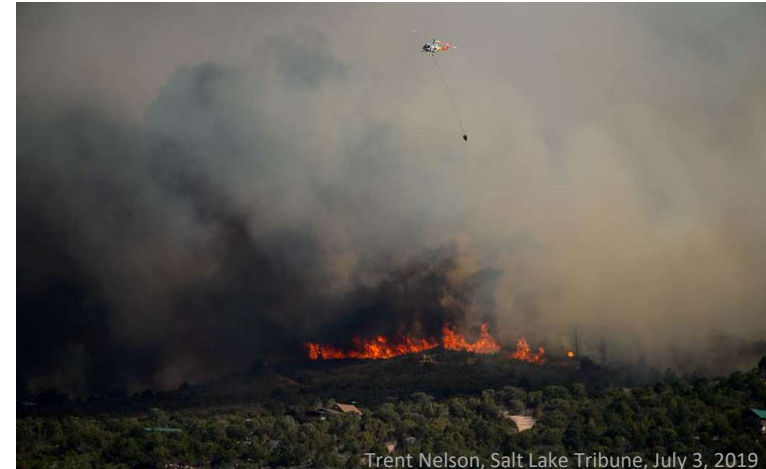
Trent Nelson, Salt Lake Tribune, July 3, 2019

- Dollar Ridge Fire burned 300 km<sup>2</sup> summer of 2019
- Weeks after peak of fire, 50 year flood and debris flows
  - Roads and >300 structures destroyed
- Large increase in woody debris
- Dollar Ridge Fire Emergency Watershed Protection Project

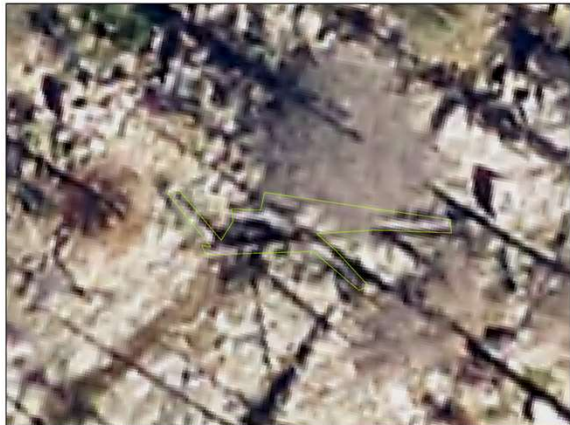
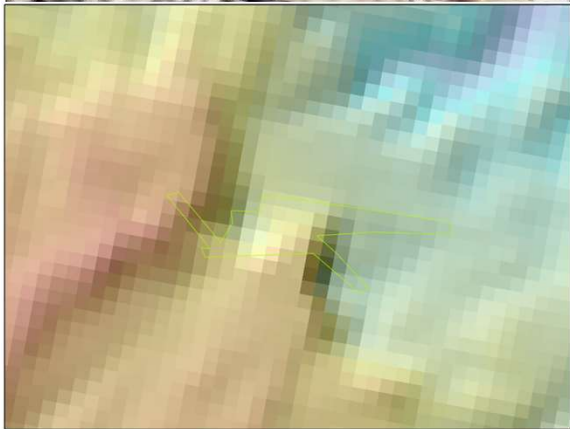
# Wood Jams

0 2.5 5 Meters

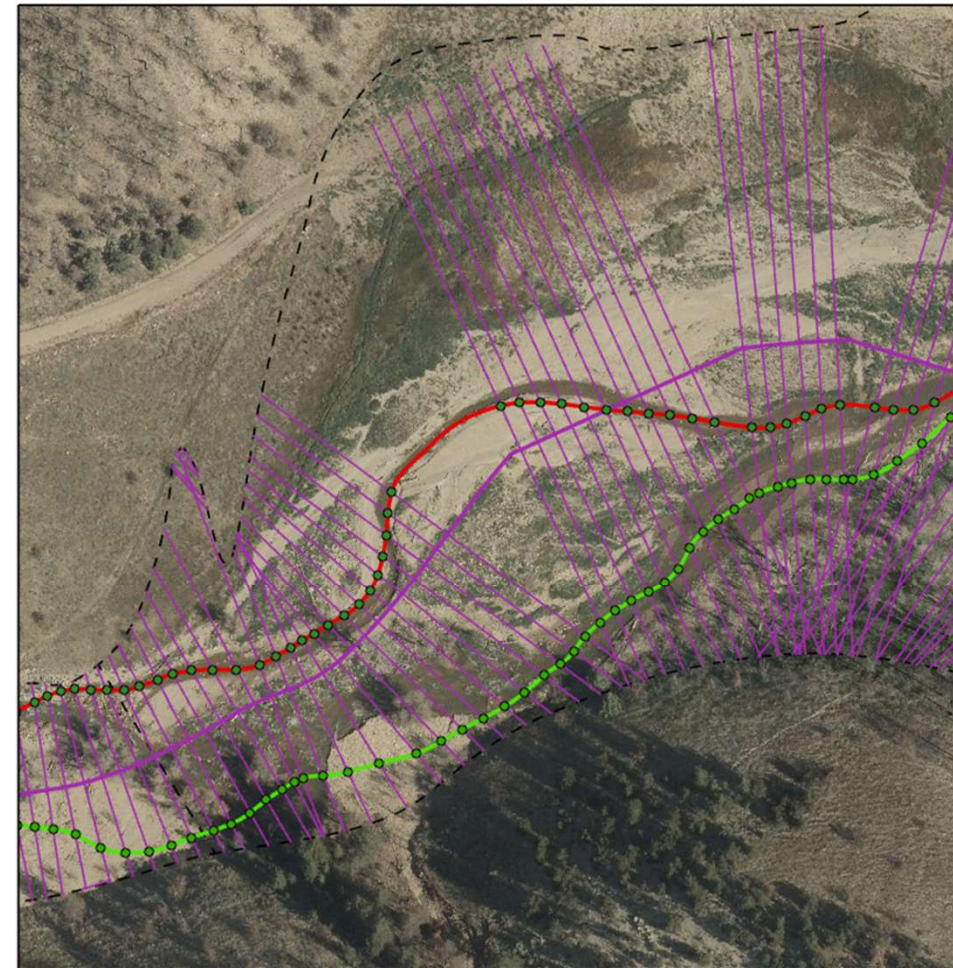
# Reaches and Stream Network

- 2018 and 2019 DEMs
- Fluvial Corridor Toolbox
  - Valley bottom, Centerline, Stream Network, Reaches
- Elevation profile
  - Based on centerline transects

- Valley Bottom Centerline
- Centerline Transects
- 2019 Stream
- 2018 Stream
- Intersect Points

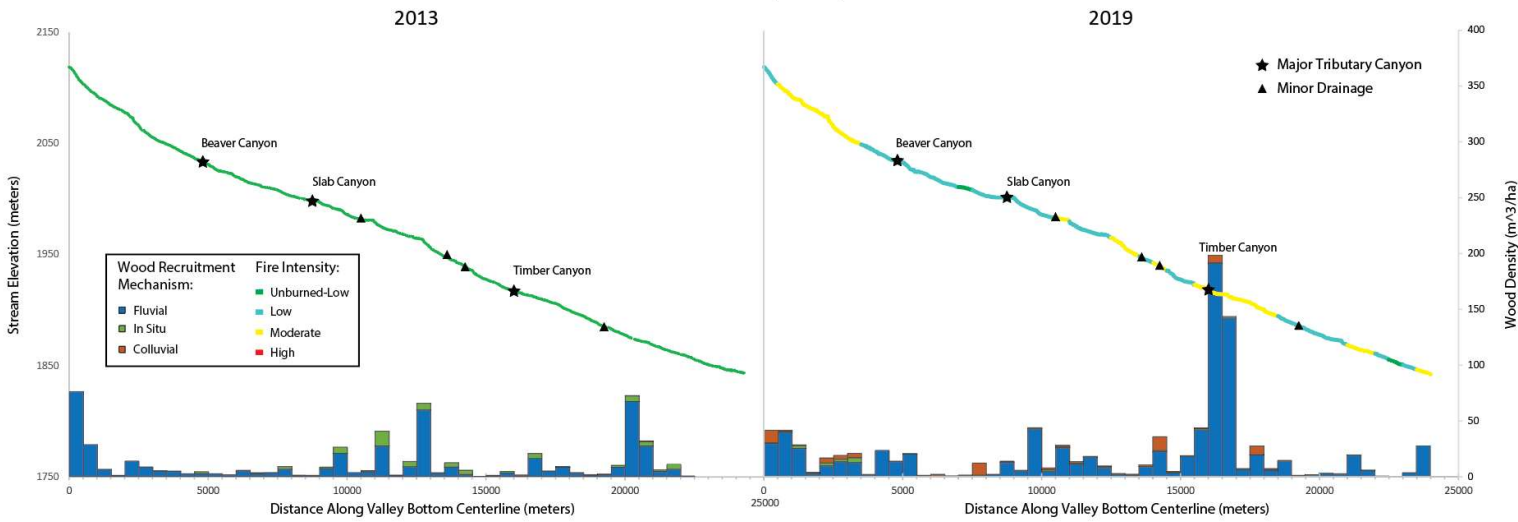
## Strawberry Canyon

Recruitment Mechanism

■ Fluvial ■ In Situ  
■ Colluvial

Recruitment Location

■ Floodplain ■ Channel  
■ Inactive Floodplain

Wood Jams vs. Dispersed

■ Wood Jam ■ Dispersed  
■ In Situ

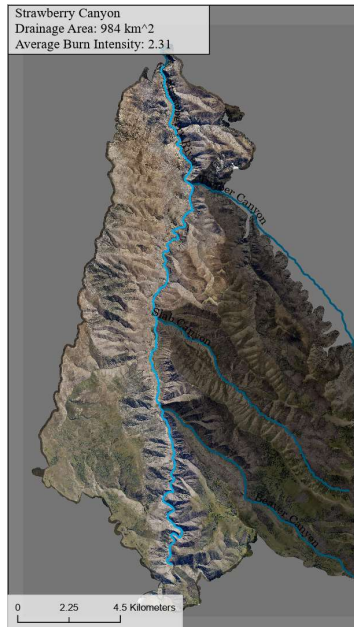
Wood Density Change in Strawberry Canyon 2019 vs. 2013

- Overall – Wood density increased by 95%
  - Largest increase in burned watersheds
- Wood transport mechanism changes depend on valley setting
  - Proximity to tributary canyons correlate to wood density
  - Fluvial transport dependent on stream power (deposition vs transportation)
