**ACES RED Experiment #1 Environmental Test Results for Industrial Grade, Non-traditional, and Other Components Lacking Flight Heritage**

Results of the thermal vacuum chamber (TVAC) testing and vibrational testing of the ACES RED Experiment #1 are presented. Performance of commercial-off-the-shelf components such as the Avnet PicoZed, the Xiphos Q7, the MAI-400, and a NovaTel GNSS during TVAC testing are provided and analyzed. To our knowledge, this is the first orbital flight of this version of the GNSS, this version of the MAI-400, and the PicoZed. The experiment utilizes a novel structural concept for ease of electronics assembly and disassembly. The health monitoring system measures temperatures, vibration, voltages, and currents for situational awareness of each of these component's relative performance. An assessment and progression of the technology readiness level of the hardware is also presented.

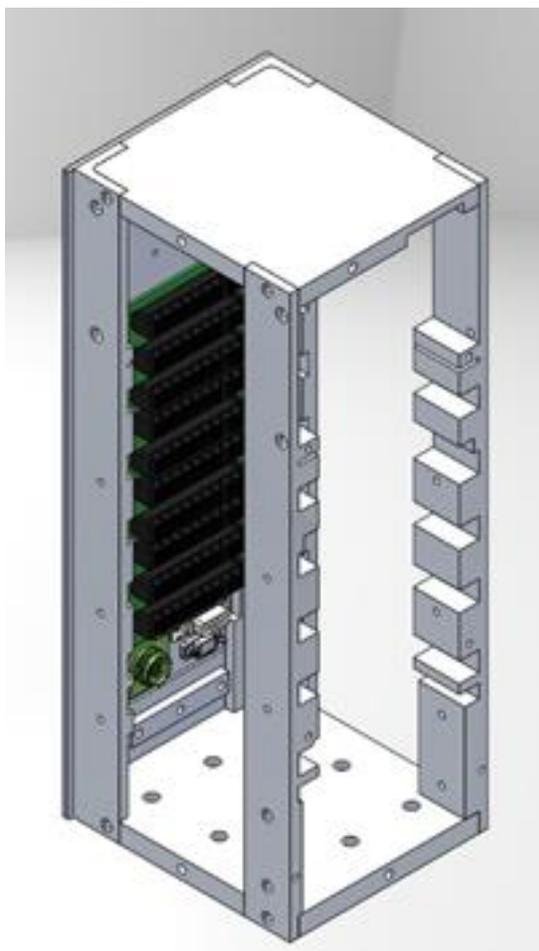
Figure 1: ACES RED Experiment #1 Frame

The final iteration of this design is a “modular tray” system. Slots with standardized dimensions were created at specific points within the AR#1 frame that accept modular trays to which hardware components are mounted. The trays were designed to insert securely into the frame of AR#1 and to fit any of the standard slots, allowing the trays to be interchanged at any time, regardless of the hardware, and re-insert into the frame at a different position.

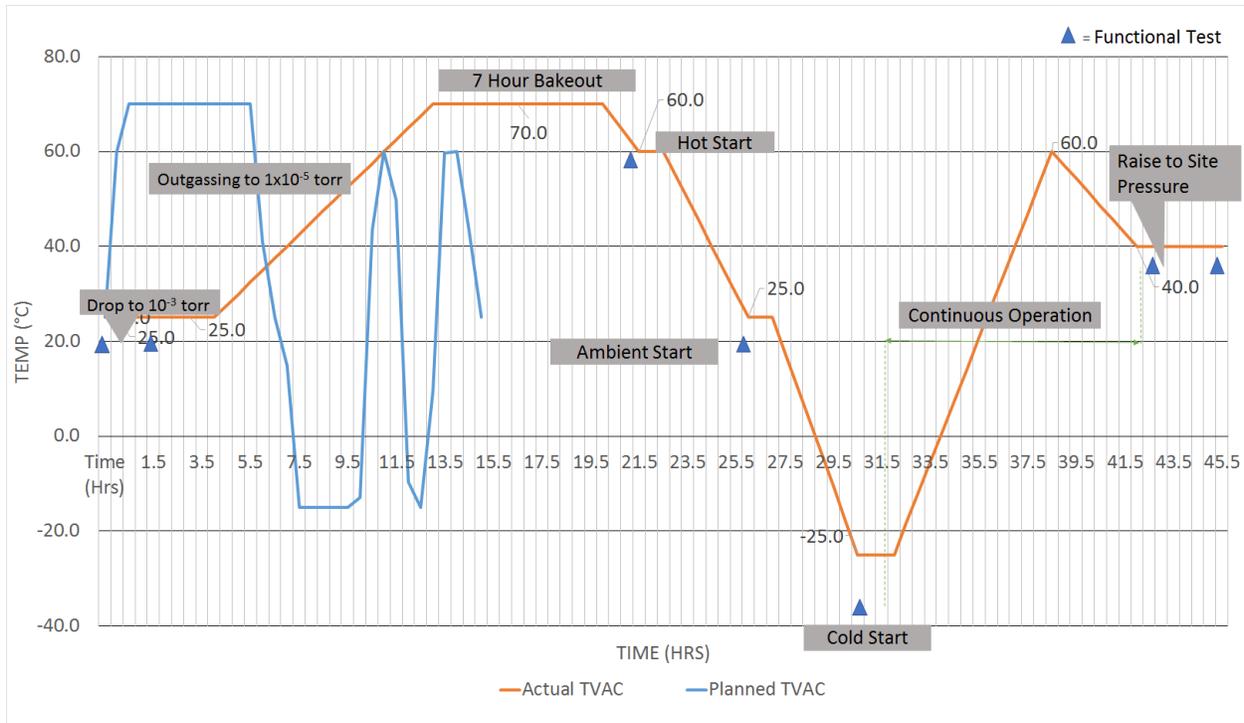
Figure 3: Planned vs Actual TVAC Thermal Profile

The TVAC (thermal vacuum) testing consisted of several phases, namely, pre-test bakeout, cold start, hot start, and continuous operations. The target test temperature profile for the TVAC testing is provided below in Figure 3. The limits for the selected upper and lower temperatures were determined by adding margins to the safe storage and operating temperatures of various internal components. These safe storage and operating temperatures are provided in Table 2.

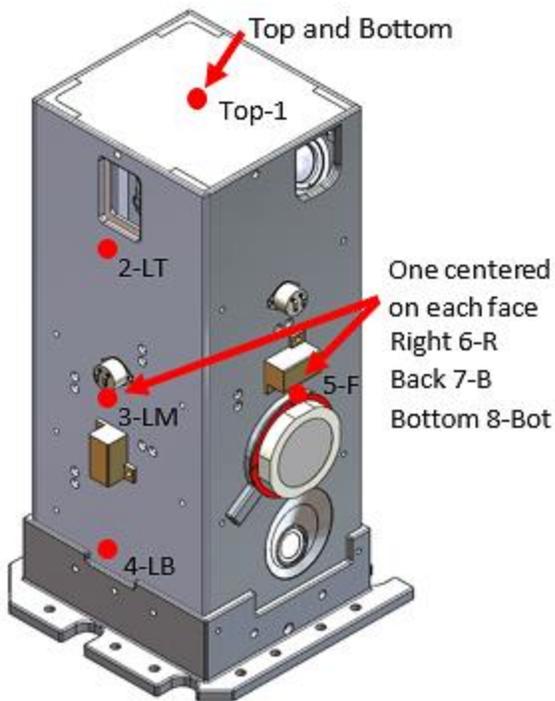
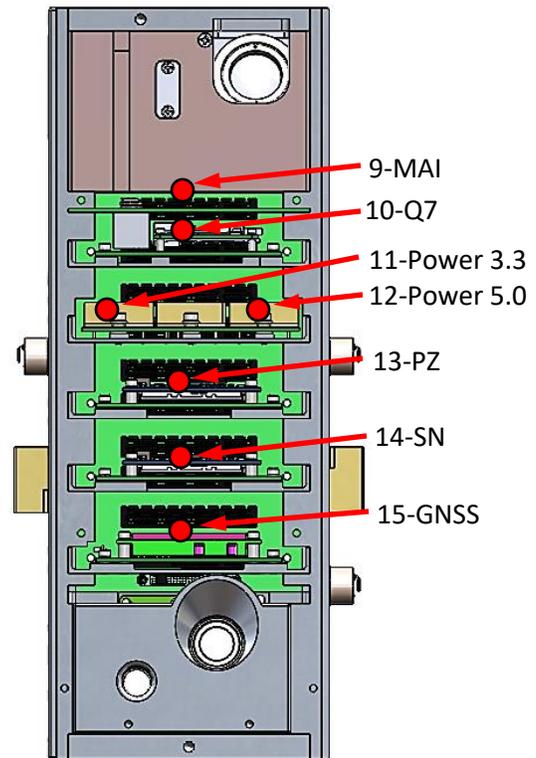
Figure 4: Thermocouple Locations

During all phases temperature monitoring was performed with T-type thermocouples placed in eight locations on the outside of the spacecraft and seven locations on the inside (Figure 4), this data was logged for later analysis. While AR#1 was powered on, board integrated thermal sensors were also monitored. Since STP requirements prohibit syncing excessive heat into the H6 pallet, the structure and flange became areas of interest for temperature monitoring because they act as the largest heat paths for the electronic components contained in AR#1 therefore, external thermocouples were mounted to the top, flange and each of the sides of AR#1 with a series of three thermocouples featured on the left side to better capture temperature distributions along the length of the specimen. Internal thermocouples were mounted directly to the processing units on each of the flight computers and to the two power converters on the power board and this data was displayed live to inform the test operator if component operating temperatures exceed allowable levels, requiring chamber conditions or operating procedures to be altered to bring component temperatures back into the allowable ranges.

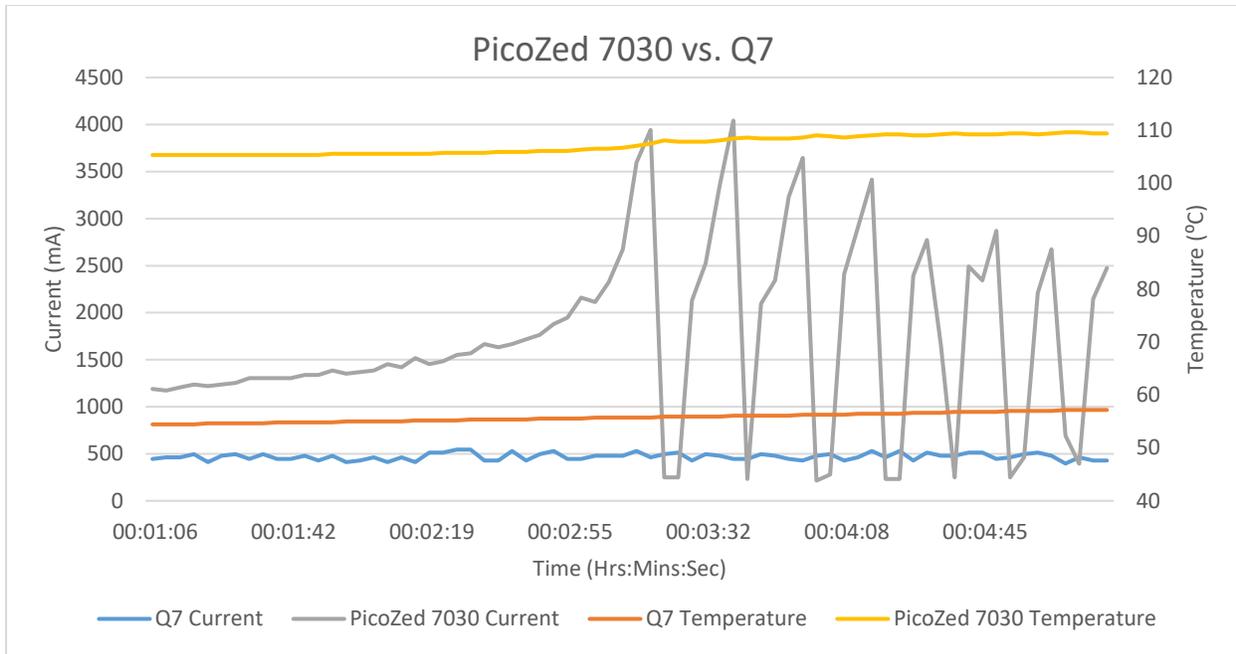
Figure 7: PicoZed vs. Q7 Current

Upon review, it became apparent that there was a problem with the PicoZed 7030. The current draw of the PicoZed 7030 was expected to never go over 1.5 amps. As shown, the PicoZed 7030 was exceeding 3 amps, which was causing the internal protection circuitry to turn off the power. All further TVAC testing was put on hold once this issue was identified. At this point, various options were considered how to fix the problem. One glaring fact was that the Q7 flight computer had the FPGA Zynq 7020. The PicoZed had the later model FPGA, the Zynq 7030, hence the name. It was shown that the Q7 FPGA was not overheating and not over-drawing its current. This was confusing at first because the 7020 and 7030 were nearly identical FPGAs, a main difference being that the 7030 was an exposed flip-chip ball grid array (BGA), whereas the 7020 was a “normal” style BGA where the silicon die is wire bonded internally, providing better heat transfer to the PCB. As reference, the Q7 data during the same round of

testing as the PicoZed 7030 is provided in the graph above.

by NTS. When the temperature was graphed against the other flight computer, the Q7, it was clear that this problem needed to be solved immediately.

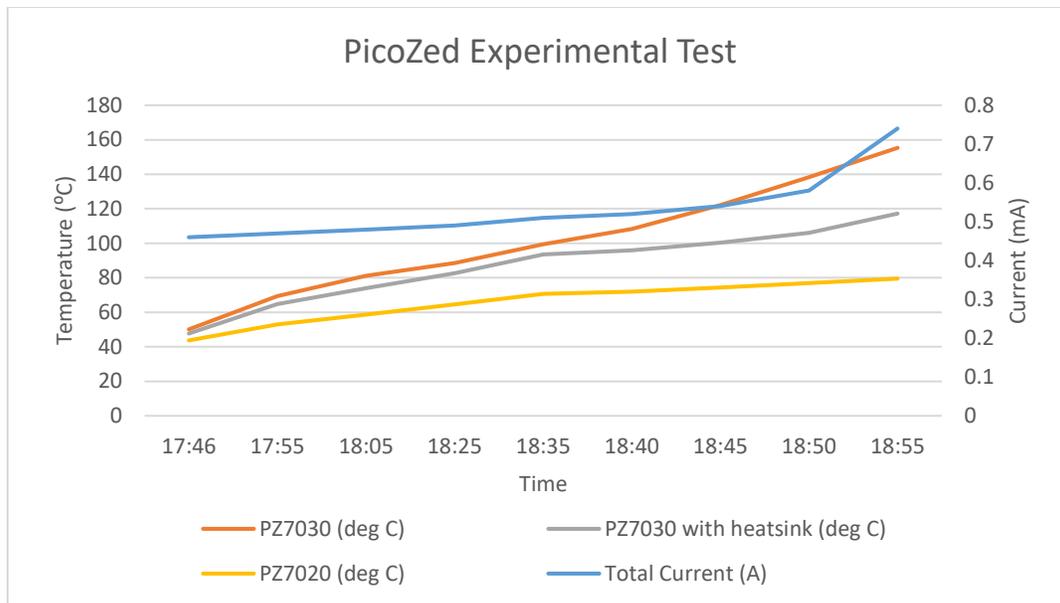
Figure 8: PicoZed Experimental Test Data

The decision was made to perform a third round of TVAC testing, featuring a previously unused PicoZed 7030 (without heatsink), PicoZed 7030 (with a heatsink), a PicoZed 7020, as well as the previously used power board. The heatsink used on the PicoZed 7030 was a copper heat strap attached to the mounting system of the daughter card of the PicoZed 7030 and between the FPGA of the PicoZed 7030. The TVAC testing procedure was to leave the temperature at ambient and pull the pressure down while the spacecraft was on with all computers idling. Shortly after the chamber reached near vacuum, it became apparent that the PicoZed 7030 without a heatsink was quickly reaching critical temperatures again. A small time later, the PicoZed 7030 with a heatsink started reaching critical temperatures as well, most likely having saturated the copper heatsink with too much heat. Throughout the entire test, in stark contrast to the PicoZed 7030, the PicoZed 7020 did not reach critical temperature. The PicoZed 7020 temperatures matched closely to the Q7 flight computer’s temperature data from earlier testing.

After reviewing the results of the test, the decision was made to swap the PicoZed 7030 with a PicoZed 7020. Thanks to the modular electrical and mechanical system, and the foresight to have enough on-hand, the PicoZed 7020 was integrated with the flight hardware as our secondary flight computer in a matter of minutes. After this modification was done, the rest of the boards were able to be rapidly placed back into the satellite.

TVAC testing yielded several lessons that validated parts of our design and exposed the need to exchange other parts. Firstly, the PicoZed 7030 thermal and current runaway indicates that this system on module (SOM) is not suitable for use in a vacuum without an appropriate method to sink heat from the processor die. This is because the die on the PicoZed 7030 is

exposed and does not sink its heat into the rest of the SOM. The PicoZed 7020, however, does sink its heat into the rest of the SOM. It has the same form factor as the 7030 and is a suitable replacement.

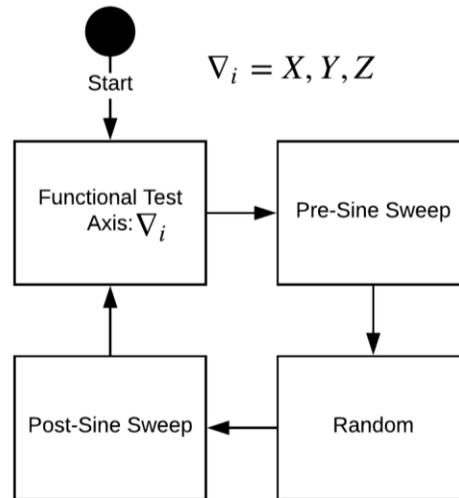
Figure 9: AR#1 Vibe Test Procedure

Prior to transport of the test article to the testing facility, we performed an initial functional test. Next the test article was mounted on the vibration table for the X-axis tests. The Pre-Sine Sweep, Random, and Post-Sine Sweep were performed as described in Figure 9: AR#1 Vibe Test Procedure, and the test article was removed for inspection. During review, the vibration table was

setup for the Y-axis tests. The same procedure was followed for the remaining Y and Z axes with functional tests being run in between.

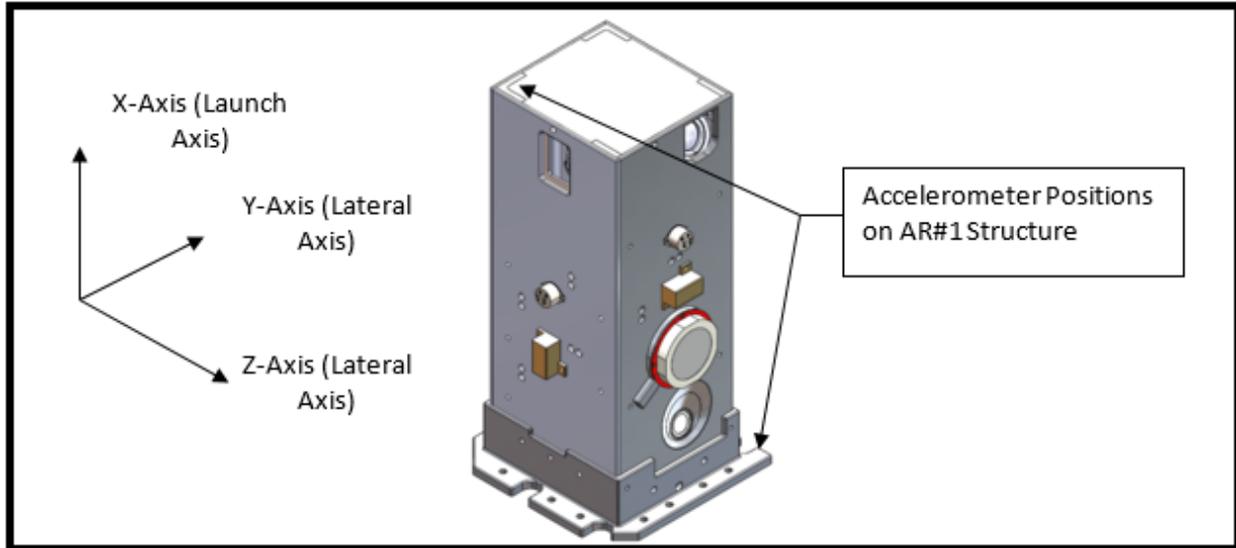
Figure 10: Testing Axes and Accelerometer Positions

Once the experiment was installed on the vibe table, two tri-axis accelerometers provided by NTS were affixed on the top and bottom (on opposite faces) of the flight unit. This was achieved by placing a piece of Kapton tape on the AR#1 structure then using a quick-drying glue to stick the accelerometers onto the tape. The locations of the accelerometers are shown in the Figure 10.

Technicians at National Testing Service (NTS) located in Huntsville, AL performed the vibration tests in their dynamics lab. The test engineer handling the ACES RED project machined a mounting plate to interface between the AR#1 flange and the surface of the vibe table. Installation of the experiment onto the vibe table entailed fastening the mounting plate to the vibe table then the flight unit onto the mounting plate. The only ways in which the execution of the vibe test deviated from the original plan was that the order of the axes tested was not X, Y, Z but instead Y, Z, X and the sine sweeps were specified to be performed up and down between 20Hz and 2000Hz. This was because the vibe table was already in the horizontal testing configuration when we arrived, so it was more efficient to test both of the axes parallel

to the ground and then flip the vibe table to test the last axis.

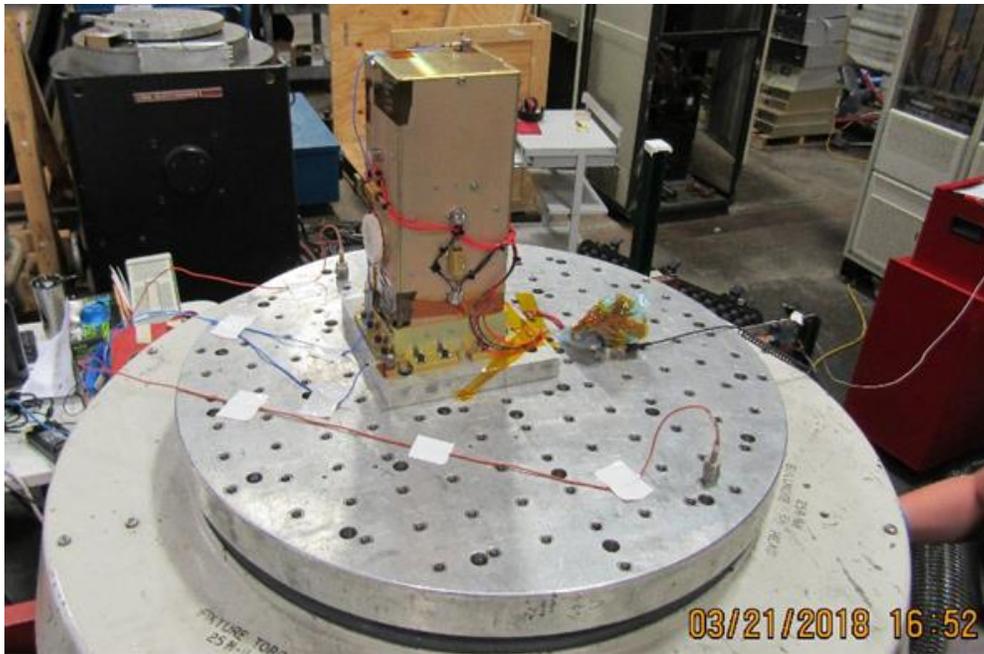
*Figure 11: X-Axis Vibe Test Configuration*

The vibe test began with the Y-axis by performing a 0.5G sine sweep up and down between 20Hz and 2000Hz at a rate of 0.5-1 octave/minute. Then random vibrations lasted for a minute after the applied spectrum reached 0 db and was followed by another identical sine sweep. After that axis was complete, the AR#1 team conducted a visual inspection and connected to the experiment to perform another set of aliveness, full-functionality, and STP Interface tests. Once those were passed, the mounting plate was unscrewed, spun, and re-attached to the vibe table in order to test the Z-axis. This axis followed the same pattern and passed its electrical testing. Then the vibe table was disconnected from the vibration drum and the drum was flipped 90 degrees so that a circular plate could be placed on top. The mounting plate with AR#1 still attached were placed on the new plate and screwed into position (as shown below). Then the X-axis (launch axis) was tested in the same way as the previous two axes. At the conclusion of the vibe test, the experiment again passed the electrical testing.
