Determining Natural Frequencies Using Embedded and Placed Sensors under Ambient and Shaker Excitation

DETERMINING NATURAL FREQUENCIES USING EMBEDDED AND PLACED SENSORS
UNDER AMBIENT AND SHAKER EXCITATION

Civil and Environmental Engineering
(Structural Engineering and Mechanics)

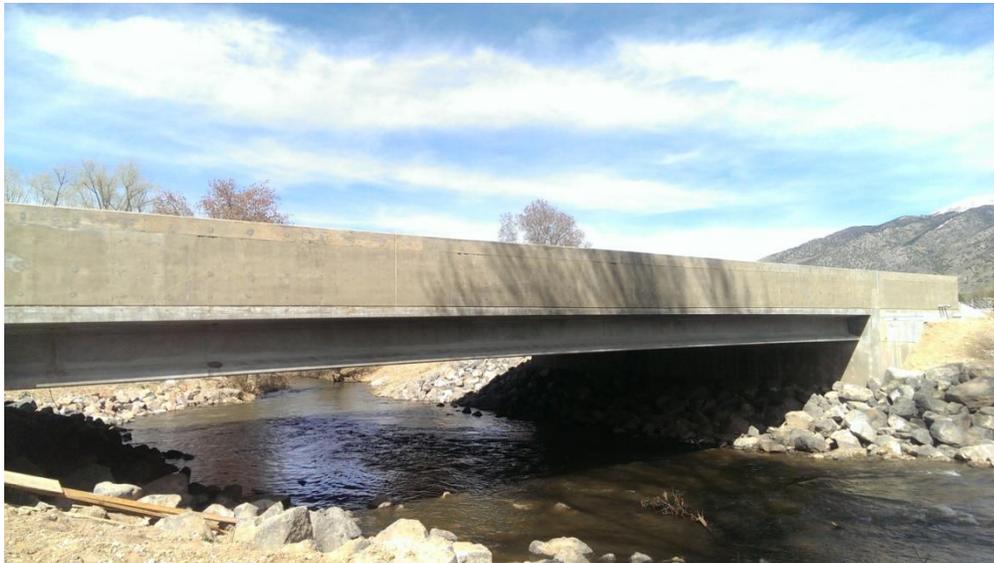
Figure 1: Elevation View Looking North

The Nibley Bridge is a recently constructed short bridge over the Blacksmith Fork River, connecting Highway 165 to the newly constructed high school in Millville. The bridge consists of ten girders 27.3m (89.5 ft.) long. The Nibley Bridge was planned with instrumentation before construction began. Sensors to measure strain, temperature, and acceleration are embedded in the bridge. Construction began in the fall of 2015, with the girders being cast in December. The bridge was opened to the public in August of 2016. Two girders were instrumented, one located on the outer edge of the bridge and the other located at the center of the bridge. Figure 1 shows a side image of the bridge.

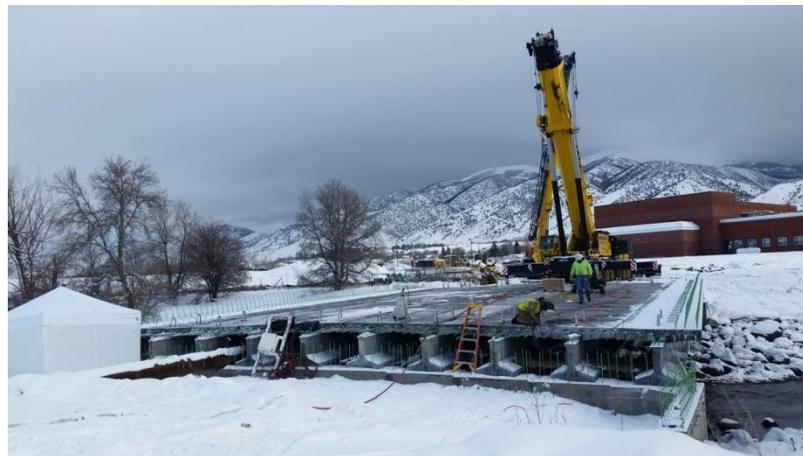
Figure 2: Girder Placement during Construction (Ira Tibbits, personal communication, Oct. 18, 2016)

Ten prestressed precast deck bulb T girders span the river and form the deck of the Nibley Bridge. Figure 2 shows the girders just after placement on the bridge. Each girder is 1.07 m (3.5 ft.) high and has a 1.82 m (5.98 ft.) flange width. The girders are spaced 1.83 m (6 ft.) on center. The upper flanges of the girders are grouted together, forming the deck of the bridge. Metal weld ties connecting the girders are spaced 305 mm (1 ft.) from the end and 1.52 m (5 ft.) on center across the bridge. The keyways are grouted with 58.6 MPa (8.5 ksi) strength grout along their length. The total girder span length is 27.28 m (89.5 ft.), but the deck length spans only 25.91 m (85 ft.).

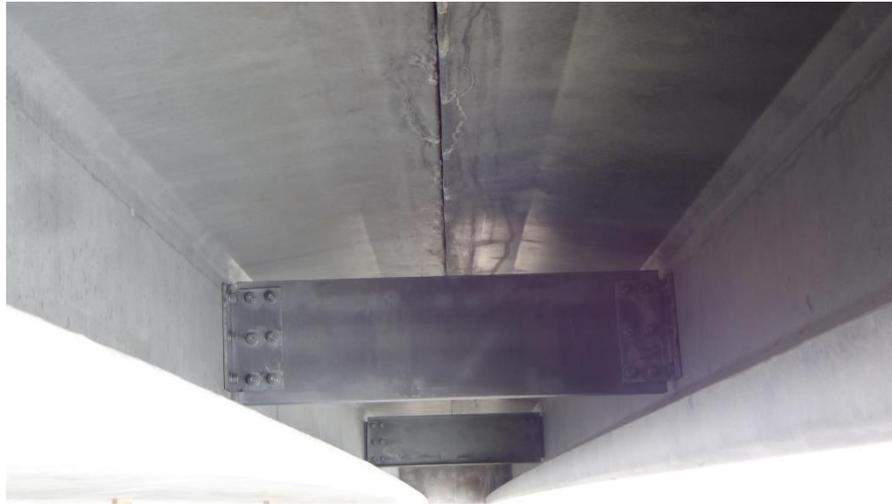
Figure 3: Diaphragm Connecting Girders of the Bridge

The deck width is 18.29 m (60 ft.) across. Two steel intermediate diaphragms connect the girders at third points of the span, as shown in Figure 3. These diaphragms stop for the steel sewer pipe that passes between girders 3 and 4. Both of these are indicated on Figure 4. Prestressed tendons were placed in both harped and straight

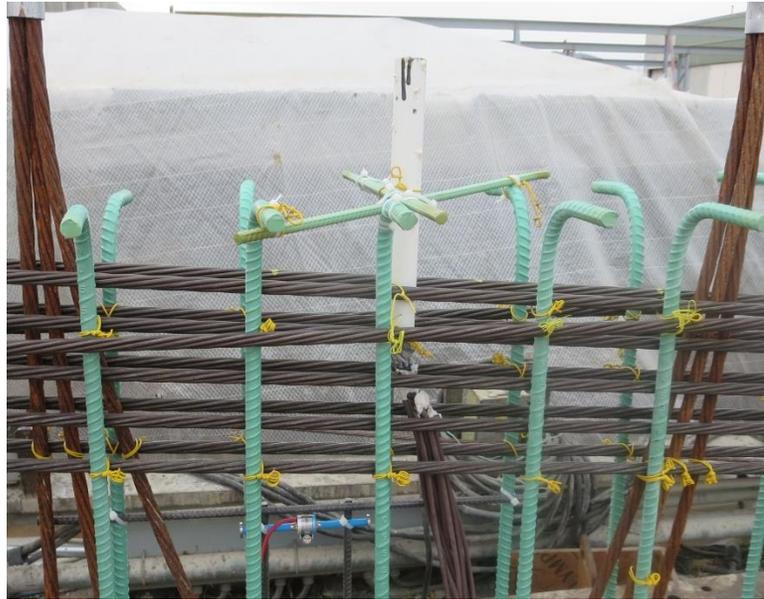
Figure 14: Thermocouple Placement during Construction

allowed the creation of a temperature gradient profile from within the center of the girder. Figure 14 shows a thermocouple placed before the girders were cast.

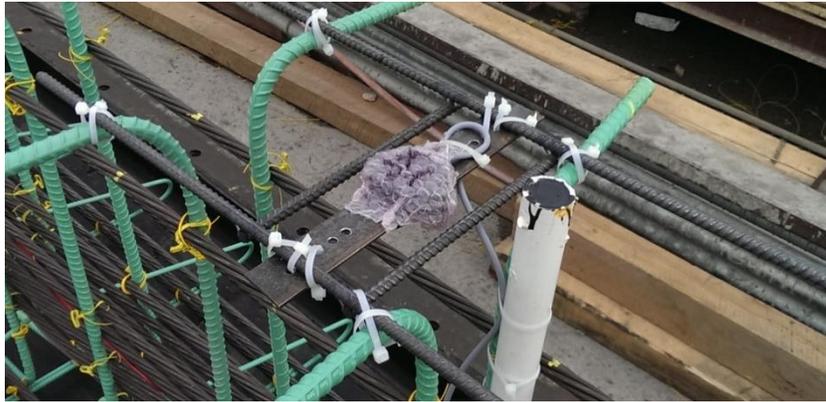
Figure 15: Embedded Accelerometers during Construction

Measurement Specialties triaxial accelerometers were selected for this project based on availability. The accelerometers are embedded within the bridge at midspan 13.49 m (44.25 ft.) and quarter span 6.74 m (22.12 ft.). Accelerometers were mounted to a metal brace to maintain axial alignment during casting. Silicone and bubble wrap were used to waterproof and protect the sensors as shown in Figure 15. These locations were chosen to maximize detection of the first three vertical modes.

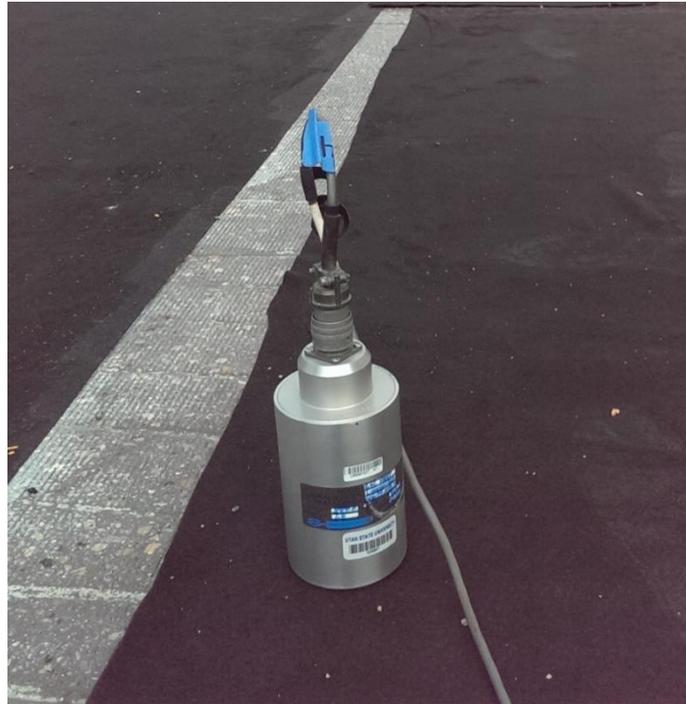
Figure 16: Velocity Transducer on the Bridge prior to Asphalt Installation

The velocity transducers were placed on the surface of the bridge and measured velocity in the vertical direction. Figure 16 shows a velocity transducer on the bridge

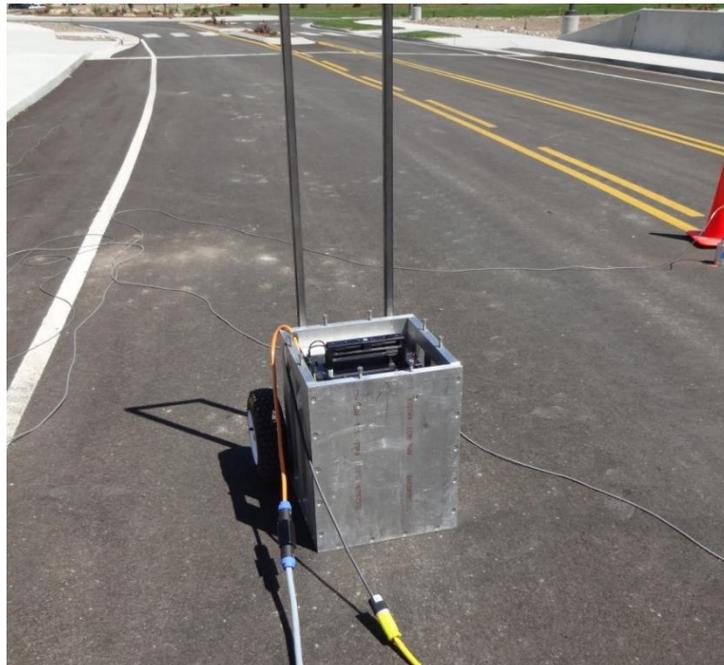
Figure 17: APS Shaker during First Shaker Test

An APS Dynamics shaker was used to excite the bridge, shown in Figure 17. The shaker provided excitation in the vertical direction. This shaker has been retrofitted to allow easy placement and transport. The shaker itself weighs 73 kg (160 lb.) and provides excitation at a peak force of 445 N (100 lb.). The intensity of the excitation was not recorded as part of this project.

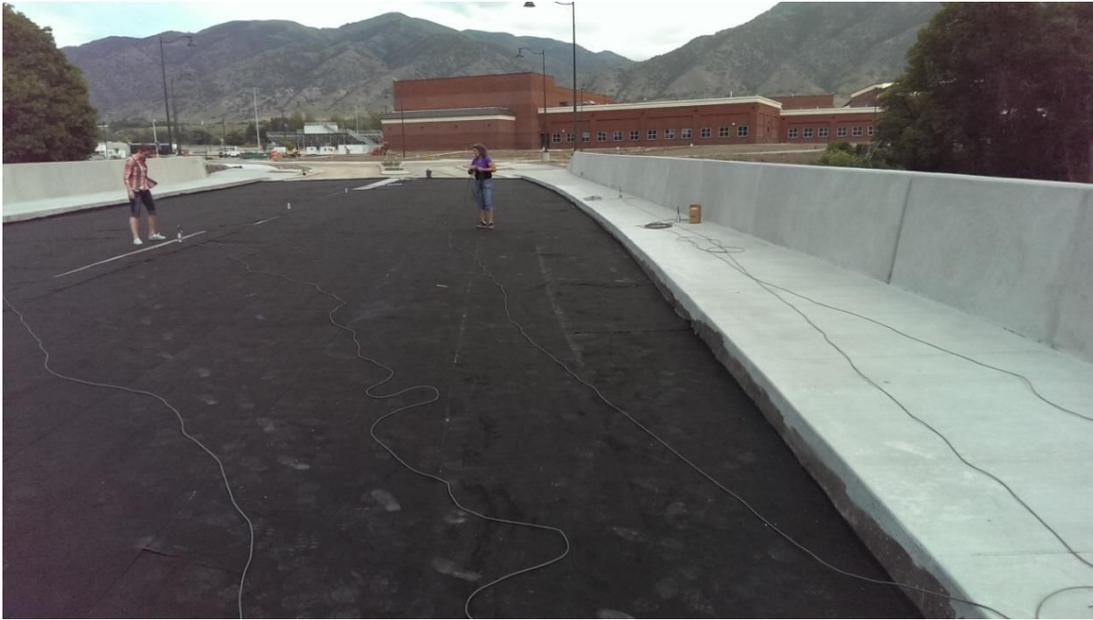
Figure 18: Preparing Sensors for the Impact Test

There were two main goals of the impact test. The first was to test the sensitivity of the embedded sensors against the external sensors. The second goal was to determine the natural frequency of the bridge prior to asphalt installation. To correlate the embedded sensors, the velocity transducers and data physics system were used. The test involved seven velocity transducers and the four embedded accelerometers. A picture of the test is shown in Figure 18.

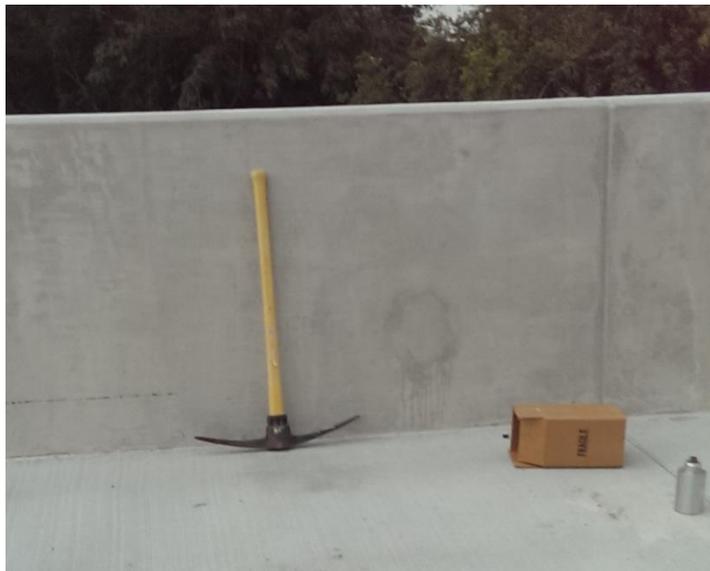
Figure 19: Pickaxe used to Excite the Bridge during Impact Test

The sensors were placed to compare the response between the velocity transducers and the accelerometers. Excitation was caused by dropping a pick axe, shown in Figure 19. Multiple hits were performed at each location. Excitement locations were near the embedded accelerometers to maximize their response to the test. Along with the impacts, ambient excitation from walking on the bridge also occurred.

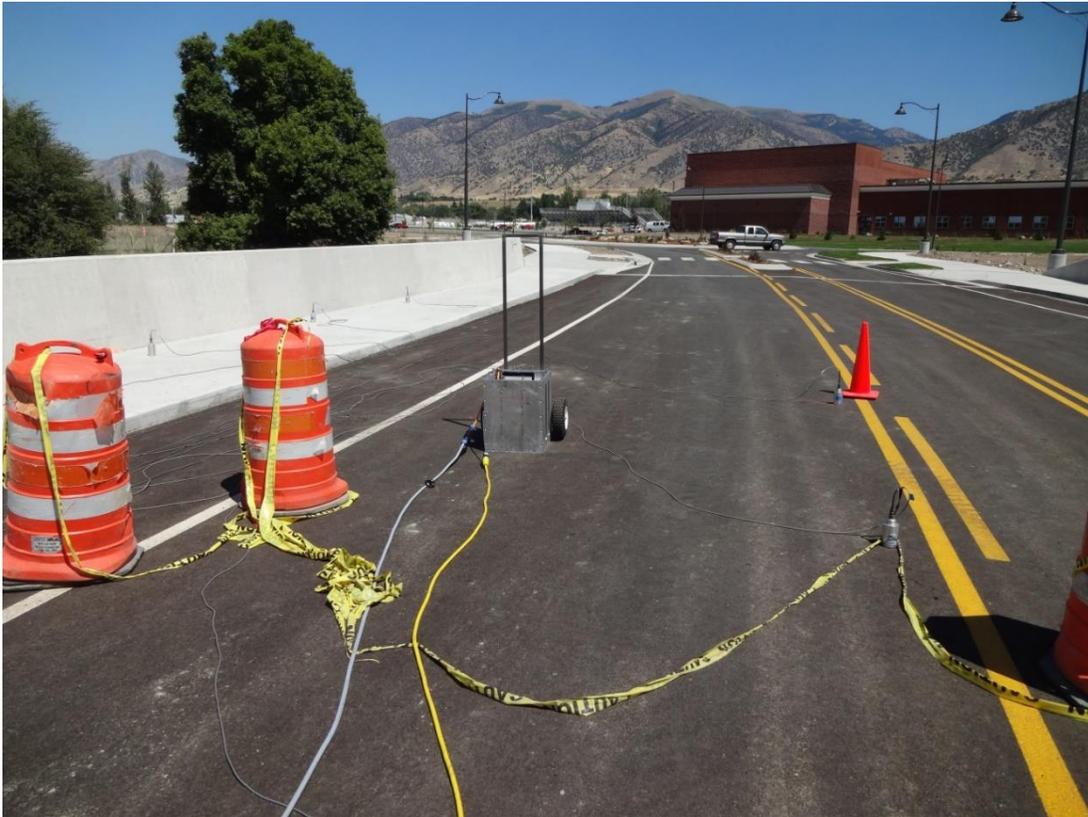
Figure 23: First Shaker Test

The first shaker test had multiple goals. As with the impact test, calibration of the embedded accelerometers was a main goal. Additional goals were to confirm the natural frequencies detected during the impact test and detecting the frequency change due to the added asphalt. Lastly, by using the shaker, the steady state condition could be used to detect the mode shapes of the bridge. Figure 23 shows the first location of the shaker during the test.

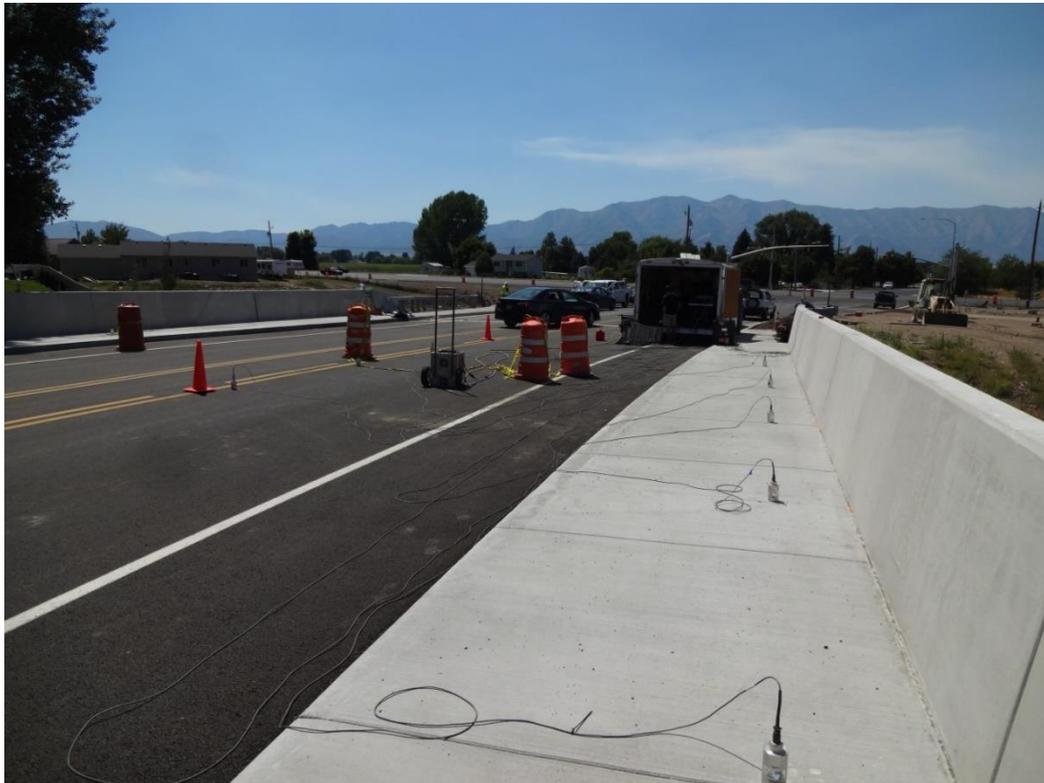
Figure 24: View along the North Side of the Bridge during the Test

The velocity transducers were sampled at 1280 Hz, using the data physics system. This sampling rate was determined to be sufficient for the applied excitation. Though the bridge was closed to the public, large construction vehicles occasionally crossed the bridge during the test. 11 velocity transducers were spaced on the bridge, again aligning with the embedded sensors and in an effort to cover the mode shapes of the bridge. Though the sensor was responding, it was determined later that the data from sensor 7 was incorrect, and the response measured by this sensor was ignored. Figure 24 shows a view of the sensors aligned on the north side of the bridge.

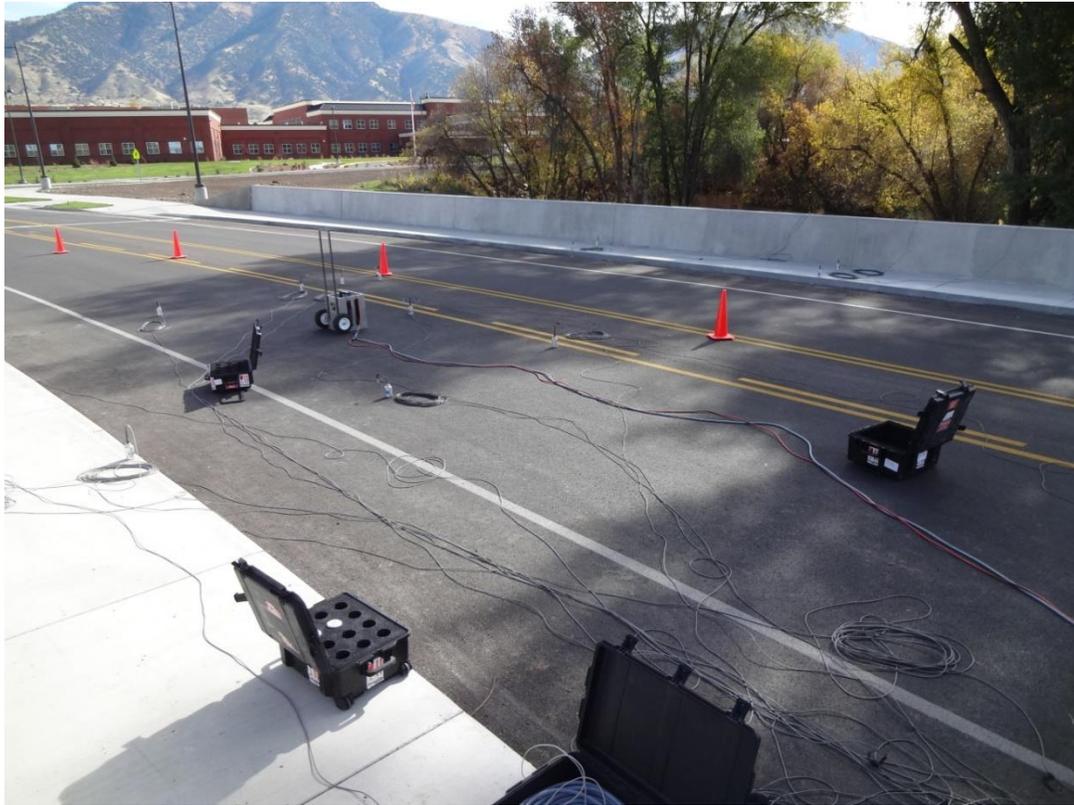
Figure 27: Sensors and the Shaker during the Second Shaker Test

Similar to the first shaker test, excitation began with a swept sine signal ranging from 5 to 15 Hz. Detected frequencies were then excited in turn, with the effort being to determine the resonant frequency using the shaker and the time history. Traffic occurred during most of the shaker tests, as there was a fairly consistent flow of traffic. Gaps between traffic were long enough to establish a steady state response of the structure to continuous sinusoidal excitation. Ambient response of the structure was also recorded. Because the embedded sensors have a large noise amplitude, knowing the amplitude generated by ambient response could help define how useful the embedded sensors would be. If the noise amplitude overpowered the ambient response, it is likely the embedded sensors would be useless. Data processing for this test was done in the same way as the first test. A picture of the sensors on the bridge is shown in Figure 27.
