## Evaluation of Stream Bank Restoration to Improve Water Quality in a Semi-Arid Stream

EVALUATION OF STREAM BANK RESTORATION TO IMPROVE WATER  
QUALITY IN A SEMI-ARID STREAM

Watershed Science

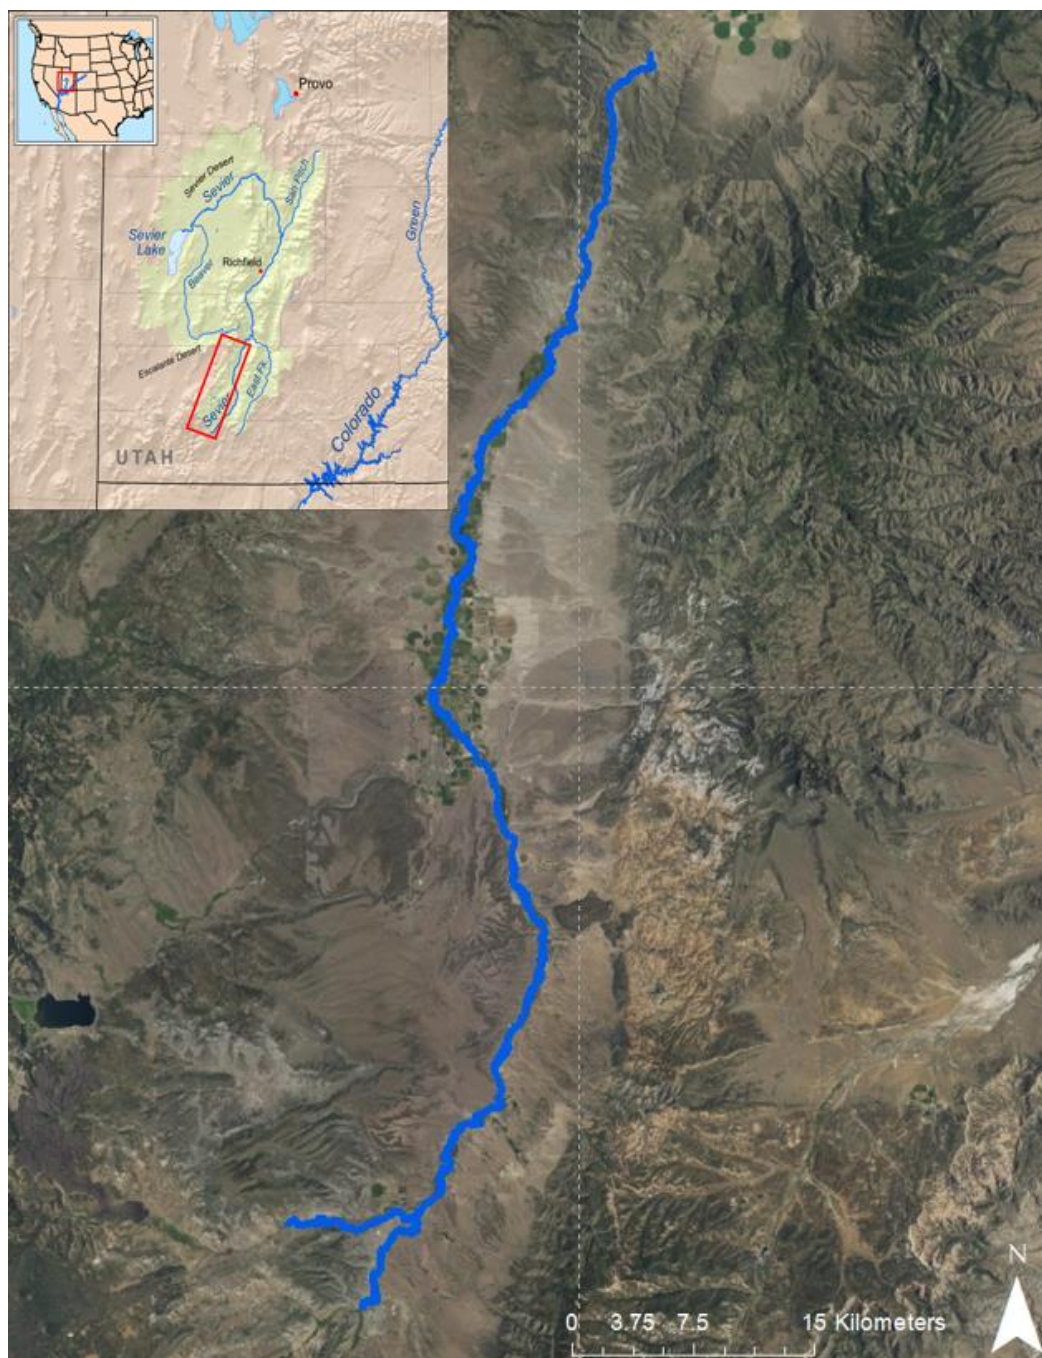
**Figure 1.** The Sevier River (with Mammoth and Asay Creeks at southern map extent) in Hatch and Panguitch Valleys and its location in Utah.

Located in south-central Utah, the Sevier River flows from its headwaters on the Paunsaugunt Plateau to the intermittent and endorheic Sevier Lake located in the Sevier Desert (Figure 1). Sevier Basin elevation ranges from 1,400 meters at Sevier Lake to over 3,600 meters in the high mountains. Yearly precipitation varies from as little as 163 mm in dry valleys to 1000 mm at upper elevations (SRWUA, 2018). Three HUC-8 watersheds comprise the Sevier River: the Lower, Middle, and Upper Sevier basins. In the 312,000-hectare Upper Sevier watershed (Figure 1), extensive water development and agricultural land conversion have altered the basin and the river. These changes have negatively impacted stream health in a variety of ways including habitat alteration, increased phosphorus, turbidity, and stream temperature (USFS, 2004). As a result, the Upper Sevier River was listed as an impaired 3A cold water fishery under the Utah Division of Water Quality's 2004 Total Maximum Daily Load for suspended solids (USFS, 2004).

I used Hydrologic Engineering Center's River Analysis System (HEC-RAS) to simulate a one-dimensional, steady flow for ~140 kilometers of the Upper Sevier River from Asay Creek to the end of Circleville Canyon (Figure 1). My model consisted of three "hydraulic reaches": Asay Creek, Mammoth Creek, and the Sevier River from the confluence to Circleville Canyon. A HEC-RAS model is a prerequisite for the use of SIAM. HEC-RAS models one- and two-dimensional river hydraulics, sediment dynamics, and water quality using both steady and unsteady flows and was developed by the U.S. Army Corps of Engineers (USACE, 2010). HEC-RAS has been applied to a wide variety of topics from flood prediction (Timbadiya et al., 2011) to river restoration (Buchanan et al., 2012). Table 3 lists the data necessary to develop my HEC-RAS model and their sources.

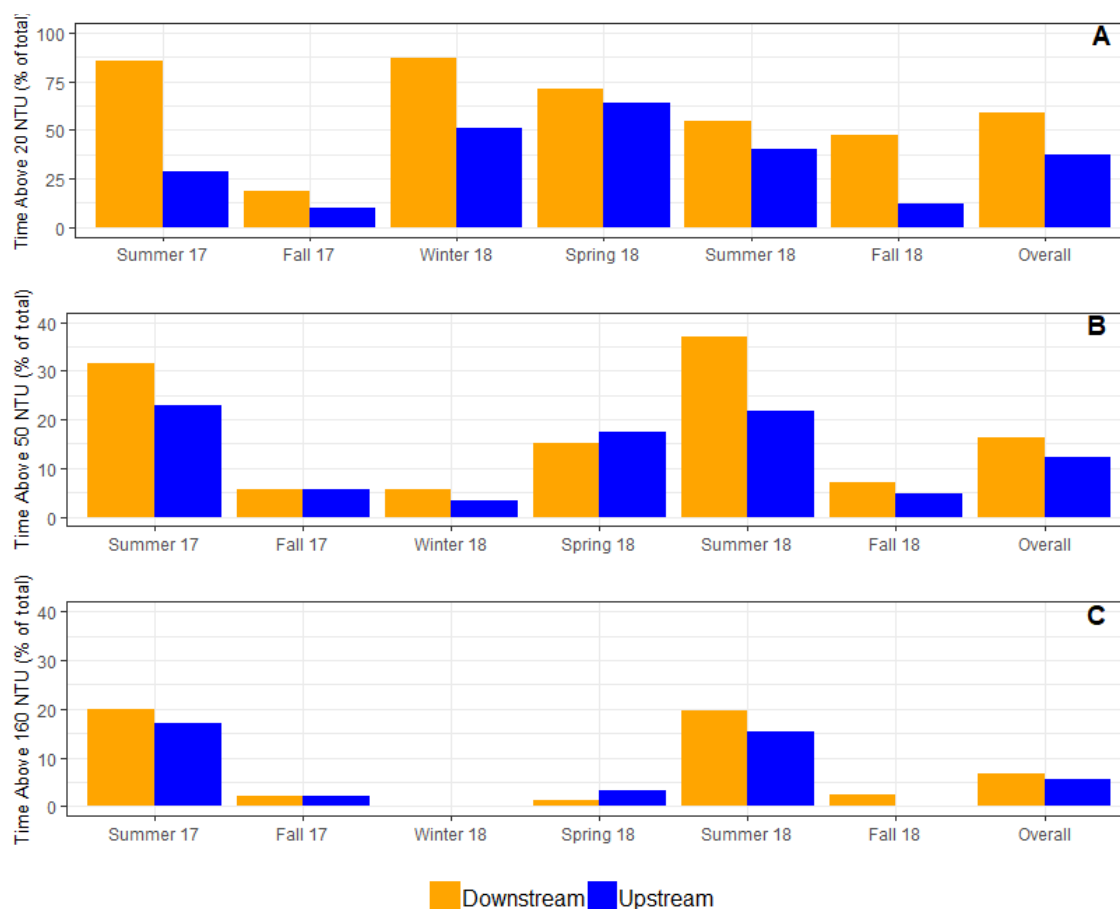
**Figure 18.** Daily mean turbidity threshold violations as fraction of total days for upstream and downstream sites by season. Turbidity thresholds are (a) 20 NTU, (b) 50 NTU, and (c) 160 NTU. Note that the y-axis of (b) and (c) differs from (a).

The downstream sites violated the 20 NTU turbidity standard more often than the upstream site (Figure 18a). Over the entire period of observation, the downstream and upstream sites violated the 20 NTU threshold 58.8% and 37.6% of the time respectively. The sites violated the threshold most often during winter 2018 (downstream, 86.7%) and spring 2018 (upstream, 64.1%). Fall 2017 was the season with the least violations at both sites. These results suggest that both sites are violating the 20 NTU threshold although the downstream site was substantially worse.

Both sites violated the 50 NTU threshold at least one day in each season (Figure 18b). This threshold was an absolute, instantaneous threshold recommended by Idaho DEQ so a single violation would constitute an impairment. The downstream and upstream site violated the 50 NTU threshold 16.3% and 12.2% of the time respectively. Most of the 50 NTU violations occurred in summer 2018 and summer 2017 at 31.4% and 22.8% for downstream and upstream respectively. Winter 2018 violated the 20 NTU threshold at least 50% of the time, but violations of the 50 NTU threshold during the same season were under 6% for both sites. This suggests that the baseline turbidity was higher in winter than other seasons, but that winter had fewer turbidity spikes (Figure 16). Upstream violations exceed downstream violations during just one time period: spring 2018.
