TECHNICAL NOTE

Distribution	Prepared by Hans Erik Mathisen		Document No TN19081902	
	Sign HEM(sign)	Date 19.08.2019	Page of	1 108
Document Title Radiation testing of STIM210 and STIM300

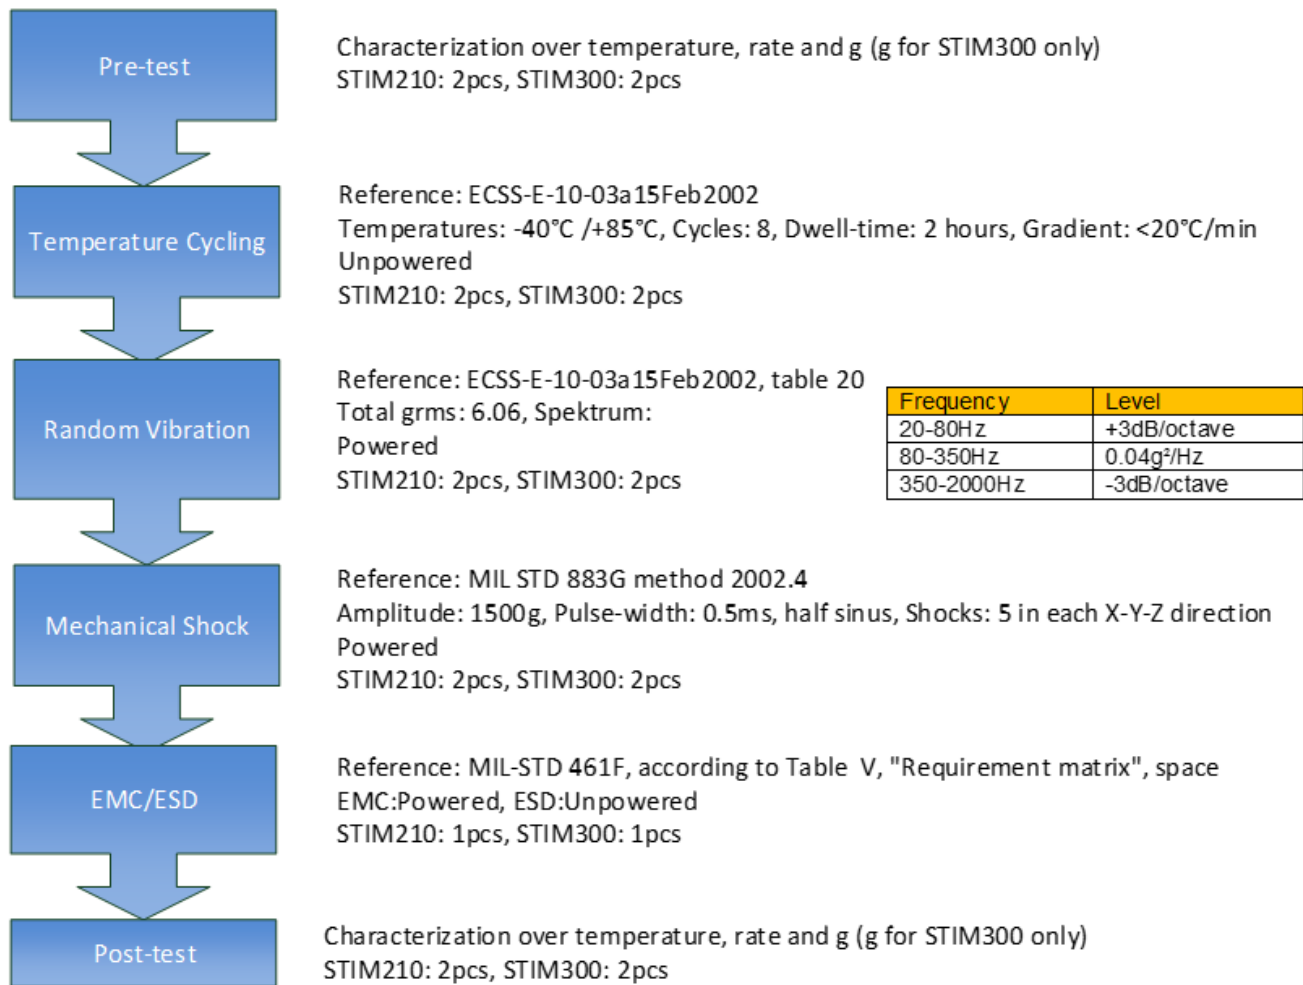
Figure 2 Test plan for the Technological Acceptance test

Figure 2 shows the test flow for the TA test.

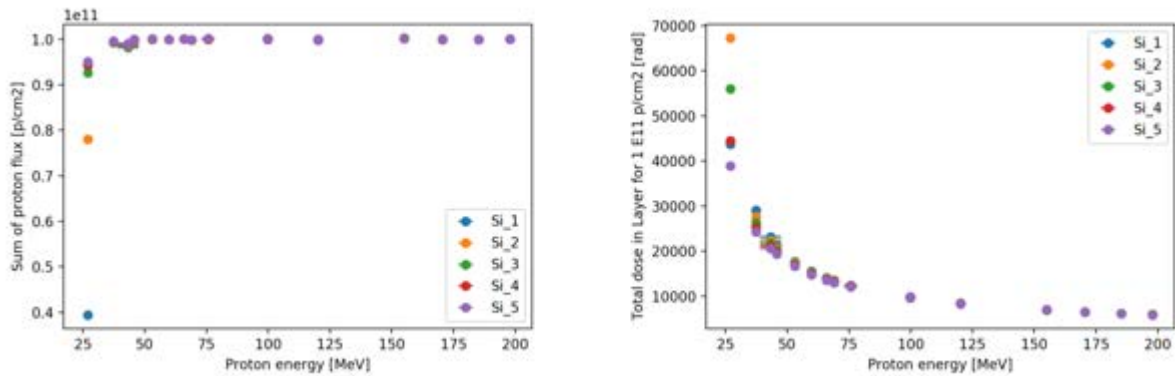
Figure 4: Simulation results (Si1 = bottom layer, Si5 = top layer). Left side: Simulated proton flux through the Si layers versus proton energy, Right side: Total dose deposited by the protons in the Si layers versus proton energy. The proton energies were evaluated after passing the degraders and before entering the UUT enclosure.

As the proton energy wasn't set directly, and as the actual degrader properties to achieve a certain proton energy were not provided by PSI, a series of simulations were performed (Figure 4). Per simulation run, 5E6 protons were simulated and the resulting flux and total dose scaled to an incident fluence of 1E11 p/cm².

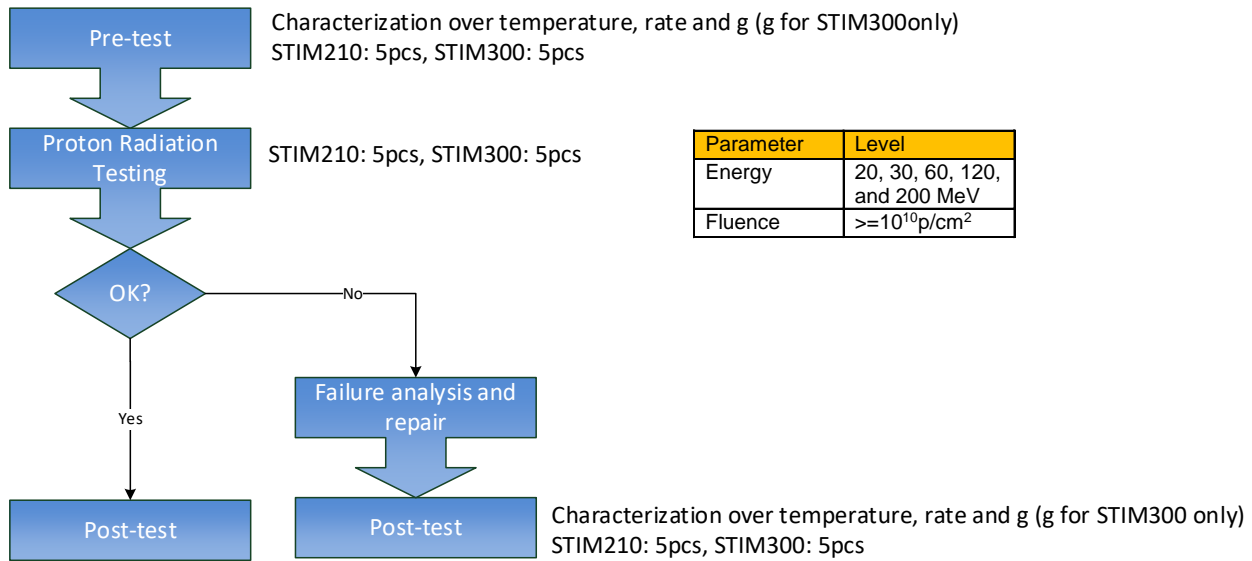
Figure 5 Pre-radiation test, SEE

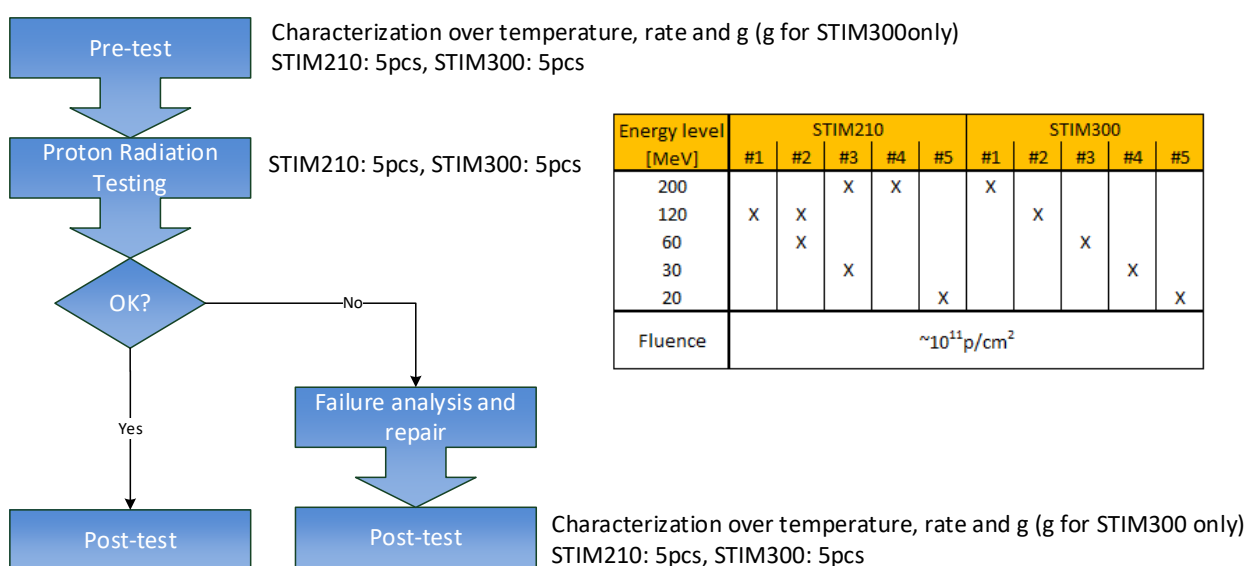
Figure 7 Revised Test plan, SEE test

Due to these circumstances, a new test plan was created. The revised test plan is seen in Figure 7.

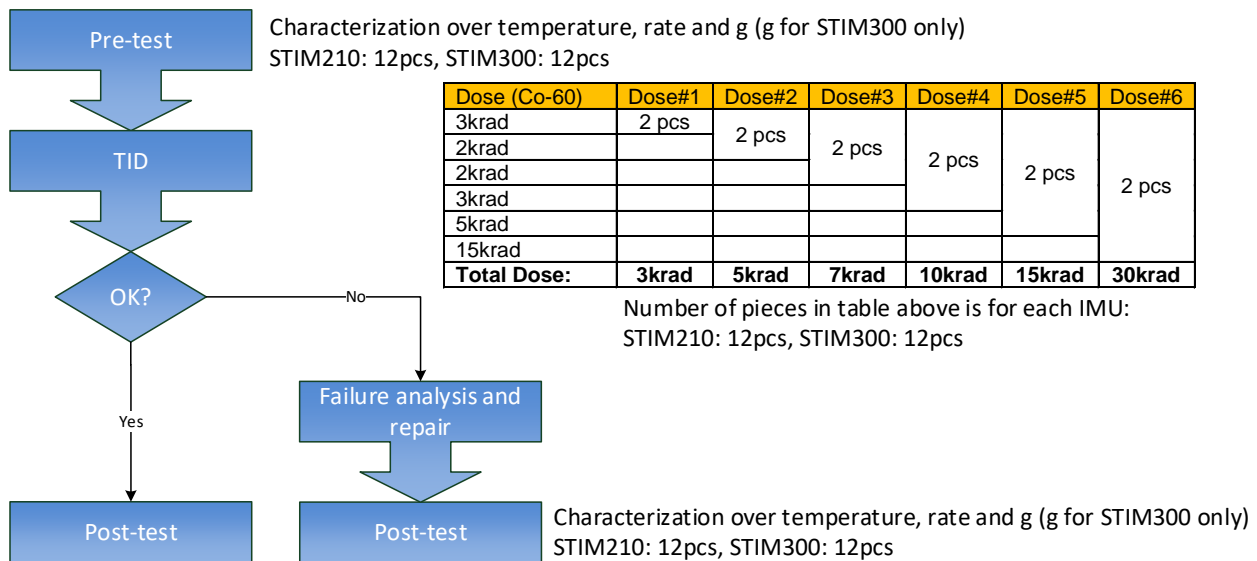
Figure 8 Test plan, TID test

Starting with 6 powered and 6 unpowered UUTs, one UUT of each power condition is to be removed after completion of a dose step for further post-test analysis. This is valid for both STIM210 and STIM300

The test plan for TID testing is shown in Figure 8.

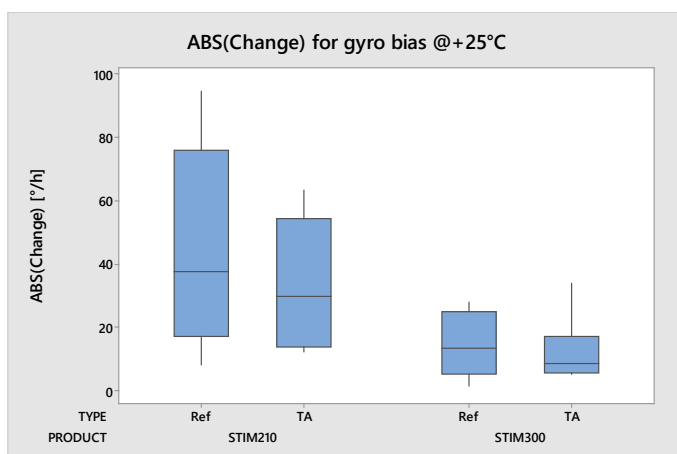
Figure 12 Change in gyro bias

The plots in Figure 12 to Figure 17 shows the absolute value of the bias and scale factor drift between pre- and post-tests. The boxplots represents the interquartile range with the middle line representing the median. The full comparison of test results can be found in Appendix B.

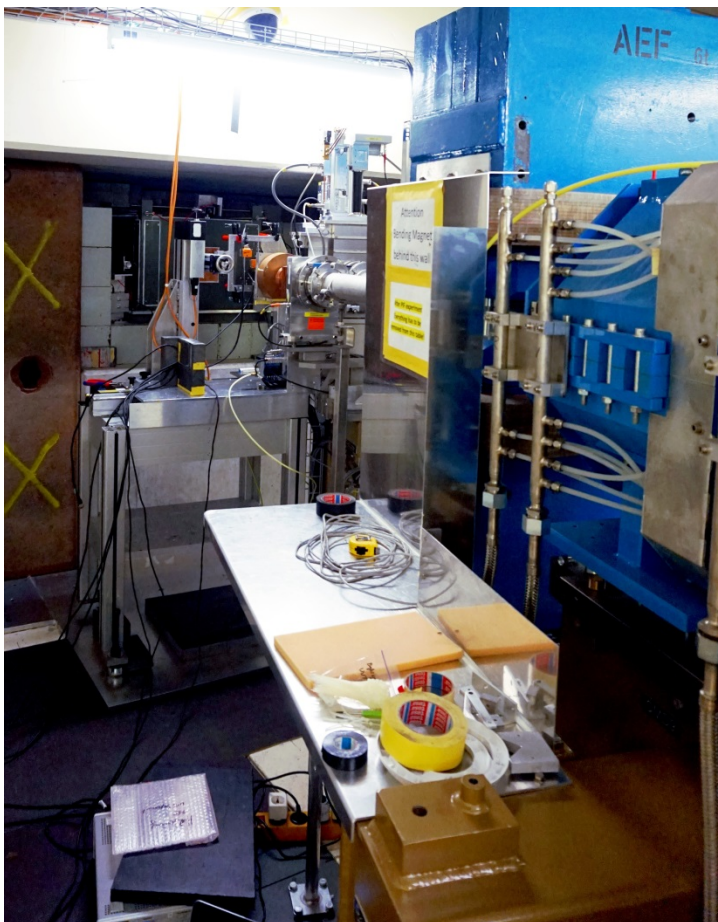
Figure 18: PIF, Exposure room

The experimental set-up consists of the local PIF energy degrader, beam collimating and monitoring UUTs. A moveable XY table with sample holder and a laser mounted downstream from the XY tables allowed for controlling the positioning of the UUT (Figure 20 right). The beam energy delivered from PROSCAN was degraded locally using the PIF energy degrader (Figure 20 left). In that way the beam energies could be set from the PIF control room (Figure 19).

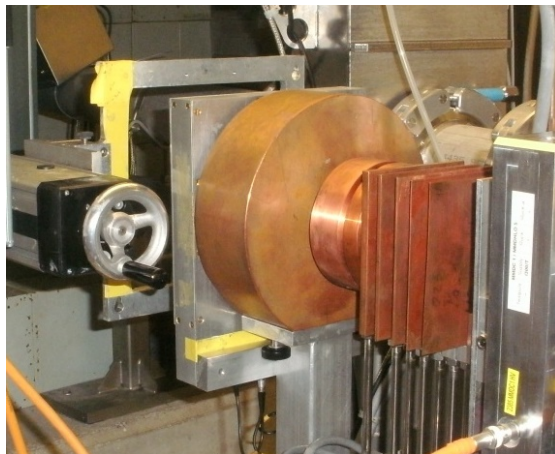
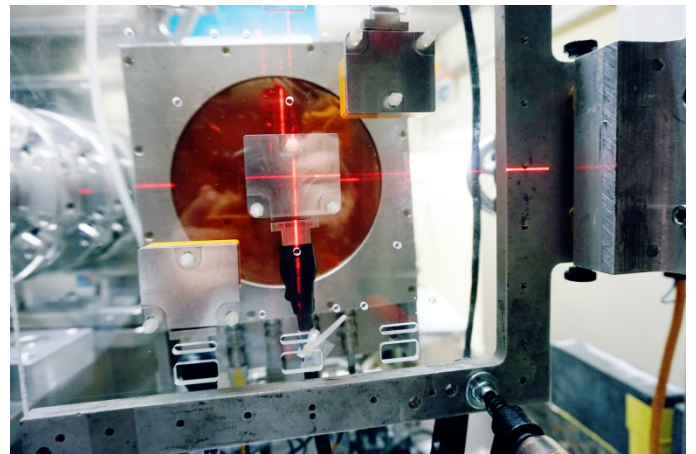
Figure 20: SEE Facility. Left: PIF Energy Degradator. Right: Laser-assisted alignment

It was initially planned to perform tests at 20, 30 and 60 MeV proton energy by a reduction of an initial energy of 74 MeV. Each switch of the initial energy would have taken up to 2 hours of beam time, so a decision was made to use 200 MeV initial energy protons and degrade radiation by the PIF Energy Degradator (Figure 20).

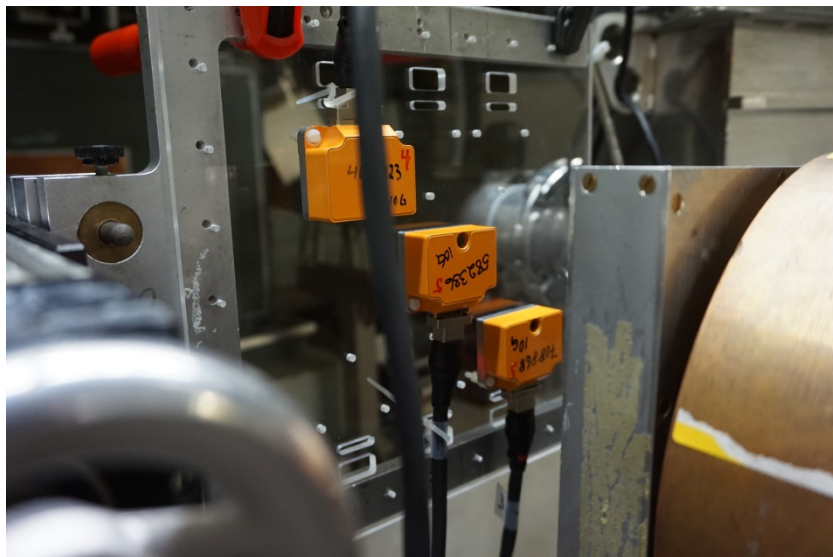
Figure 21: SEE: Irradiation board installed at PIF, PSI

The beam calibration performed by the PIF staff assumed a distance of 10 cm from the energy degrader to the UUTs. That distance was thus set using the moveable table in the area. To limit the area of exposure to the UUTs, a circular collimator of 5 cm diameter was installed. The beam profile measured and provided by the PIF staff is shown in Figure 23. In X-direction, the beam shows a flat profile over the UUT dimension, on the y-axis there is some reduction of the intensity. Overall, the profile looks reasonable. The UUT positions on the board were determined using a laser system installed in the irradiation room (Figure 20). To place a UUT in the center of the beam, the board was moved remotely to these positions.

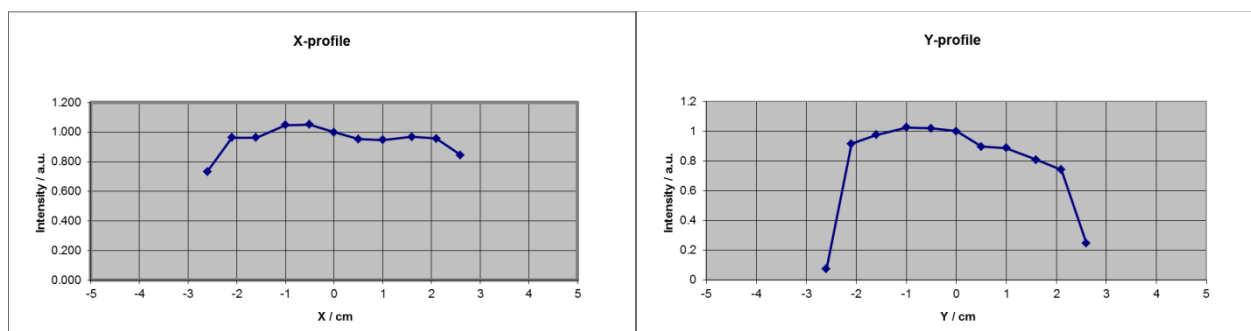
Figure 23: PIF: Beam profile measurement provided by PIF

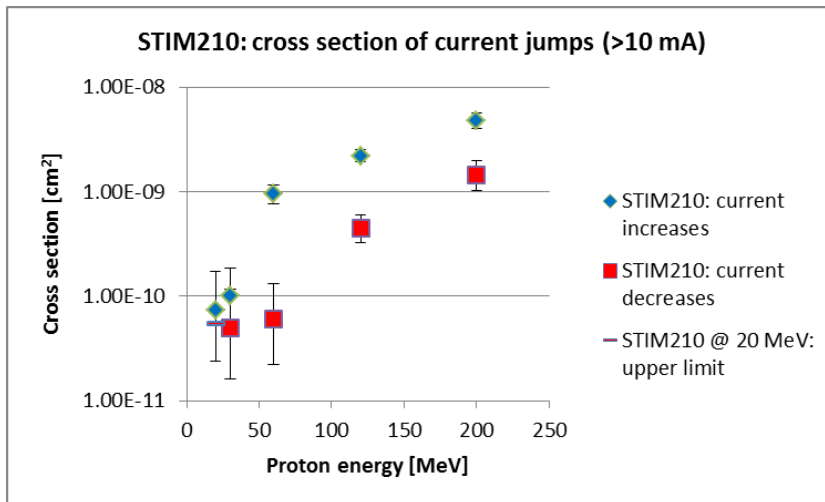
Figure 26: SEE: STIM210: Cross section evaluation of the current jumps versus proton energy. A threshold of 10 mA from one data point to the next is applied when counting the current jumps. At 20 MeV no such current decrease was observed, so only the statistical upper limit of the cross section is given.

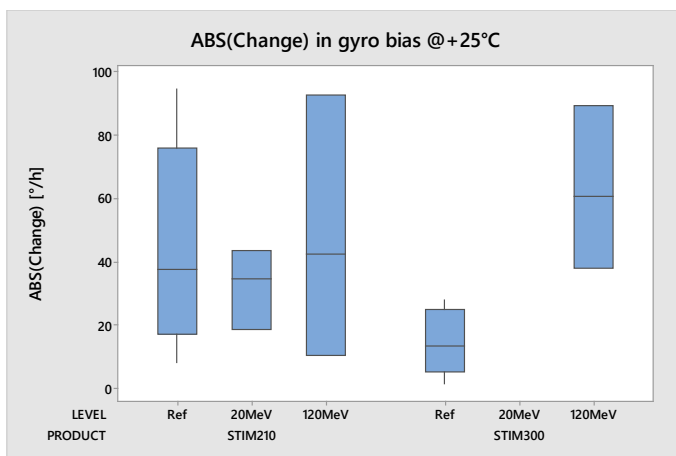
Figure 27 Change in gyro bias

The plots in Figure 27 to Figure 32 show the absolute value of the bias and scale factor drift between pre- and post-tests. The boxplots represent the interquartile range with the middle line representing the median. The full comparison of test results can be found in Appendix D.

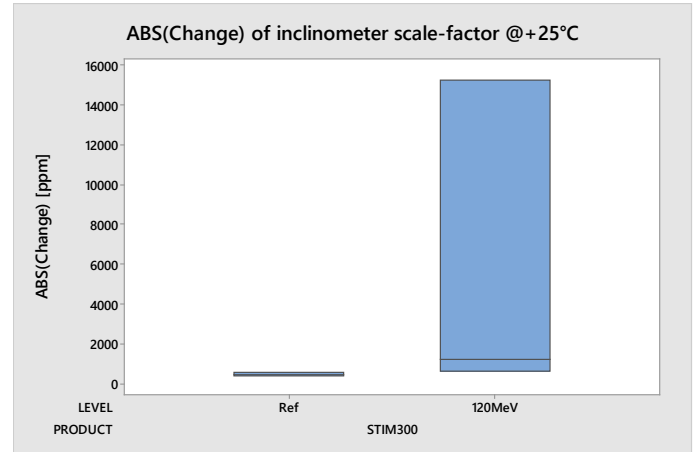
Figure 32 Change in inclinometer scale factor

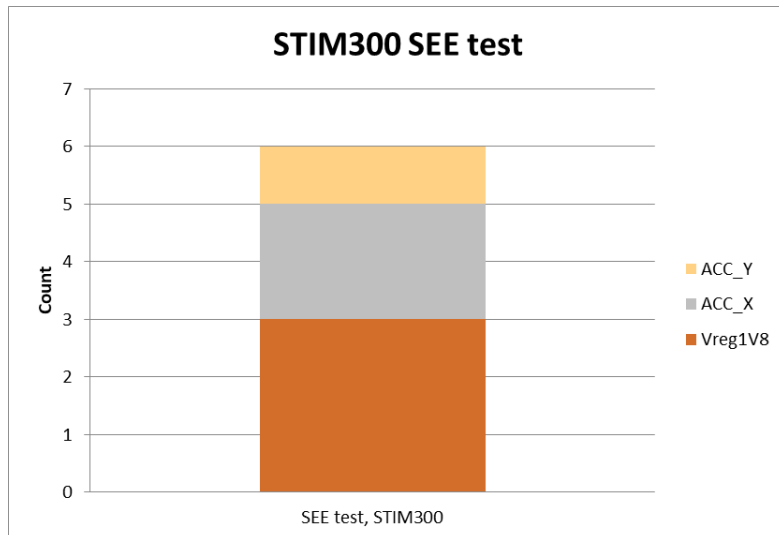
Figure 33: Failing electronics in STIM300 during SEE test

Figure 33 shows all failing electronic components for STIM300 modules that were irradiated in the SEE test. Figure 34 shows all failing electronic components for STIM210 modules that were irradiated in the SEE test. Figure 35 shows a Pareto of all electronic components that have failed during SEE test.

Several modules experienced multiple component failures. No assessment has been made as to whether any failure is derived from the radiation itself or is a consequence of other electronic failures.

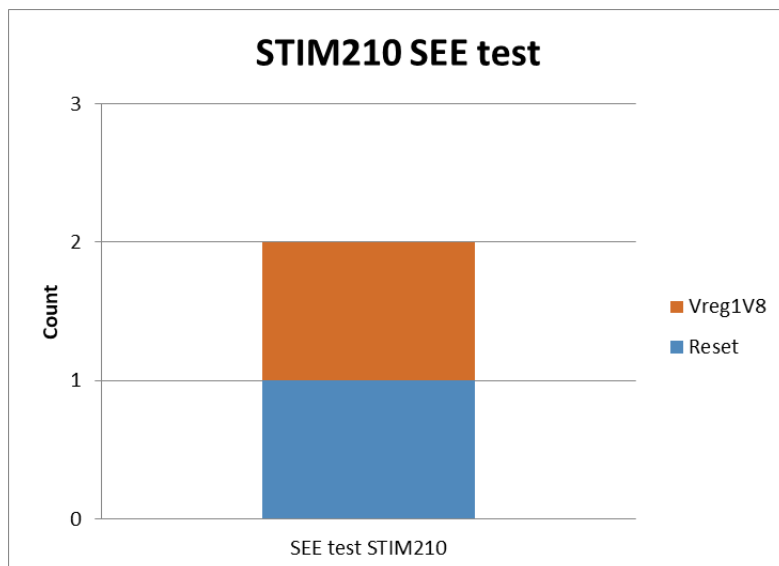
Figure 34: Failing electronics in STIM210 during SEE test

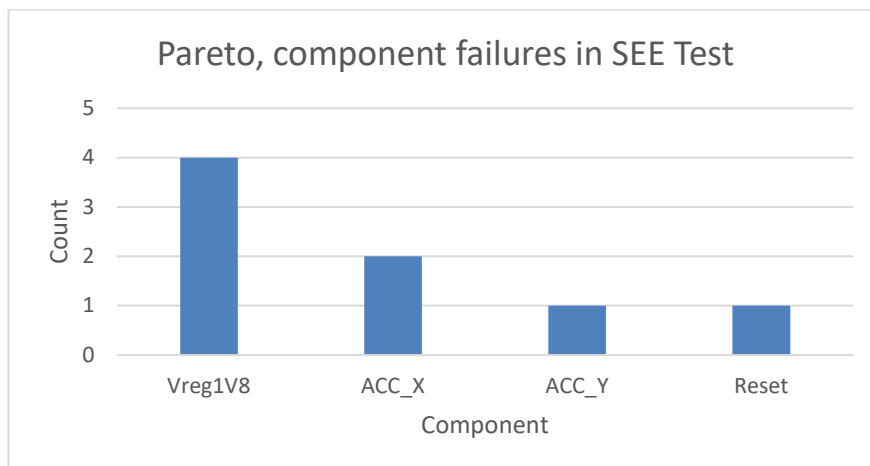
Figure 35: Pareto, Failing electronics in STIM210 and STIM300 during SEE test

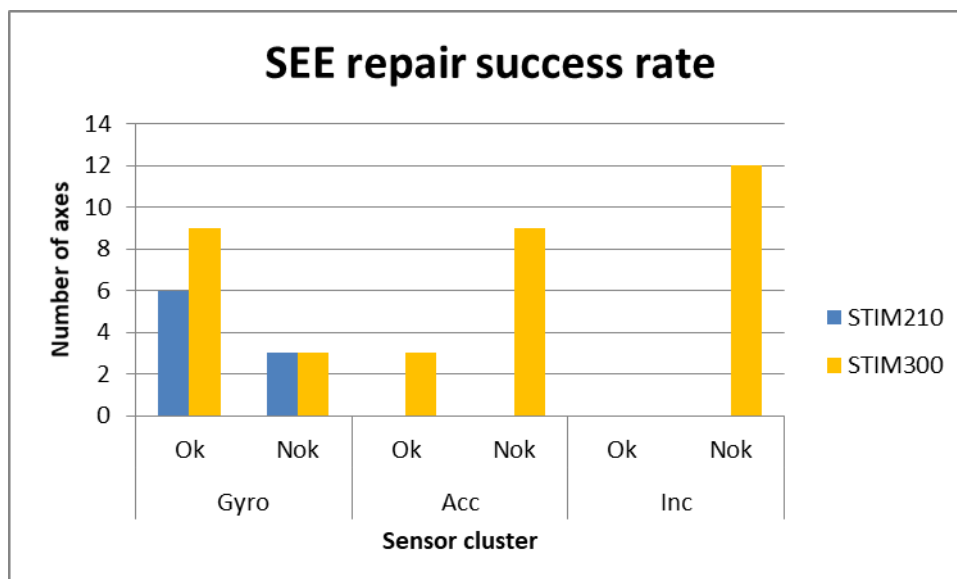
Figure 36: SEE success rate of repairs

After replacing components in all failing units necessary for powering up the STIM300 and STIM210 without error indication, the units were tested in a set of standard production test insertions. Overall results are shown in Figure 36.

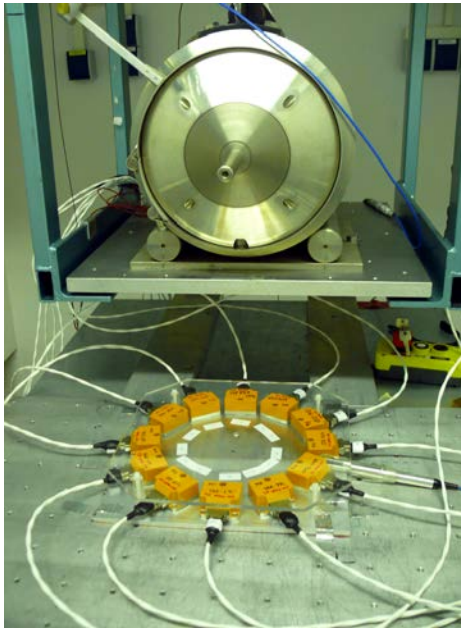
Figure 38: TID: Sample holder with PMMA top plate at TK1000B

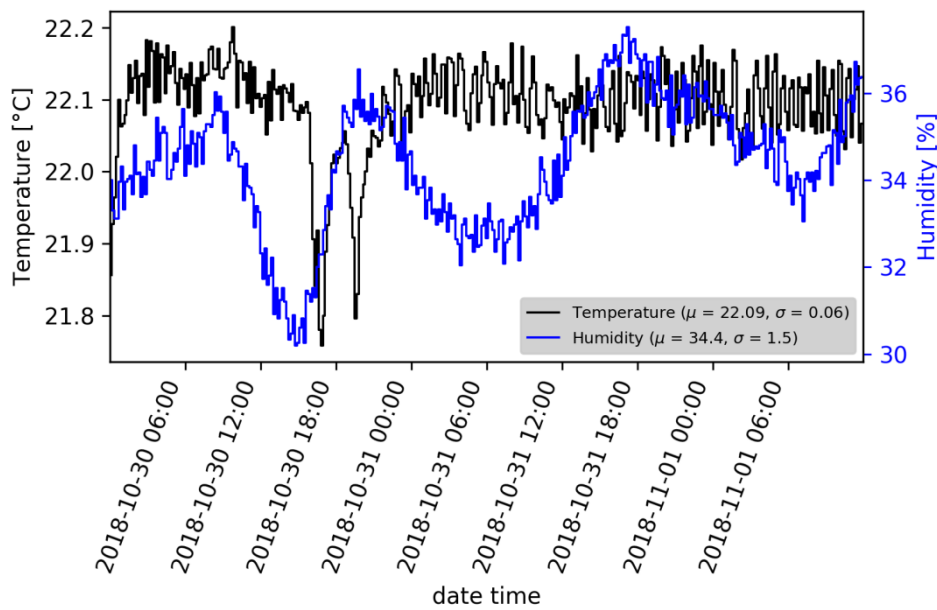
Figure 40: TID: Environment variables during the irradiation tests.

All irradiation steps were done in air. The samples at TK1000B were irradiated in ambient light. The parameters of the humidity and the temperature are given in the Table 14 and Figure 40. In addition to the dosimetry system installed at TK1000B, the dose rate was checked during the irradiation with a calibrated ionization chamber (Table 13) positioned on the sample holder next to the UUTs. That data was not stored and only used for consistency checks during the campaigns.

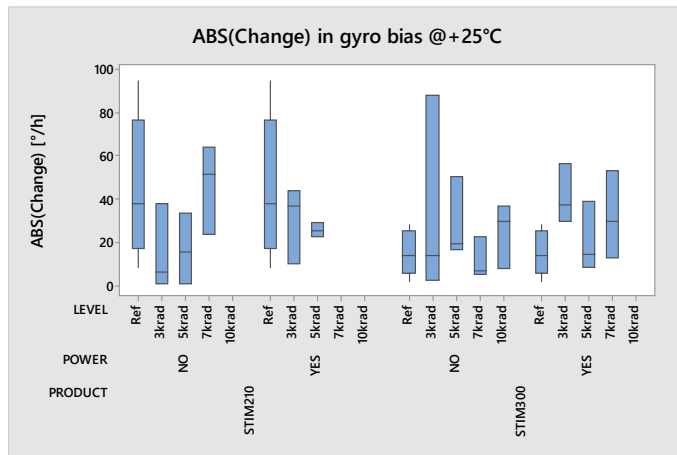
Figure 45 Change in gyro bias

The plots in Figure 45 to Figure 50 show the absolute value of the bias and scale factor drift between pre- and post-tests. The boxplots represent the interquartile range with the middle line representing the median. The full comparison of test results can be found in Appendix C.

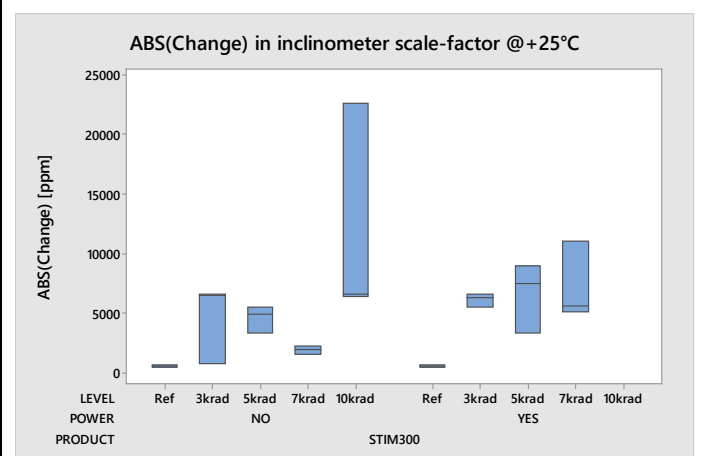
Figure 50 Change in inclinometer scale factor

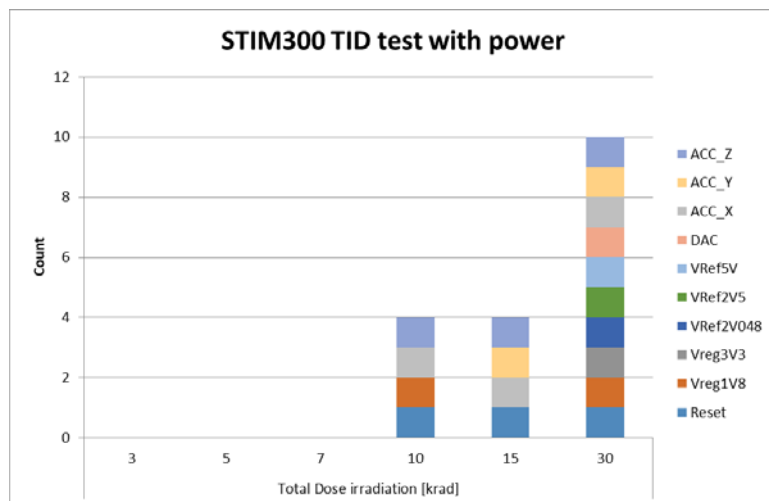
Figure 51: Failing electronics in powered STIM300 during TID test

Note that the total dose indicated in the plots for the TID tests indicates the total dose each component has been exposed to, not necessarily at what dose the failure first occurred.

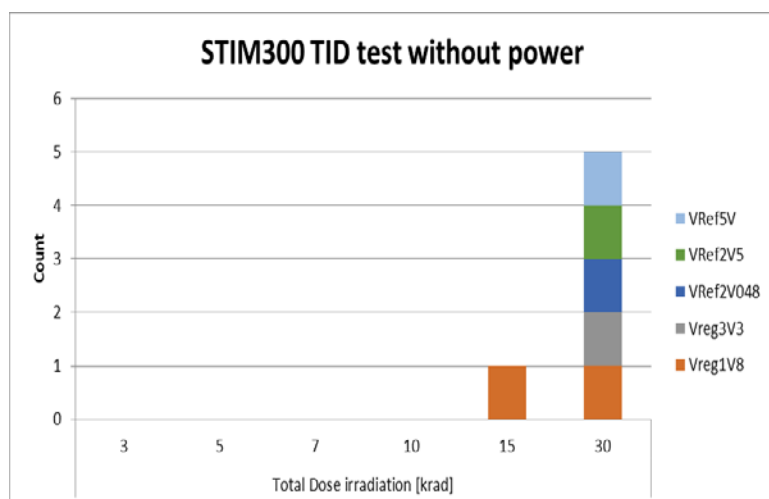
Figure 52: Failing electronics in unpowered STIM300 during TID test

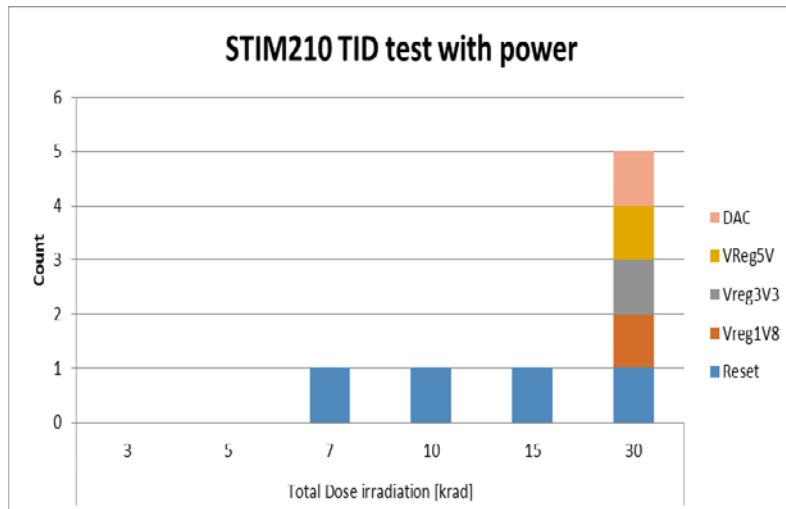
Figure 53: Failing electronics in powered STIM210 during TID test

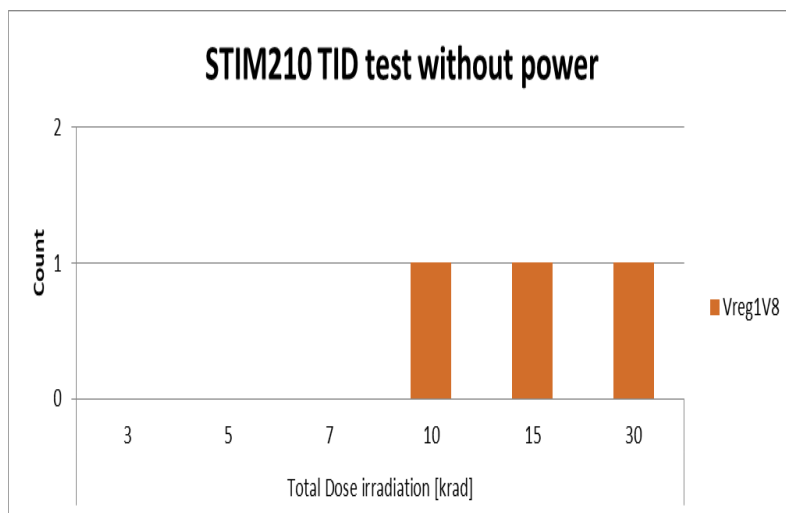
Figure 54: Failing electronics in unpowered STIM210 during TID test

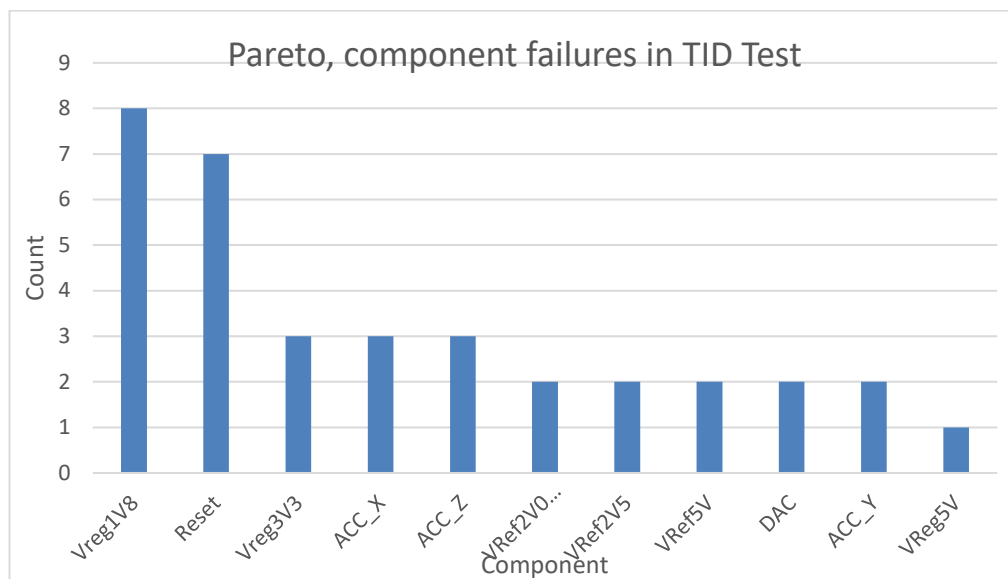
Figure 55: Pareto, Failing electronics in STIM210 and STIM300 during TID test

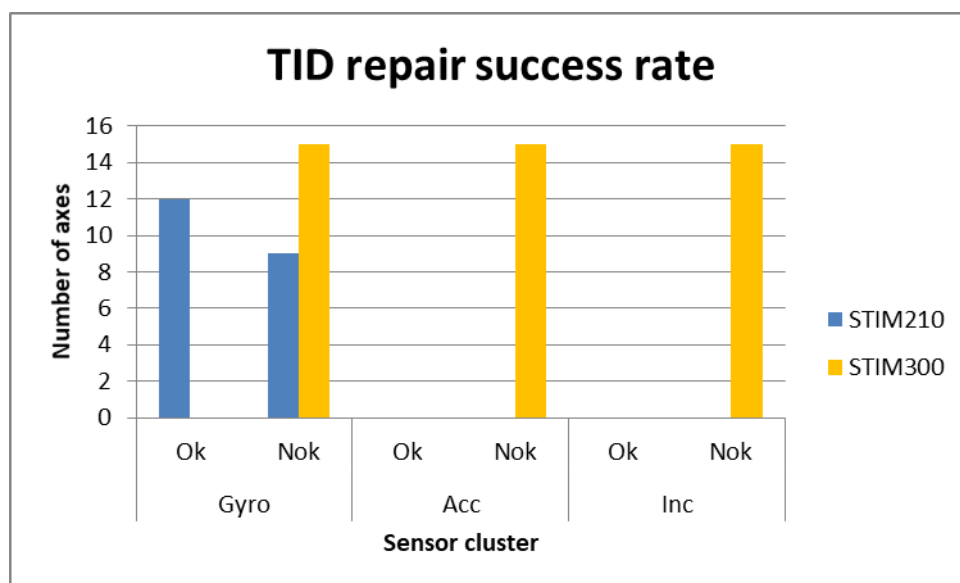
Figure 56: TID success rate of repairs

After replacing components in all failing units necessary for powering up without error indication, the units were tested in a set of standard production test insertions. Results are shown in Figure 56.

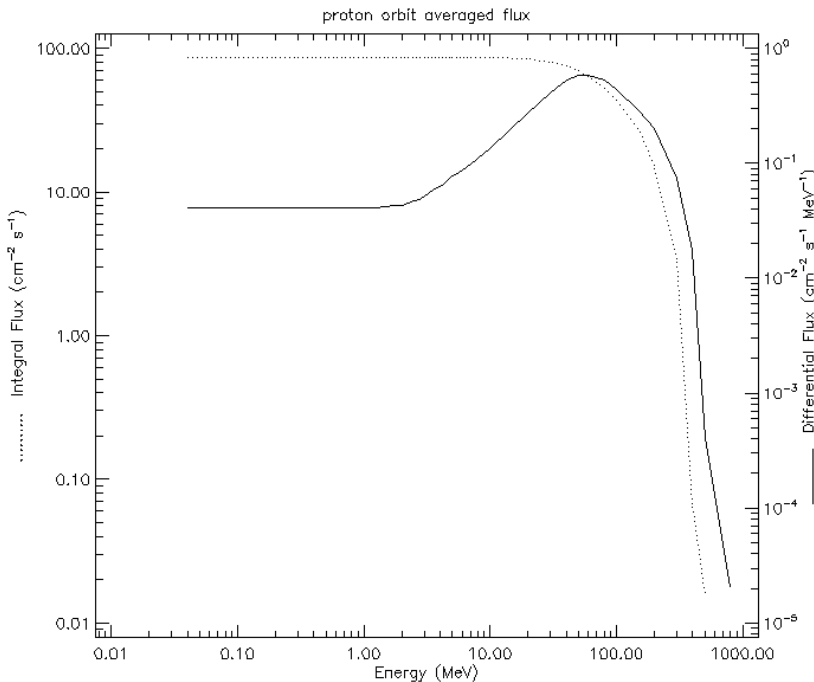
Figure 57: MFLUX results of the proton fluences behind 11.1 mm Al on an example LEO mission (800 km, 10 years, heliosynchronous)

As an example a 10 year mission in heliosynchronous orbit at 800 km altitude is considered. The tool used for generation of the orbit and estimation of the radiation environment and levels is the Space Environment Information System (SPENVIS) and the tools and models contained therein. As discussed in chapter 9.3.1, a relevant thickness of the aluminium shielding is 14mm. Using the MFLUX tool in SPENVIS, the shielded flux of protons behind 11.1 mm aluminium has been calculated (the next lower value from 14 mm, as only limited values are allowed in the tool), ref. Figure 57. In this example the highest contribution in the energy spectrum comes from protons of approx. 50-100 MeV energy with fluxes in the order of 100 p/cm²/s and thus accumulates to approx. 3.2E10 p/cm² over the 10 year mission.

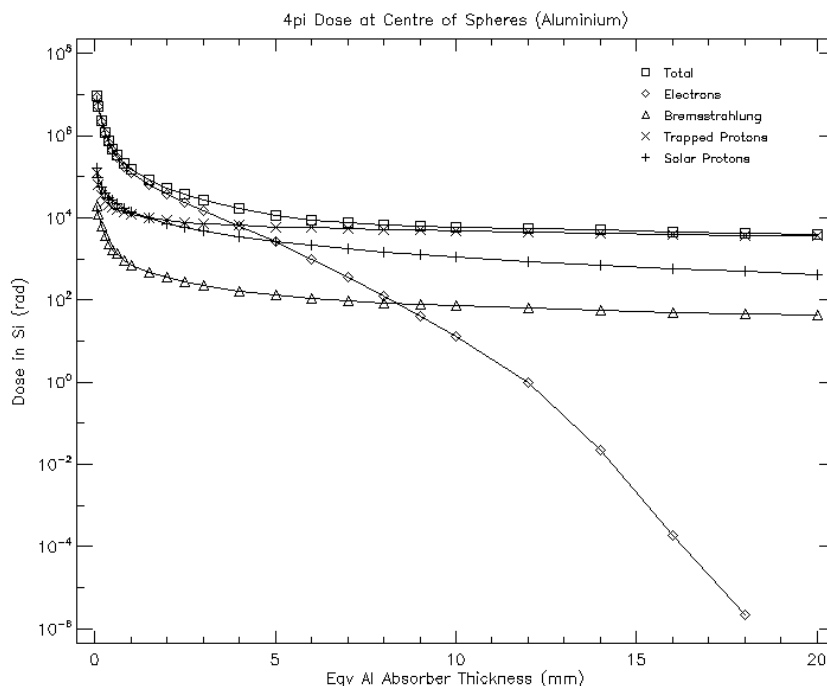
Figure 58: SHIELDOSE2Q results of the total dose behind aluminium on an example LEO mission (800 km, 10 years, heliosynchronous)

As an example a 10 year mission in heliosynchronous orbit at 800 km altitude is considered. The tool used for generation of the orbit and estimation of the radiation environment and levels is the Space Environment Information System (SPENVIS) and the tools and models contained therein. To estimate the total ionizing dose behind aluminium shielding, e.g. the outer hull of the satellite, a SHIELDOSE2Q simulation is used, ref. Figure 58. This is a standard tool for this type of estimation. However it has some intrinsic limitations and may not be fully applicable to the STIM210 or STIM300. This is mainly because the total dose is simulated in silicon positioned directly behind the aluminium shielding, whereas in the UUTs tested here are more complex and feature a thick aluminium package themselves.

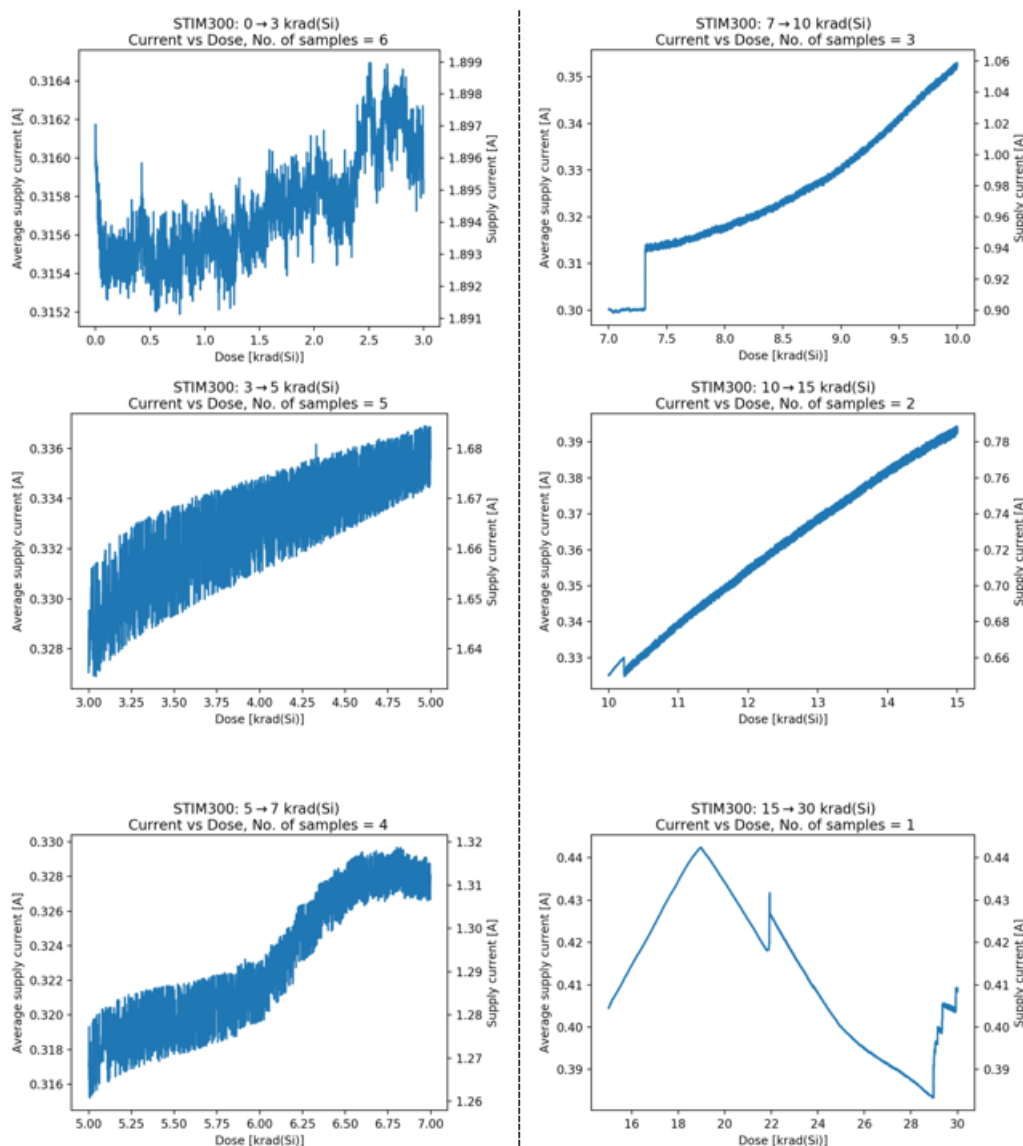
Figure 59: TID test of STIM300: Average supply current vs. total ionizing dose (individual dose steps)

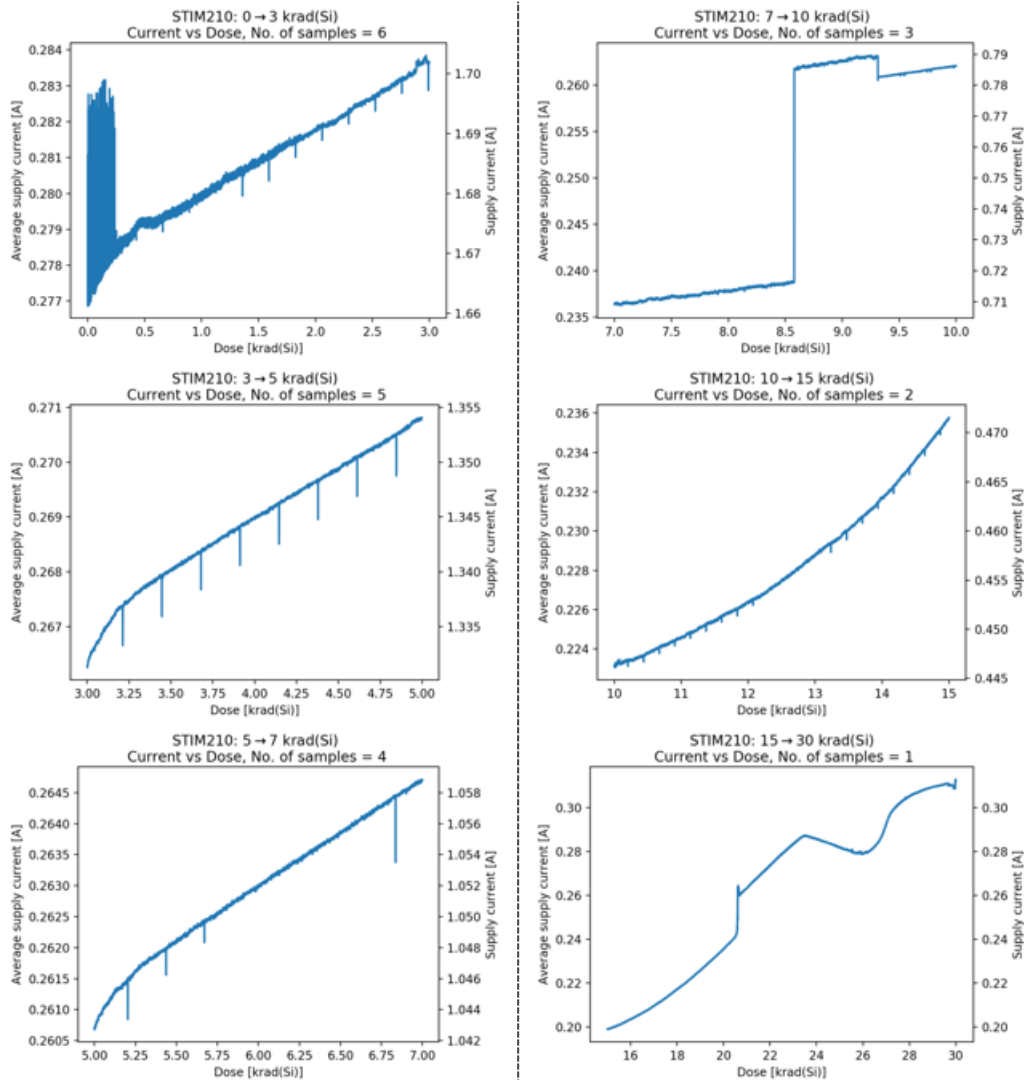
Figure 60: TID test of STIM210: Average supply current vs. total ionizing dose (individual dose steps)

Furthermore to some extent the STIM210 shows a regular pattern of reduced current spikes. From the data it cannot be concluded whether this is a dose or a time effect.

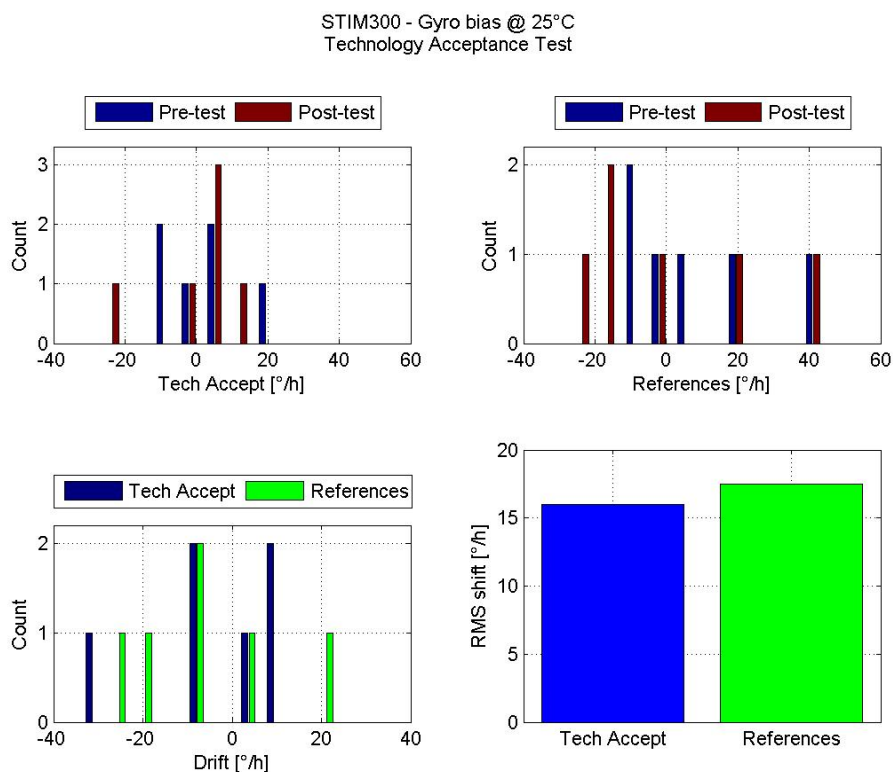
Figure 61 STIM300 Gyro bias at +25 °C before and after TA test

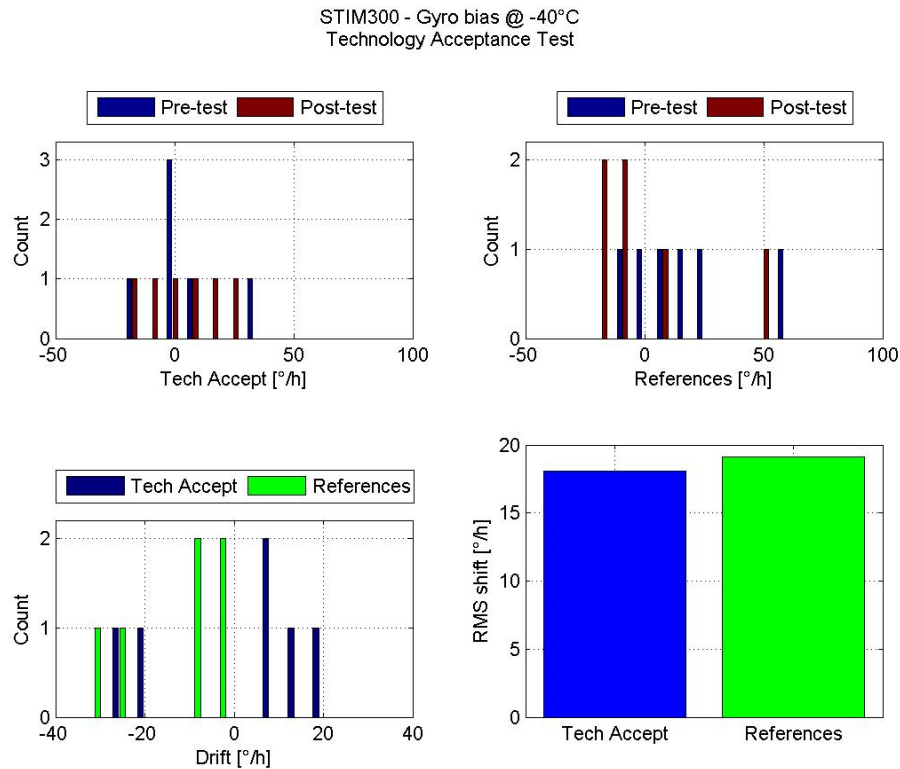
Figure 62 STIM300 Gyro bias at -40°C before and after TA test

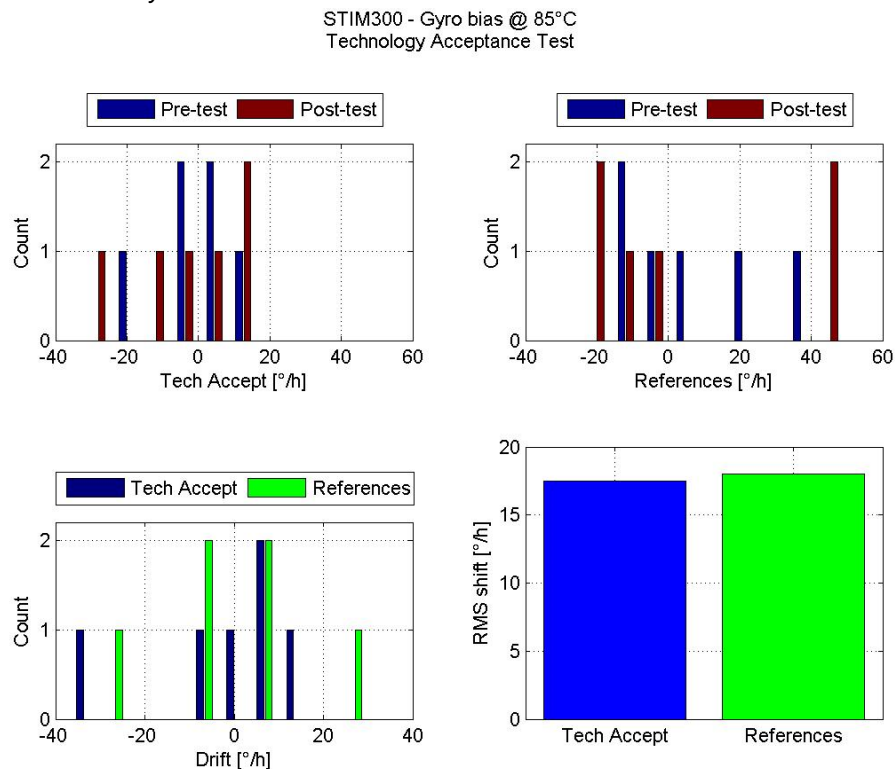
Figure 63 STIM300 Gyro bias at +85 °C before and after TA test

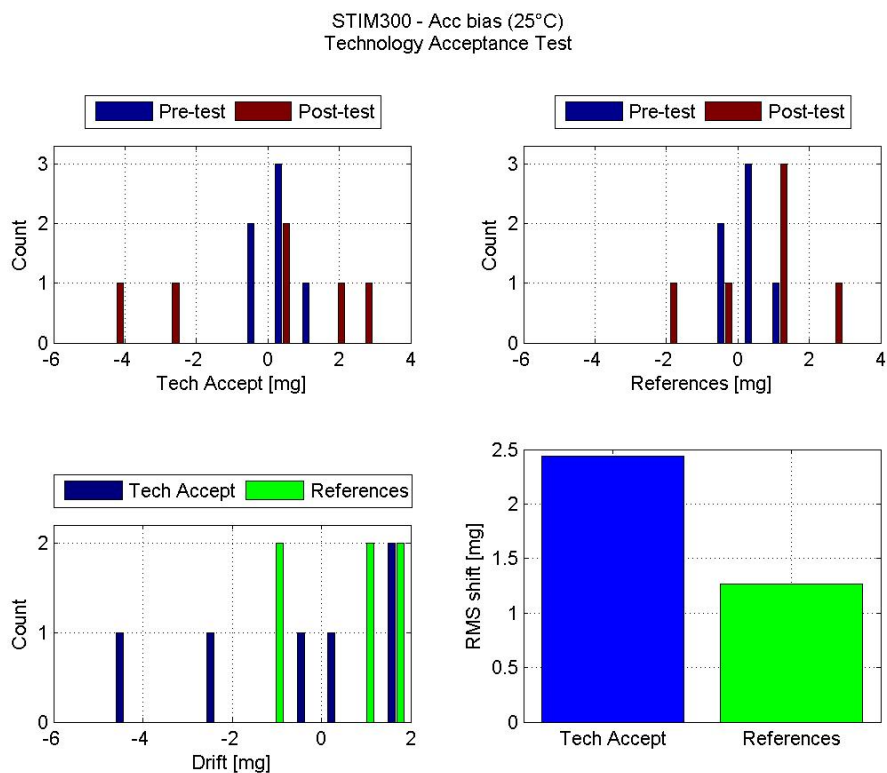
Figure 64 STIM300 Accelerometer bias at +25 °C before and after TA test

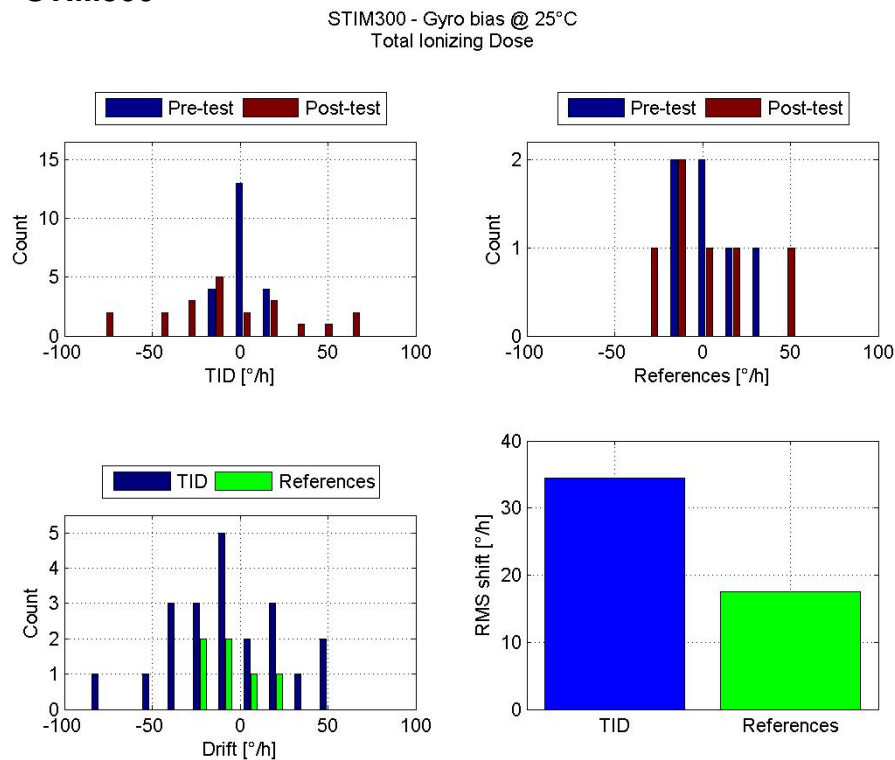
Figure 91 STIM300 Gyro bias error at +25 °C before and after TID test
