TECHNICAL NOTE

Distribution	Prepared by Hans Erik Mathisen		Document No TN19081902	
	Sign HEM(sign)	Date 19.08.2019	Page of	1 108
Document Title Radiation testing of STIM210 and STIM300

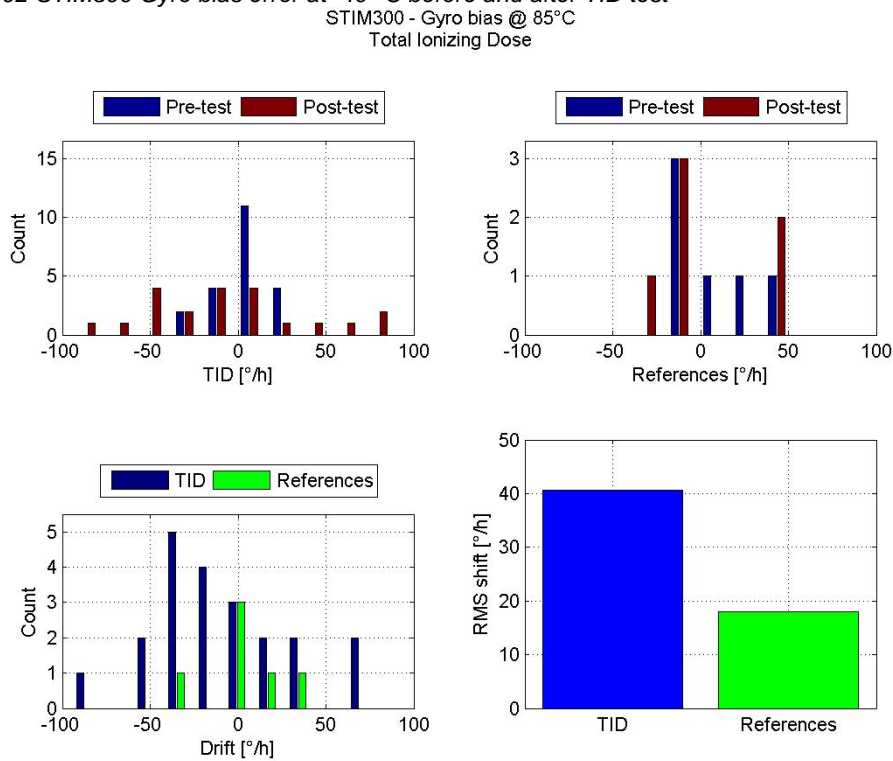
Figure 93 STIM300 Gyro bias error at 85 °C before and after TID test

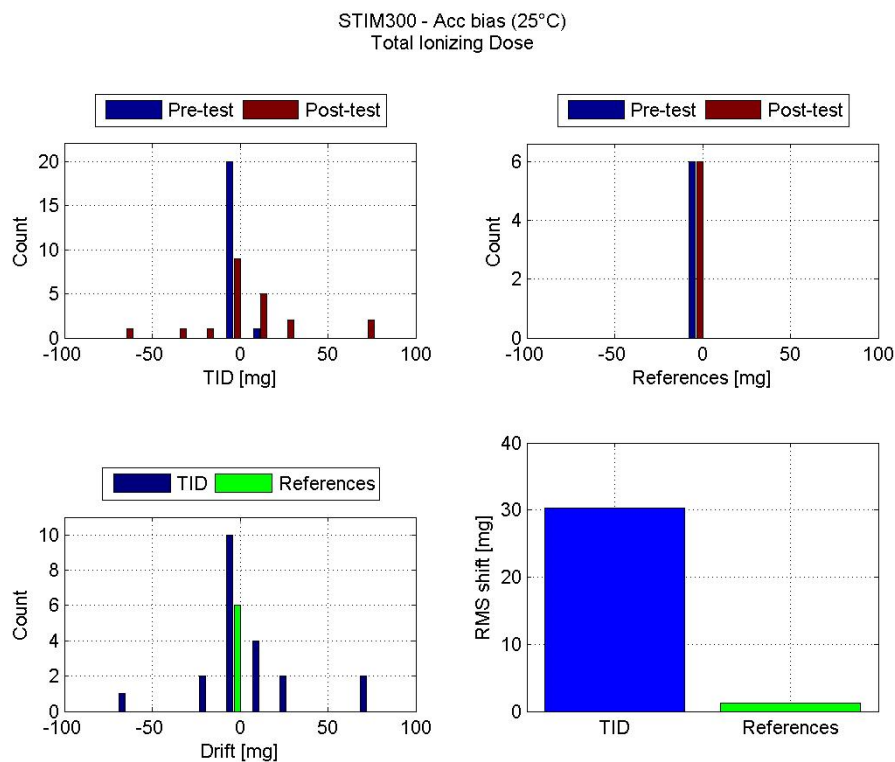
Figure 94 STIM300 Accelerometer bias error at +25 °C before and after TID test

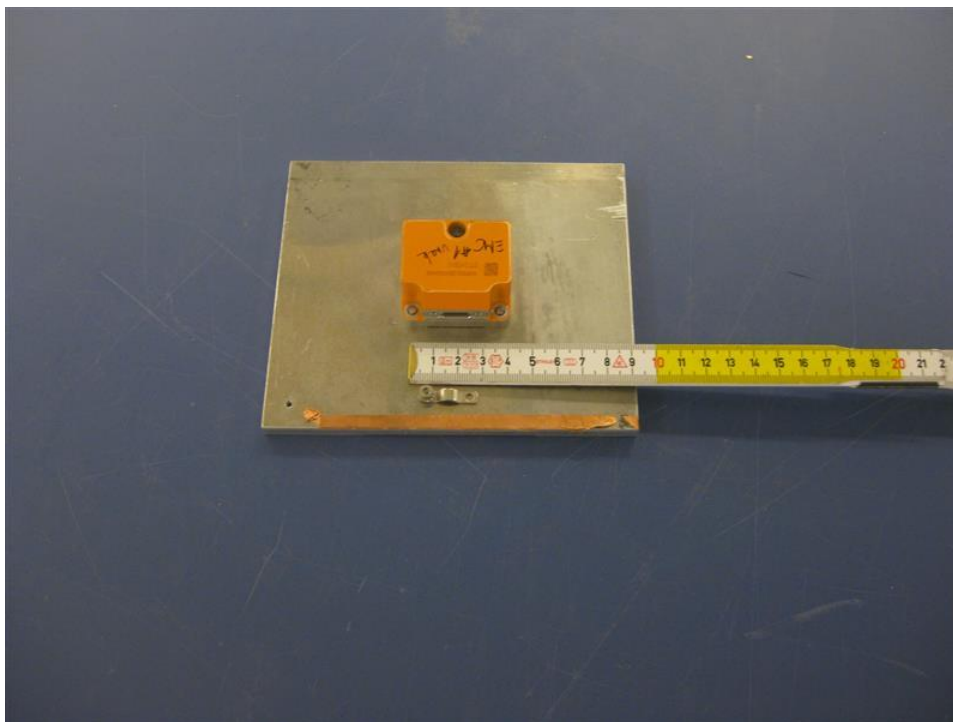
Photo 2.1.1 Test object.

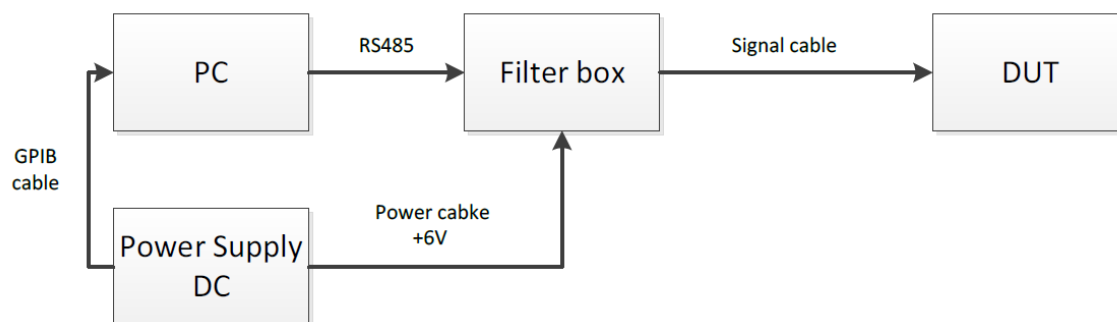
Figure 3.1.1 Block diagram of test object(s) with cables and auxiliary equipment.

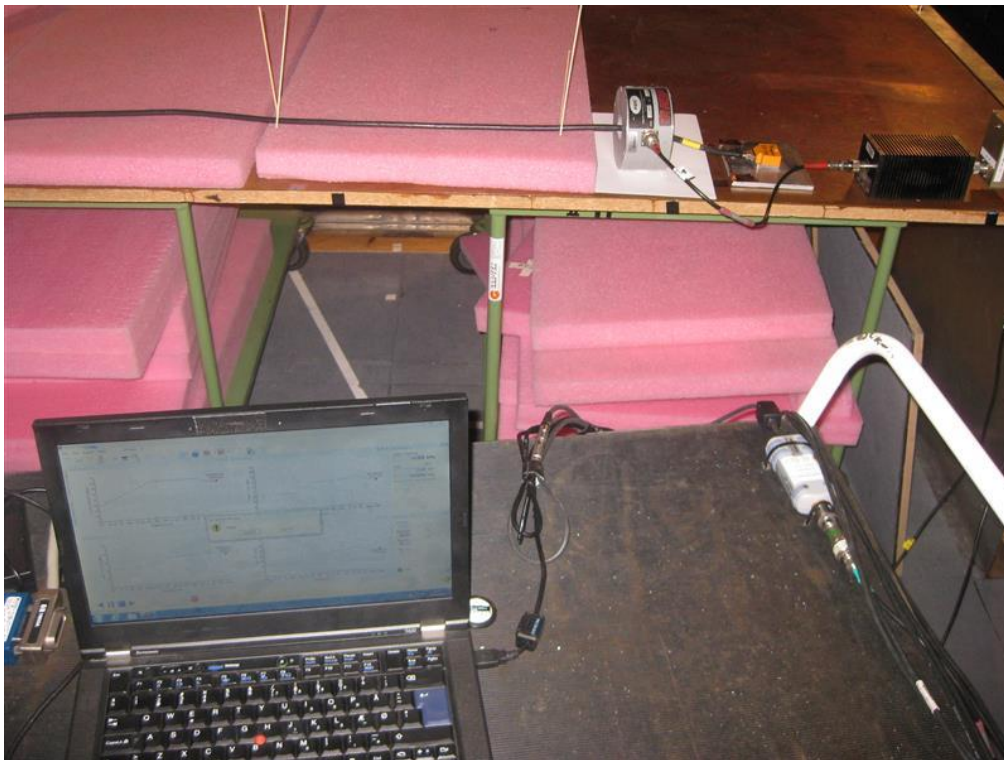
Photo 4.1.1 Test setup regarding CS114, Conducted Susceptibility, Bulk Cable Injection.

Comments The current has not been measured during the test, which may have resulted in over-testing using more than the specified current limit.

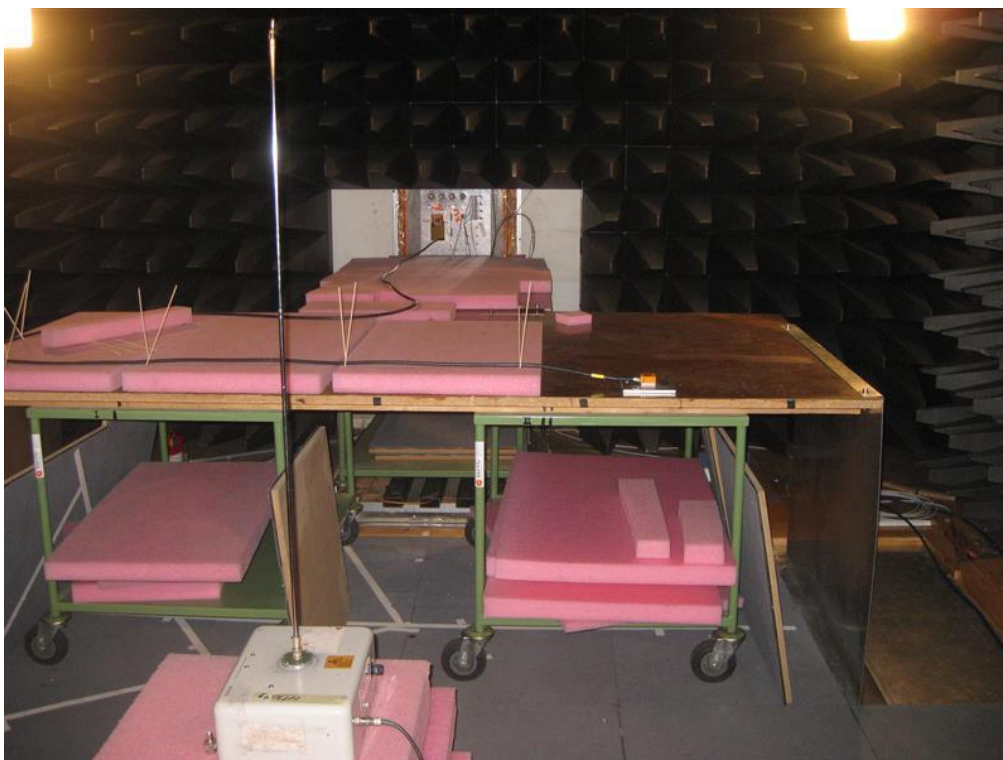
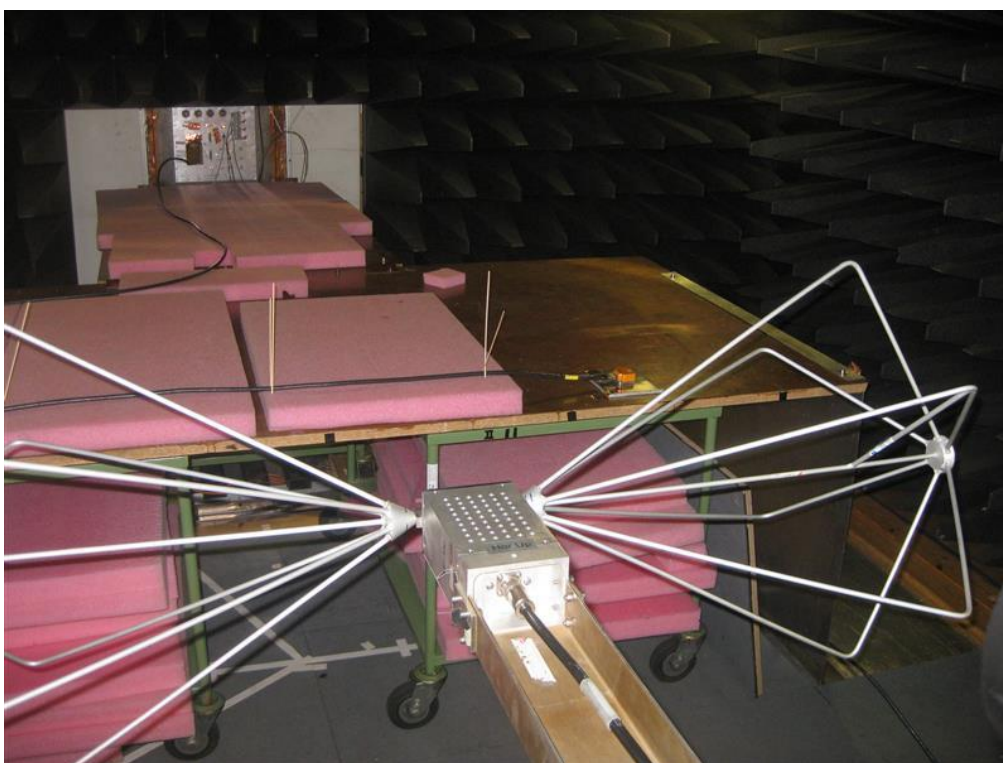
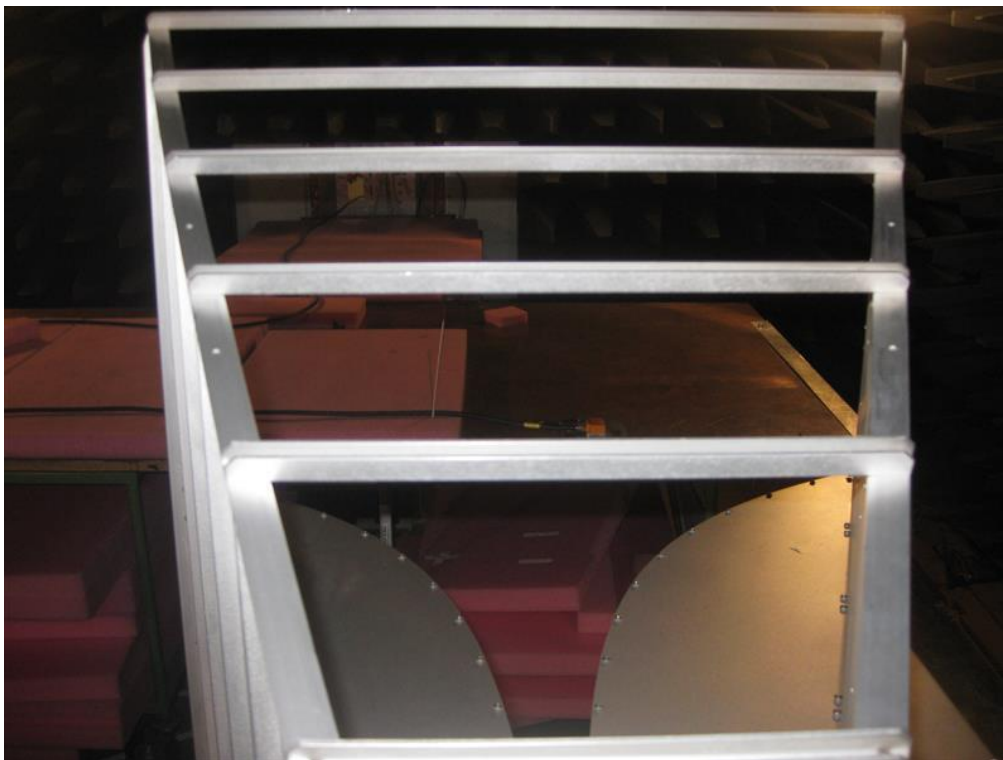
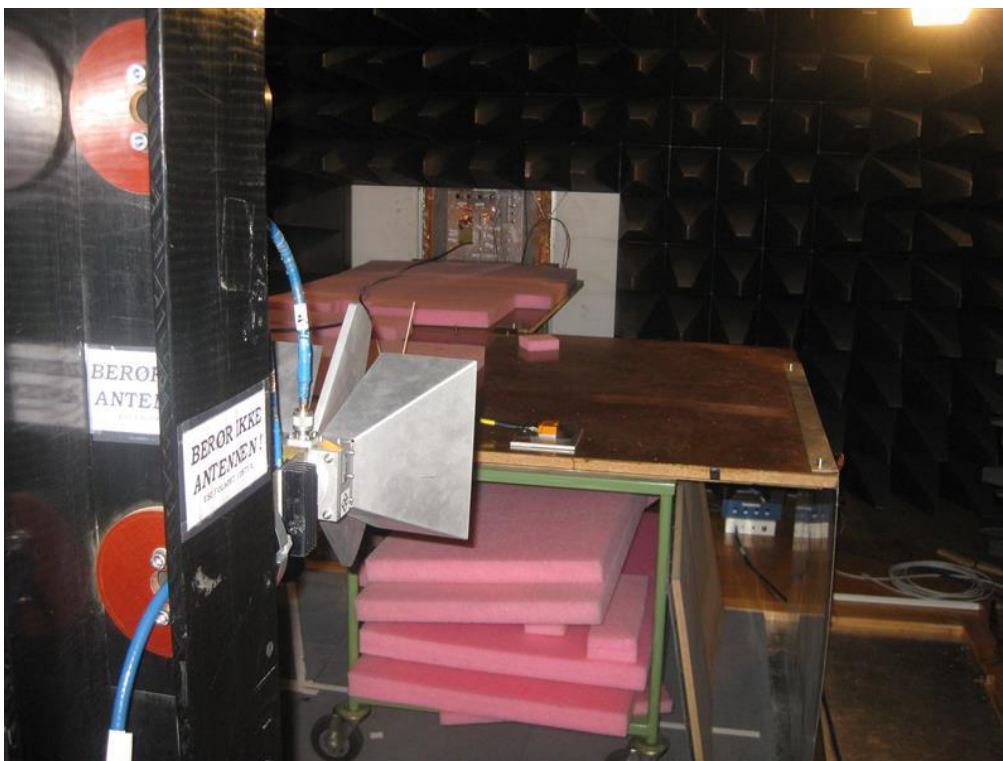
Photo 4.2.1 Test setup regarding RE102, Radiated emissions, electric field.

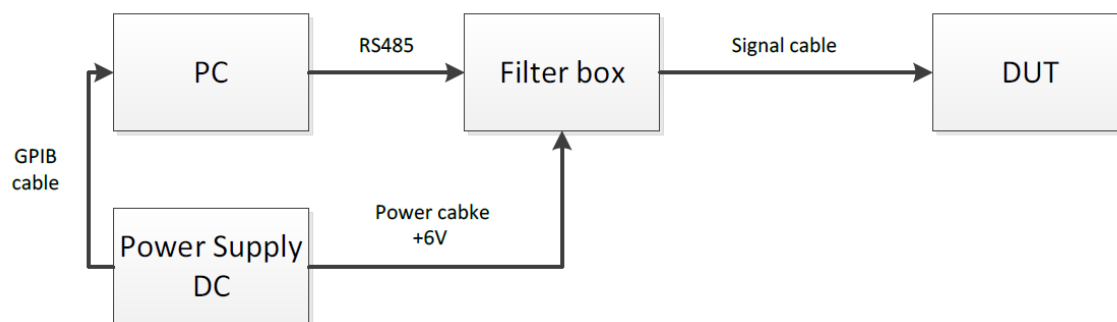
Figure 3.1.1 Block diagram of test object(s) with cables and auxiliary equipment.

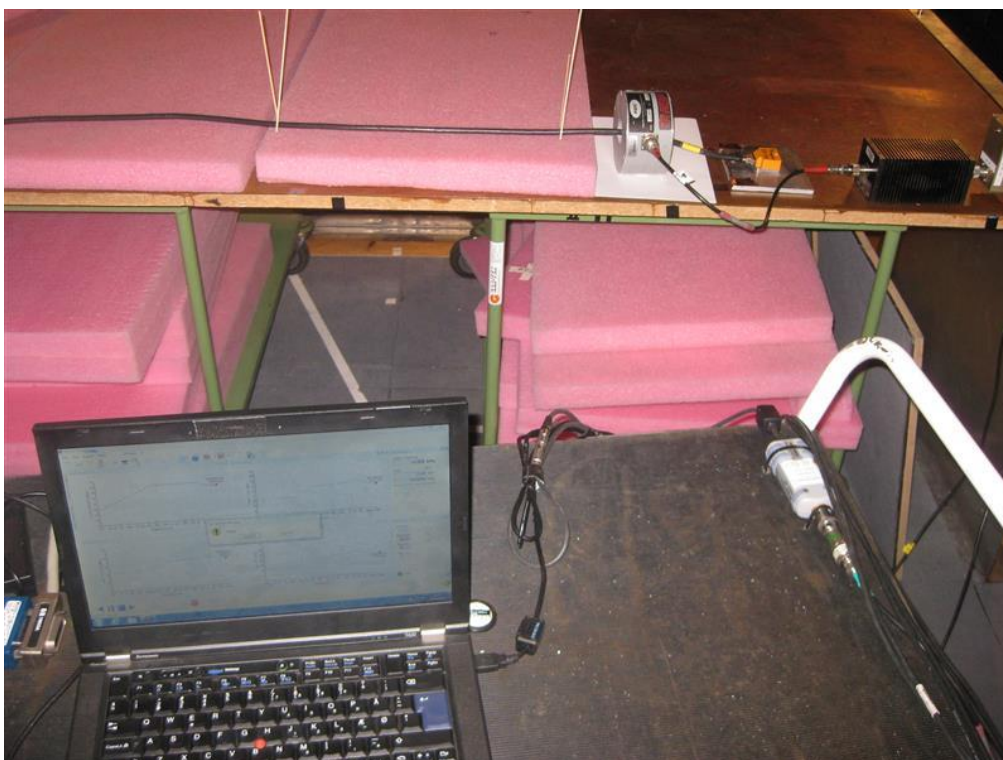
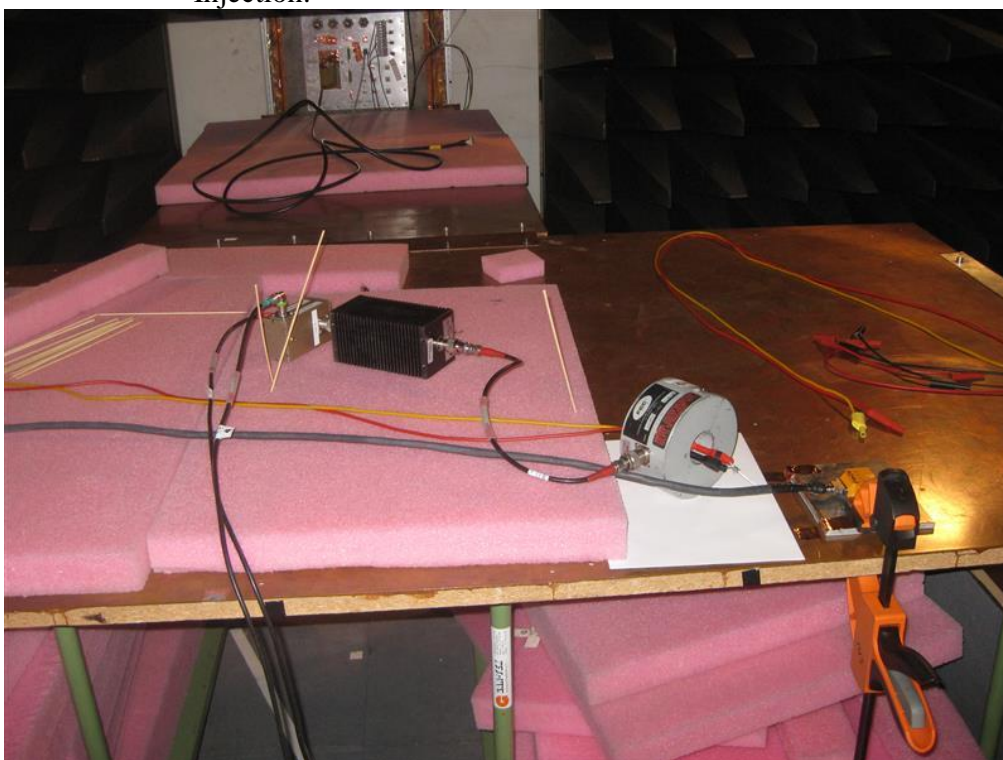
Photo 4.1.1 Test setup regarding CS114, Conducted Susceptibility, Bulk Cable Injection.

Requirement for space is Curve 3. The combined cable is tested at a higher level due to client request.

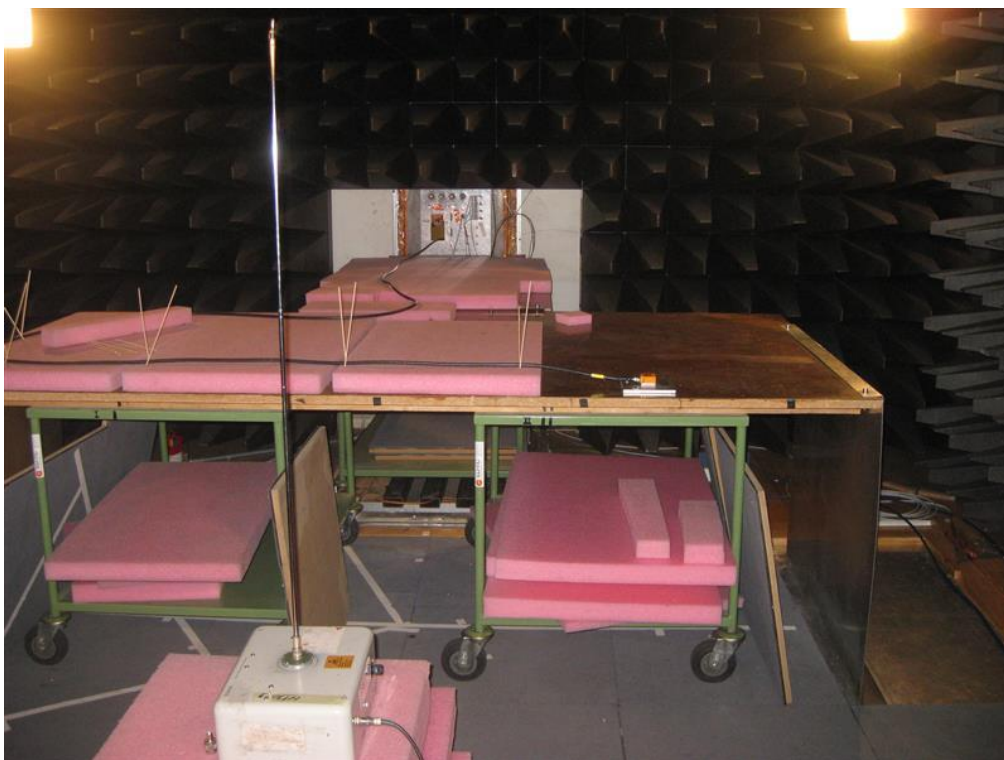
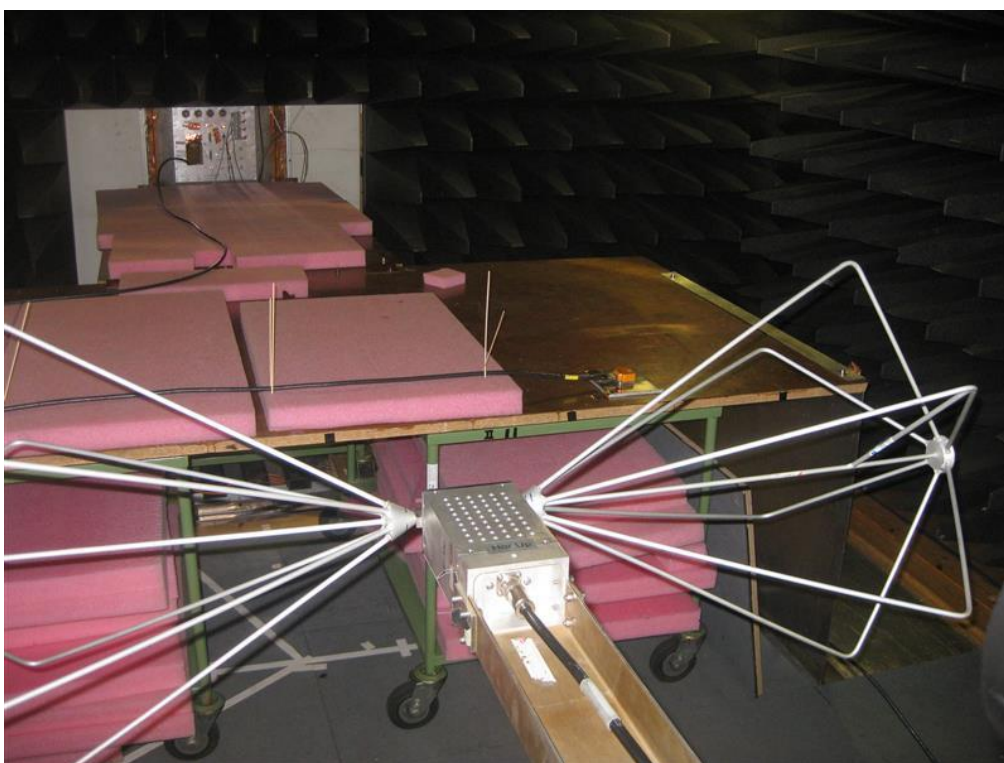
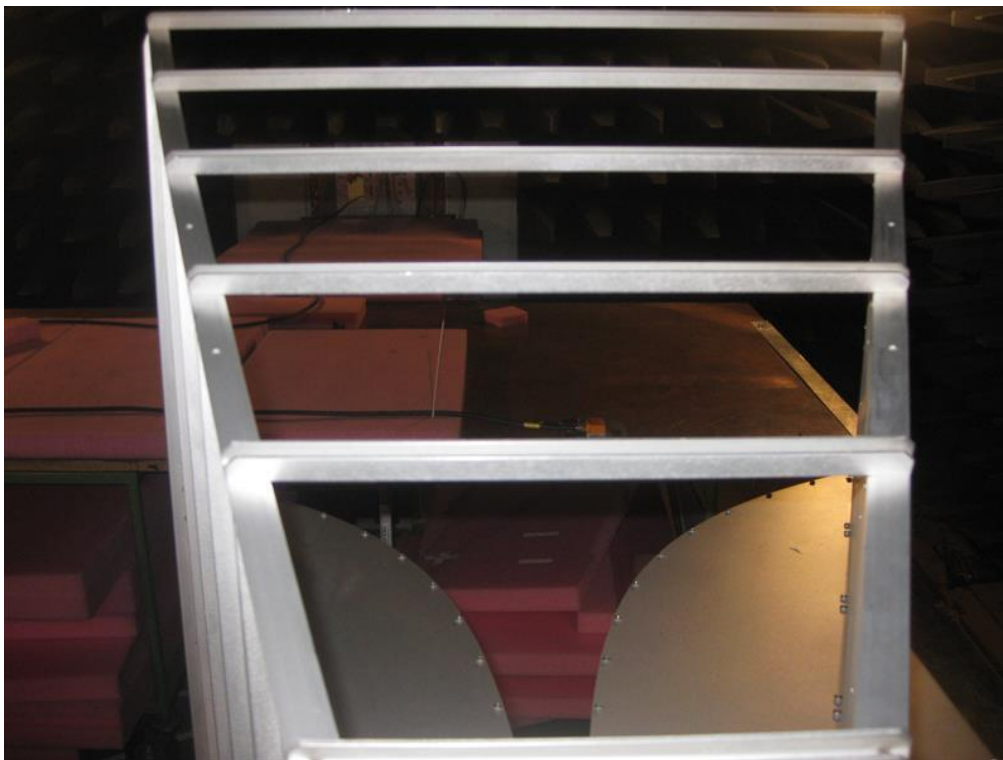
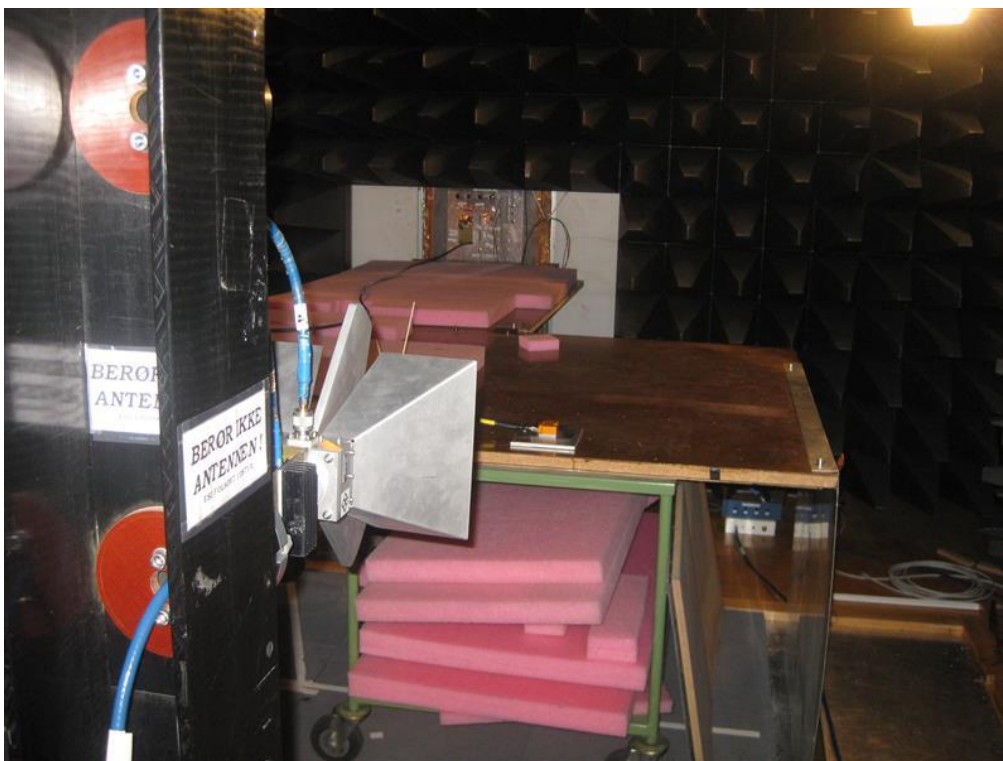
Photo 4.2.1 Test setup regarding RE102, Radiated emissions, electric field.
