## Short Term Effectiveness of High Density Large Woody Debris in Asotin Creek as a Cheap and Cheerful Restoration Action

SHORT TERM EFFECTIVENESS OF HIGH DENSITY LARGE WOODY  
DEBRIS IN ASOTIN CREEK AS A CHEAP AND  
CHEERFUL RESTORATION ACTION

Watershed Science

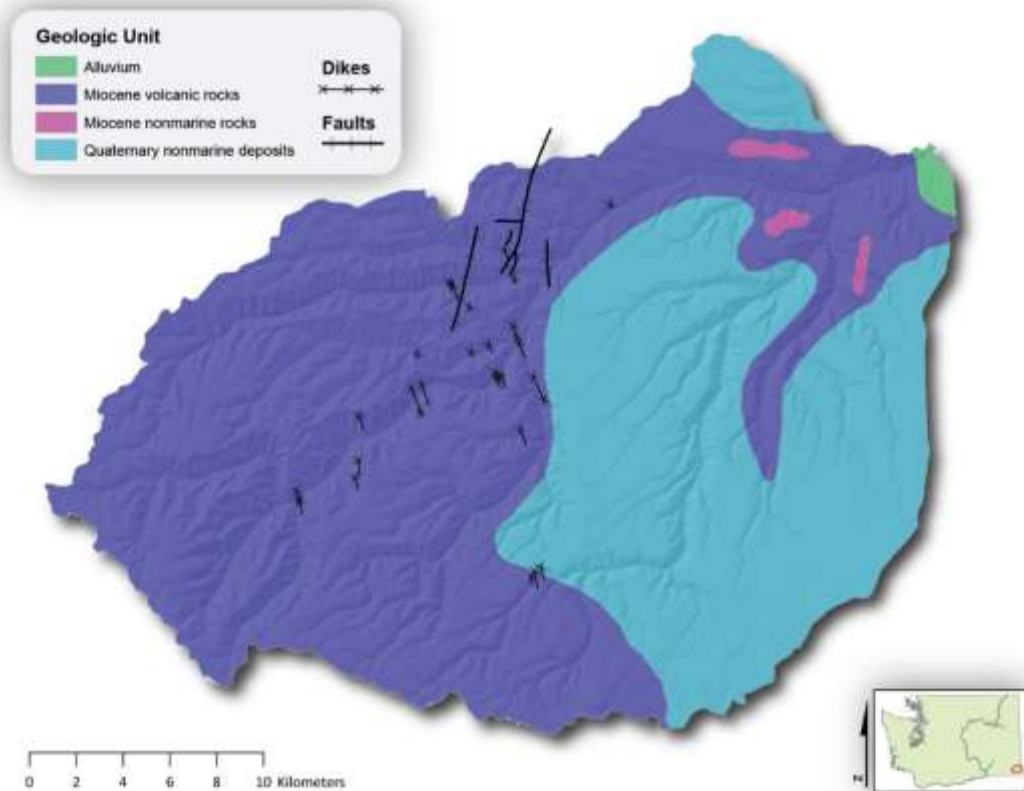
Figure 2.1. Geology within the Asotin Creek drainage.

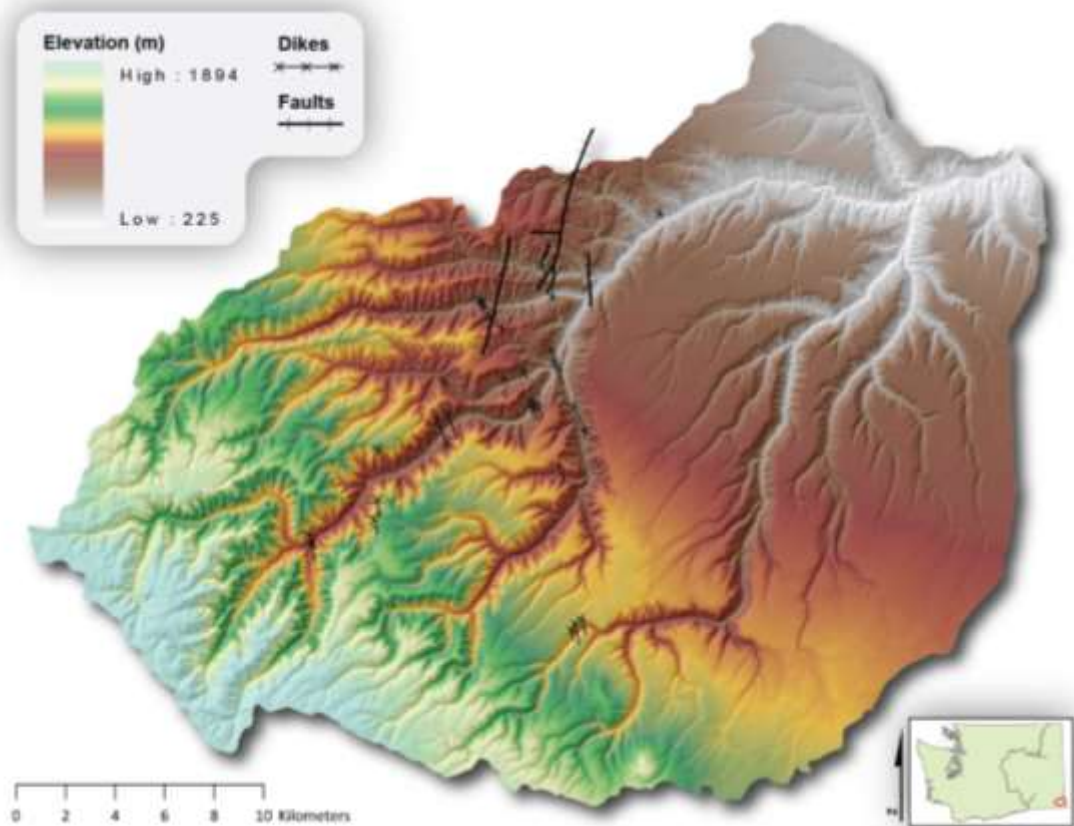
Figure 2.3. Digital elevation model of Asotin Creek drainage and surrounding area. Major dikes and faults are also shown.

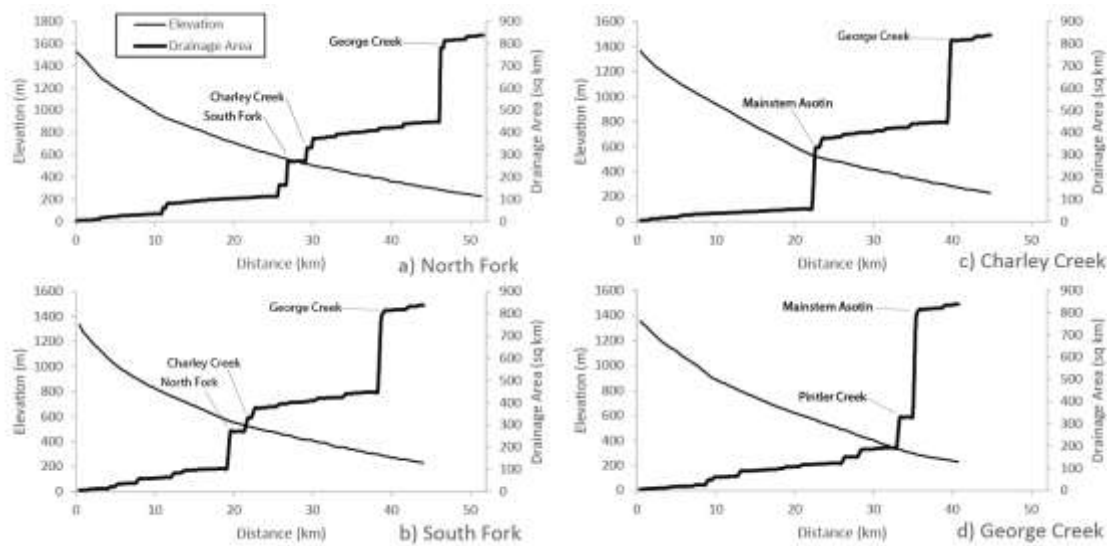
Figure 2.4. Longitudinal profiles and cumulative drainage areas extending to mouth of Asotin Creek and starting in four major tributaries to Asotin Creek: North Fork of Asotin Creek, South Fork of Asotin Creek, Charley Creek, and George Creek.

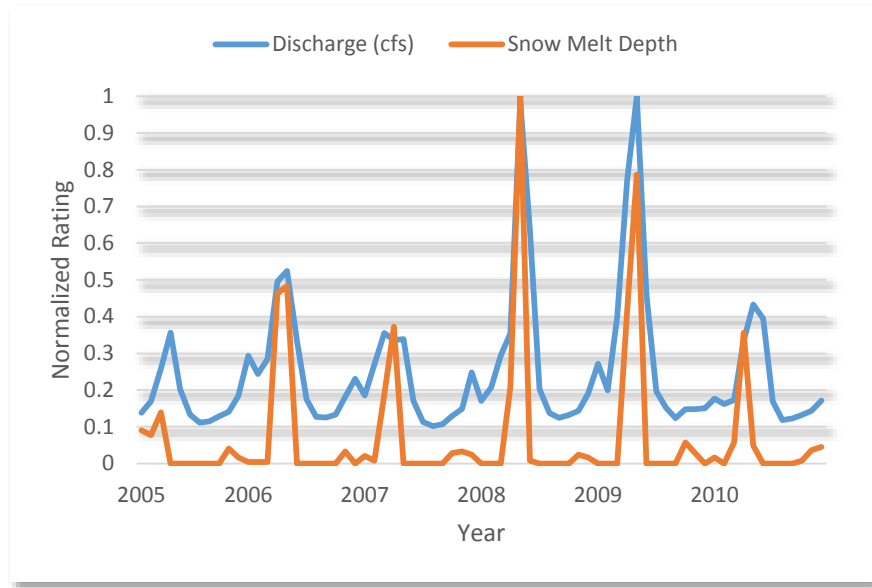
Figure 2.7. Normalized snowmelt depth and discharge by year on Asotin Creek. Discharge is from the Washington Department of Ecology stream gauge #35D1000. Snow melt depth was obtained from the Spruce Springs SNOTEL gauge.

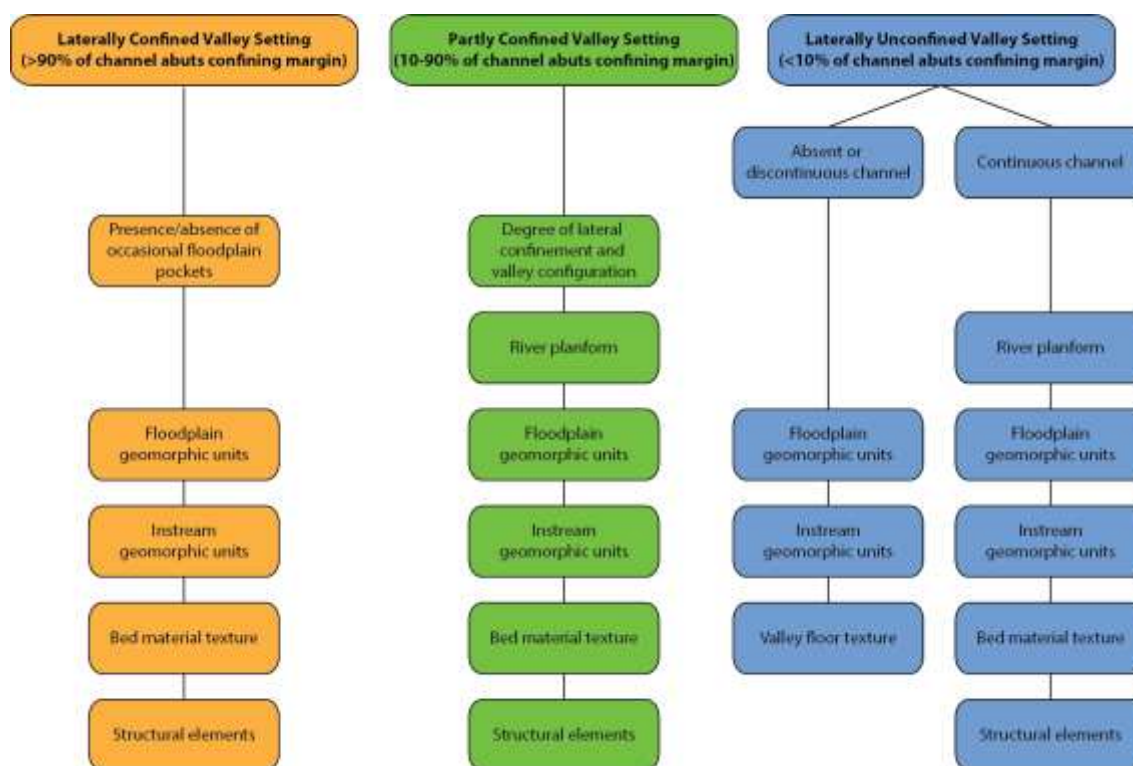
Figure 2.8. River styles procedural tree for delineating reach types adapted from Brierley and Fryirs (2005).

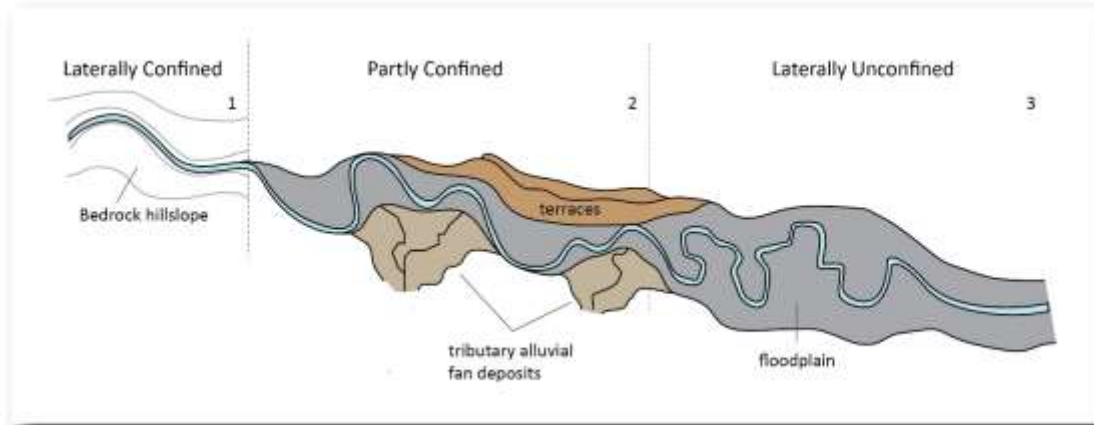
Figure 2.9. Conceptual diagram illustrating the differences between valley settings in the River Styles Framework. The stream channel abuts the valley margin  $>90\%$  in (1) laterally confined reaches,  $10-90\%$  in (2) partly confined reaches, and  $<10\%$  in (3) laterally unconfined reaches. From Obrien and Wheaton, 2015.

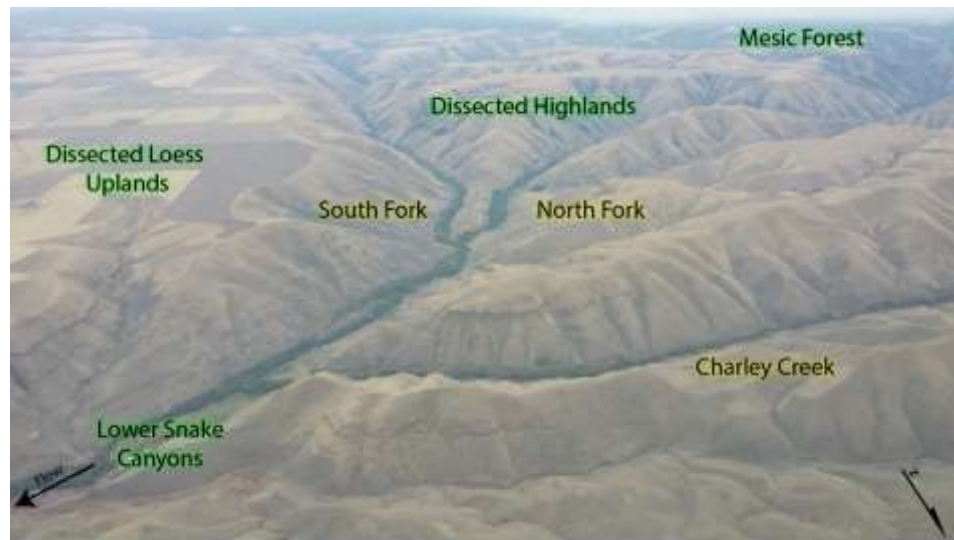
Figure 2.10. Aerial photograph of the study streams in the Asotin Creek Intensively Monitored Watershed study area (yellow) and the landscape units of the Asotin Creek Basin (green).

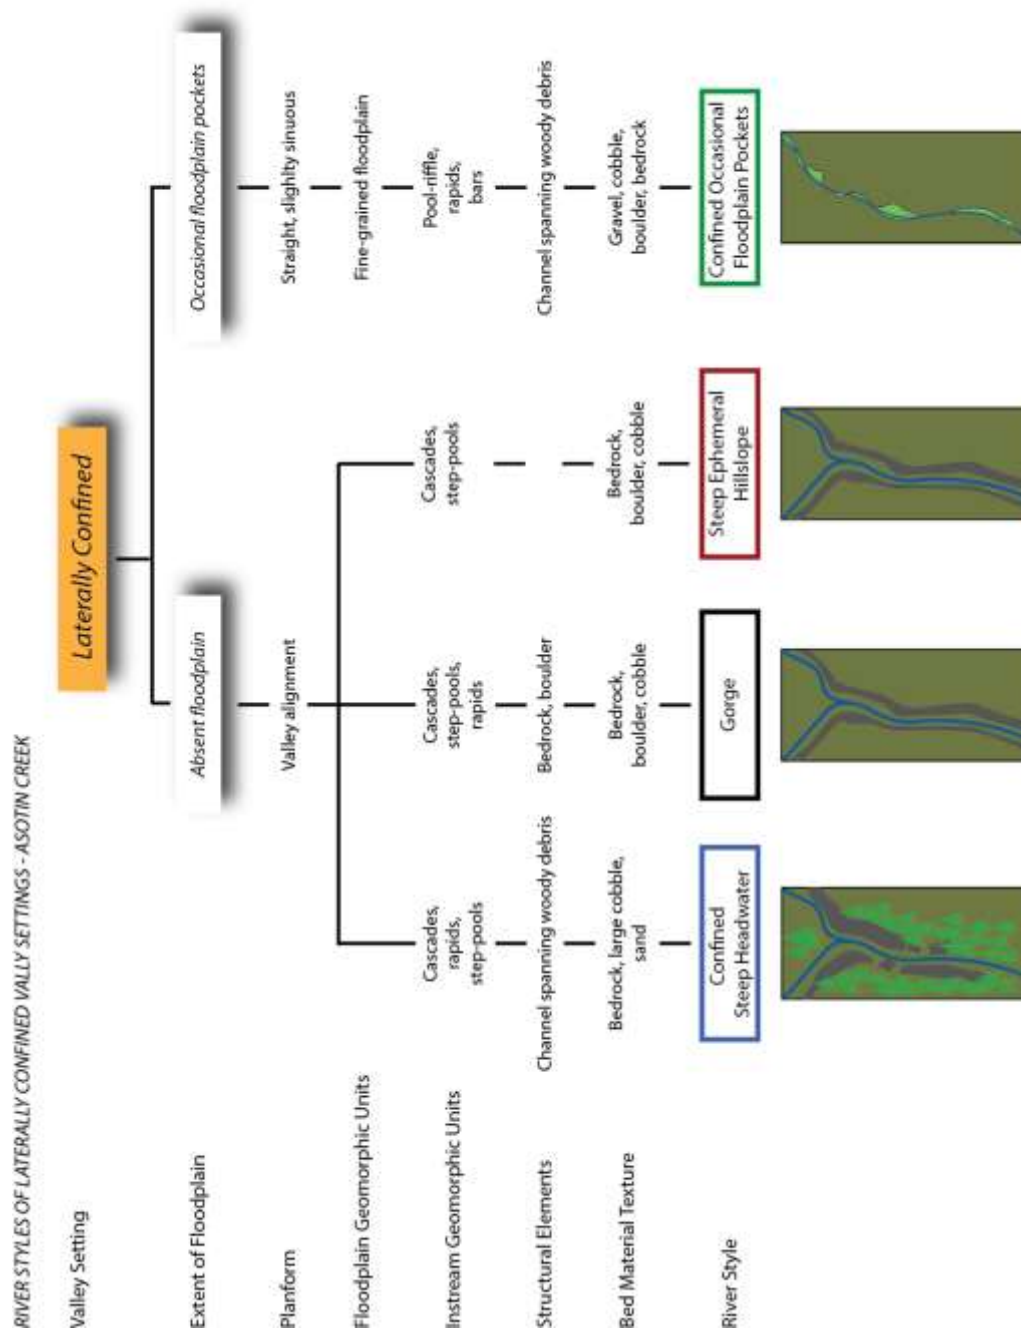
Figure 2.11. River styles tree for laterally confined valley settings in the Asotin Creek drainage.

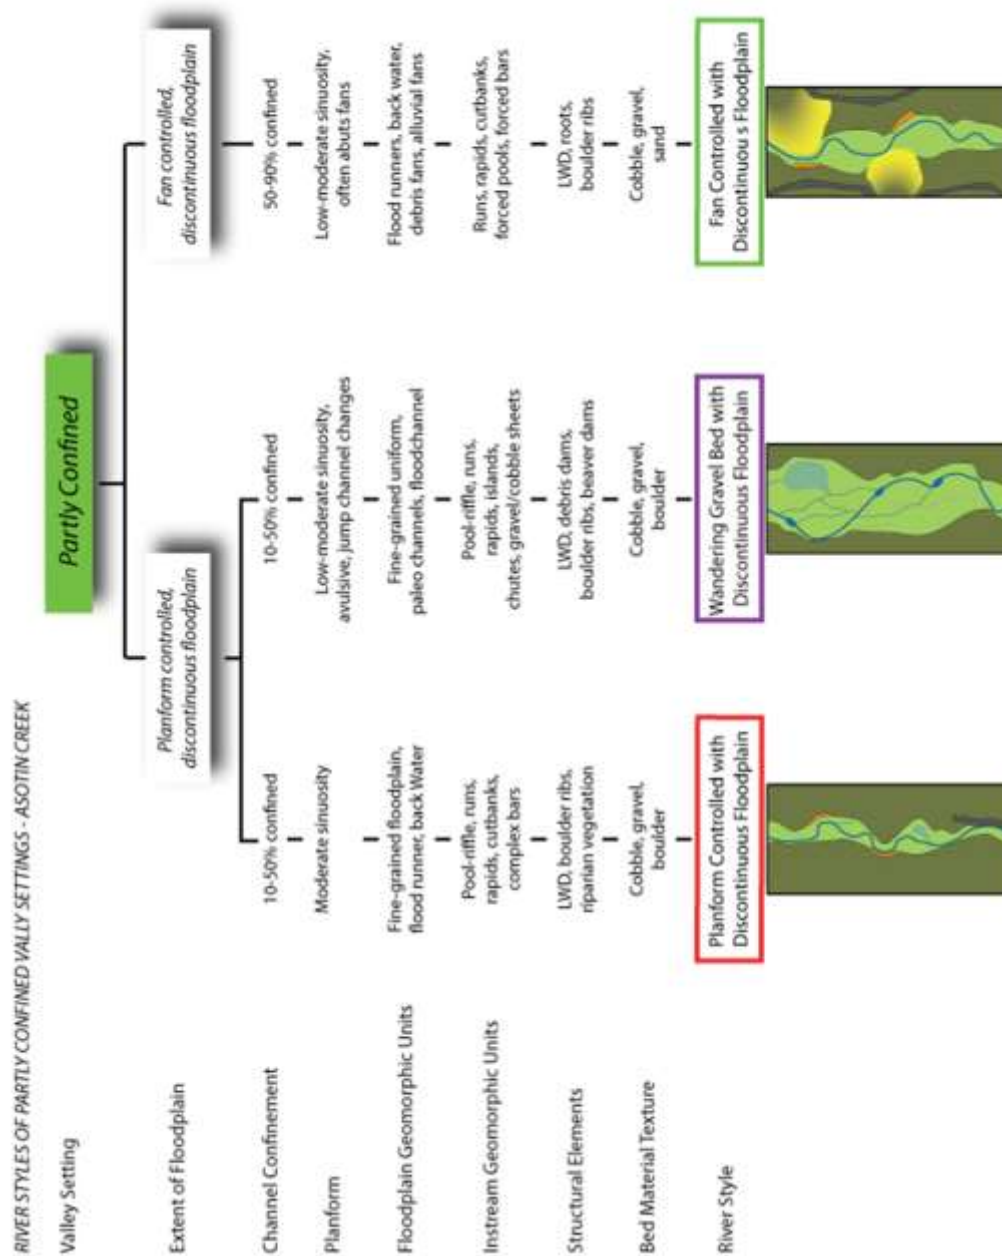
Figure 2.12. River styles tree for partly confined valley settings in the Asotin Creek drainage.

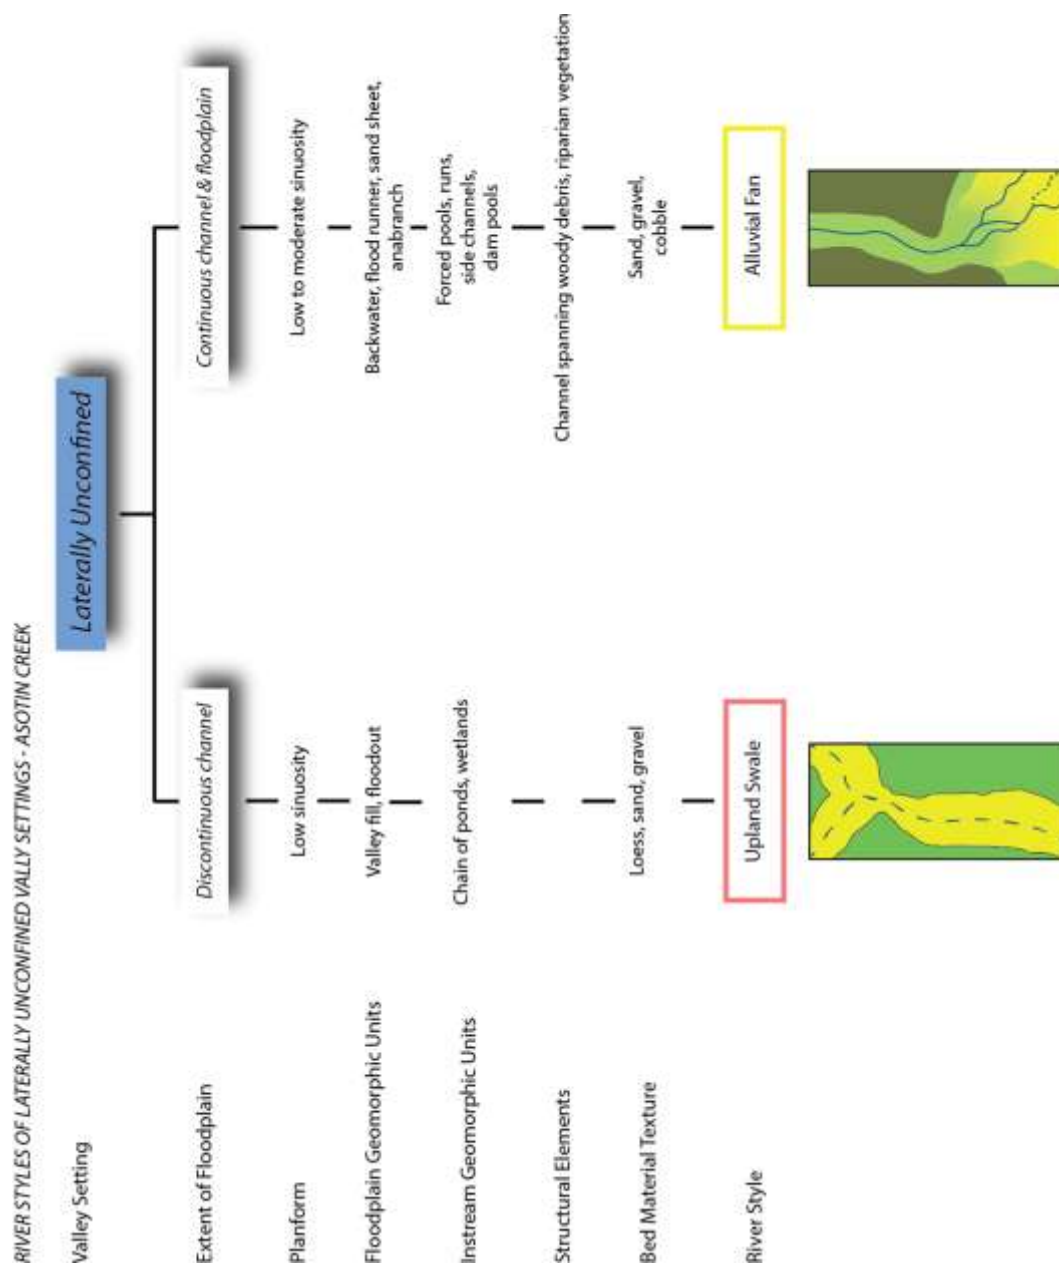
Figure 2.13. River styles tree for laterally unconfined valley setting in the Asotin Creek drainage.

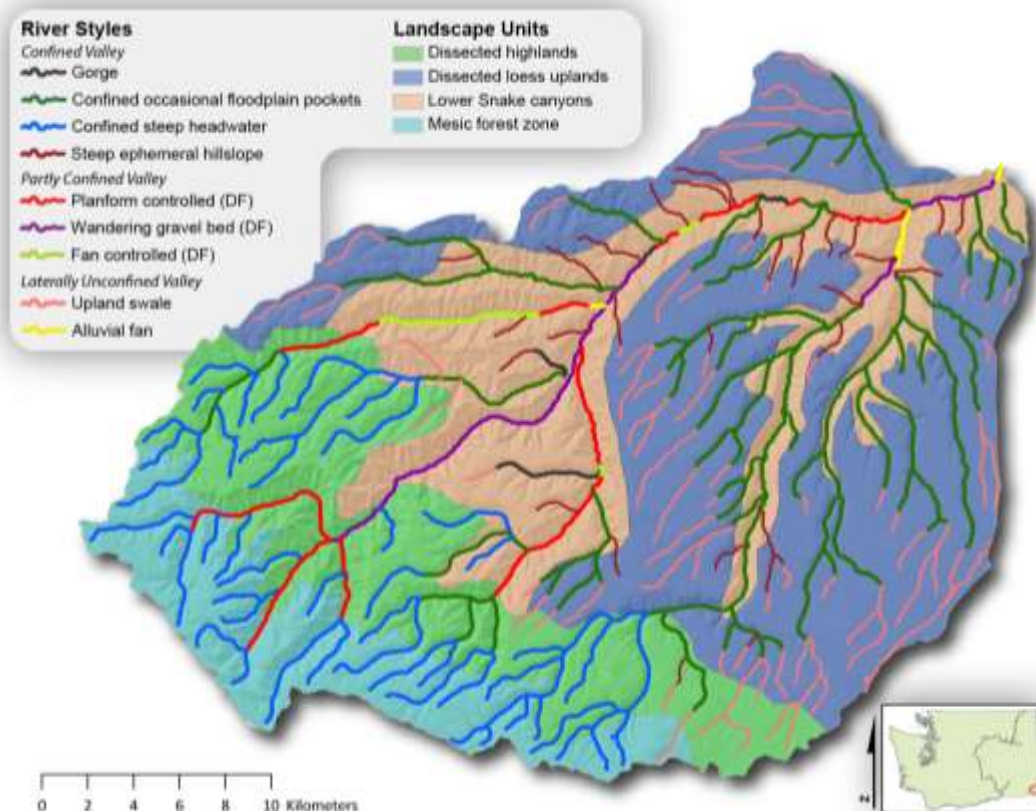
Figure 2.14. River styles classified for 2nd order streams and higher in the Asotin Creek drainage. DF = discontinuous floodplain.

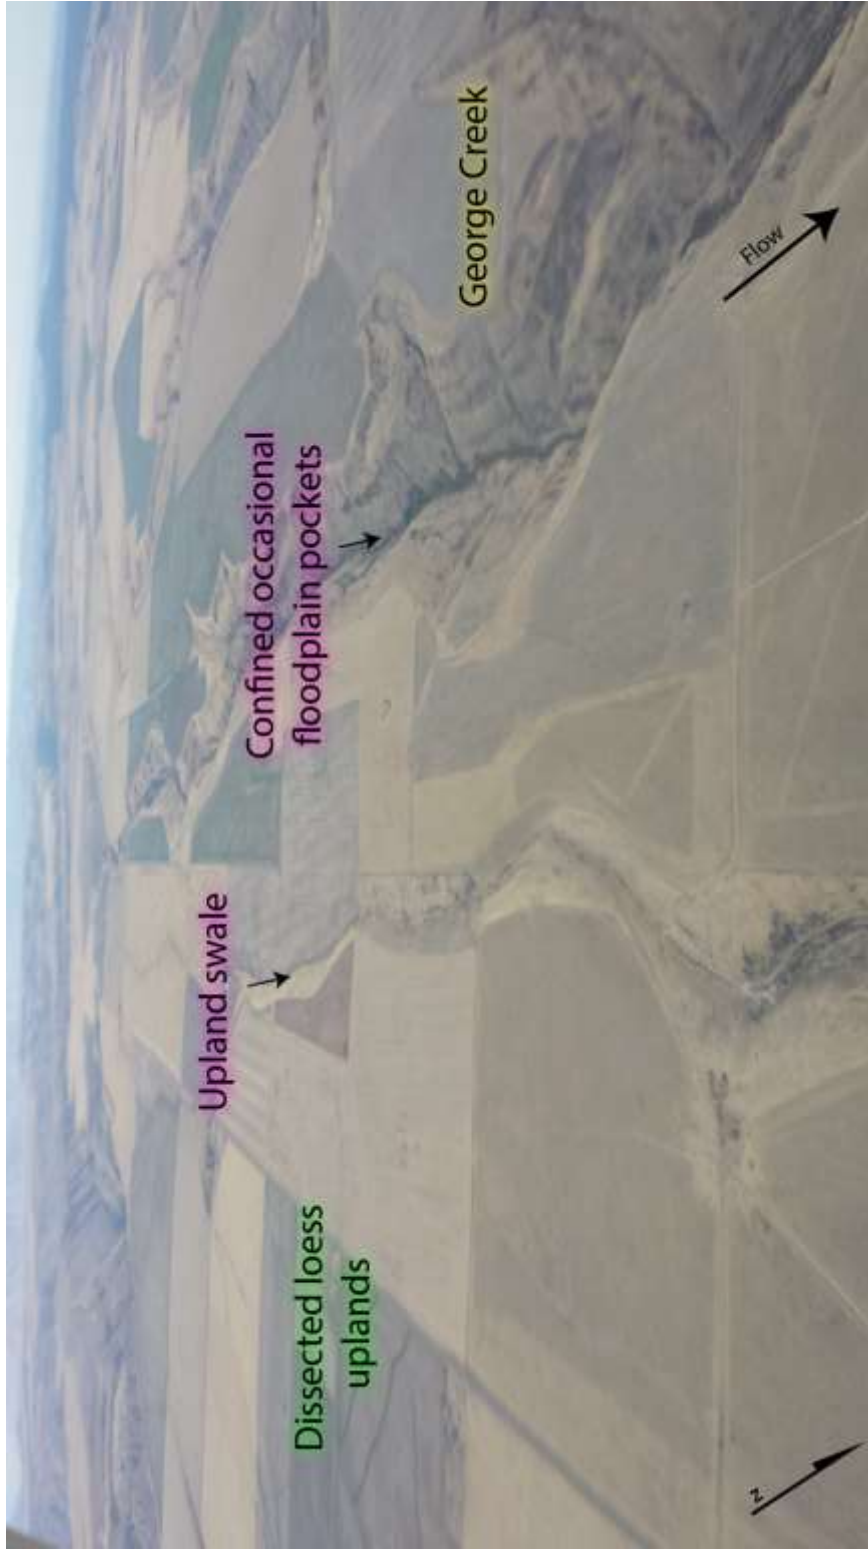
Figure 2.17. Aerial photograph of the dissected loess uplands landscape unit near George Creek in the Asotin Creek watershed. The two contrasted river styles, upland swale and confined with occasional floodplain pockets are outlined in pink.

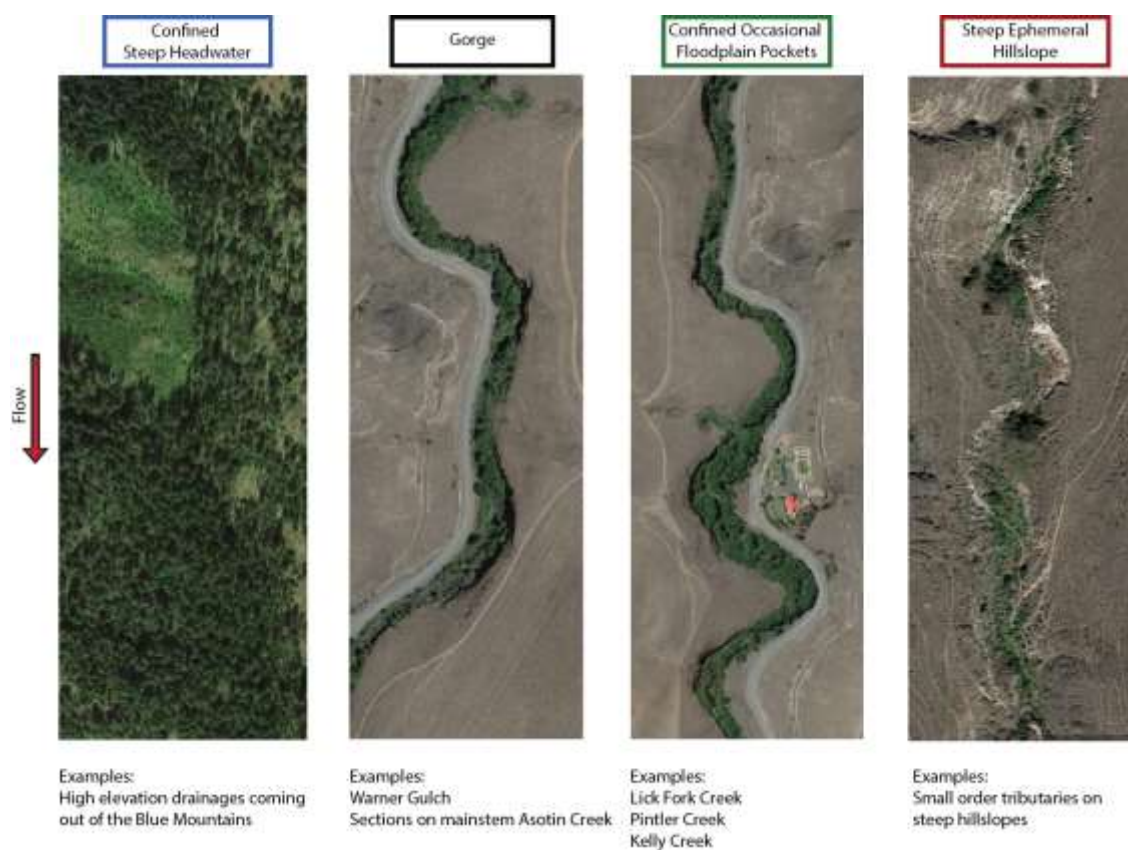
Figure 2.19. Aerial photograph examples of representative confined river styles in the Asotin Creek drainage.

River styles in the confined valley setting about the valley margin 90-100% of their length on one or both sides. Nearly 66% of the stream network in Asotin Creek is within a confined valley setting, with the primary imposition by bedrock. There are four types of confined reaches that occur in Asotin Creek and its tributaries (Figure 2.19).

The *Confined steep headwaters River Style* is present only in the upper reaches of the drainage extending from the Blue Mountains. Although most reaches are perennial,

The *Gorge River Style* occurs infrequently in the drainage, primarily because one of its defining characteristics is the complete lack of a floodplain. The channel is mostly bordered by bedrock, although the bed usually contains a mixed load of boulder, cobble, and gravel. The gradient is steep (5-10%) and the planform is restricted by exposed basalt outcroppings, forcing the river to align to the valley margin, and become greatly incised. These reaches are found in some minor tributaries and on some sections of the mainstem of Asotin Creek. Aside from the sections on the mainstem, gorges in the Asotin watershed are typically ephemeral and are large sediment sources during intense, local storm events because of the high valley constriction and proximity to loess sediment sources. For example, the *Gorge River Style* section on Warner Gulch (an ephemeral tributary to the South Fork) has experienced multiple documented localized storms which brought in large amounts of sediment deposits to the South Fork.

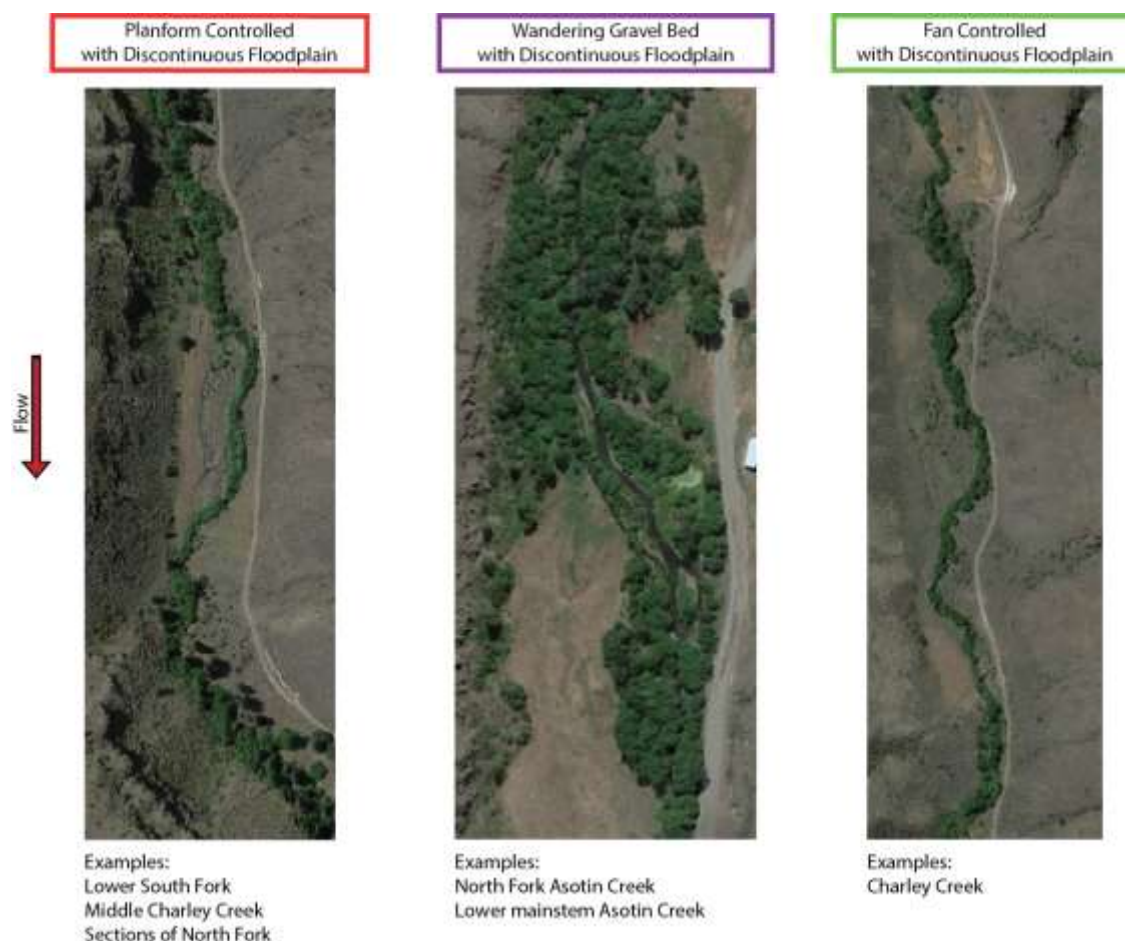
Figure 2.20. Aerial photograph examples of representative partly confined river styles in the Asotin Creek drainage.

debris fans. They occur in the main tributaries and mainstem of Asotin Creek and are the primary focus of instream habitat restoration for threatened native fish. There are four types of partly confined river styles in the Asotin Creek drainage (Figure 2.20).

The *Planform controlled with discontinuous floodplain River Style* occurs where the valley widens slightly but is still partly confining. These rivers about the valley margin 10-50% of the time, and are moderately sinuous. Multiple high-stage flood channels are common, indicating periodic overbank flows that rework the valley floor. Large floods

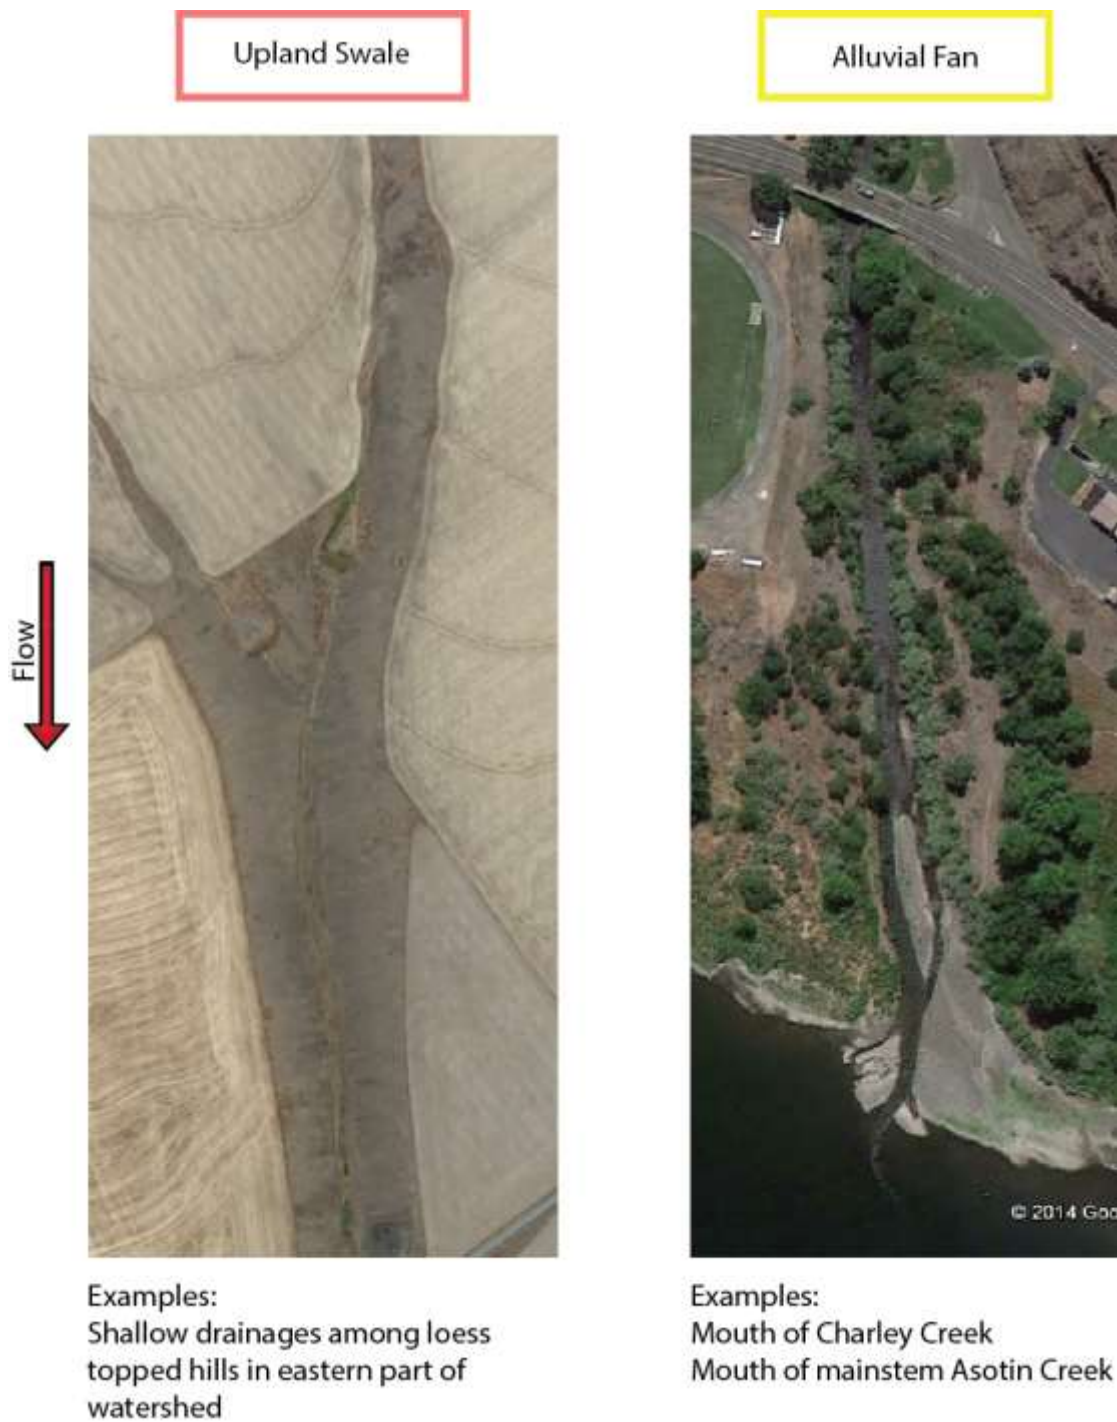
Figure 2.21. Aerial photograph examples of representative laterally unconfined river style in the Asotin Creek drainage.

With the restrictive geology of the Asotin Creek watershed, there are very few perennial reaches that are laterally unconfined. However, 23% of the river network exhibits an unconfined valley setting, but most of these are ephemeral or intermittent streams. Perennial reaches in the unconfined valley settings are only found near and at the mouths of some tributaries and at the mouth of the mainstem of Asotin Creek. There are two laterally unconfined river styles in Asotin Creek (Figure 2.21).

The ***Upland swale*** is the most predominant river style within a laterally unconfined valley setting in the Asotin Creek drainage. The channel of this river style is discontinuous with intermittent ponds and wetlands, and the valley is filled with fine sediment. The ***Upland swale River Style*** is found among smooth-sided rolling hills in the dissected loess uplands. Long, shallow swales converge to create larger, smooth-sided

depressions in the landscape to form this river style. In the Asotin Creek watershed, most of these reaches are within areas of high agricultural use, and some of the naturally occurring wetlands have been converted into ponds.

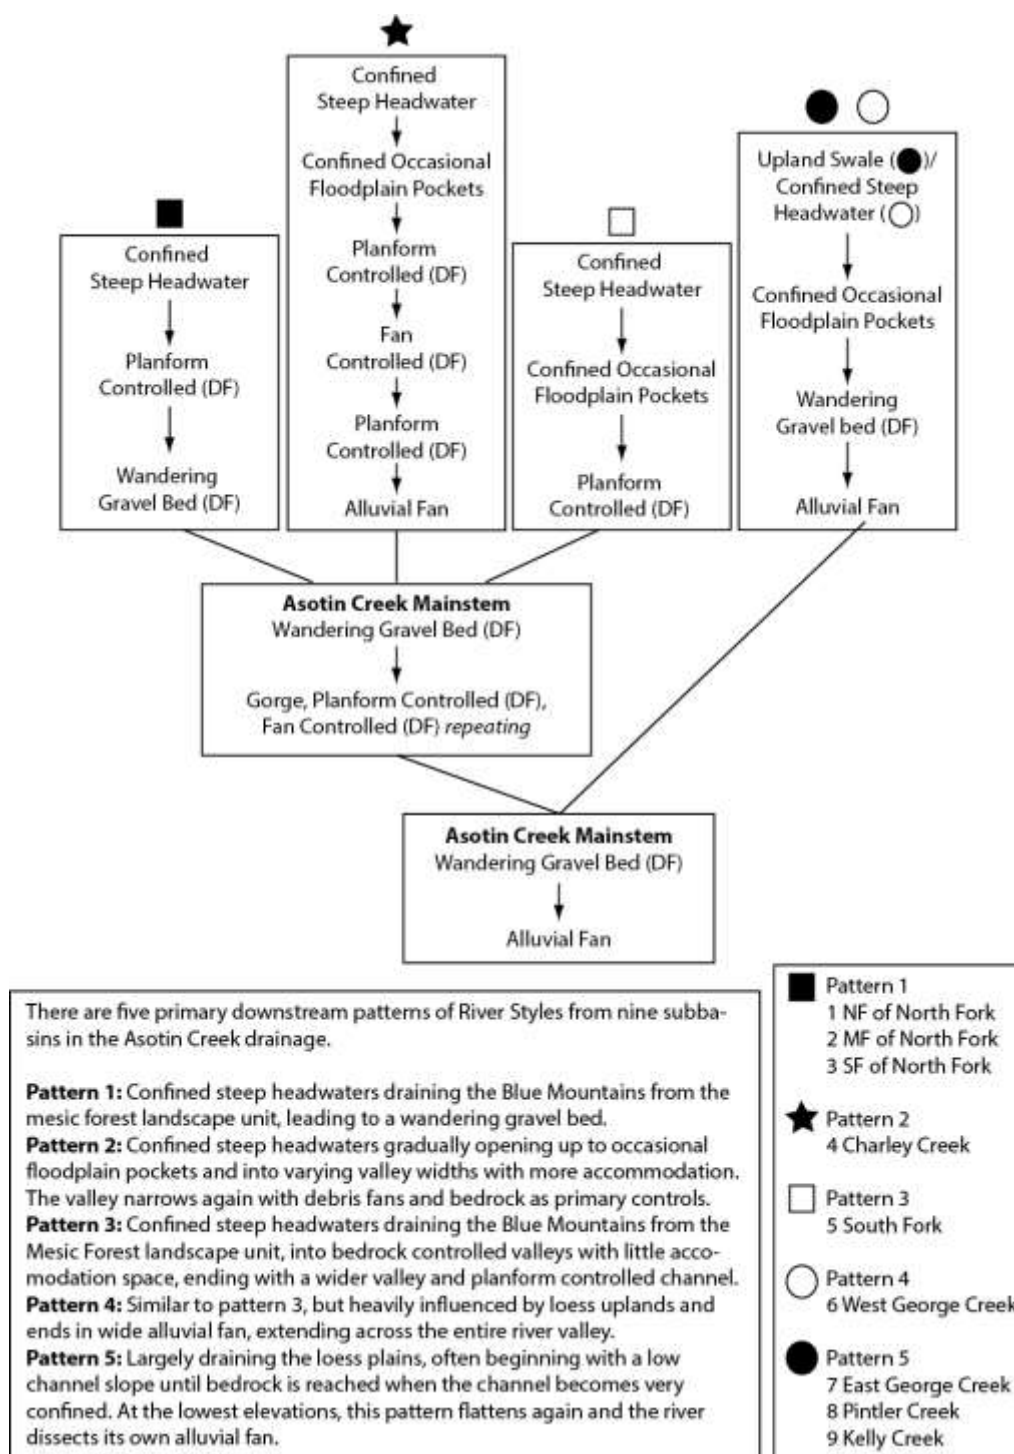
Figure 2.22. Primary downstream patterns of river styles present in the Asotin Creek basin. DF = discontinuous floodplain, NF = north fork, MF = middle fork, SF = south fork.

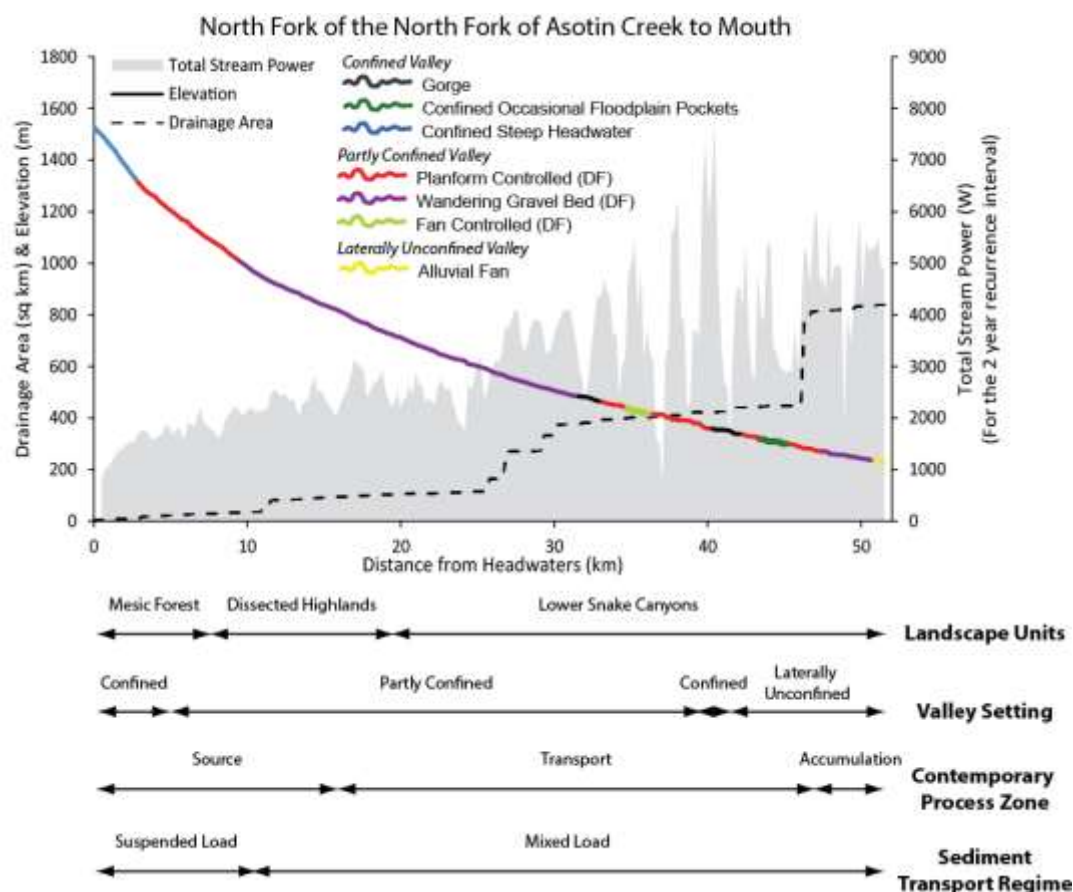
Figure 2.23. Example of longitudinal profile from the North Fork of the North Fork of Asotin Creek to the mouth of the Asotin Creek mainstem. This figure also shows drainage area, total stream power, and various controls. DF = discontinuous floodplain.

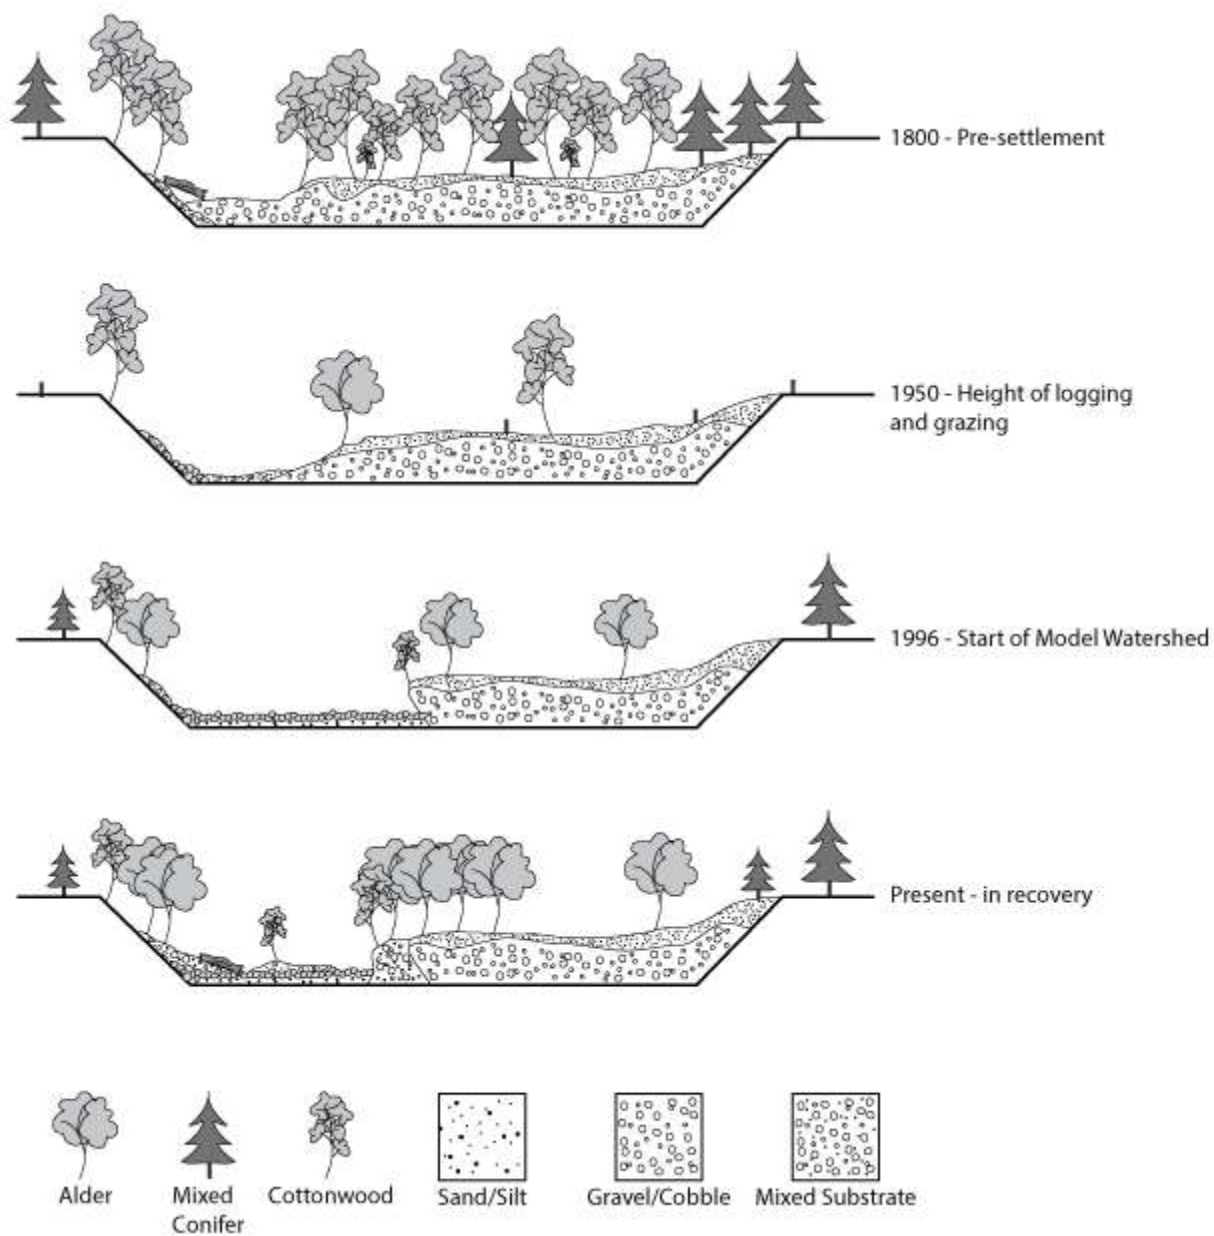
Figure 2.24. Evolution of the Planform controlled with discontinuous floodplain River Style in Asotin Creek.

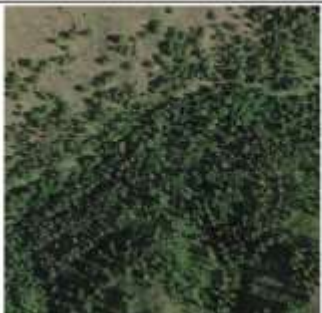
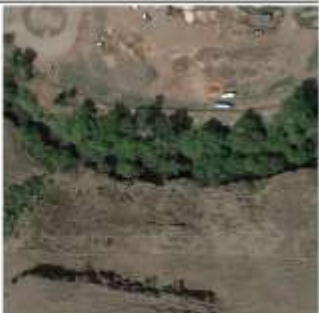
Figure 2.26. Geomorphic condition variants of River Styles in the Asotin Creek watershed.

<b>Channel Planform</b>	Usually single, but sometimes multiple channels forced by organic structural elements. Low sinuosity along valley margin, moderate sinuosity when traversing to opposite valley margin. Moderate lateral stability, and adjusting when conditions permit. Planar features are separated by forced bar and pool complexes. Riparian zone is relatively wide with mix of cottonwoods, alders, and native conifers.	Almost always single channel and low sinuosity. Laterally unstable with accelerated bank scour, but limited lateral expansion. Mostly planar geomorphology, with some forced pools and bars. Occasional private levees restrict access to floodplain. Limited riparian zone with mixed native and exotic canopy. Much of the floodplain has been converted for agriculture.	Single channel with low sinuosity. Laterally unstable, but no room for expansion. Almost entirely planar channel units with occasional pools. Floodplain has been converted to agriculture or urban use. Very limited riparian cover.

<b>Bed Material</b>	Well sorted bed material with well defined facies typically forced by structural elements. Bars are comprised of gravel and smaller clasts. The channel bed is stable and sediment flux is balanced. Sediment transfer zone with pockets of storage.	Poorly sorted bed material with pockets of defined texture around infrequent structural elements. Limited roughness due to lack of instream vegetation and woody debris. Bed is stable and the sediment flux is balanced. Sediment transfer zone.	Homogeneous bed material, mostly large clasts armoring the bed. Sediment is poorly sorted with limited pockets of defined texture. Unstable bed is incising in most areas. Sediment transfer zone.
<b>Photograph</b>	Upper Charley Creek	Middle of South Fork Asotin Creek	Lower Asotin Creek

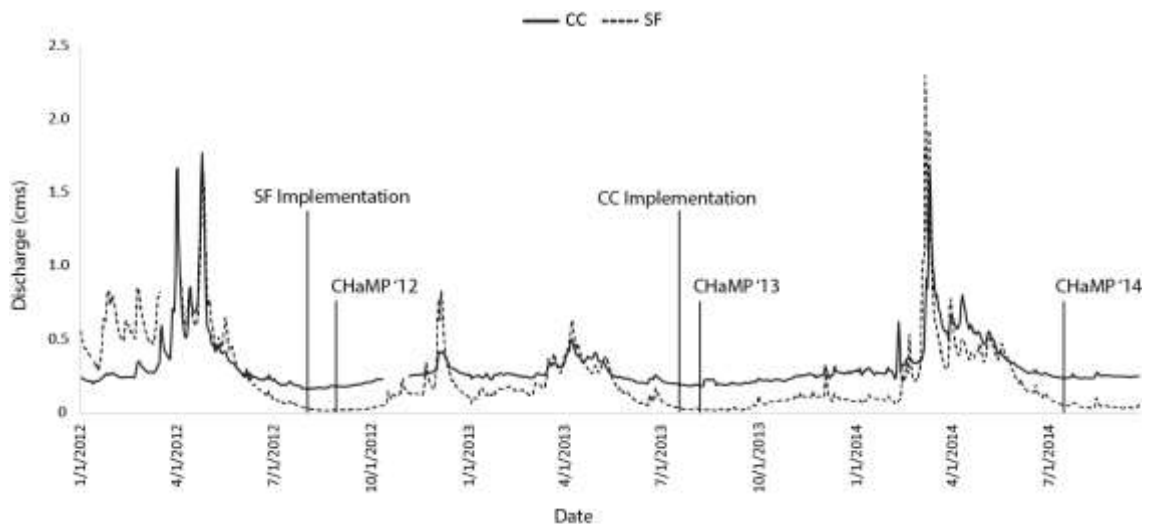
Figure 3.2. Discharge in cubic meters per second at the mouths of Charley Creek (CC) and the South Fork (SF) of Asotin Creek from January 2012 to September 2014. 'Implementation' markers represent the day that restoration started on each creek and the 'CHaMP' markers represent when CHaMP surveys began each year.

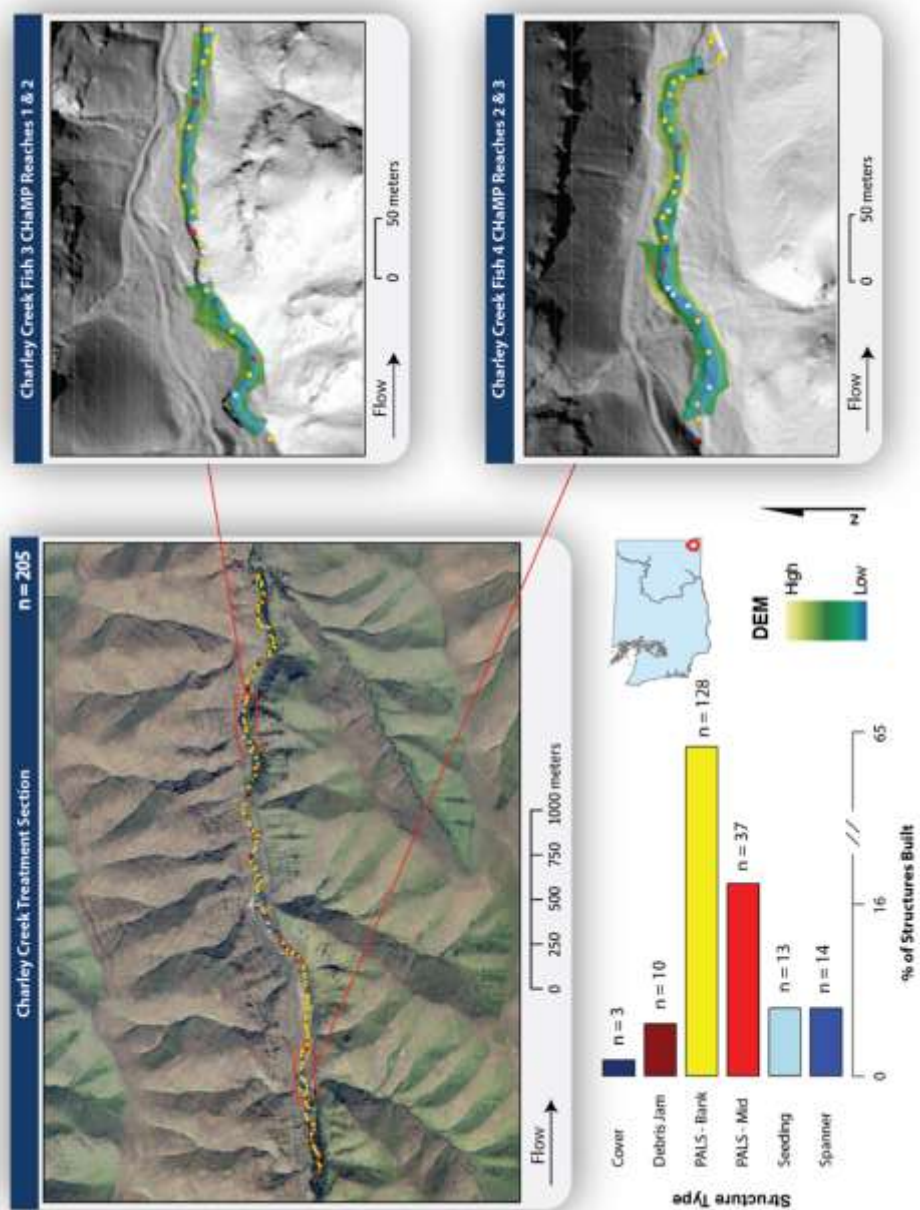
Figure 3.3. Proportion of structure types and their locations implemented on Charley Creek. The inset maps show the overlap of structures within annually monitored habitat reaches. The colors of the dots represent the structure type as indicated in the bar chart.
