## Short Term Effectiveness of High Density Large Woody Debris in Asotin Creek as a Cheap and Cheerful Restoration Action

SHORT TERM EFFECTIVENESS OF HIGH DENSITY LARGE WOODY  
DEBRIS IN ASOTIN CREEK AS A CHEAP AND  
CHEERFUL RESTORATION ACTION

Watershed Science

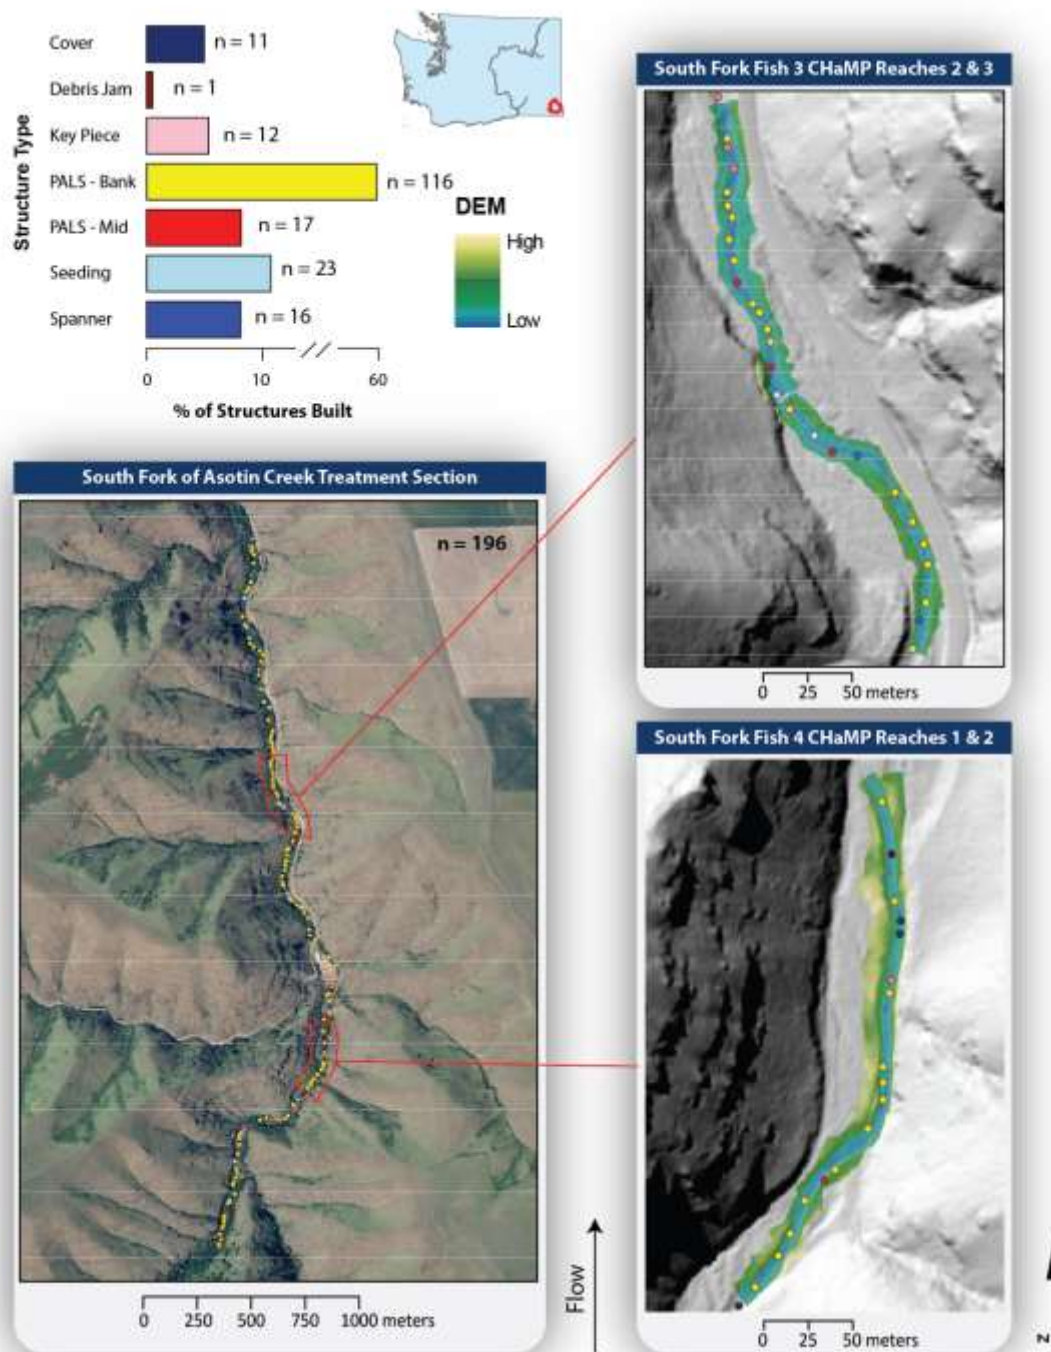
Figure 3.4. Proportion of structure types and their locations implemented on the South Fork of Asotin Creek. The inset maps show the overlap of structures within annually monitored habitat reaches. The colors of the dots represent the structure type as indicated in the bar chart.

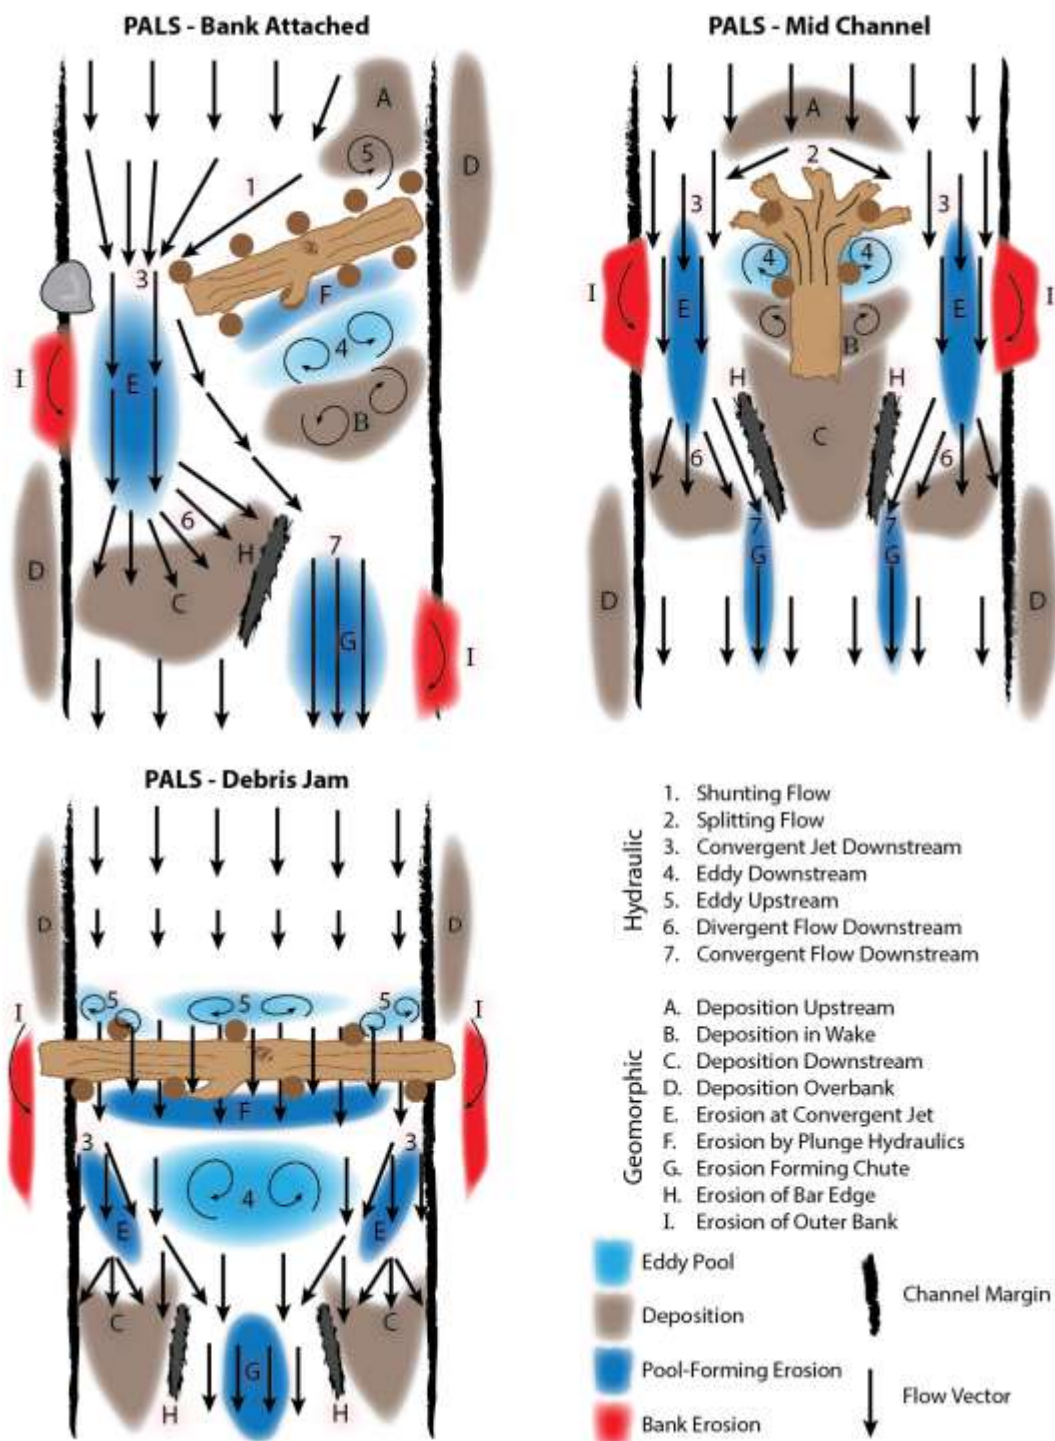
Figure 3.5. Expected hydraulic and geomorphic responses for structures implemented on Charley Creek and the South Fork of Asotin Creek.

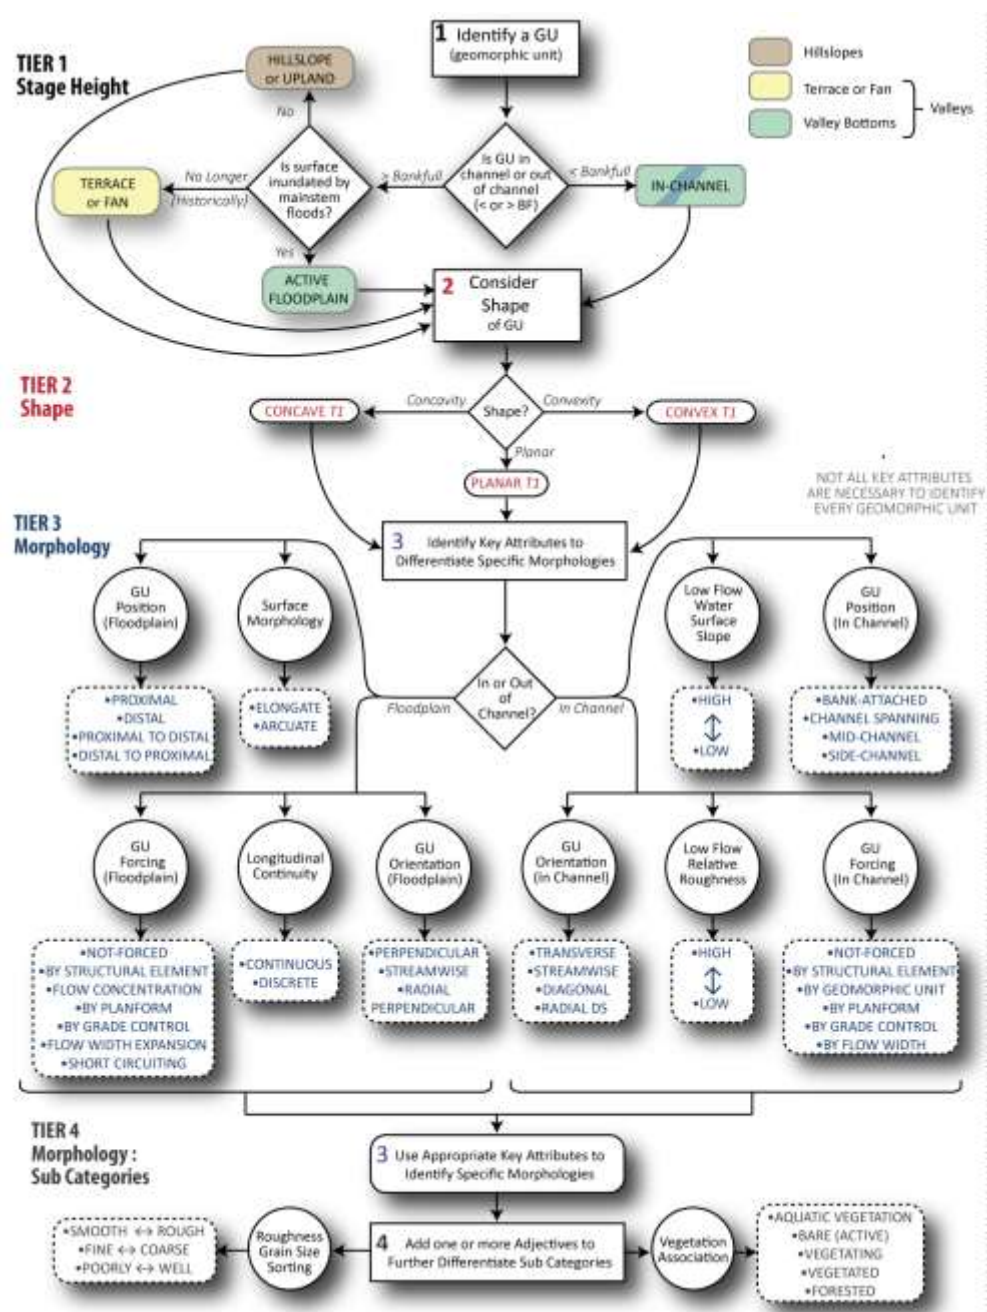
Figure 3.6. Four tier dichotomous key for determining geomorphic units in fluvial valleys. This study delineated units up to tier 3 – the specific morphology of geomorphic units. From [Wheaton et al., submitted to *Geomorphology*, 2014].

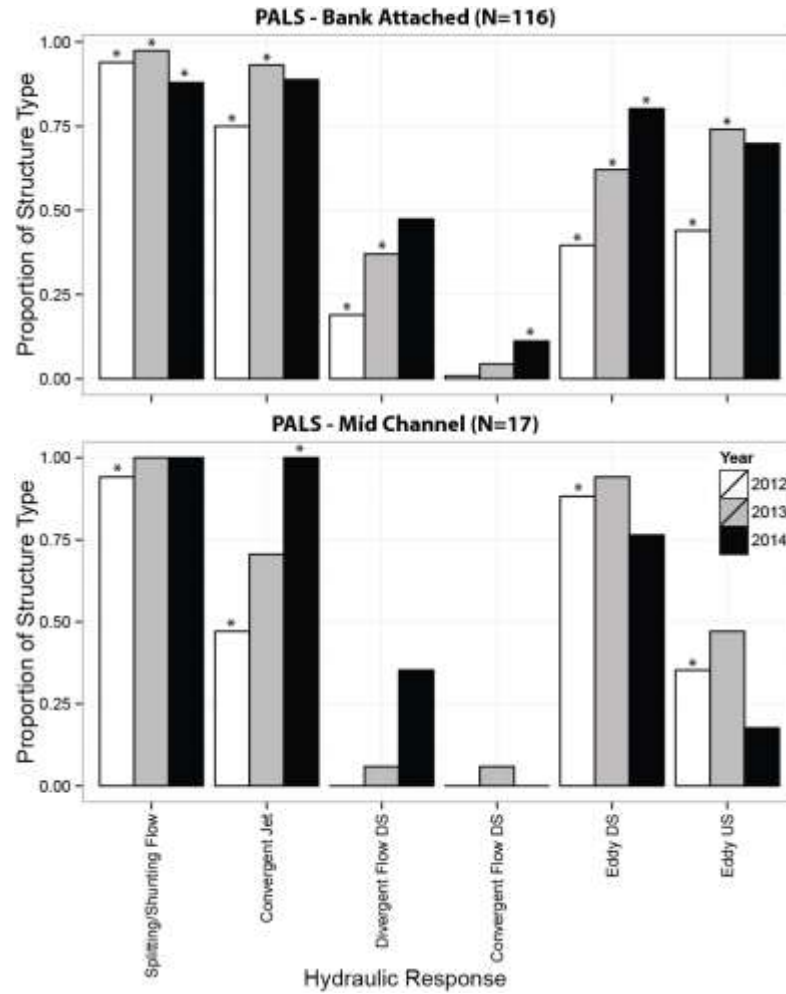
Figure 3.7. Proportion of restoration structures eliciting hydraulic responses during the summers of 2012-2014 on the South Fork of Asotin Creek. An asterisk above a bar represents a significant difference in that response compared to the previous year (\* =  $P < 0.05$ ). Responses in 2012 were compared to the initial condition of 0% presence ( $\mu = 0.0$ ). US = upstream, DS = downstream.

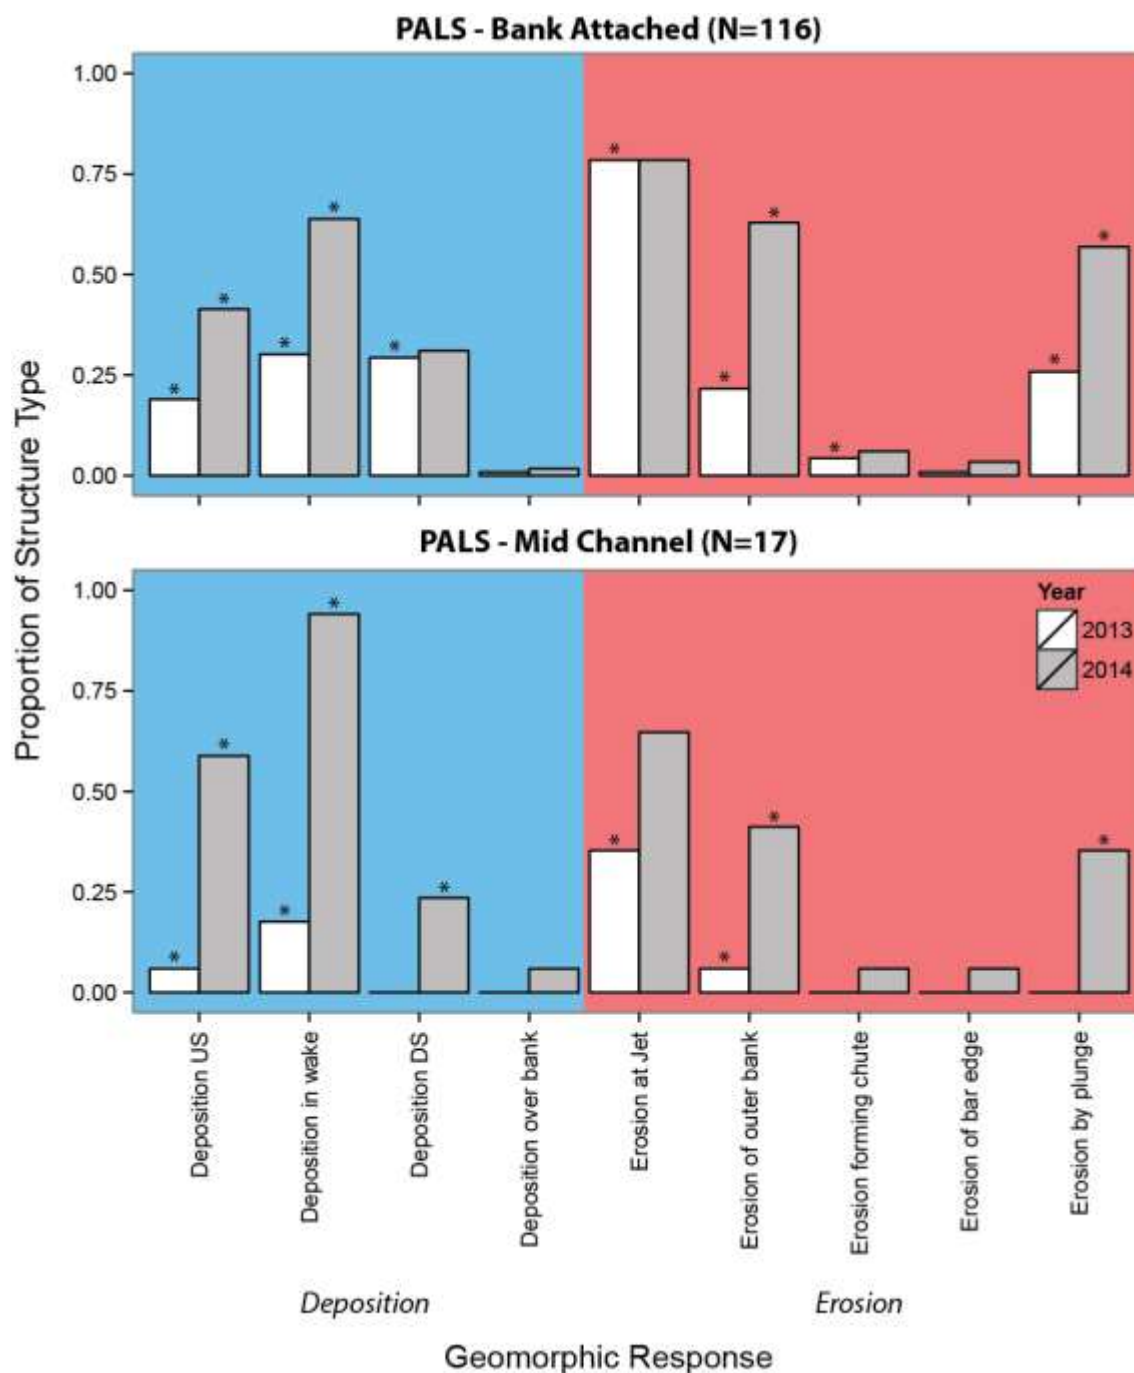
Figure 3.8. Proportion of restoration structures eliciting geomorphic responses during the summers of 2013-2014 on the South Fork of Asotin Creek. An asterisk above a bar represents a significant difference in that response compared to the previous year (\* =  $P < 0.05$ ). Responses in 2013 were compared to the initial condition of 0% presence ( $\mu = 0.0$ ). US = upstream, DS = downstream.

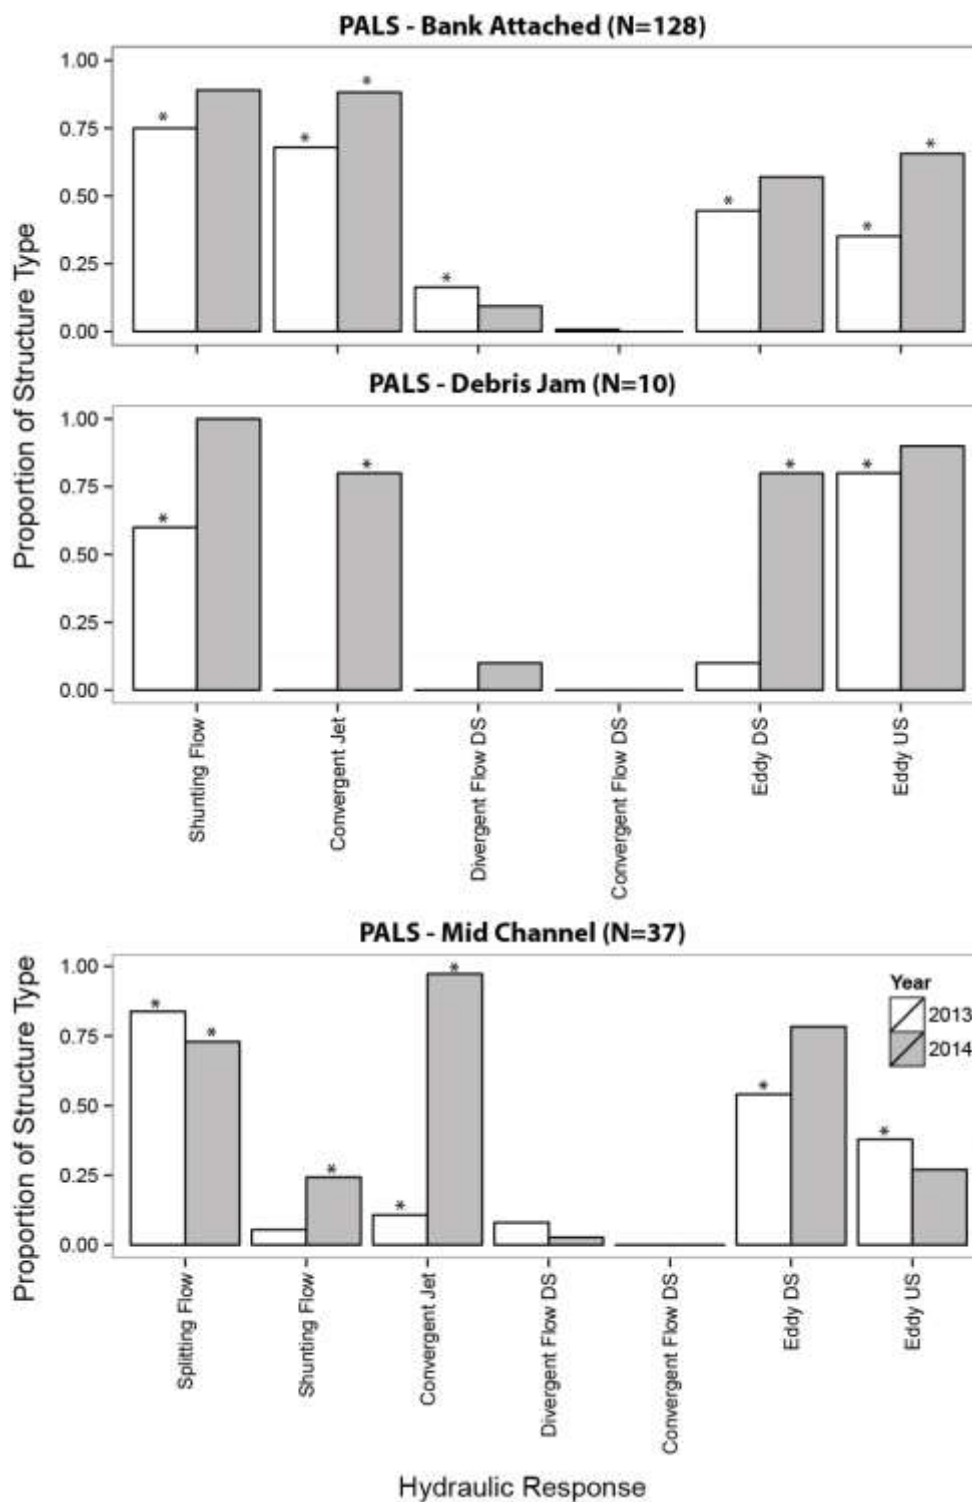
Figure 3.9. Proportion of restoration structures eliciting hydraulic responses during the summers of 2013-2014 on Charley Creek. An asterisk above a bar represents a significant difference in that response compared to the previous year (\* =  $P < 0.05$ ). Responses in 2013 were compared to the initial condition of 0% presence ( $\mu = 0.0$ ). US = upstream, DS = downstream.

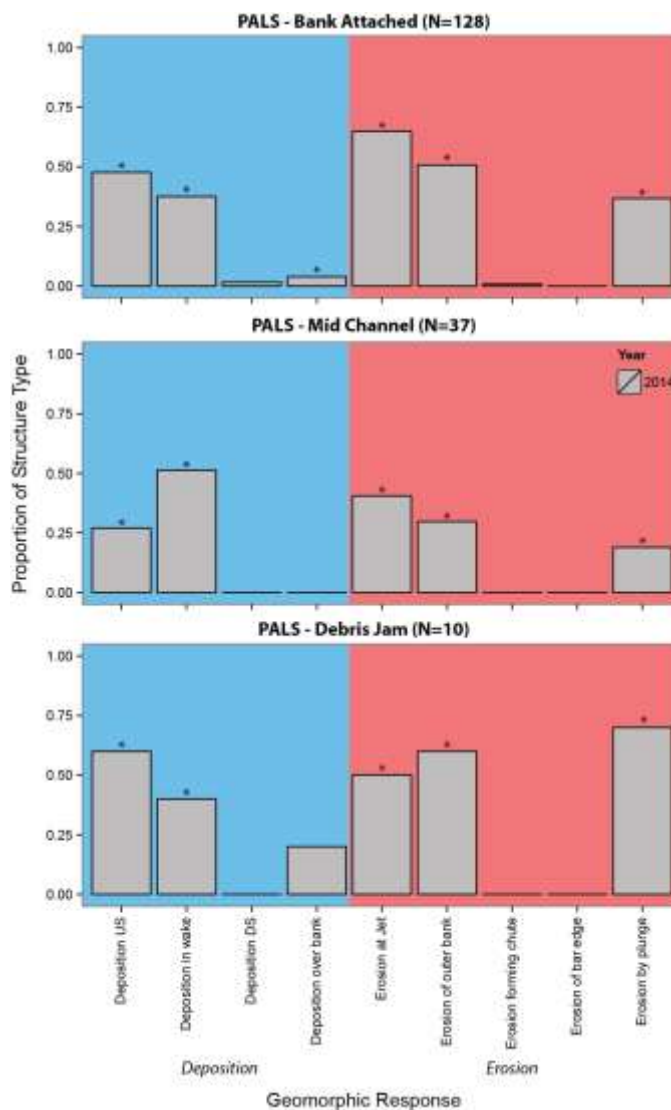
Figure 3.10. Proportion of restoration structures eliciting geomorphic responses during the summer of 2014 on Charley Creek. An asterisk above a bar represents a significant difference in that response compared to the implementation year when no geomorphic responses had developed (\* =  $P < 0.05$ ,  $\mu = 0.0$ ). US = upstream, DS = downstream.

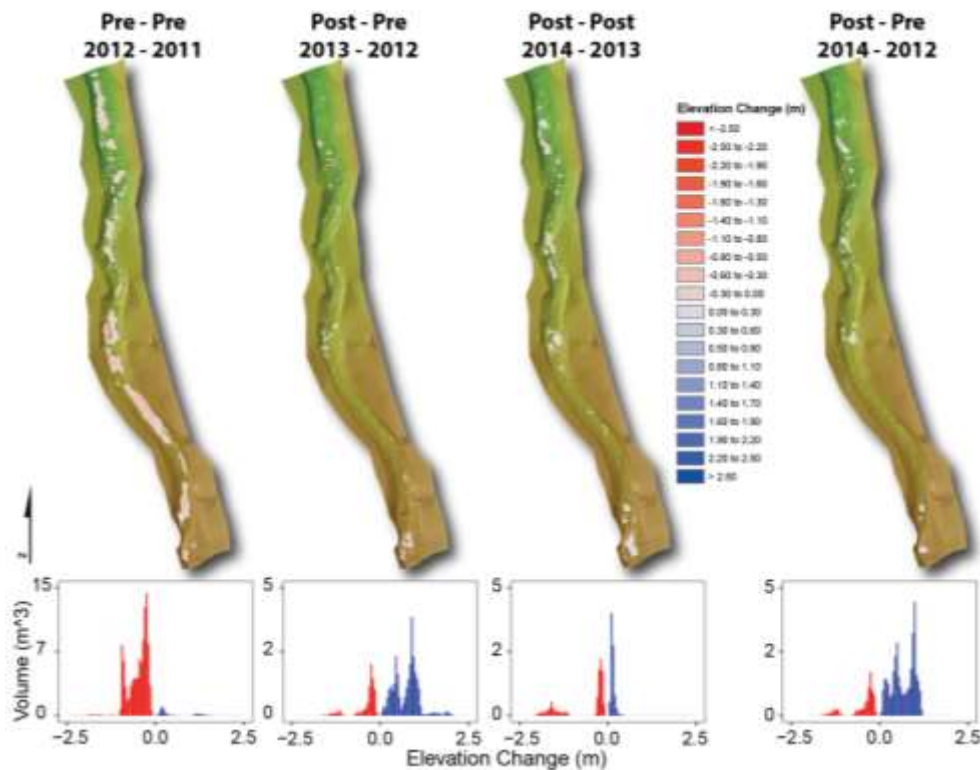
Figure 3.11. Example of thresholded digital elevation models of difference (DoD) and the elevation change distributions at a 160 m reach on the South Fork of Asotin Creek. The DoDs represent change that has a, 80% probability of being real after uncertainty analysis. The volumetric elevation change distributions below each DoD show the thresholded distributions by erosion (red) and deposition (blue).

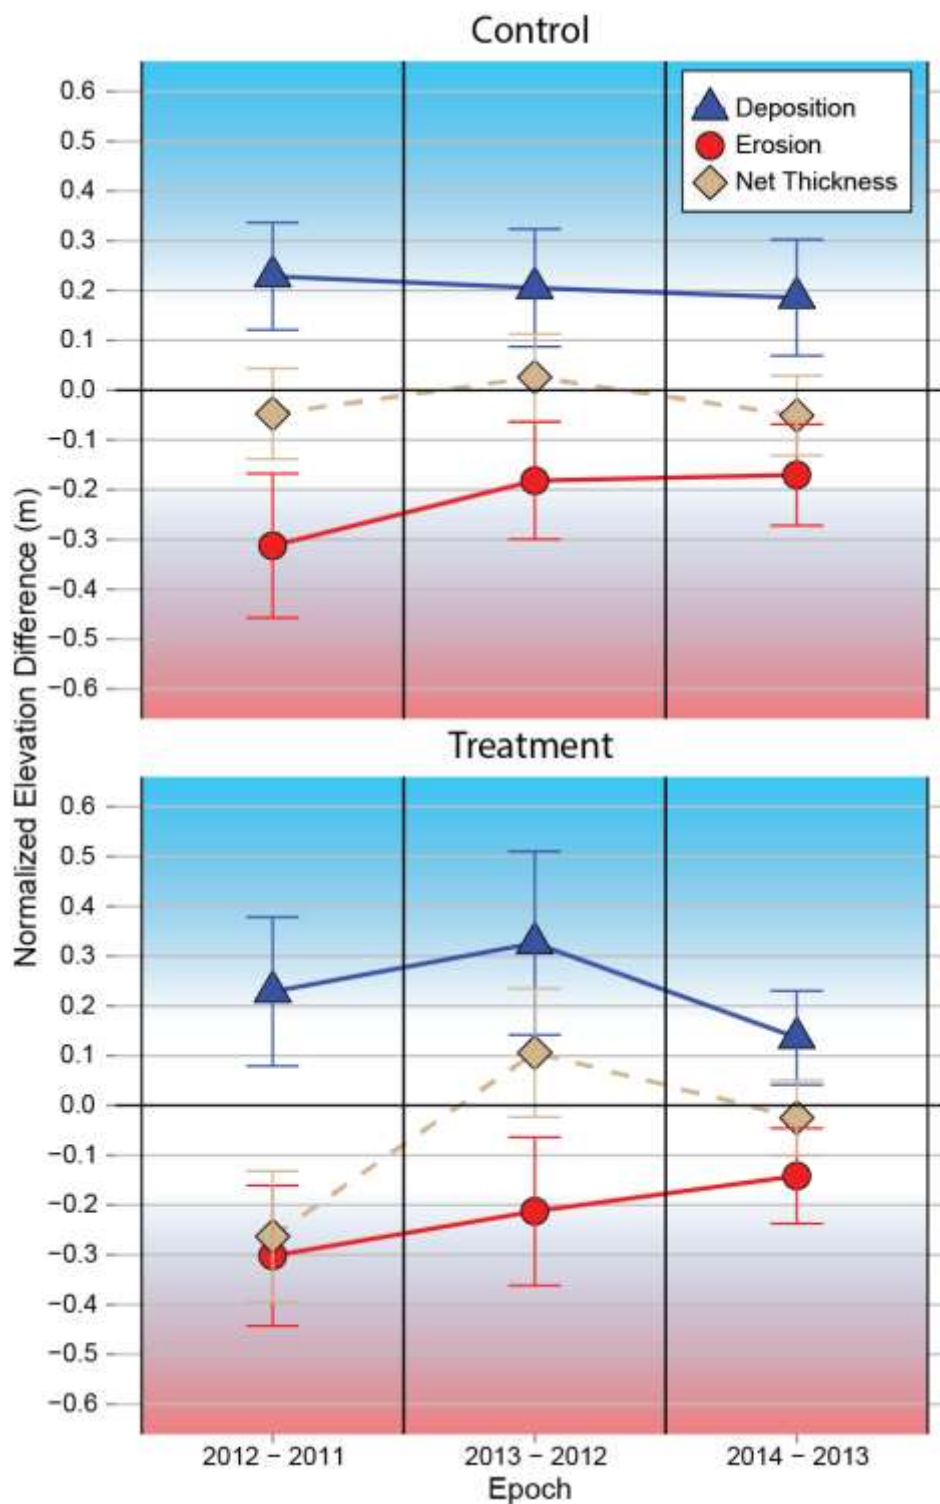
Figure 3.12. Normalized elevation difference of thresholded change in meters across control sites (top) and treatment sites (bottom). The net thickness represents the mean difference in deposition and erosion thickness. The error bars represent the uncertainty from the original DEM of difference estimate.

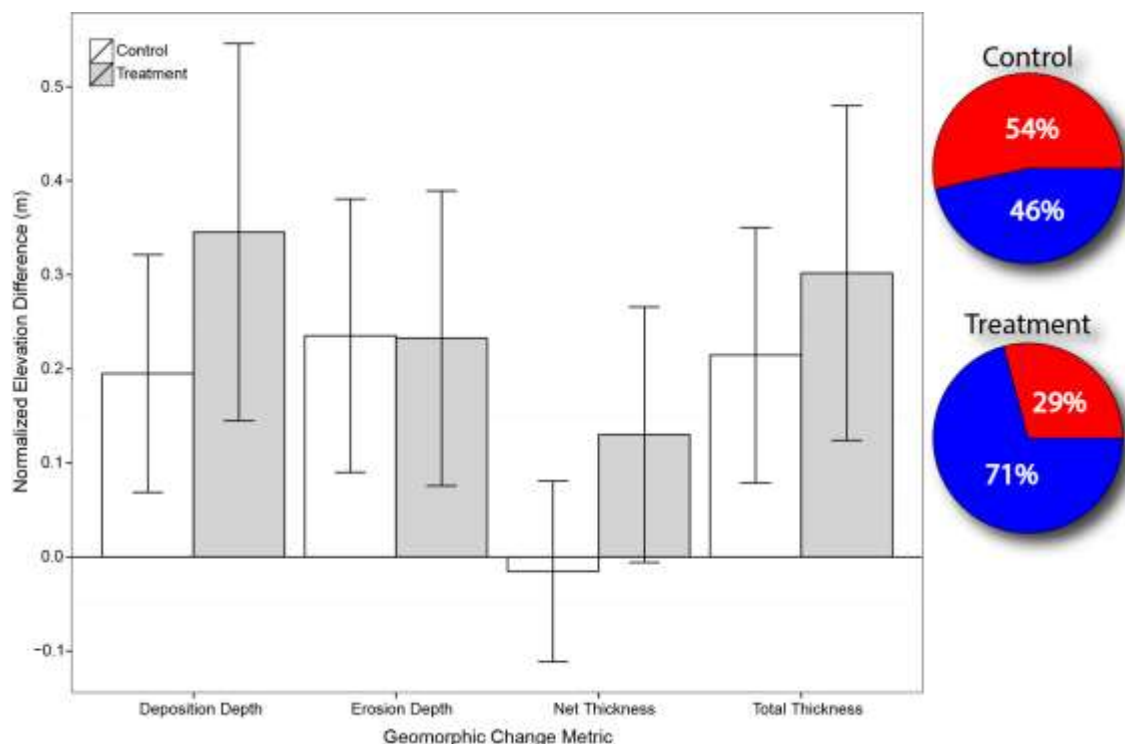
Figure 3.13. Mean differences between deposition depth, erosion depth, net thickness, and total thickness before and after restoration, separated by treatment and control sections. The error bars are the mean error estimates from a fuzzy inference system uncertainty analysis.

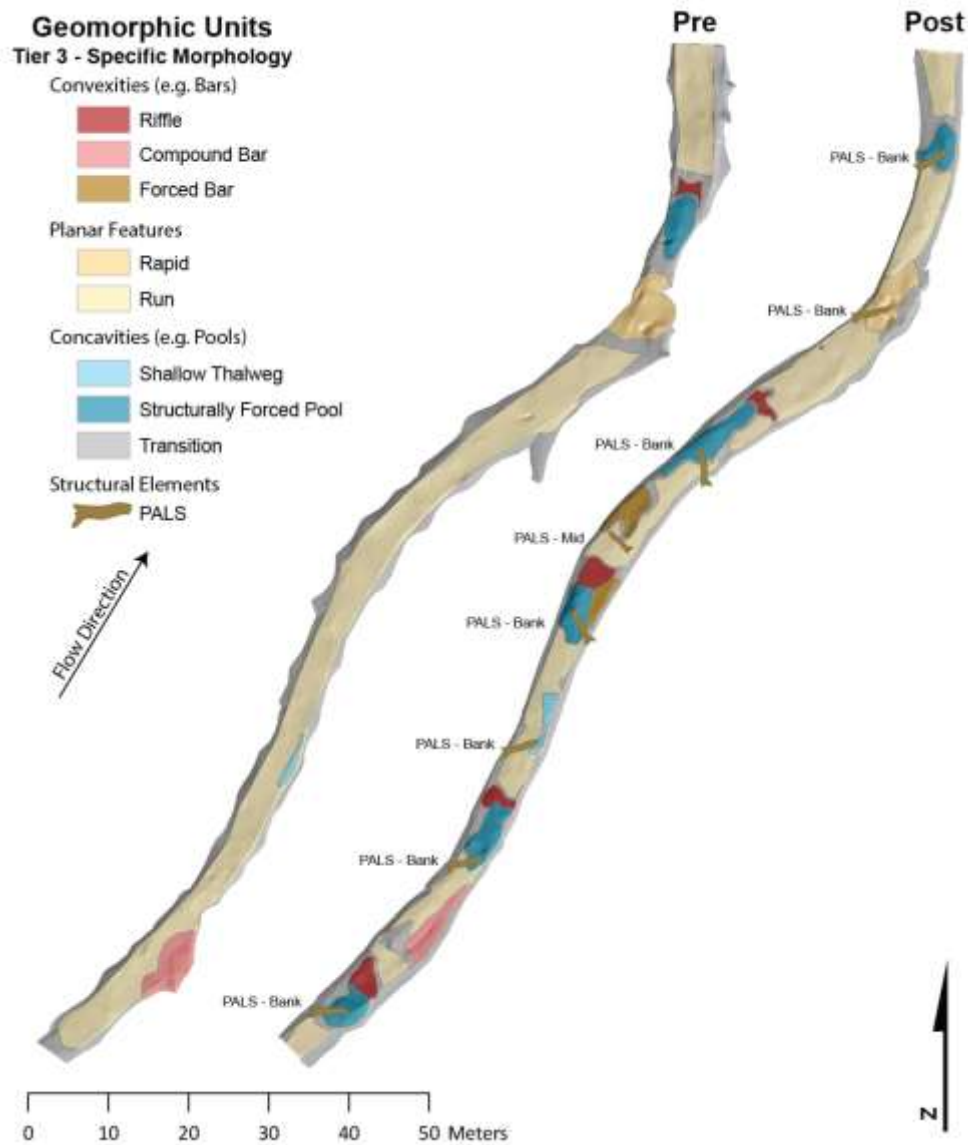
Figure 3.14. Example of geomorphic unit delineation pre- and post-restoration at a treatment reach on the South Fork of Asotin Creek. Pre-restoration, this reach was heavily dominated by runs. Post-restoration, post assisted log structures (PALS) imposed several riffles, forced bars, and structurally forced pools.

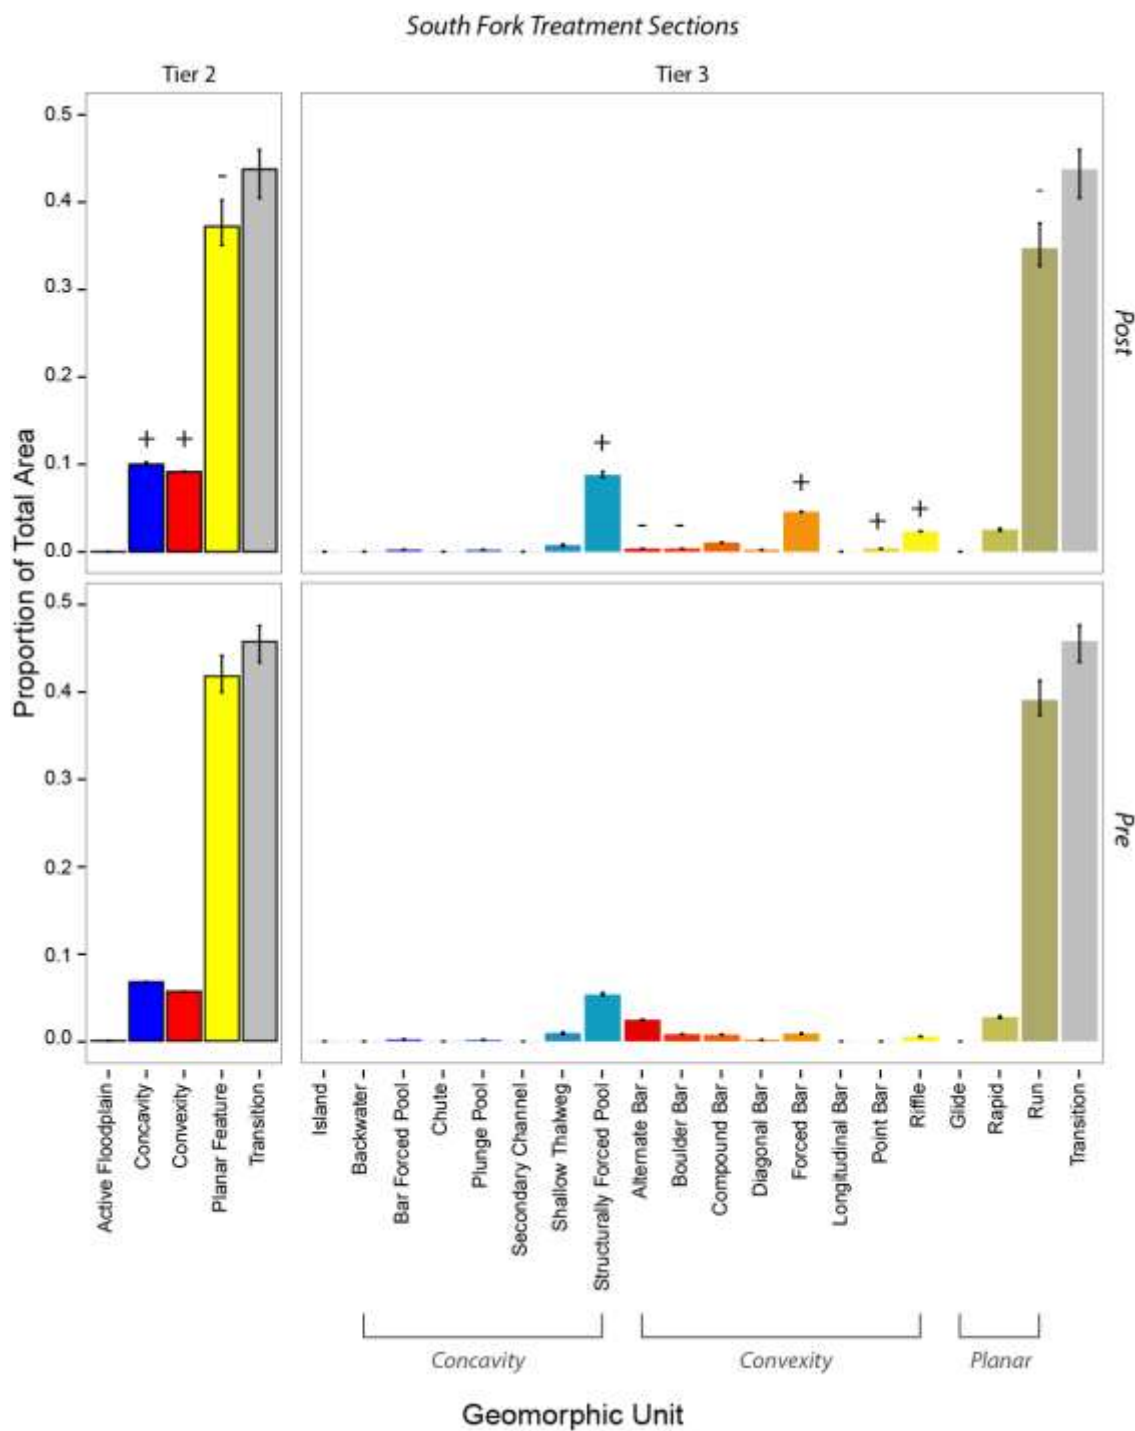
Figure 3.15. Proportional areas of tier 2 geomorphic units at treatment sites within the South Fork of Asotin Creek. Units were manually delineated from topographic data collected at CHaMP sites. Error bars represent the upper and lower area estimates after a  $\pm 0.1$  m buffer on the original area. A plus (+) or minus (-) sign above a bar indicates the direction of a statistically significant difference in pre- and post-restoration areas ( $P < 0.05$ ).

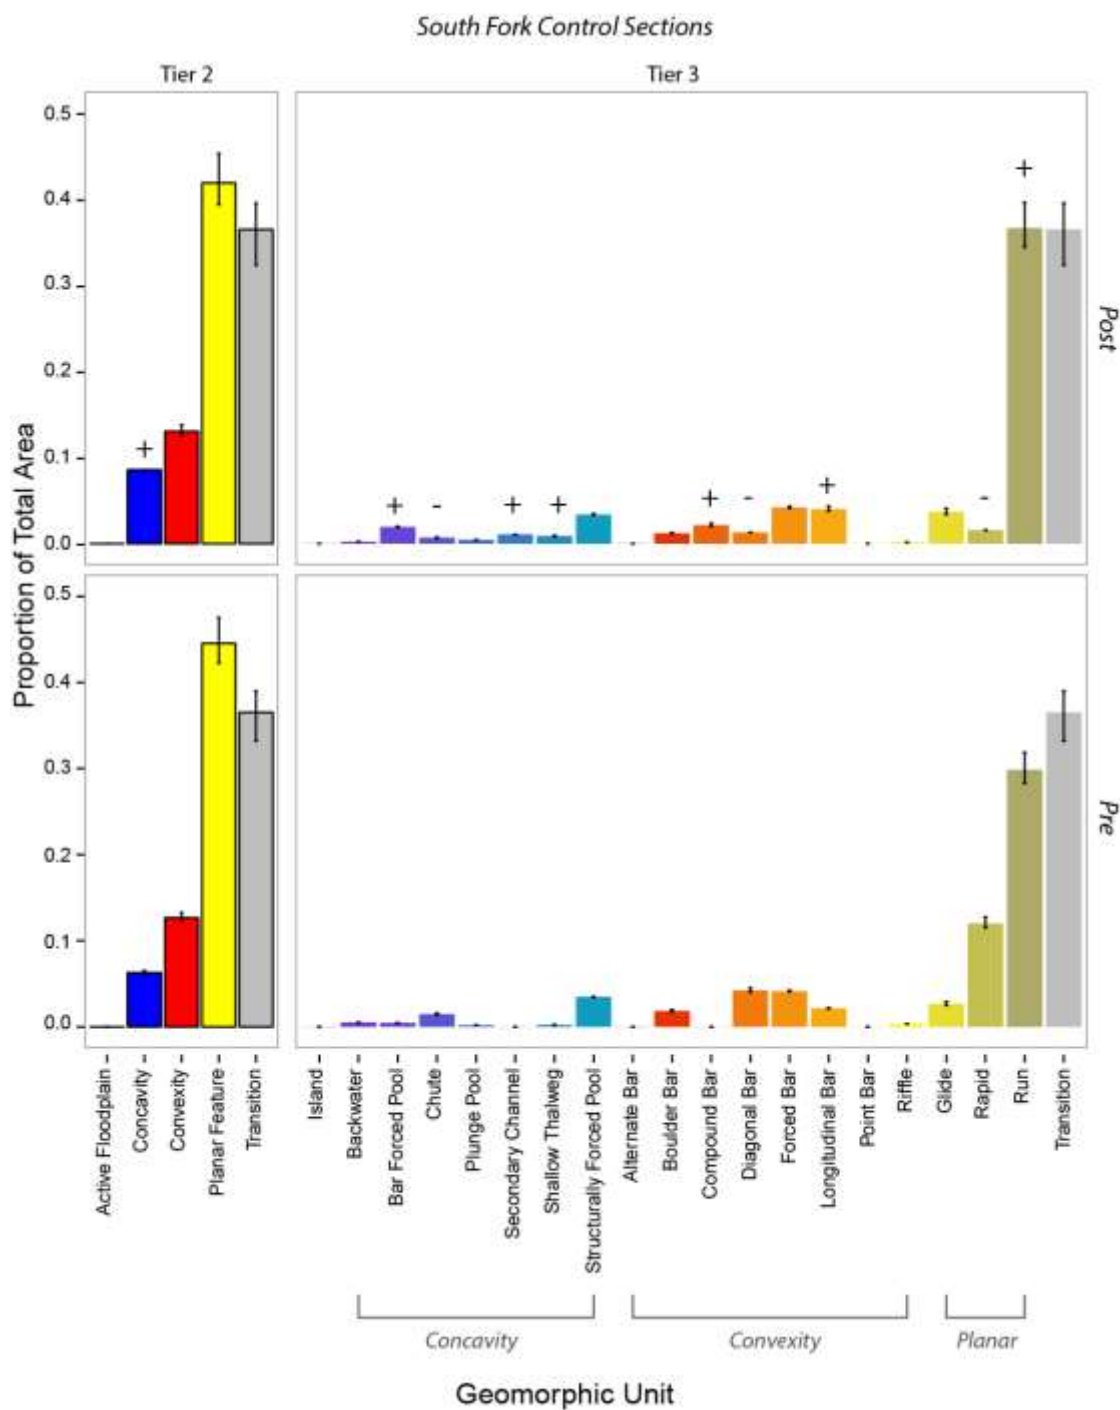
Figure 3.16. Proportional areas of tier 2 geomorphic units at control sites within the South Fork of Asotin Creek. Units were manually delineated from topographic data collected at CHaMP sites. Error bars represent the upper and lower area estimates after a  $\pm 0.1$  m buffer on the original area. A plus (+) or minus (-) sign above a bar indicates the direction of a statistically significant difference in pre- and post-restoration areas ( $P < 0.05$ ).

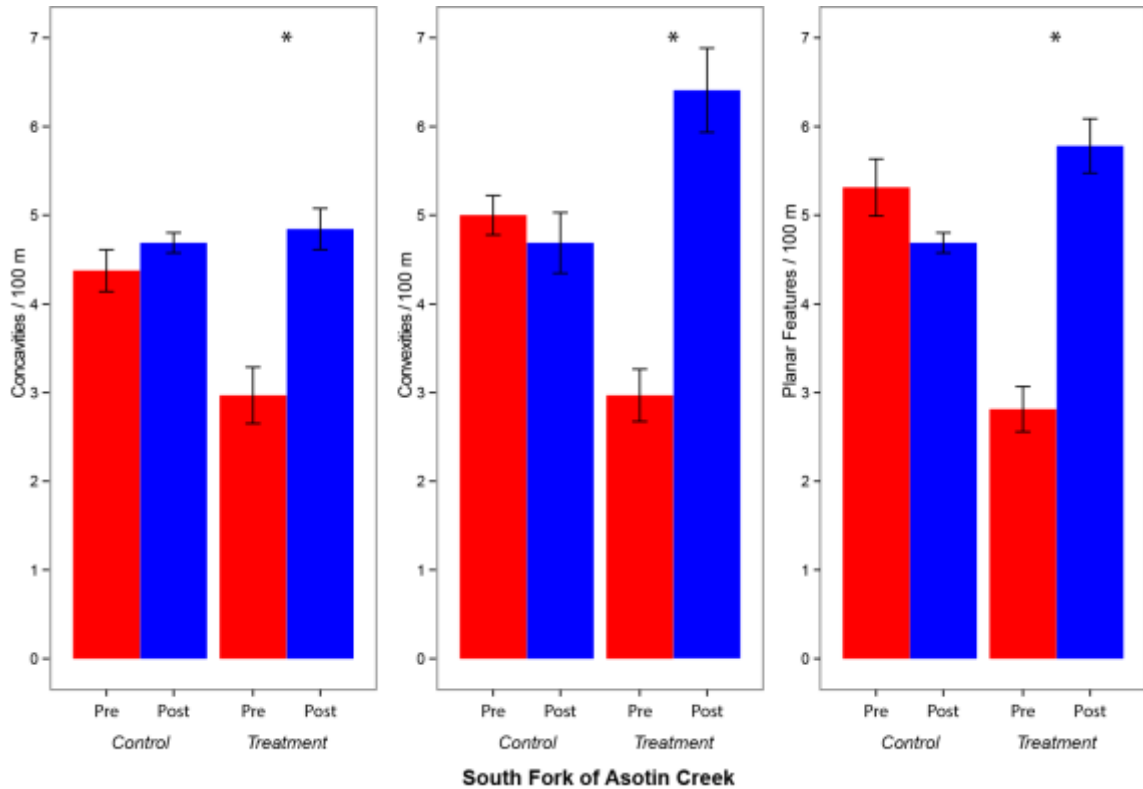
Figure 3.17. Mean concavities, convexities, and planar feature units per 100 meters by pre- and post-restoration and control and treatment sites on the South Fork of Asotin Creek. Units were manually delineated from topographic data collected at CHaMP sites. Error bars represent the standard errors. An asterisk between bars represents a significant difference in the means of unit counts pre- and post- restoration (\*= $P < 0.05$ ).

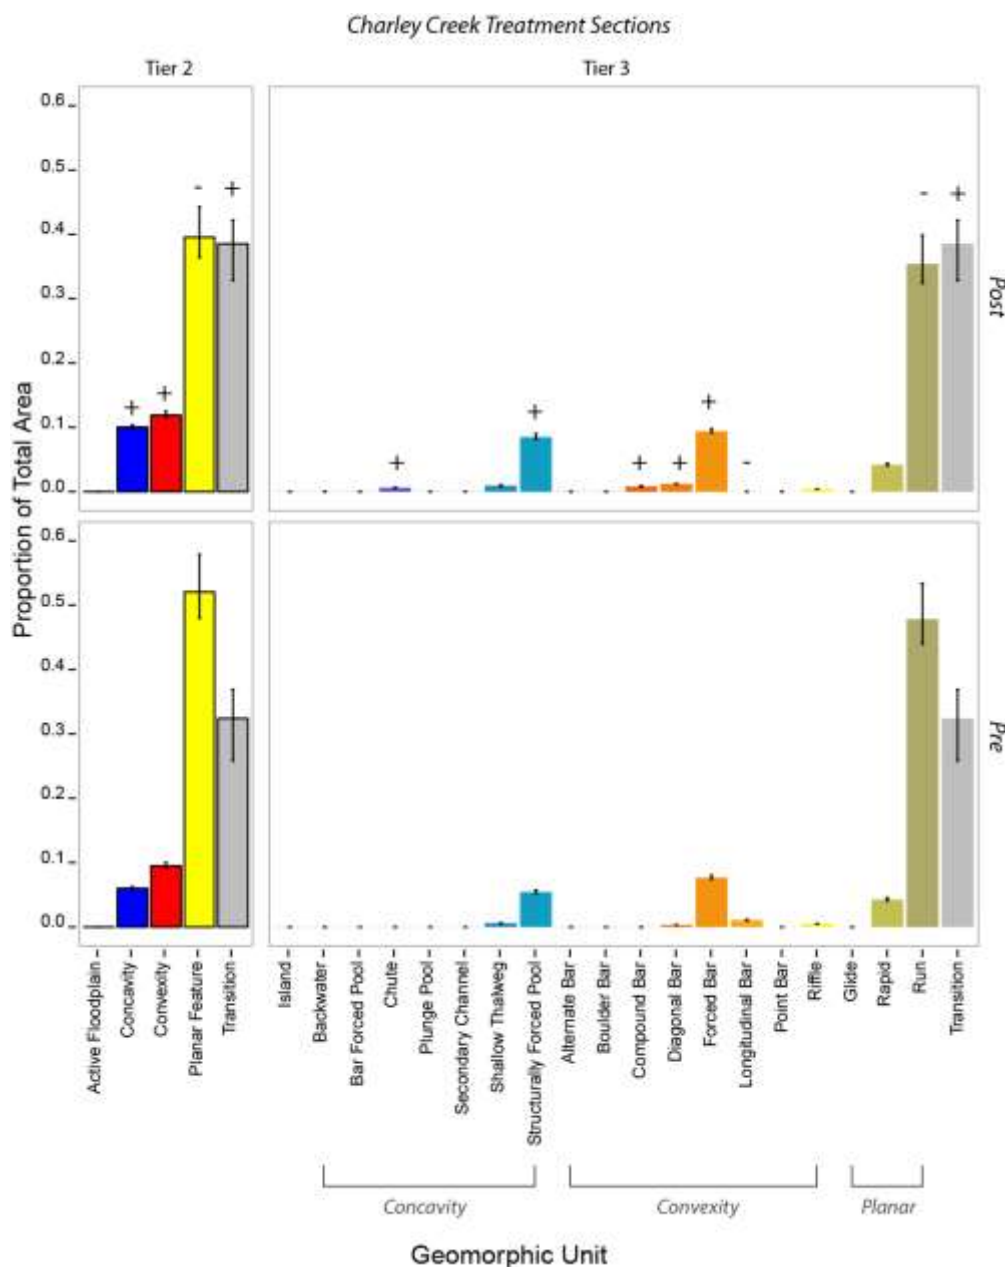
Figure 3.18. Proportional areas of tier 2 geomorphic units at treatment sites within Charley Creek. Units were manually delineated from topographic data collected at CHaMP sites. Error bars represent the upper and lower area estimates after a  $\pm 0.1$  m buffer on the original area. A plus (+) or minus (-) sign above a bar indicates the direction of a statistically significant difference in pre- and post-restoration areas ( $P < 0.05$ ).

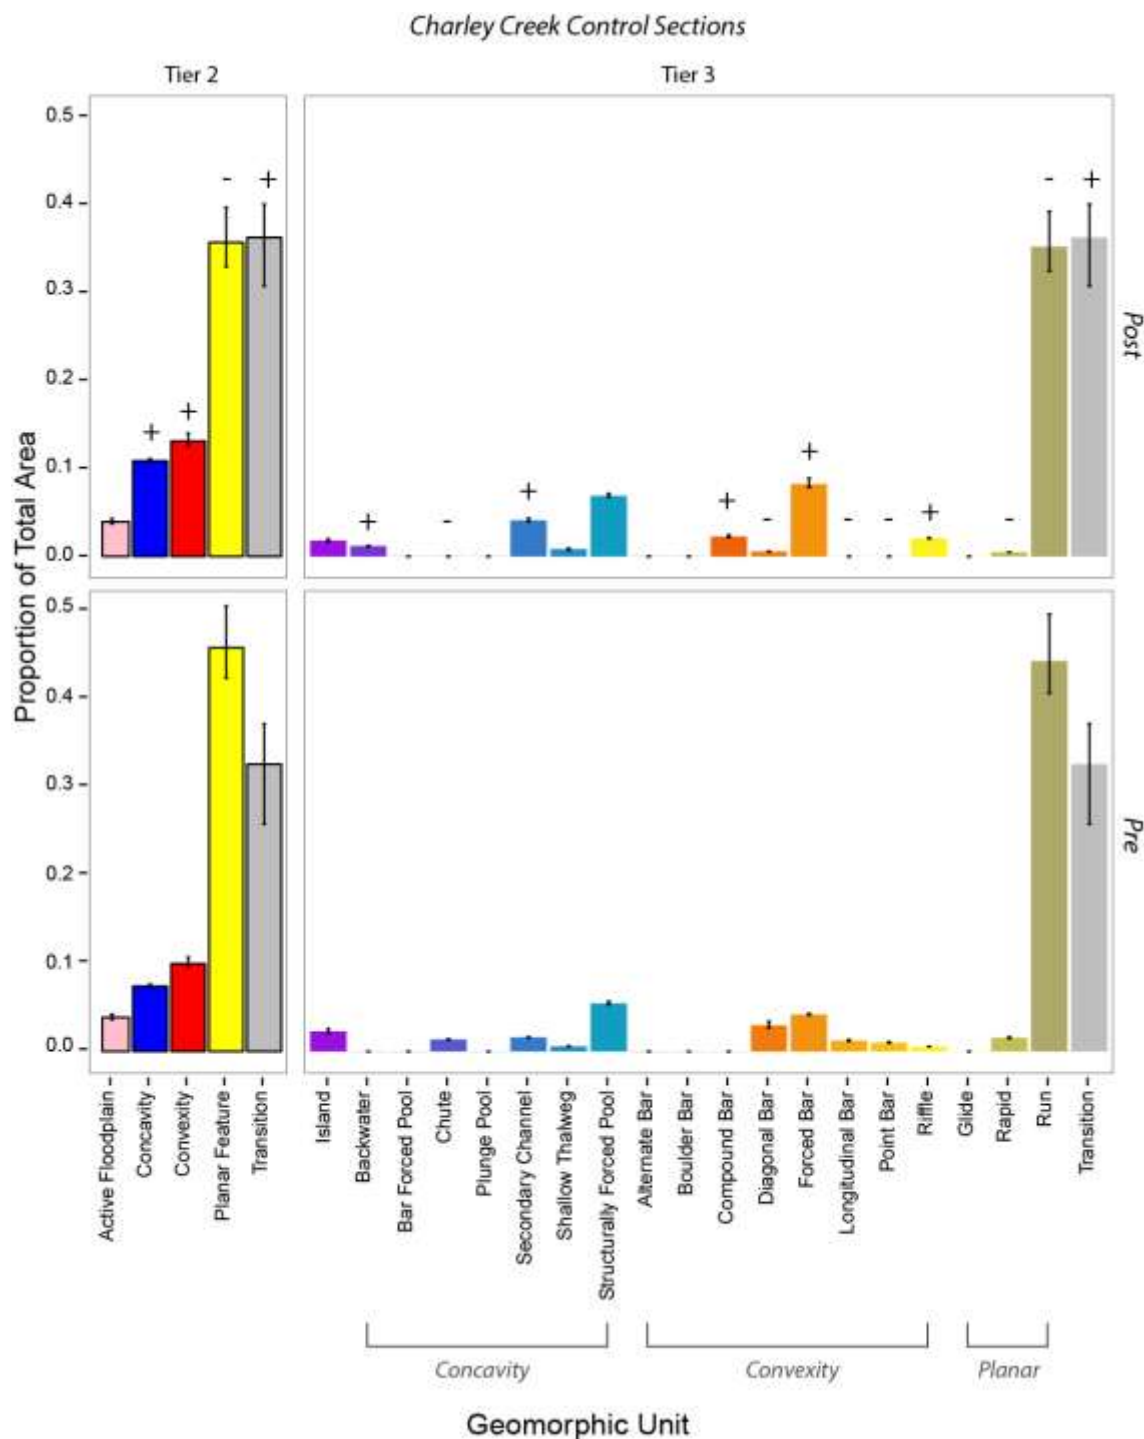
Figure 3.19. Proportional areas of tier 2 geomorphic units at control sites within Charley Creek. Units were manually delineated from topographic data collected at CHaMP sites. Error bars represent the upper and lower area estimates after a  $\pm 0.1$  m buffer on the original area. A plus (+) or minus (-) sign above a bar indicates the direction of a statistically significant difference in pre- and post-restoration areas ( $P < 0.05$ ).

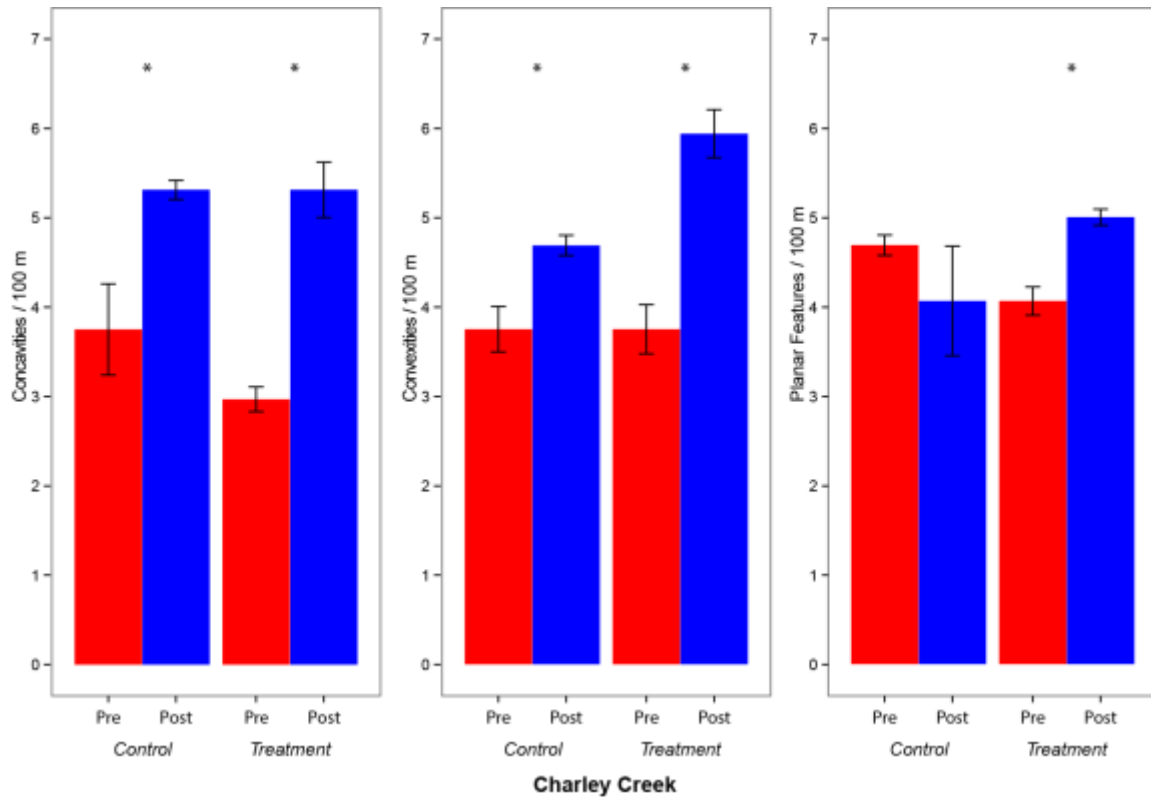
Figure 3.20. Mean concavities, convexities, and planar feature units per 100 meters by pre- and post-restoration and control and treatment sites on Charley Creek. Units were manually delineated from topographic data collected at CHaMP sites. Error bars represent the standard errors.
