## Short Term Effectiveness of High Density Large Woody Debris in Asotin Creek as a Cheap and Cheerful Restoration Action

SHORT TERM EFFECTIVENESS OF HIGH DENSITY LARGE WOODY  
DEBRIS IN ASOTIN CREEK AS A CHEAP AND  
CHEERFUL RESTORATION ACTION

Watershed Science

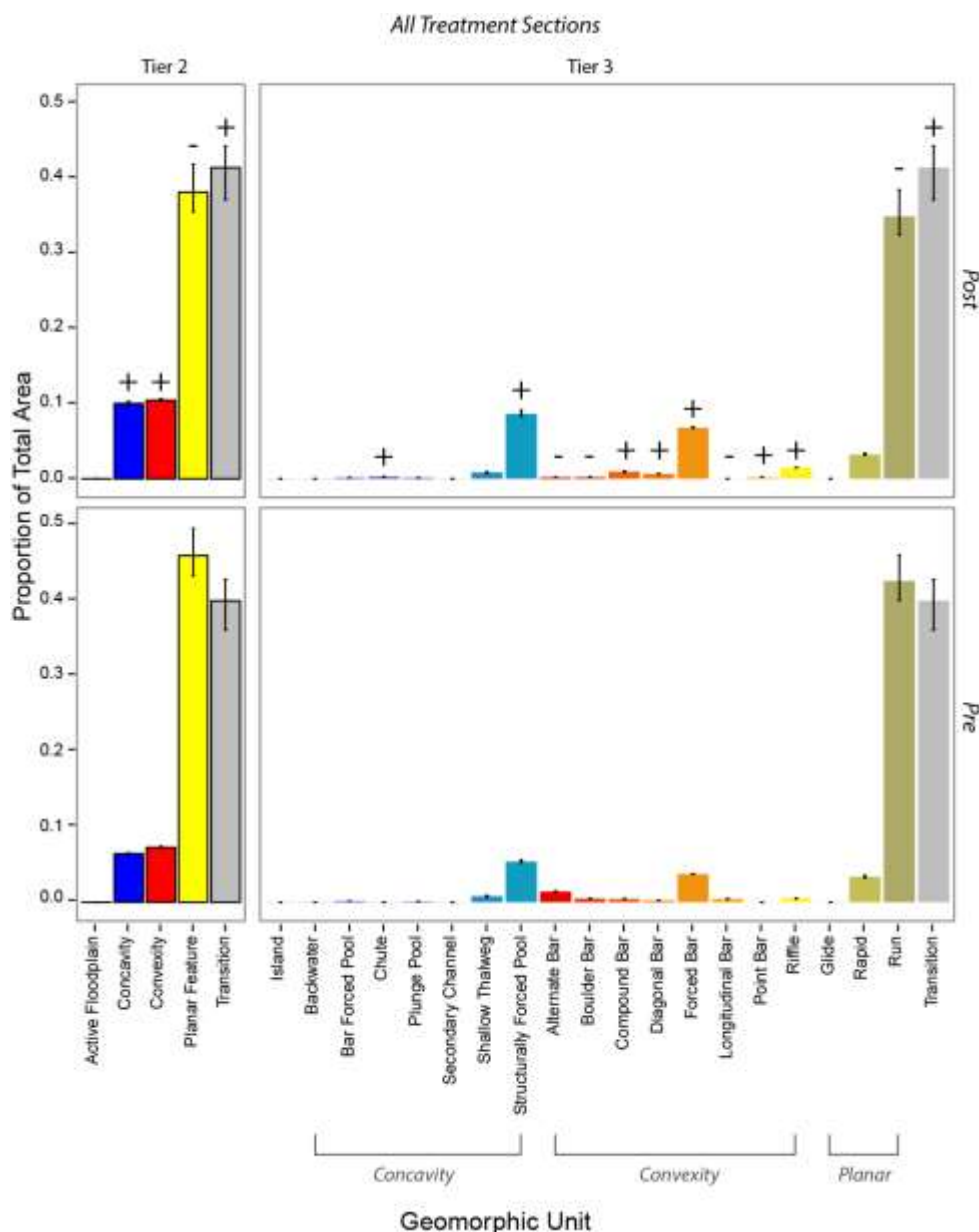
Figure 3.21. Proportional areas of tier 2 geomorphic units at treatment sites within the South Fork of Asotin Creek and Charley Creek combined. Units were manually delineated from topographic data collected at CHaMP sites. Error bars represent the upper and lower area estimates after a  $\pm 0.1$  m buffer on the original area. A plus (+) or minus (-) sign above a bar indicates the direction of a statistically significant difference in pre- and post-restoration areas ( $P < 0.05$ ).

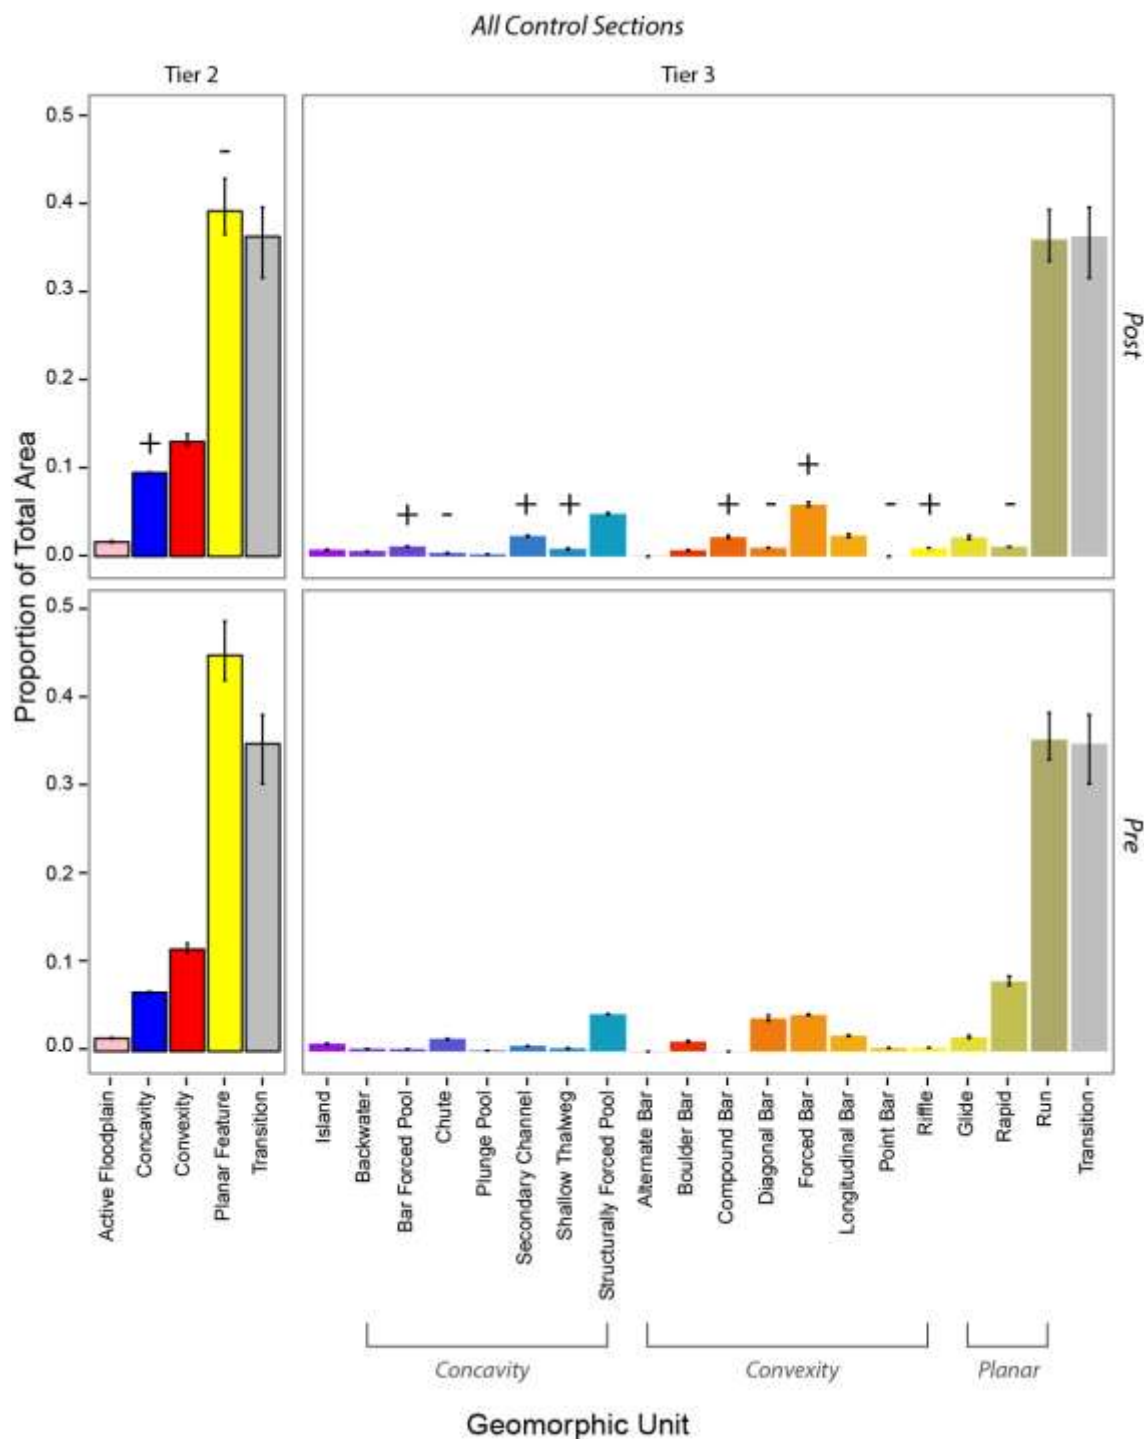
Figure 3.22. Proportional areas of tier 2 geomorphic units at control sites within the South Fork of Asotin Creek and Charley Creek combined. Units were manually delineated from topographic data collected at CHaMP sites. Error bars represent the upper and lower area estimates after a  $\pm 0.1$  m buffer on the original area. A plus (+) or minus (-) sign above a bar indicates the direction of a statistically significant difference in pre- and post-restoration areas ( $P < 0.05$ ).

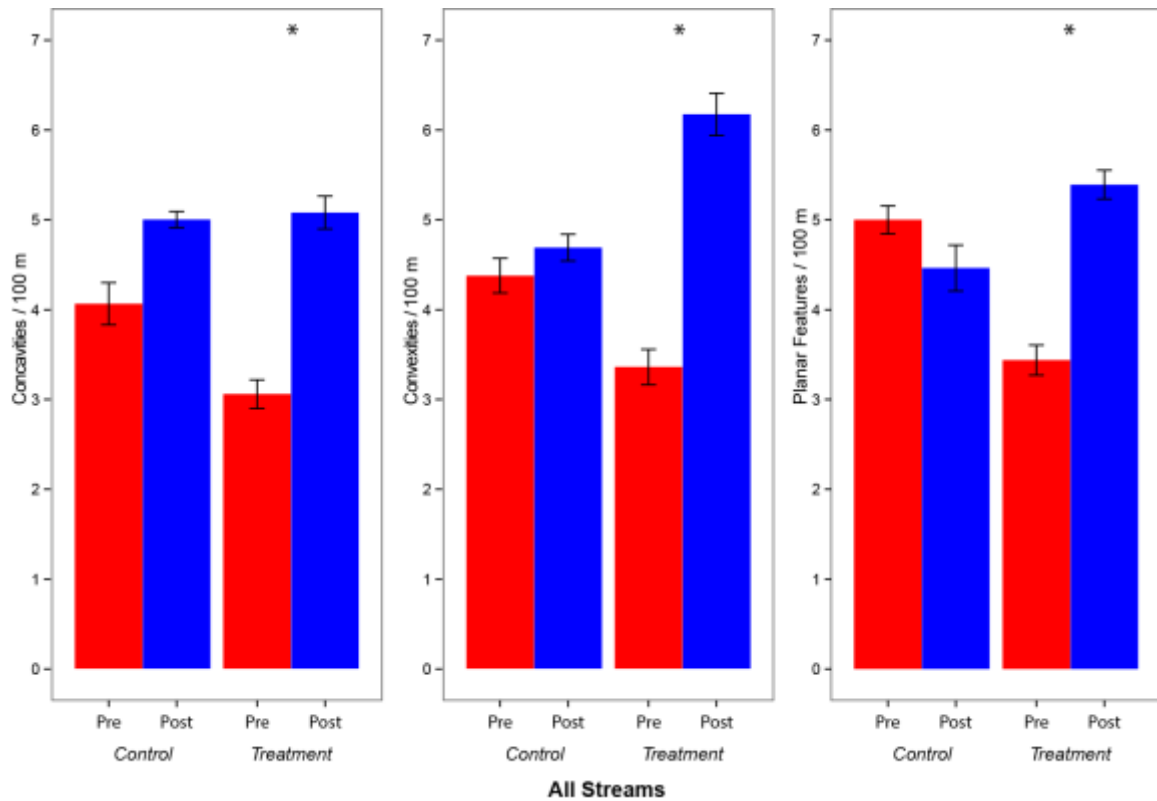
Figure 3.23. Mean concavities, convexities, and planar feature units per 100 meters by pre- and post-restoration and control and treatment sites on the South Fork of Asotin Creek and Charley Creek combined. Units were manually delineated from topographic data collected at CHaMP sites. Error bars represent the standard errors. An asterisk between bars represents a significant difference in the means of unit counts pre- and post-restoration (\*= $P < 0.05$ ).

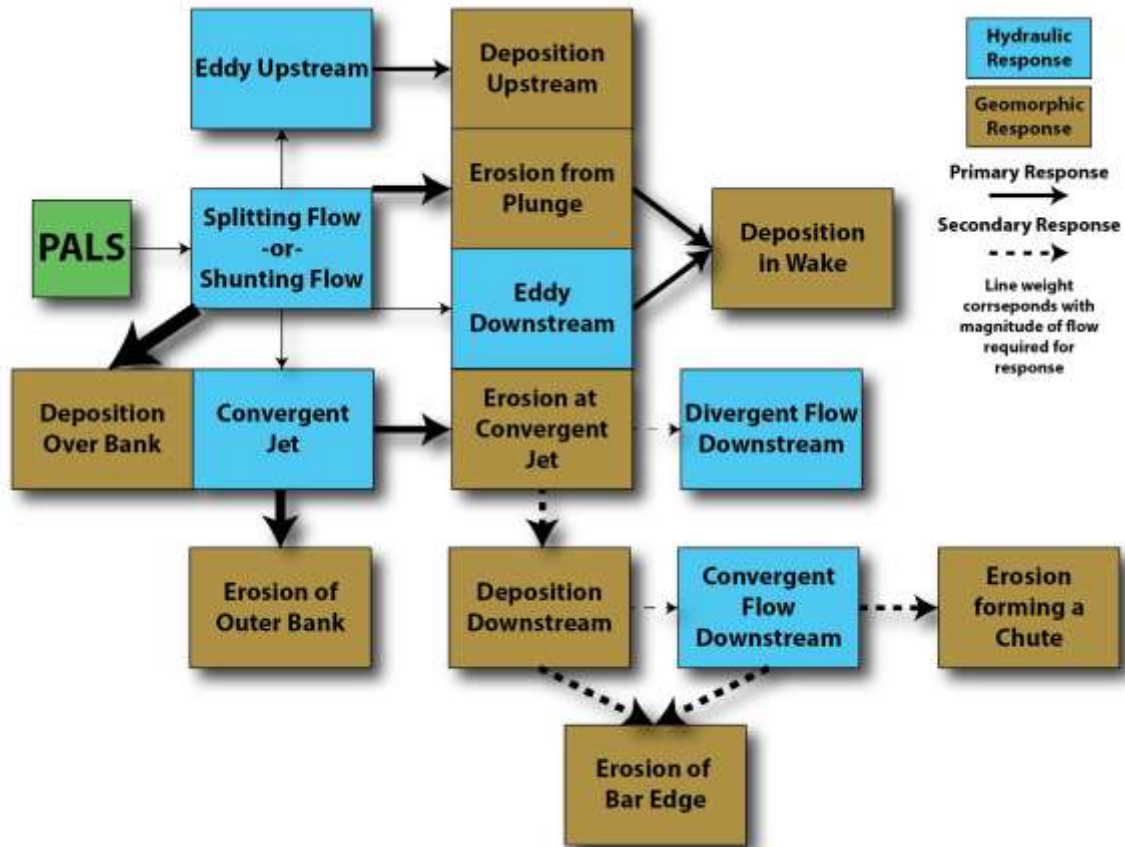
Figure 3.24. Conceptual pathway for expected responses at a post-assisted log structure (PALS) after implementation. Hydraulic responses are blue and geomorphic responses are tan. The line weight between responses corresponds with the magnitude of flow required to elicit the response (thicker = higher flow). Responses connected by a dashed line are secondary, meaning they require the presence of the previous response to form.

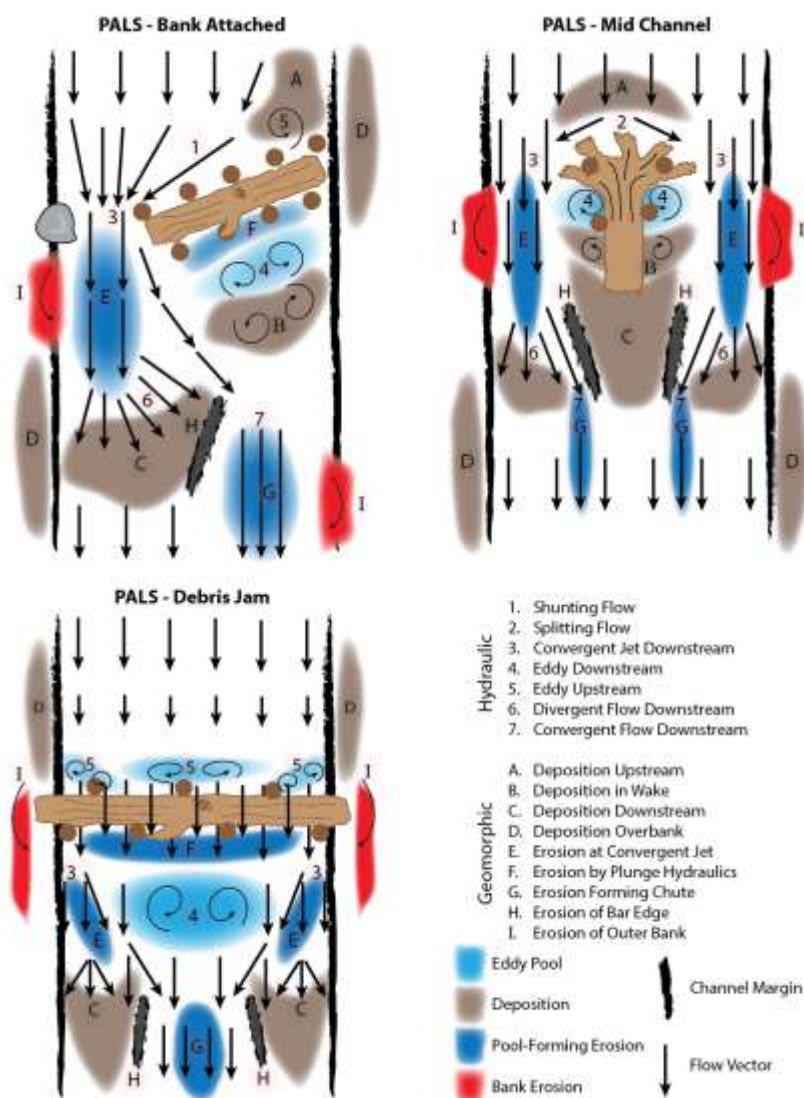
Figure 4.3. Example of expected hydraulic and geomorphic responses for structure types implemented on the South Fork of Asotin Creek. Vectors indicate hydraulic responses, and colored polygons indicate geomorphic responses. Red = bank erosion, blue = pool development, gray = bar development. The noted presence of each response was compared between observers.

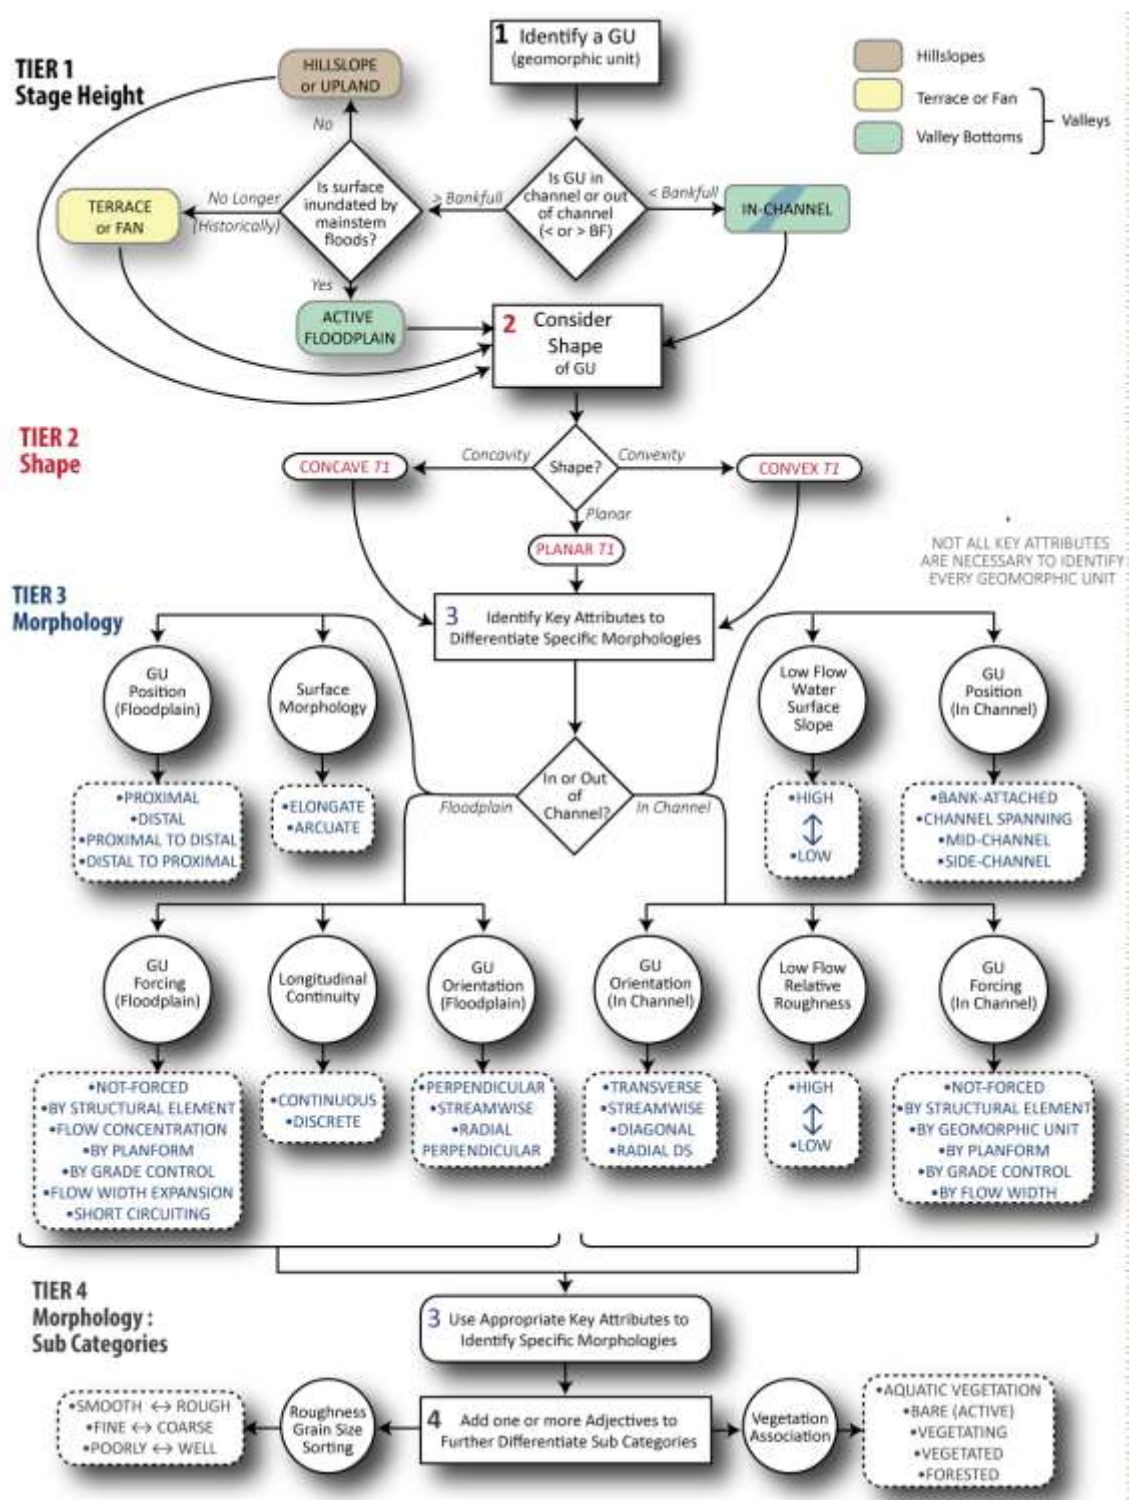
Figure 4.4. Four tier dichotomous key for determining geomorphic units in fluvial valleys. This study delineated units up to tier 3 – the specific morphology of geomorphic units. From [Wheaton et al., submitted to *Geomorphology*, 2014].

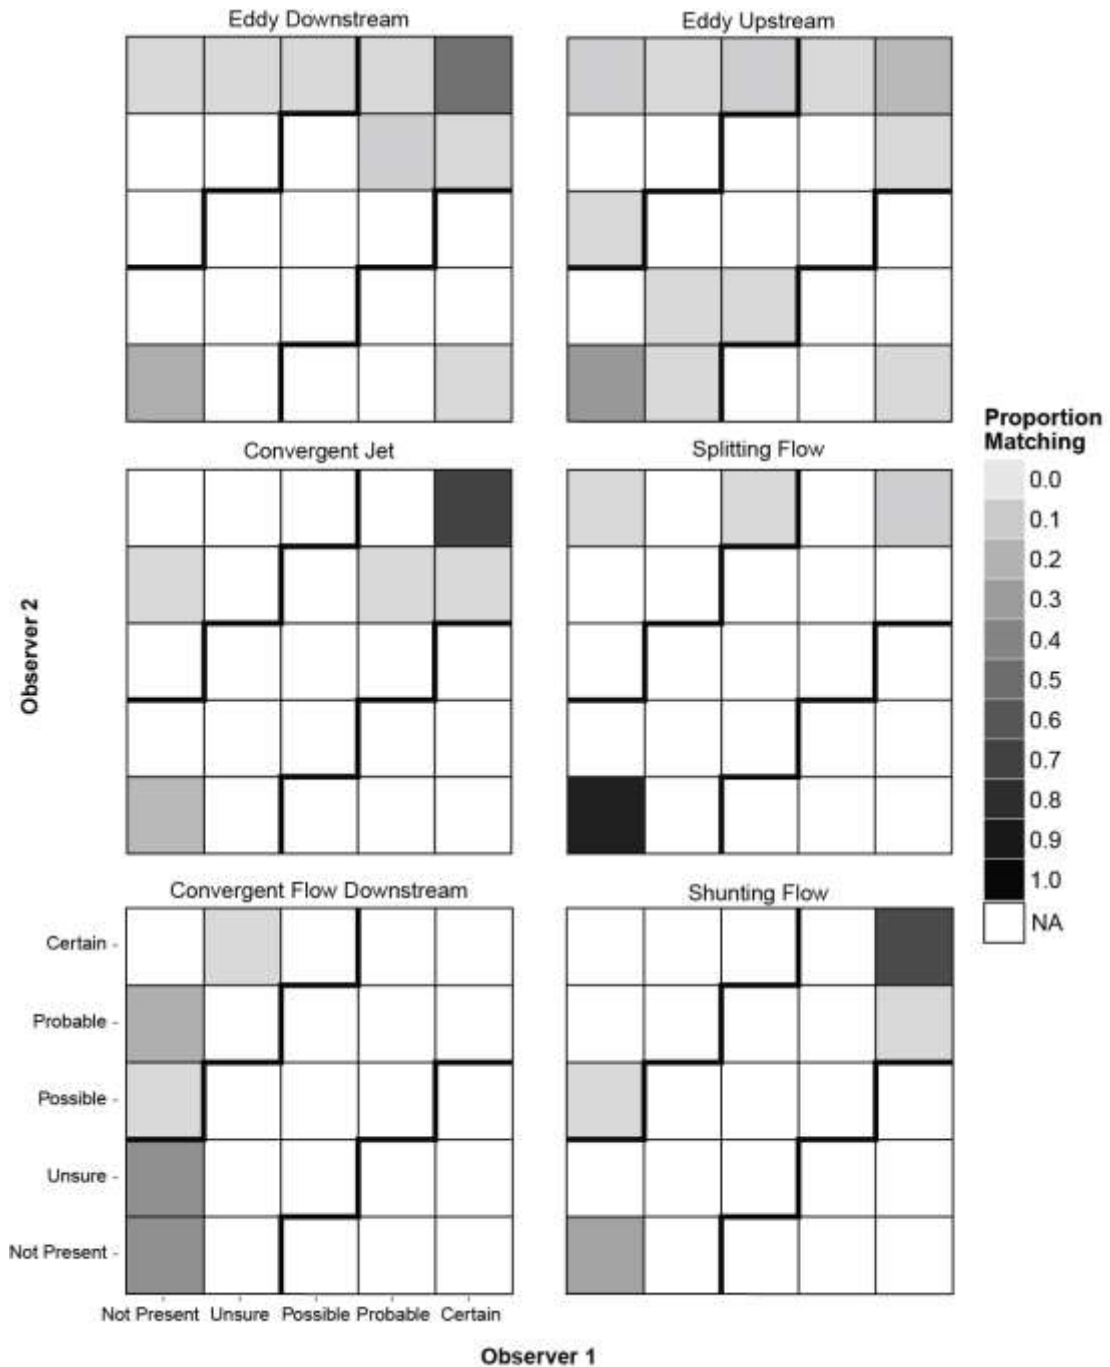
Figure 4.5. Agreement matrices for hydraulic responses comparing observations between observers. The bold black line represents a deviation of one factor level between observers.

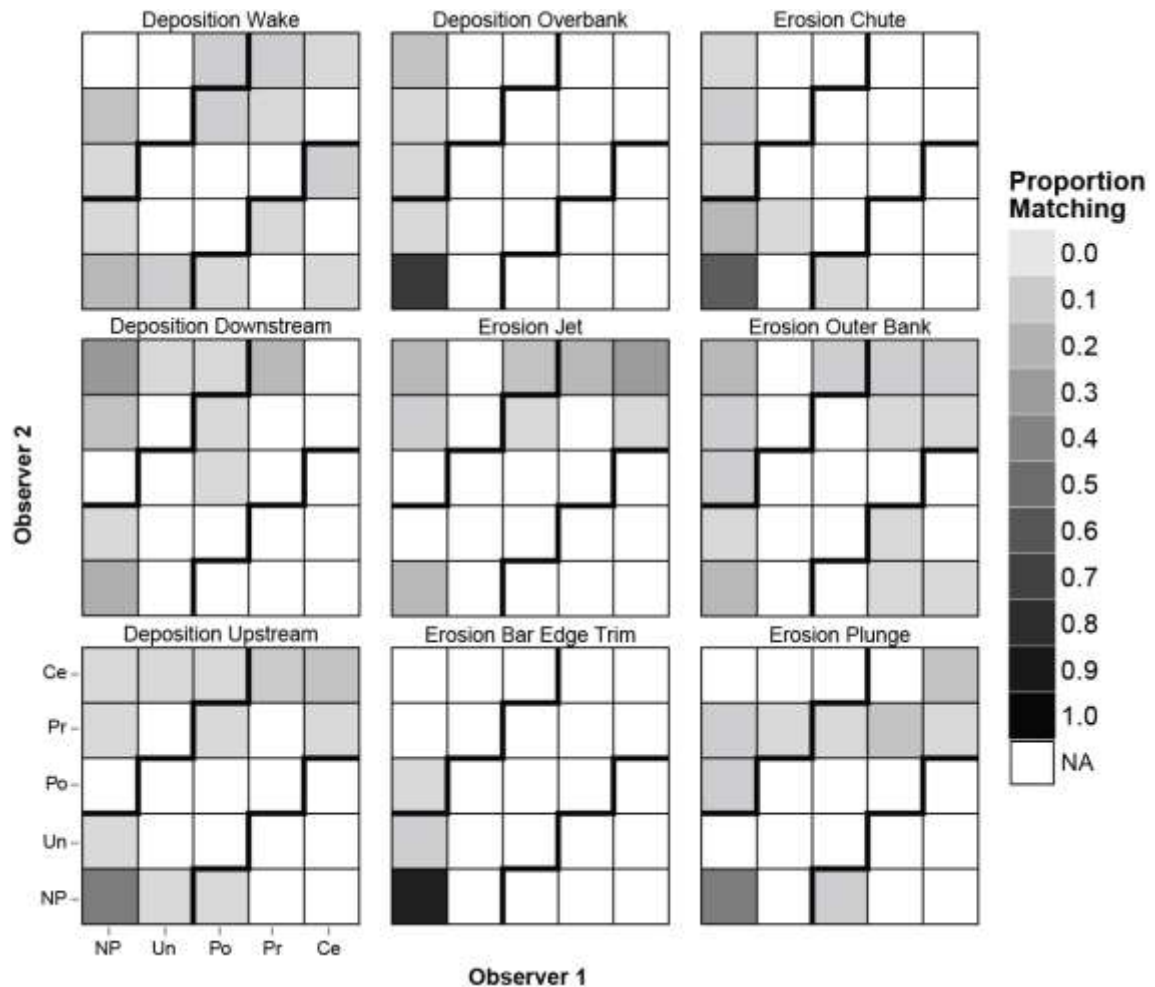
Figure 4.6. Agreement matrices for geomorphic responses comparing observations between observers. The bold black line represents a deviation of one factor level between observers.

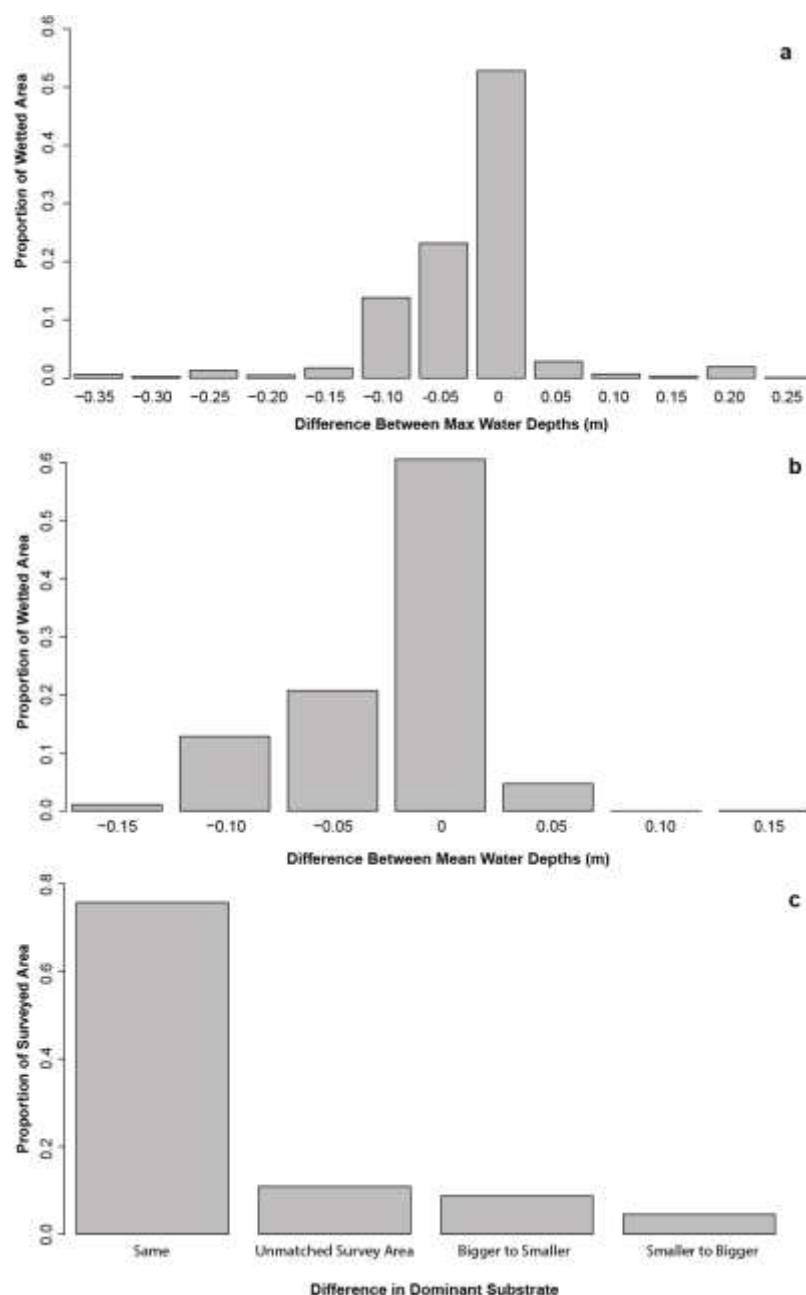
Figure 4.7. Differences in max water depth, mean water depth, and dominant substrate between observers. Differences are calculated by comparing raster cells within each surveyed area around 25 structures.

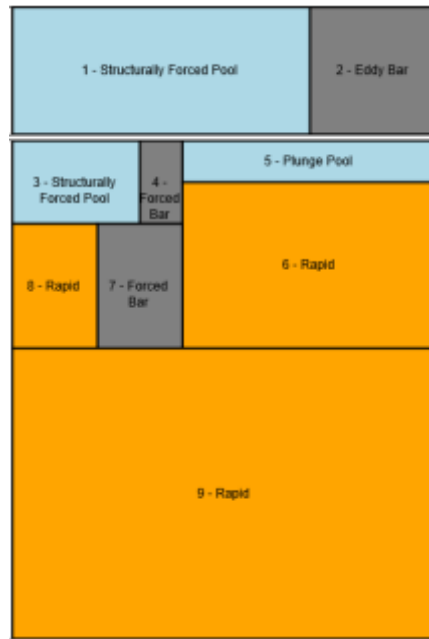
Figure 1. An example tetris diagram showing the geomorphic units surrounding structure 1 on the South Fork of Asotin Creek.
