HYRUM PROJECT - UTAH

PROPOSED
REHABILITATION
AND
BETTERMENT
PROGRAM
DRAFT

FEBRUARY 1989

BUREAU OF RECLAMATION
C. Dale Duvall, Commissioner

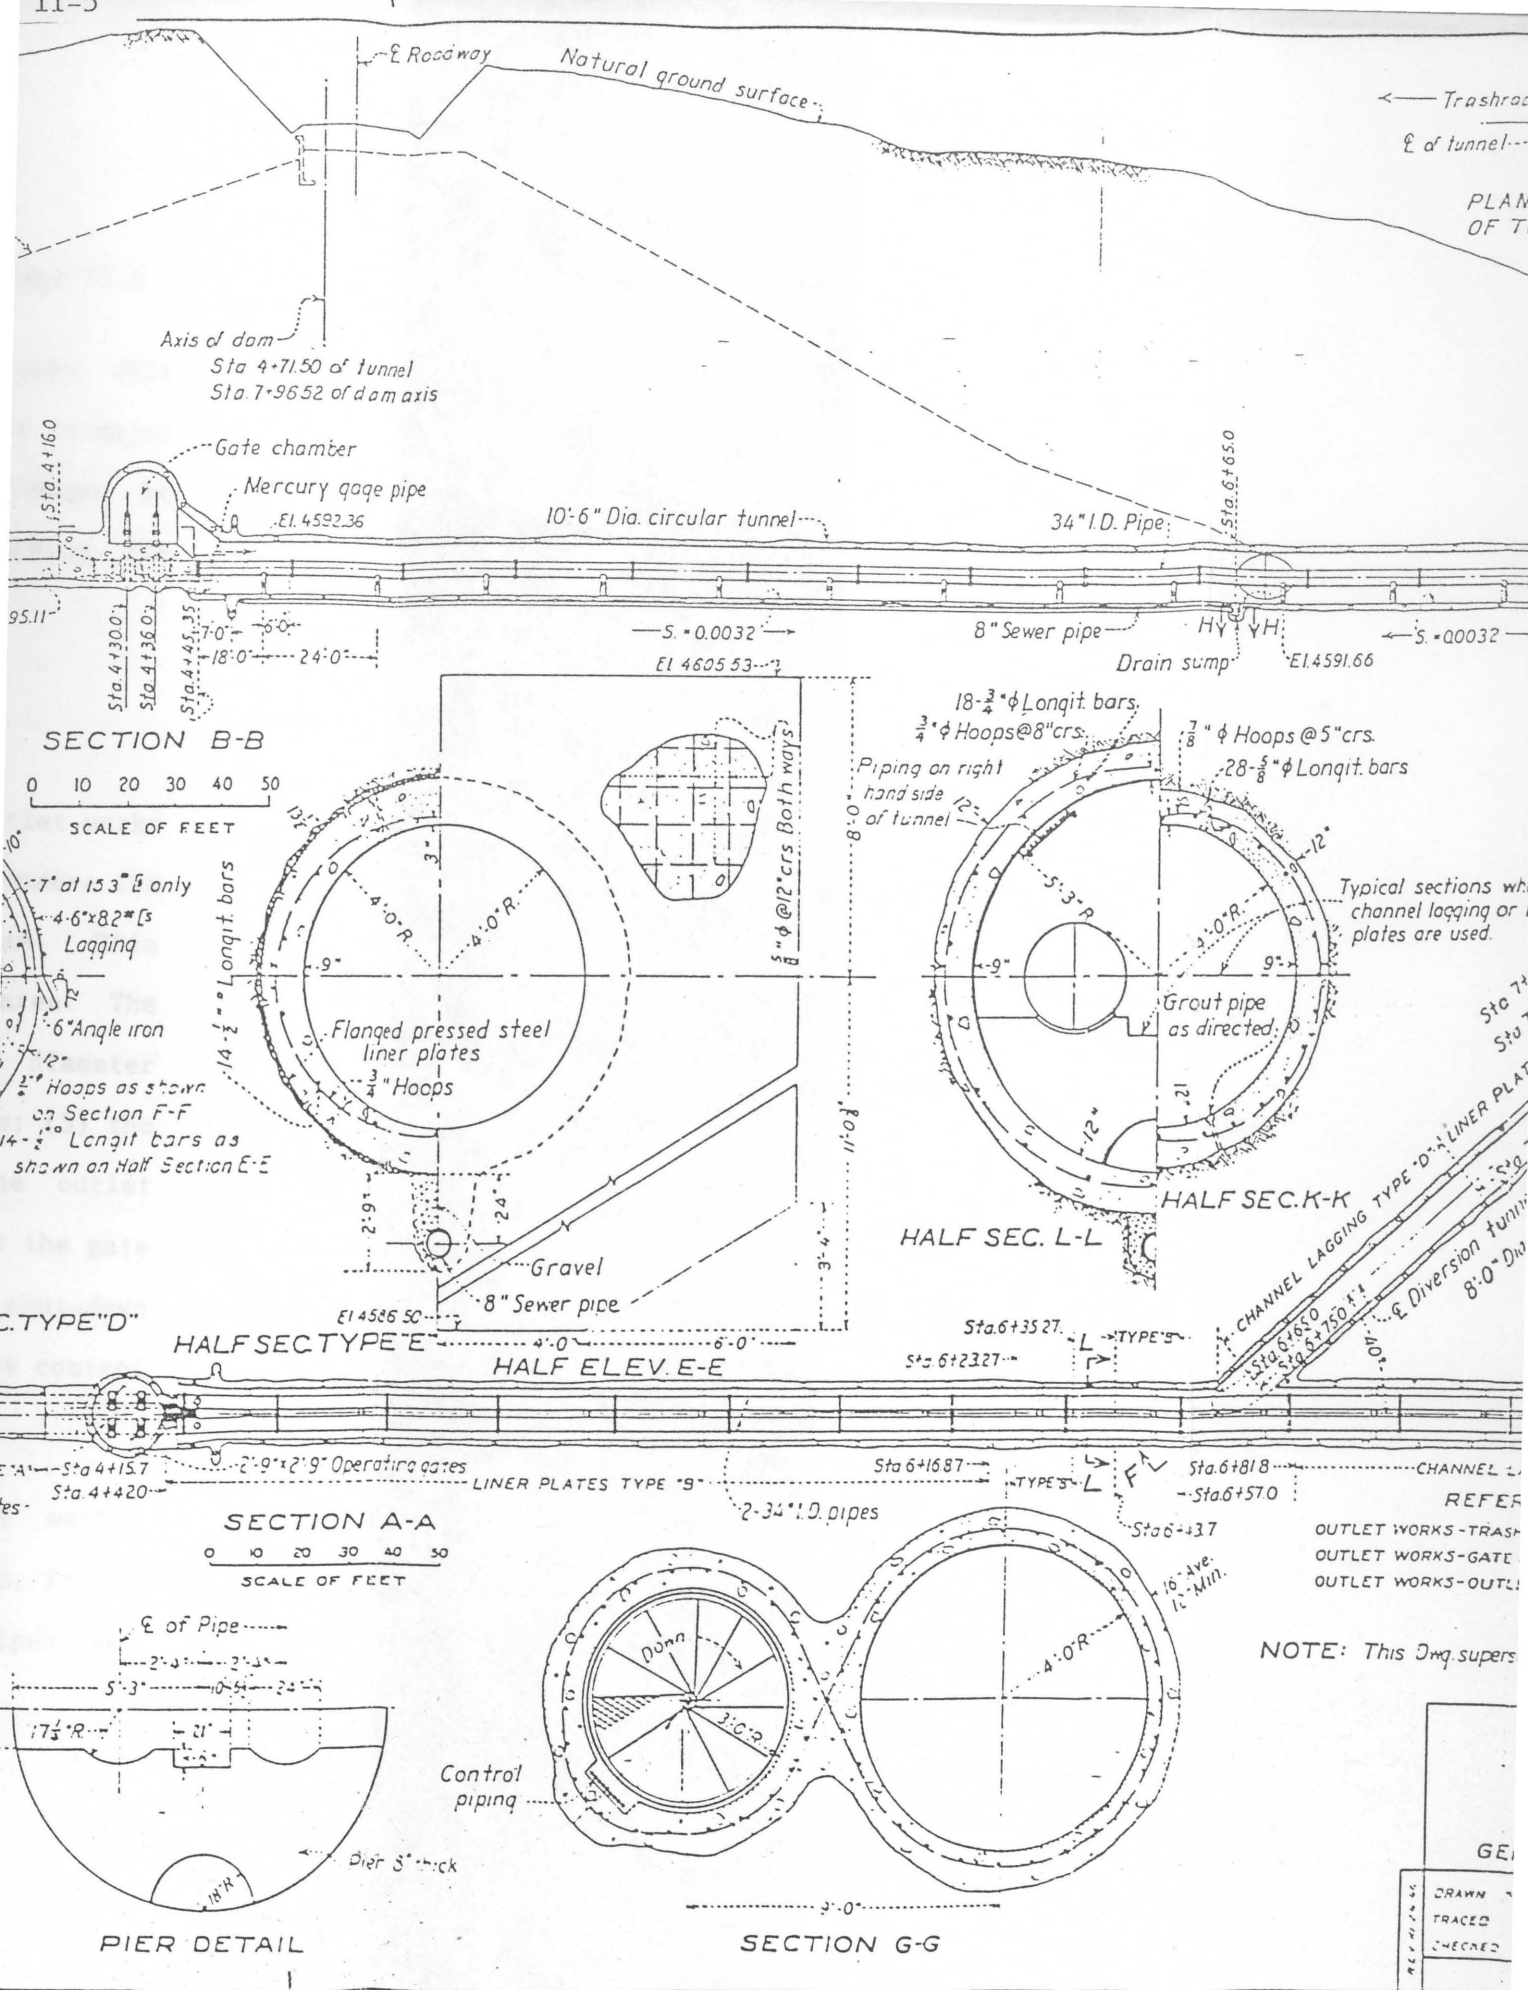
The water user's have reported that the outlet works at Hyrum Dam have been diminishing in capacity over the past several years. Two underwater dives (1981 and 1987) have confirmed that the intake structure to the outlet works is almost silted in. A copy of the 1987 diving report is contained in Appendix C. The problem has also been addressed in the Review of Operation and Maintenance (RO&M) program. RO&M recommendation (84-1-A), is to remove the silt from around the intake structure. Figure II-1 shows a cross section of Hyrum Dam including the intake structure and the outlet works.

If the situation is allowed to continue, the outlet works will likely become completely silted over. This would result in major economic losses to the area. Additionally, the dam could no longer be evacuated in the event of an emergency, greatly increasing the probability of dam failure.
