Lightning arc channel effects on surface damage development on a PRSEUS composite panel: An experimental study

Abstract. Composite aircraft structures are vulnerable to lightning strike damage due to their relatively low electrical and thermal conductivities. A preceding work has investigated the lightning damage resistance of a carbon-epoxy Pultruded Rod Stitched Efficient Unitized Structure (PRSEUS) panel. The damage includes intense local damage (*i.e.*, matrix decomposition/sublimation, fiber rupture, delamination) accompanied by widespread surface damage (*i.e.*, distributed fiber rupture and tow splitting) further from the lightning attachment point. This study focuses on investigating the cause of the widespread surface damage. Two possible driving mechanisms are explored: *i*) magnetically-induced currents and *ii*) lightning arc-root/channel expansion. Fifteen laboratory-scale lightning strike tests at nominal peak currents of 50-125 kA were performed on modified PRSEUS mid-bay locations. The surface modifications were placed adjacent to or enclosing the intended lightning arc attachment point, including through-slots, a non-conductive silicon-filled slot, insulating tape

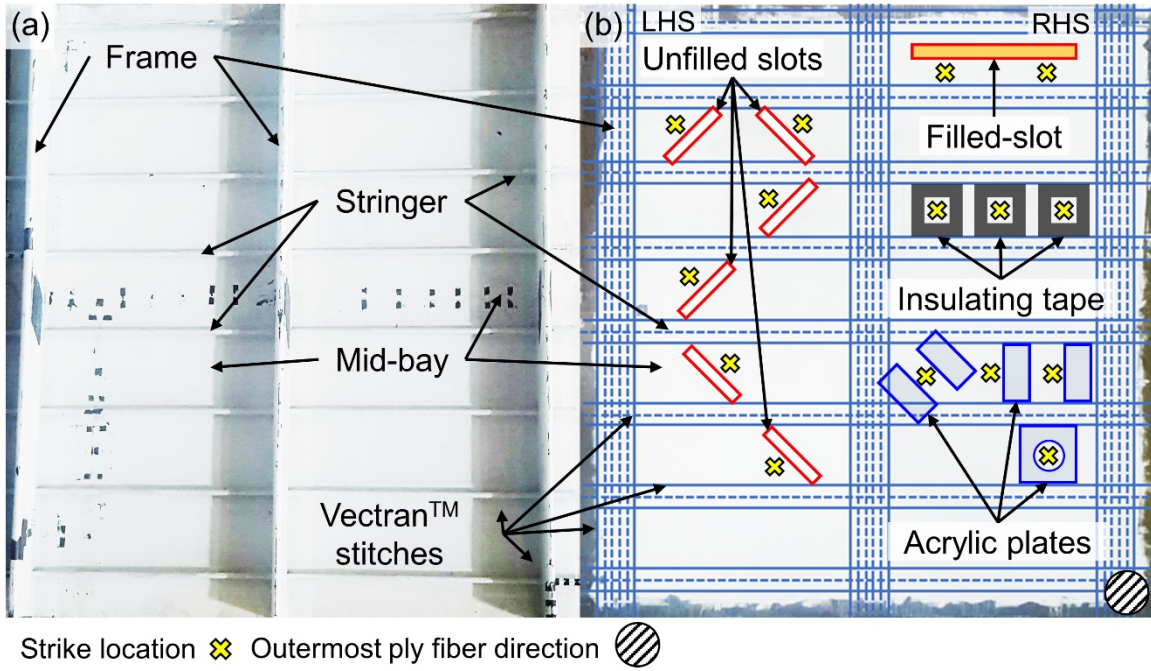
Figures 6a-b show lightning damage due to an actual 120 kA mid-bay strike, where the slot was oriented parallel to the outer ply fiber direction (+45°). Similar to the results shown in Fig. 2, a region of intense local damage formed at the attachment point and was elongated in the outer ply fiber direction. In addition, widespread surface damage formed on both sides of the slot (Fig. 6b) but was less pronounced on the isolated side of the slot. This distributed damage tended to be loosely clustered about an axis perpendicular to the fiber direction that also passed through the attachment point. This axis roughly defines the direction of maximum arc expansion [20], as well as the location of the peak magnetically-induced currents [25, 35, 40]. In this experiment, it is unclear whether the surface damage occurring on the opposite side of the unfilled slot resulted from reattachment of the expanding arc (which “jumped” the slot due to the presence of high electric field) or from the formation of strong secondary currents induced by the primary magnetic field. This was the only experiment, however, where damage formed on the opposite side of an unfilled slot.

Additional strikes at 118.4 kA (Fig. 6c) and 136 kA (Fig. 6d) were performed adjacent to parallel slots at mid-bay locations. In each case, the domain with intense fiber damage was more rectangular-shaped and noticeably more pronounced than for the earlier 120 kA strike (Fig. 6b). Moreover, in these latter two cases, *no widespread surface damage appeared across the slot from the attachment point*. It seems reasonable that the discontinuity in surface geometry provided by the slot caused the expanding arc to detach from the surface, leading to more pronounced

Fig. 6. Lightning strike damage adjacent to unfilled through slots oriented parallel to the outermost ply fiber direction due to peak currents of (a) 120 kA typical strike test setup, (b) 120 kA, (c) 118.4 kA, and (d) 136 kA.
