Dellingr: Reliability lessons learned from on-orbit

Larry Kepko, Luis Santos, Chuck Clagett, Behnam Azimi, Dean Chai, Alan Cudmore, Scott Starin, James Marshall,
John Lucas
NASA Goddard Space Flight Center
Space Weather Laboratory, Greenbelt, MD, 20771; 301-286-2728
Larry.kepko@nasa.gov

Table 1. Dellinger on-orbit event list

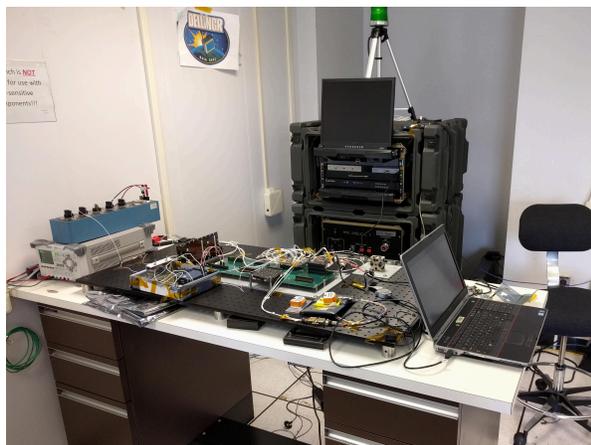
Figure 7. Dellinger flatsat

We have attempted to recreate the issue on the ground through use of a flatsat (Figure 7). The flatsat has been assembled from engineering units and spare parts. It is based around a custom backplane for PC-104 connectors which allows components to be added and removed with ease. One thing we are lacking is a spare Cadet radio. Instead, we are using a Cadet simulator program developed by NASA's Independent Verification and Validation (IV&V) Facility. This allows us to complete the loop between the flight software and ground control software to view the telemetry in real-time. Despite

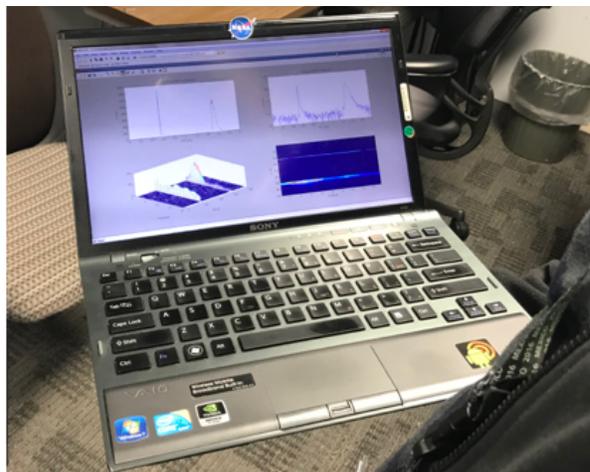
Figure 10. The first ion spectra from Dellinger.

By turning off the wheels, we had removed the resets completely. But without wheel control the spacecraft could no longer maintain a sun pointing orientation. Still, we were finally able to turn on the INMS, and a few days later, on February 9th, we had spectra (Figure 10). Validating the INMS instrument was a key goal of the mission, and the team rightly celebrated the recovery.
