## Friction Factor Tests on 375 mm High Density Polyethylene Pipe

Hydraulic Report No. 223

**FRICITION FACTOR TESTS ON 375mm  
HIGH DENSITY POLYETHYLENE PIPE**

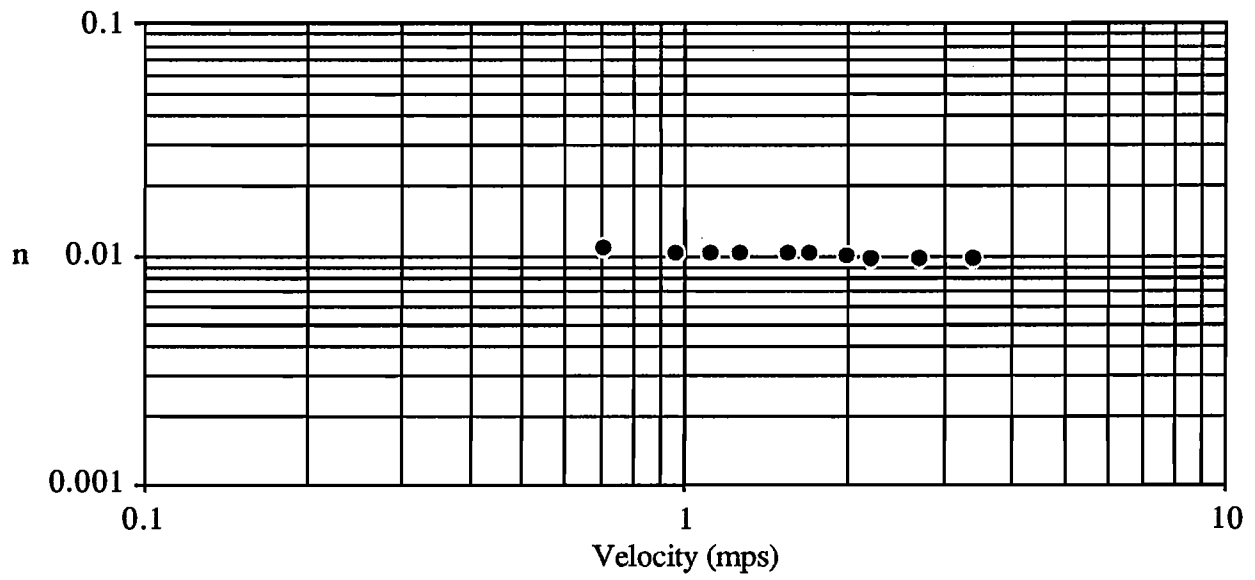
**Manning n vs. Velocity for 375mm Diameter HDPE Pipe**  
**Figure 2**

Experimental results from the three sets of tests are contained in Table 1 and Figures 2-3. Plots are provided of the variation of the Darcy-Weisbach friction factor  $f$  versus velocity and the Manning's  $n$  versus velocity. (To calculate the average velocity, the diameter of the pipe was consistently measured at the corrugation peaks, and the flow ran in the same direction as the seams to reduce friction.)

Note that the Manning's  $n$  varies from 0.0108 to 0.0099, corresponding to a velocity variation of 0.7 to 3.4m per second. Additionally, the friction factors decrease slightly with increased velocity.
