An Evaluation of In-Stream Structures Designed to Provide Fish Habitat

AN EVALUATION OF IN-STREAM STRUCTURES
DESIGNED TO PROVIDE FISH HABITAT

A Project
Submitted to the
Department of Civil Engineering Science
Brigham Young University

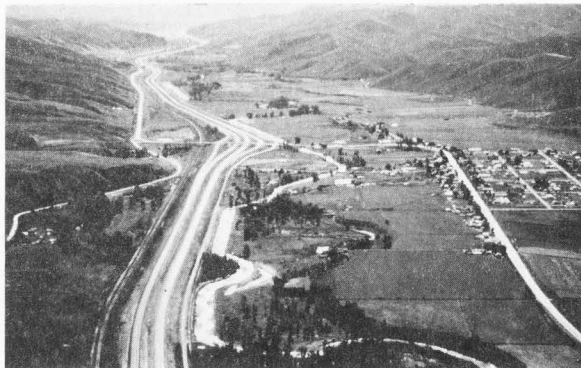
Figure 1

Channelization of the Weber River, Utah
Due to Highway Construction

Stream channelization (Figure 1) by dredging and straightening stream channels, bulldozing vegetation on stream banks, and draining associated swamps and floodplains have proven to have catastrophic effects on the environment. Some of the adverse environmental effects of channelization have been elimination of fish habitat and lowered production of aquatic life, destruction of wildlife habitats, degradation of water quality, increased erosion and turbidity, increased floods and damages downstream, lowered water tables, and losses in esthetic beauty.

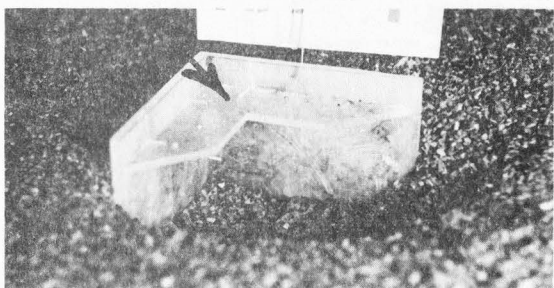
Figure 22
Model Tests

Inverted Weir

"V" Structure

Slab with Legs

Cylinder

These in-stream structures provided good cover, good holes, and calm water in the model stream, as can be seen in Figure 22.

The inverted weir (Experiments 29 and 30) scoured a very good hole under the weir projection. It was also found that deflector vanes placed on top of the slab would tend to keep any deposition directly downstream from the structure from building up.

The "V" structure (Experiments 19 and 20) was placed in a hole which was excavated prior to running the test. The real value of model tests was realized in the study of this structure. It was first tested as an open-ended triangle; then the cover plate was added and tested both on top and at the substrate level. Next a notch was made in the cover plate and it was also tested at both levels. And finally holes were drilled in the sides of the "V." Through this process of modification it was determined that the best design was to have a notched cover plate placed at the substrate level and holes in the sides of the "V." This design maintained a self-cleaning hole within the "V" and minimized the deposition build-up directly downstream from the structure. Cover was also provided.

The slab with legs (Experiments 25 and 26) provided a hole, overhead cover, and variations in velocity. Due to flow through this structure from the side, very little deposition occurred under the slab.

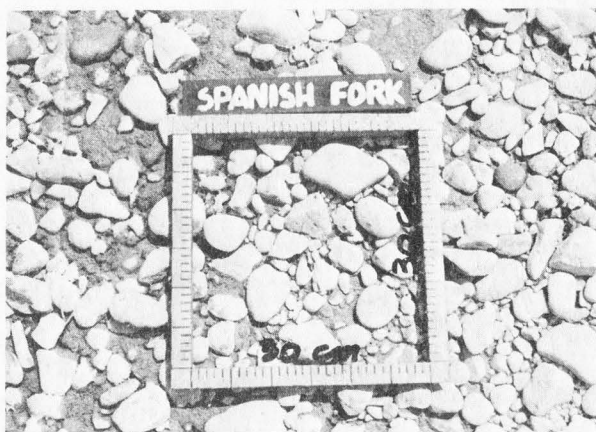
Figure 26

Spanish Fork Substrate

Provo River Substrate

Substrates on the Spanish Fork River and the
Provo River below the Murdock Diversion

Recognizing these problems, a second method had to be devised to determine the particle size distribution curves. A conventional sieve analysis was performed on samples from the Spanish Fork River, the Provo River at Murdock, and Hobble Creek. Samples were collected during low-flow conditions at the edge of the water. Care was taken so as not to wash out any fines from the samples. A percent finer by weight versus particle size was then determined. The particle size distribution curves were shifted slightly up and to the right, but surprisingly enough they were parallel to the curves derived from the first procedure in the range from 12 cm to 1 cm. The final curves are shown in Figure 25 and can also be visually compared in Figure 26.

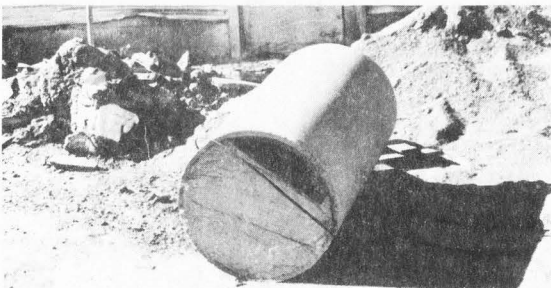
Figure 33
Structure Prototypes

Inverted Weir

"V" Structure

Slab with Legs

Cylinder

The summary of structure placement is given in Table 6. The structures can be seen in Figures 33 and 34.

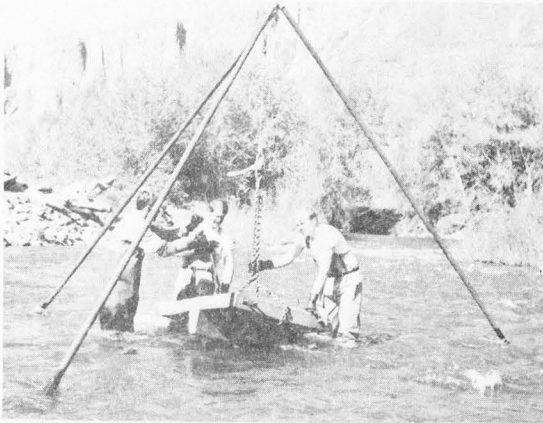
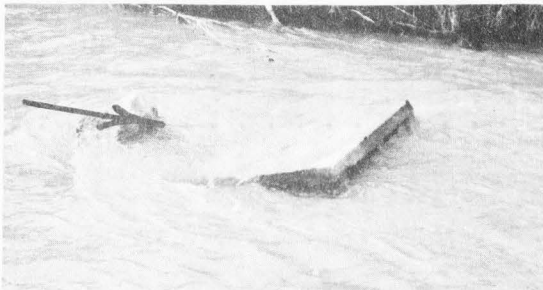
Figure 34

Installing Inverted Weir

River Performances of "V" Structure

River Performance of the Slab with Legs

River Performance of the Cylinder
