Contamination Control of the SABER Cryogenic Infrared Telescope

Dyer, James S., Steven Brown, Roy W. Esplin, Glen Hansen, Scott M. Jensen, John L. Stauder, and Lorin Zollinger. 2002. "Contamination Control of the SABER Cryogenic Infrared Telescope." Proceedings of SPIE 4774: 8–18. doi:10.1117/12.481652.

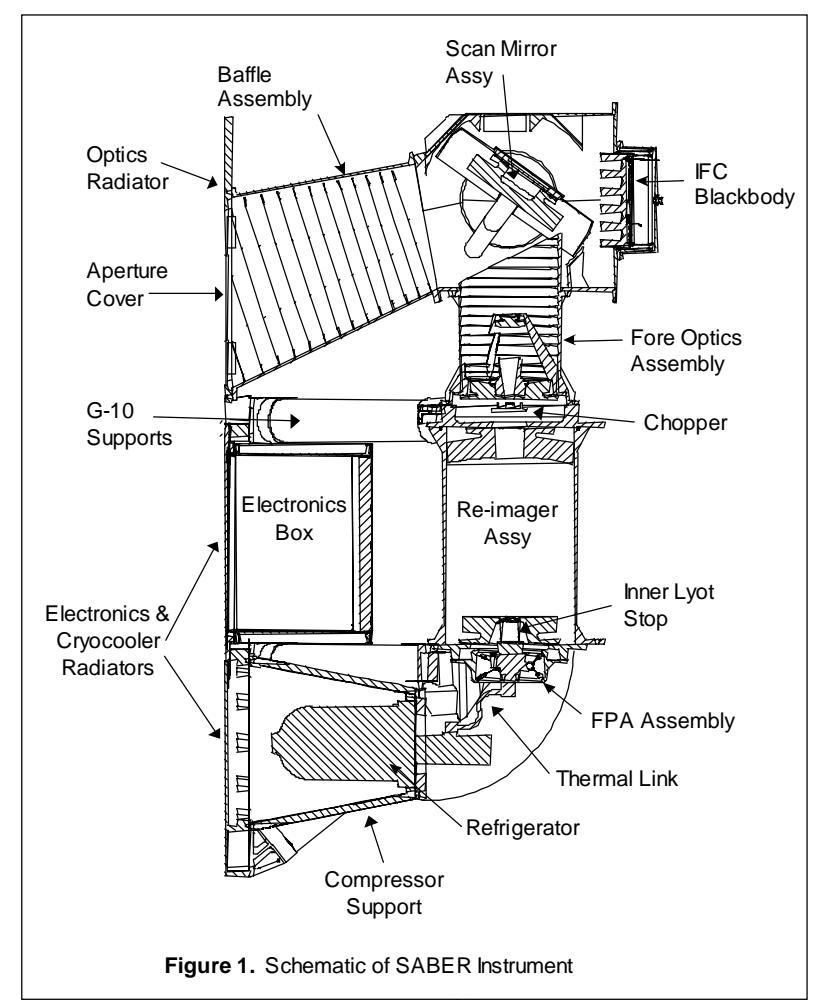
The SABER telescope is an on-axis Cassegrain design with a picket-fence tuning fork chopper at the first focus and re-imaging optics that focus the image onto the focal plane (Figure 1). Altitude profiles in the earthlimb are acquired using a single-axis scan mirror mounted in the baffle assembly.^{1,2} High off-axis rejection performance was obtained by extensive straylight analyses and optimization during design and the

required use of nearly pristine, superpolished fore-optics.^{3,4} Furthermore, an intermediate field stop and an inner Lyot stop are incorporated to eliminate the stray light and diffraction effects that are typically associated with on-axis telescope designs.⁵ The scan mirror has approximately 100° range of motion that allows it to scan across the entrance aperture or rotate to a position for on-orbit calibration using the inflight calibrator (IFC) blackbody.

Removable witness mirrors were incorporated into the sensor design at an early stage so that the cleanliness of the optics could be monitored during integration and testing. As indicated in Figures 1 and 3, the scanner compartment and the telescope aperture cover each accommodated two superpolished witness mirrors. The mirrors in the scanner were 5.7 cm diameter and the aperture cover mirrors were 3.2 cm diameter. In principle, one mirror in each location was for total integrated exposure while the other mirror was changed more frequently to measure interval exposure during distinct operations. The mirrors would then be removed at the last scheduled access prior to launch and replaced with black covers. In practice, the witness mirrors for the scanner were installed after the final optics cleaning in May '99 and were not accessible again until the preparations for integration with the spacecraft at the Johns Hopkins University Applied Physics Lab (JHU/APL) in September '99. Both scanner mirrors were removed at this time and the percent obscuration of the mirrors was conservatively estimated at no greater than 0.00086% and 0.0022%, or Mil Std 1246 Level 146 and Level 181, respectively. This is excellent performance, considering that the period of exposure included the environmental testing and several cold cycles (previbe, warm and cold boresight tests, thermal-vacuum cycling, and cold calibration).

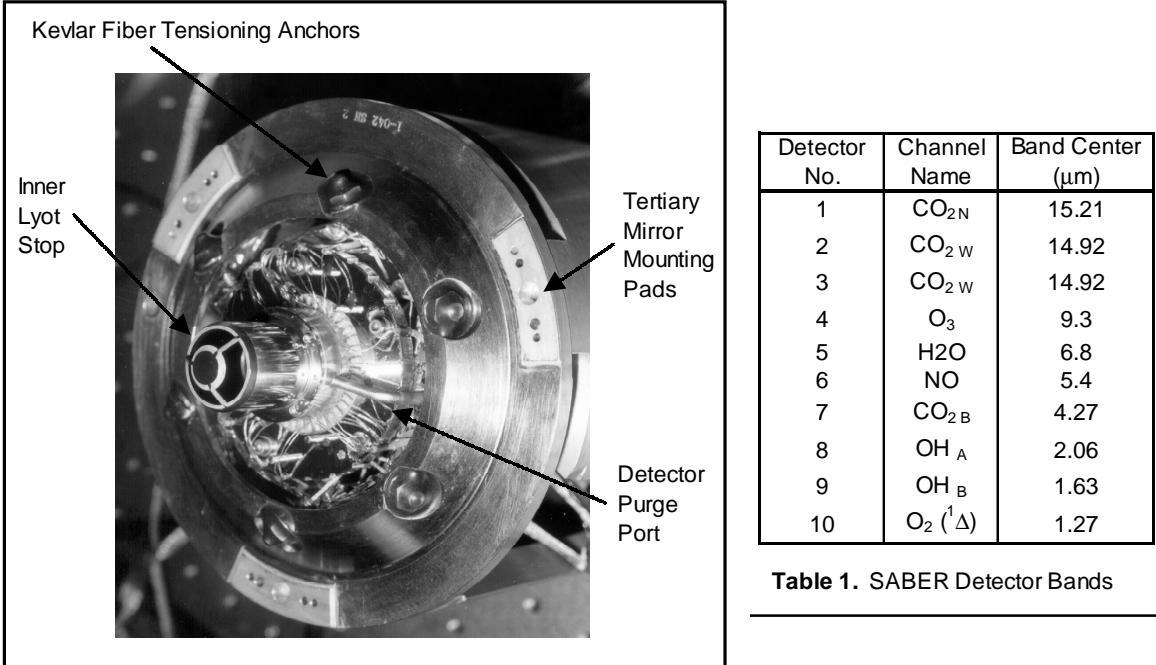
Figure 2. Detector Assembly on Kevlar Fiber Support Structure

The SABER detector array fabricated by EG&G contains discrete HgCdTe, InSb, and InGaAs detectors. As shown in Figure 2, the detector is supported using a FiST assembly integrated with the M3 mirror mount. The detector base plate incorporates a purge port connection so that it can be purged with dry nitrogen during handling or storage at atmospheric pressure. (The detector purge capability was included in response to a tests by EG&G that indicated that the HgCdTe responsivity and dark noise can be affected by exposure to atmospheric moisture.) The detector array surface is enclosed within the inner Lyot stop. The Lyot stop is designed to eliminate the scattering produced by the Cassegrain telescope secondary mirror support vanes and central obscuration. When assembled to the telescope, the Lyot stop is located within a central aperture of M3. Prior to installation of the Lyot stop, the detector surface is cleaned to Level 100 cleanliness. This is accomplished by inspection and cleaning under a microscope to remove all particles larger than 20 μ m. This limits the allowed obscuration of a detector base, Lyot stop, and M3 support ring are polished and gold plated to reduce the emissivity and thermal loading of the detector by M3 and the surrounding telescope body.

The detector assembly is connected to the pulse tube refrigerator via a flexible aluminum thermal link. The refrigerator cold post, thermal link, detector base, and Lyot stop operate at \leq 75 K and are the only surfaces in SABER that are cold enough to form water cryodeposits during on-orbit operation. The thermal link and pulse tube cold post are blanketed with approximately 20 layers of multilayer insulation (MLI). The equilibrium temperature of the warmest outer layers of MLI is assumed to be only slightly cooler than the compartment walls at approximately 250 – 260 K. This warm MLI represents a potential source of water vapor that may redistribute onto the detector assembly via the openings in the FiST assembly.

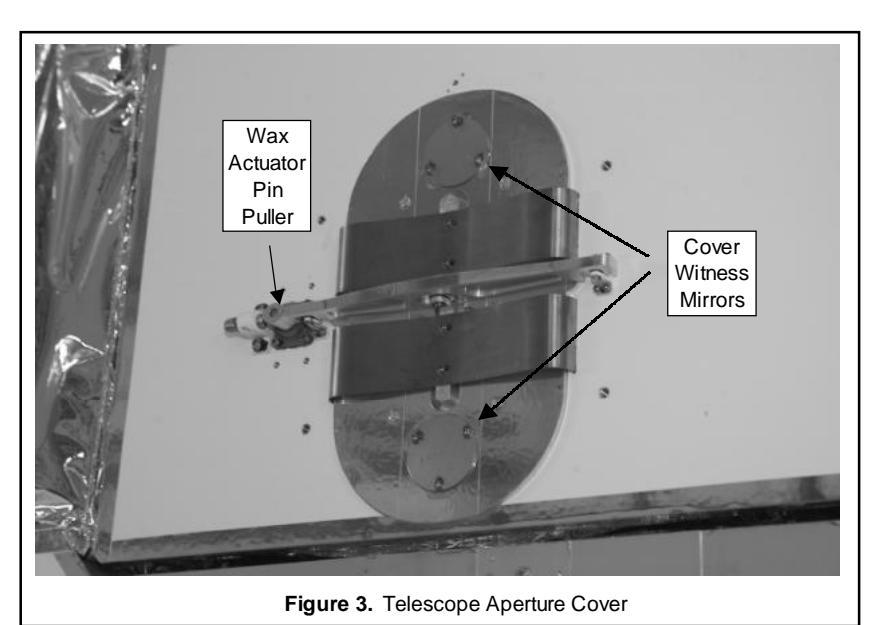
A lightweight telescope aperture cover was designed using leaf springs and a sliding retaining bar on the cover as shown in Figure 3. The cover is deployed and jettisoned into space by using a radiator-mounted wax-actuated pin puller to disengage the retaining bar. The cover provided a tight but non-hermetic seal by using a coilreinforced captured Teflon O-ring on the cover. The seal contact area on the radiator plate was covered with silver Teflon tape to minimize cold stiction and

particle generation. Vibration and cold deployment testing verified that this design produced mini mal particulates and reliable deployment.

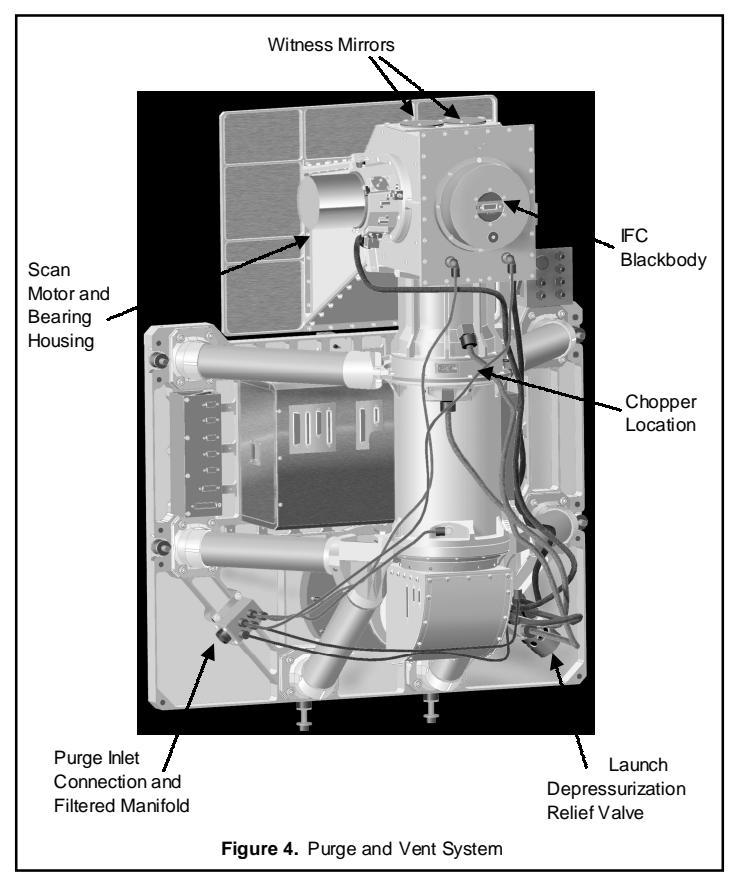
The vulnerability to water outgassing and the need to control particulate redistribution within the detector assembly and optical cavities led to the design and optimization of a purge and vent system (Figure 4). In order to make the purge system effective, the dry purge gas needed to be distributed uniformly into critical compartments and the escape paths had to be minimized so that a slight positive pressure (4-6 Torr) could be maintained at a reasonable flow rate. This was accomplished using a purge manifold that distributed dry nitrogen to five locations: two ports in the fore-optics and scanner compartment, and one port each for the re-imager compartment, tube/thermal the pulse link compartment, and the detector. The telescope purge lines are 1/8" Teflon tubing. The detector uses 1/16" tubing to restrict the gas flow to <3% of the total purge (nominally 0.5 scfm at 4 psi delivery pressure). The purge manifold includes a 5 µm filter and each purge fitting on the telescope uses a sintered

metal gas snubber filter disk to provide additional filtering, and eliminate stray light leaks. Once installed, the purge was operated continuously whenever the sensor was not under vacuum.

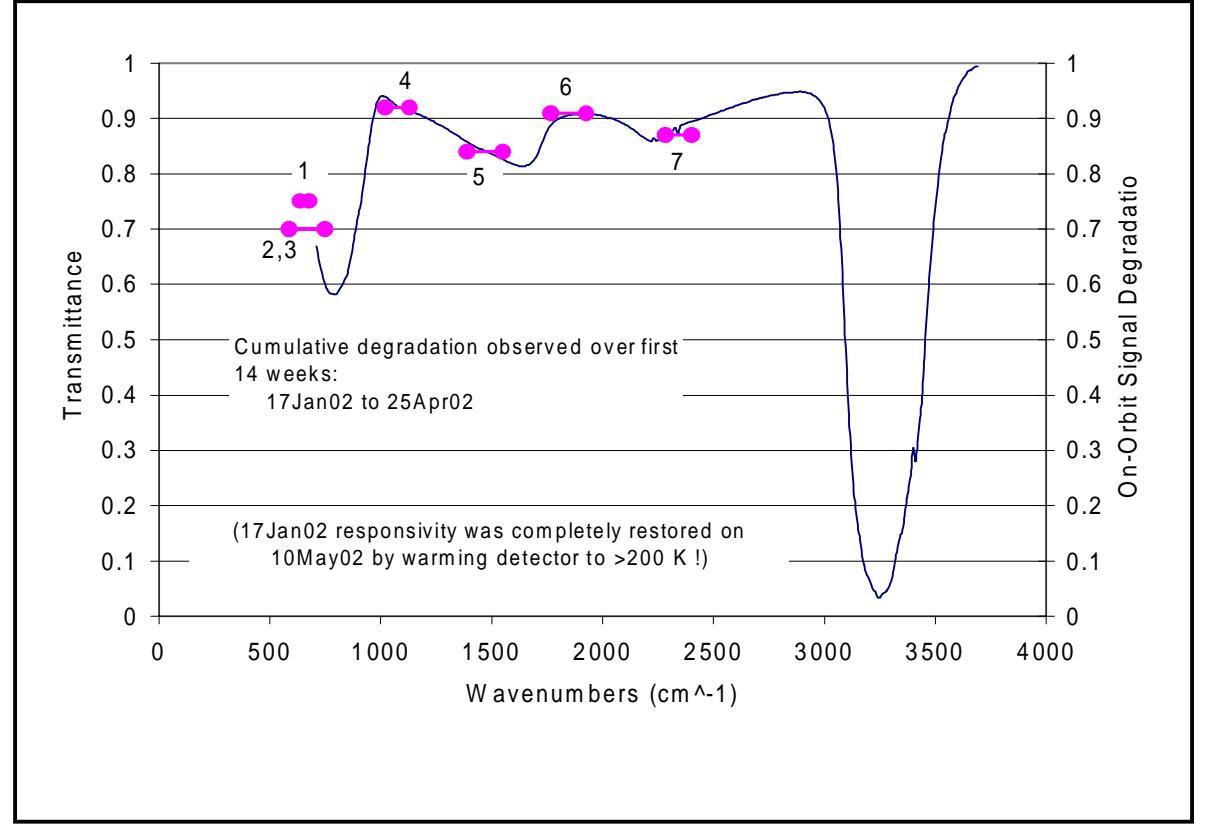
suggested that ice was being deposited on the thermal link and FiST assembly. In Figure 5, the relative detector responsivity degradation measured after 14 weeks of on-orbit operation shows good agreement with the infrared transmittance spectrum generated for 1 μ m ice film using CALCRT.¹⁷ The degradation

profiles as a function of time were also qualitatively similar to CALCRT predictions based on a constant deposition rate. (One μ m deposition in 14 weeks equates to an average local partial pressure of 6.7 x 10⁻¹⁰ Torr, assuming water vapor at 200 K). The long wavelength data (channels 1-5) exhibited a steady degradation, whereas the shorter wavelength channels displayed a slight oscillation due to thin film interference effects that were also predicted by the CALCRT model. Based on these spectral and thermal correlations, it was decided to warm up the detector in May '02 to approximately 231 K by turning off the refrigerator for 3 days. The ice completely sublimated, and all channels were restored to the initial signal levels that were measured on 17 Jan 02. Current measurements indicate that water cryodeposition has resumed, but at approximately 1/3 the previous rate. The effects of this low rate of ice deposition are being corrected and managed by using the IFC blackbody and models of the spectral response over each detector channel bandpass, as well as anticipated periodic warm-ups of the detector.

On-orbit responsivity calibrations using the IFC blackbody indicated a gradual degradation that was primarily associated with channels 1-3, 5, and 7 during the first 14 weeks. A gradual increase in the ΔT between the detector assembly and miniature pulse tube refrigerator was also observed. These observations
