The Falcon 1 Launch Vehicle: Demonstration Flights, Status, Manifest, and Upgrade Path

AIAA/USU Conference on Small Satellites, 2007 Paper SSC07-III-6

Falcon 1 Introduction

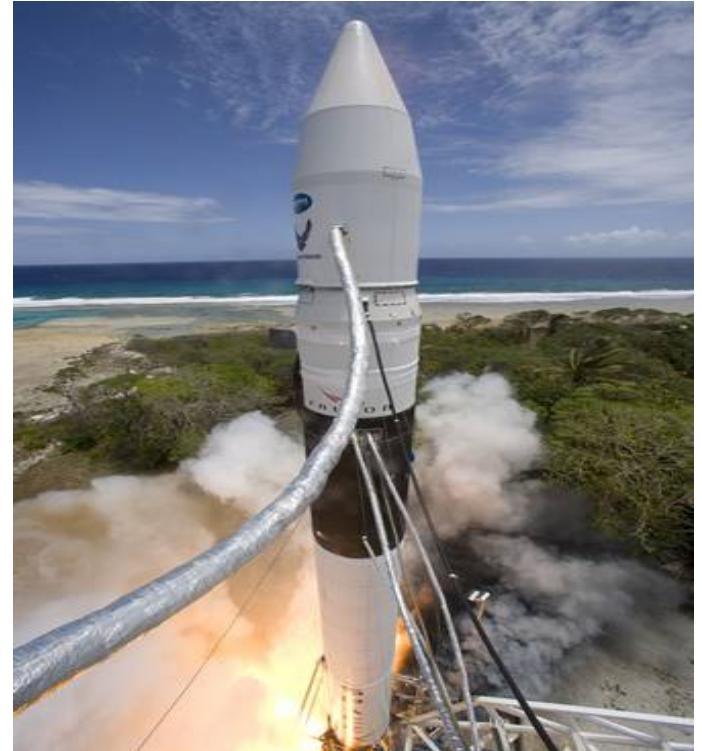
- Payload capability: Over 1500 lbs to LEO (28.5 deg, 200 nm, circular)
- Launch from Vandenberg AFB, and Kwajalein (Reagan Test Site)
- Multiple manifest, multiple orbit
- \$7.0M per launch for single flight contracts. Price includes Range fees.
 - Block upgrade planned to create <u>Enhanced Falcon 1 (F1e)</u> cost will be \$8.5M with availability planned in 2009.
- General Falcon 1 data:
 - Length 68'
 - Diameter 5.5' tapering to 5'
 - 1st Stage LOX/RP1 engine
 - 2nd Stage LOX/RP1 engine
 - 38" diameter payload attach fitting
 - 1.5m diameter fairing
 - 1st Stage Parachute to Water Recovery
 - Additional specifications can be found in the Payload Users Guide at <u>www.spacex.com</u> s

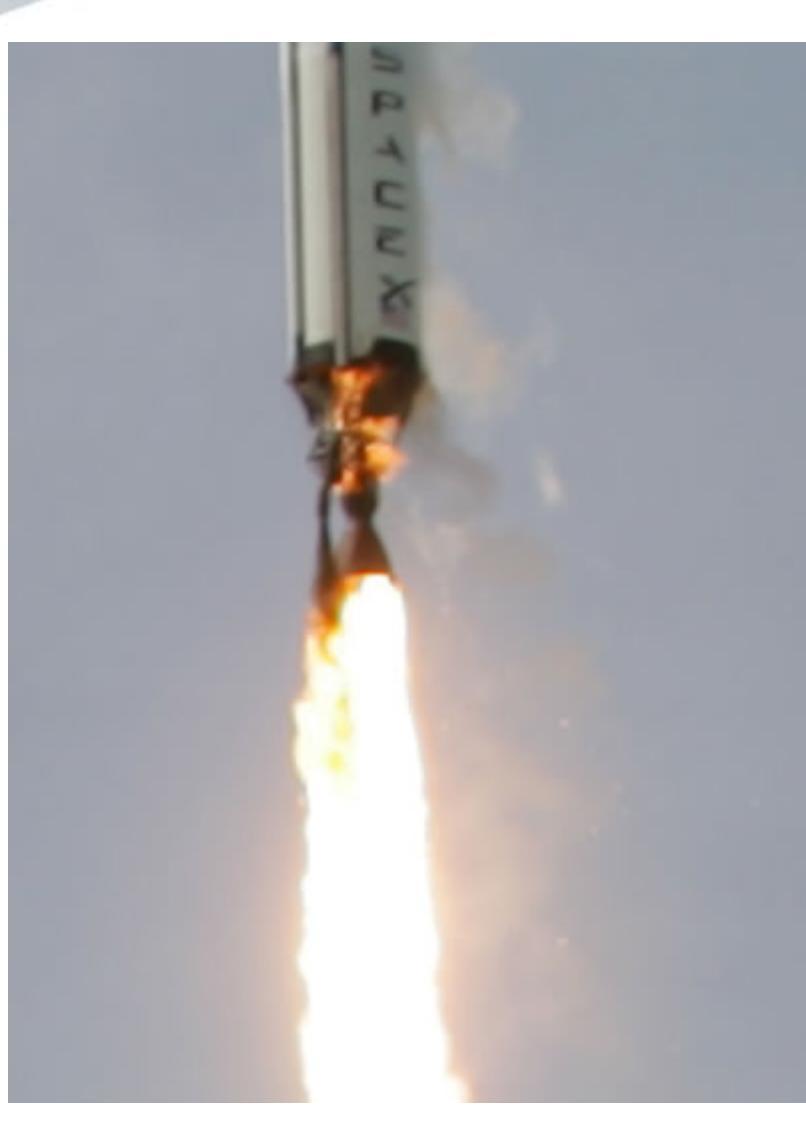
- Fuel leak in the 1st stage engine prior to lift-off caused an engine fire and subsequent loss of thrust at T+34 seconds
- DARPA and SpaceX concluded that the most probable leak cause was due to intergranular cracking of an aluminum alloy B-nut
- SpaceX implemented vehicle design and procedural changes to address identified flight anomalies as well as to improve system robustness and reliability, including:
 - Additional autonomous sensor checks during the countdown and prior to vehicle release
 - Elimination of all aluminum fittings in regions exposed to corrosive environments
 - Fire protection blankets and nitrogen purges in the engine compartments
 - Additional quality control measures employed

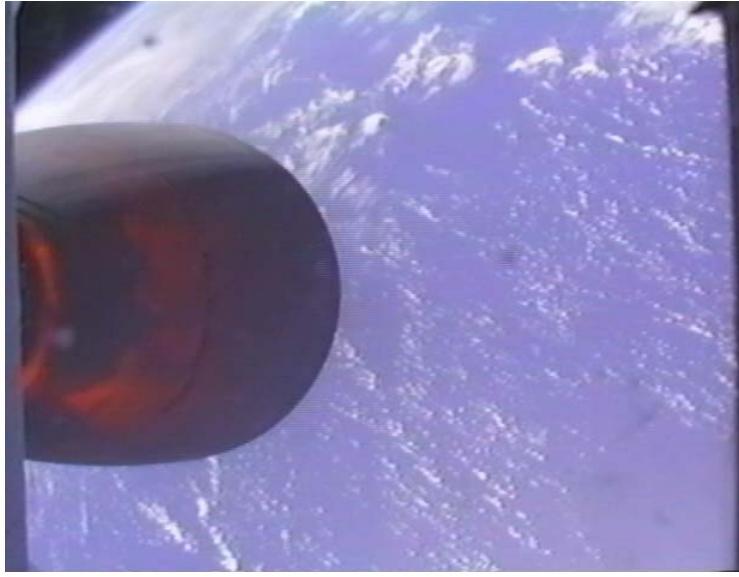
One issue prevented us from getting to orbit

- 2nd stage control issue: slosh
 - Flight data points to an unstable slosh/control system interaction
 - Oscillations began in pitch/yaw axes @ T+265s
 - Coupled into roll axis; exceeded roll control authority @ T+295s
 - Roll rate caused centrifuging of propellants & flame-out @ T+474s
- Additional observations:
 - If we had not centrifuged (i.e. Kestrel continued to burn) we would have achieved orbit within spec. (perigee ~6 km low)
 - Vehicle ground track stayed in center of corridor throughout flight
 - Vehicle IIP stayed <4.5 km from nominal throughout the mission. (i.e. GNC worked well under strenuous conditions)

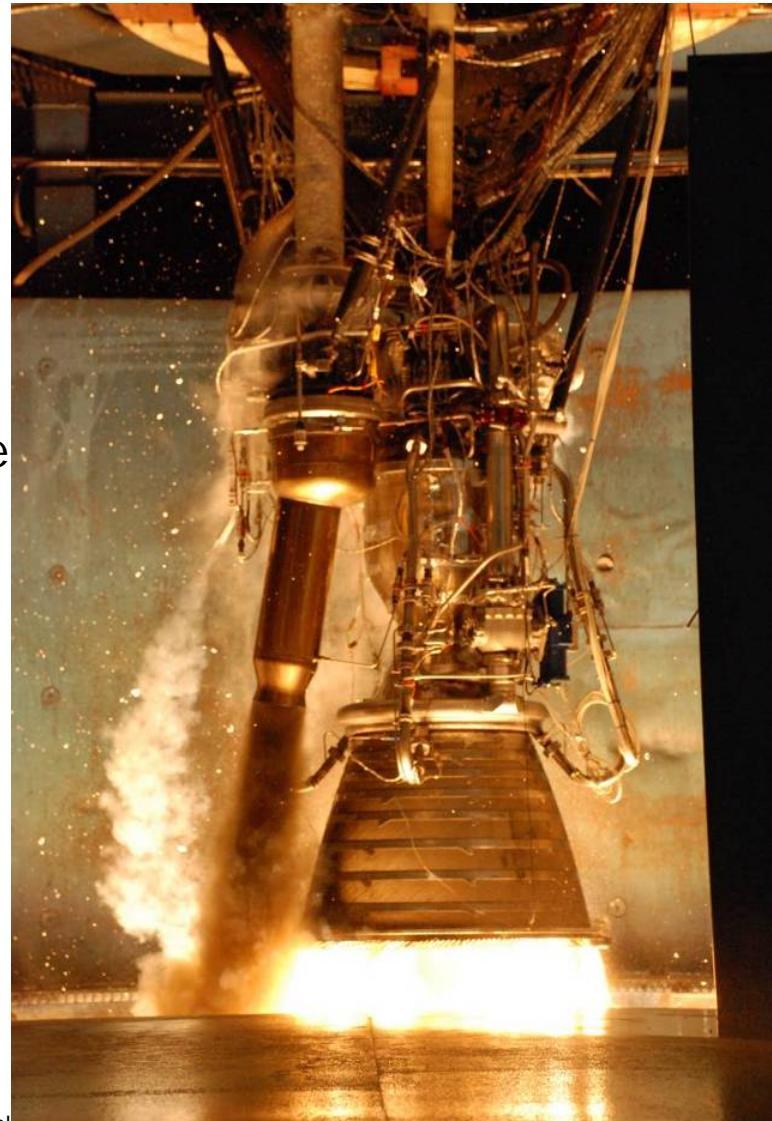
Demo flights

- Merlin 1A ablative engine
- 2219 Aluminum upperstage
- Kestrel-1 upperstage engine
- Skin/stringer fairing
- ~700 pounds to orbit
- Next 3 flights
 - De-tuned Merlin 1C (M1) Regen engine
 - 2014 aluminum upperstage
 - Kestrel-2 upperstage engine
 - Slosh baffles
 - Skin/stringer fairing
 - ~1200 pounds to orbit

Late 2009—Falcon 1e

- Full Merlin 1C (M9) performance
- Longer first stage
- 2198 Aluminum upperstage
- Composite ogive fairing
- ~1800 pounds to orbit

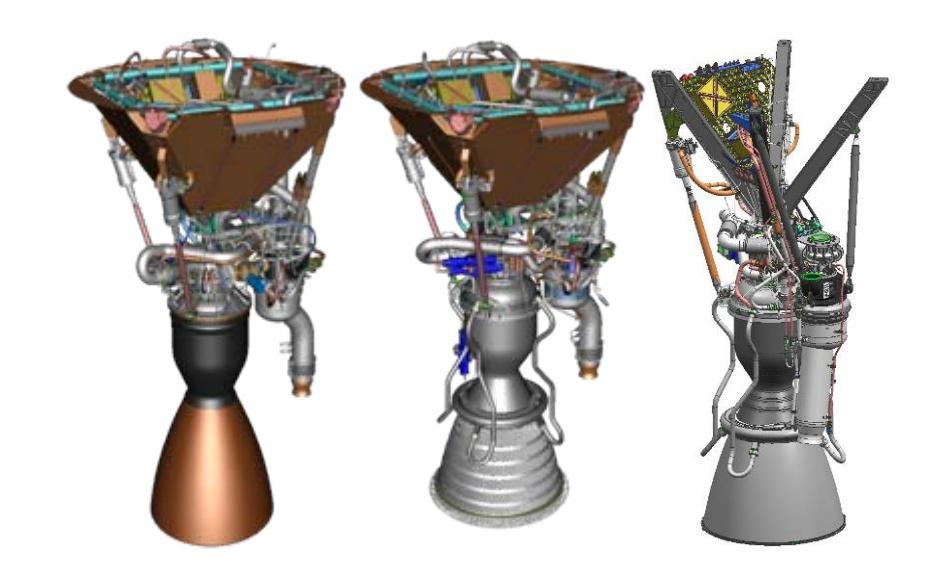
Merlin Engine Upgrade – M1A to M9

Parameter	Merlin 1A	M1 (M1C-F1)	M9 (M1C-F9)
Sea Level Thrust (lbf)	73,000	78,400	92,000
Vacuum Thrust (lbf)	83,000	88,700	105,500
Mixture Ratio (O/F)	2.20	2.20	2.20
Chamber Pressure (psia)	782	825	959
Nozzle Expansion Ratio	14.5	14.5	14.5
Isp Sea Level (sec)	244	256	263
Isp Vacuum (sec)	288.5	302.5	302
Engine Length (ft)	9.5	9.6	9.4
Engine Diameter (ft)	5.5	5.5	4.7

SpaceX Merlin Engine commonality:

- RP1/LOX
- Pintle Injector Geometry
- Pump-fed Gas Generator Cycle
- Turbine Exhaust Roll Control
- Hydraulic TVC
- Possible best-in-class performance

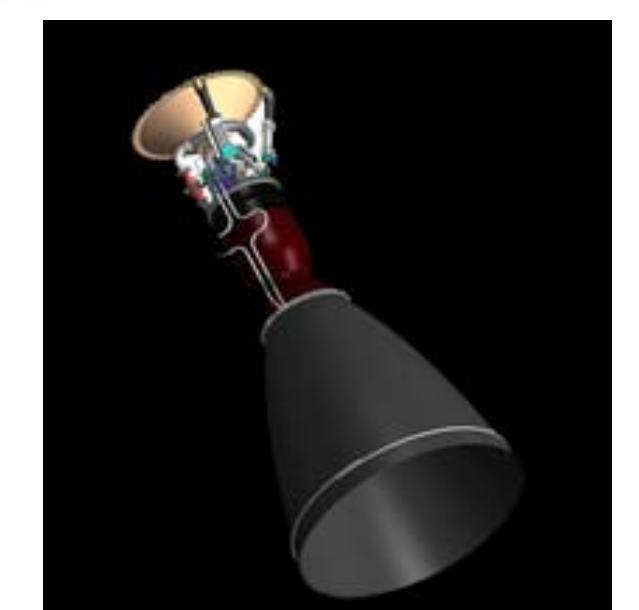
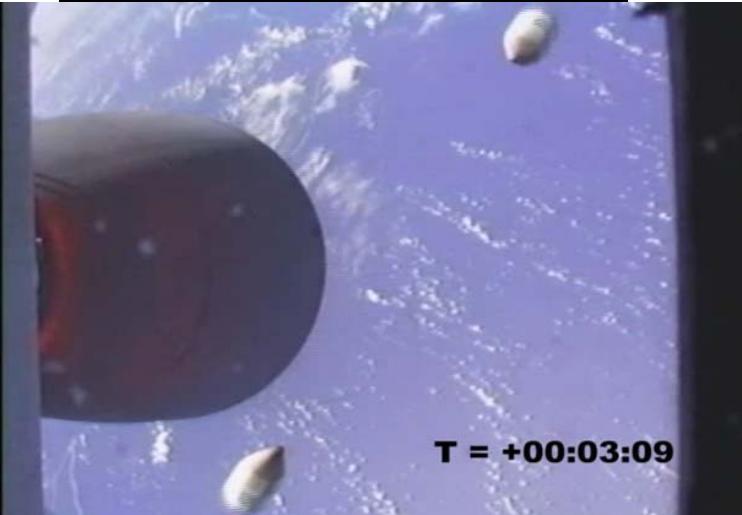
Kestrel Engine Upgrade K1->K2

- Changes made to increase reliability, reduce mass, and increase manufacturability
 - Changes include:
 - New LOX and RP1 main valve design
 - New dome design
 - Thrust structure changed from Titanium to Aluminum
 - Lightweight thrust chamber
 - Mass savings = 25 + 1bs

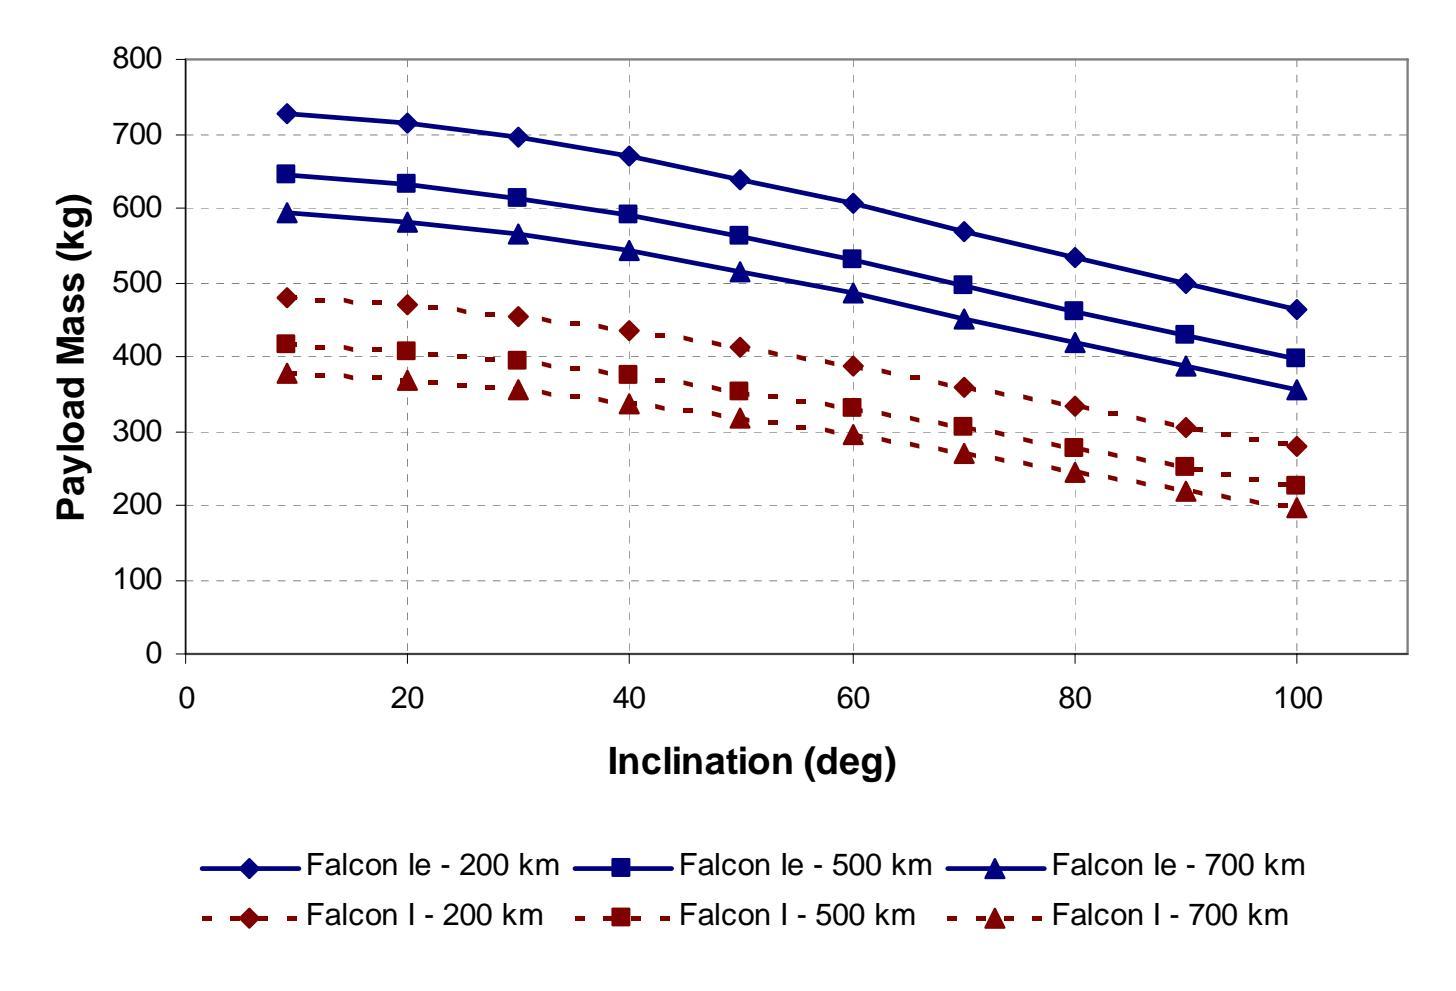
Payload Performance from Kwajalein, Two Burns (Falcon I and Falcon Ie)

Falcon 1 Performance Upgrade

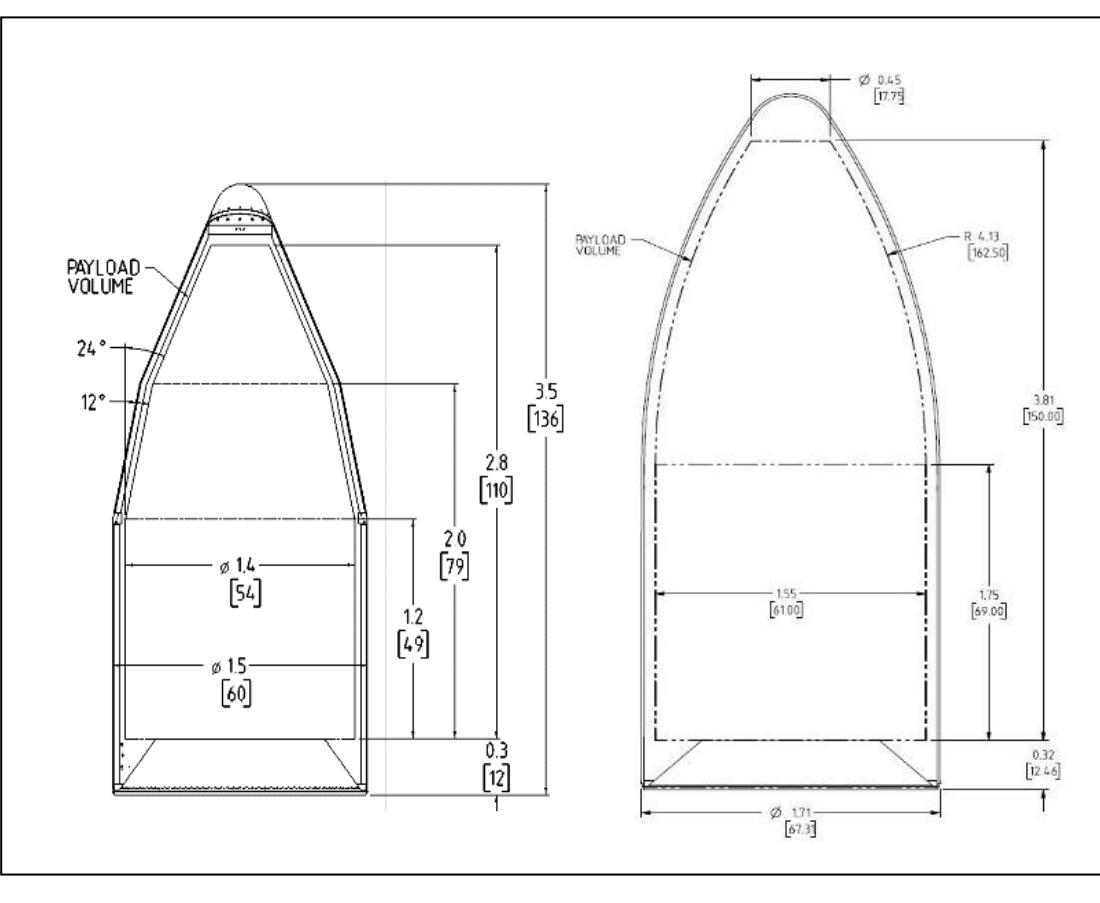
Falcon 1 Fairing Upgrade

- Current F1: Bi-conic aluminum skin & stringer
 - 1.5m diameter
- Future F1e: Composite ogive
 - 1.7m diameter planned
 - Current design is in trade, with final design work planned for Q1 2008
 - Looking for Small Satellite community design input

Current F1 fairing

Notional F1e fairing
