# ASPEN Environmental Consultants, Inc; Report of Tests: Preliminary Evaluation of Three Erosion Control Products

## Report of Tests

### *Preliminary Evaluation of Three Erosion Control Products*

Utah Water Research Laboratory  
Utah State University  
Logan, UT 84322-8200

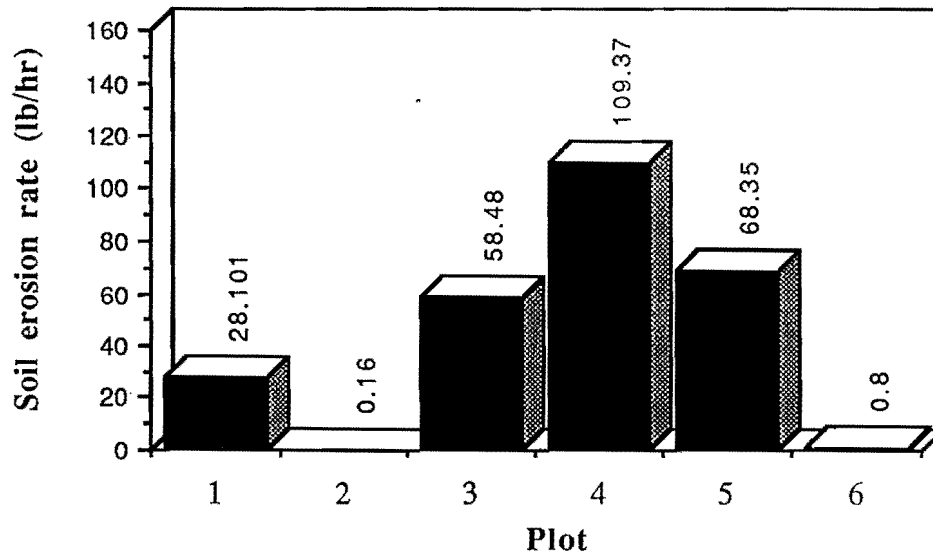
Figure 3. Water runoff and soil erosion rates for the six plots of Test 2.

The water runoff rates for Test 2, presented in Figure 3 and in Table 1, indicate very little difference between the plots. This is because the soil at the start of the rain had a high moisture content

which remained from the first run; therefore, most of the water from the second test ran off.

In Test 2 wherein the same products were used as in Test 1, the values of the erosion rate were similar to, although in general smaller than, those of Test 1. This conclusion is easily reached by comparing the lower parts of Figures 2 and 3. These results indicate that the higher water content of the soil in Test 2 had very little effect on the erosion rates of Test 2 over those of Test 1.
