## ASPEN Environmental Consultants, Inc; Report of Tests: Preliminary Evaluation of Three Erosion Control Products

### *Preliminary Evaluation of Three Erosion Control Products*

Utah Water Research Laboratory  
Utah State University  
Logan, UT 84322-8200

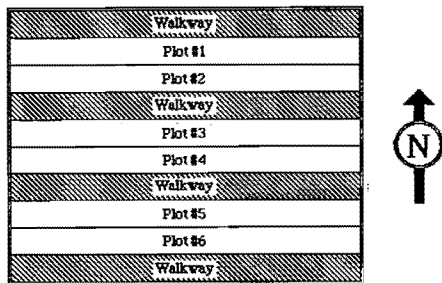
Figure 1. Plot configuration.

Figure 1 shows the plot configuration for all three tests. Water and sediment runoff data are presented in Table 1 for all three tests. Table 2 contains plant data collected from the first test. Figures 2 through 6 are graphical representations of data presented in the tables.

which is covered with a filter cloth through which water can drain. For the Aspen Environmental Consultants tests, the flume was divided into six test plots, each measuring 2 feet by 19.5 feet. There were three sets of two plots each, and the sets were separated from each other and from the side walls by 2-foot wide walkways. The rainfall simulator was arranged so that rain fell upon the plots and not upon the walkways. Runoff from each test plot was collected in a plastic container and weighed. The water was decanted off, and the soil was dried and weighed to determine the amounts of soil and water leaving each plot per unit of time.

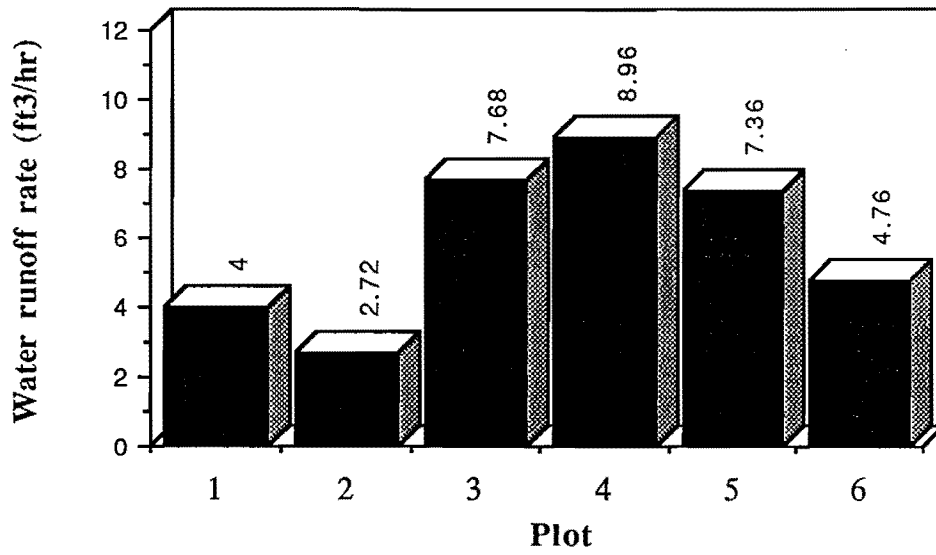
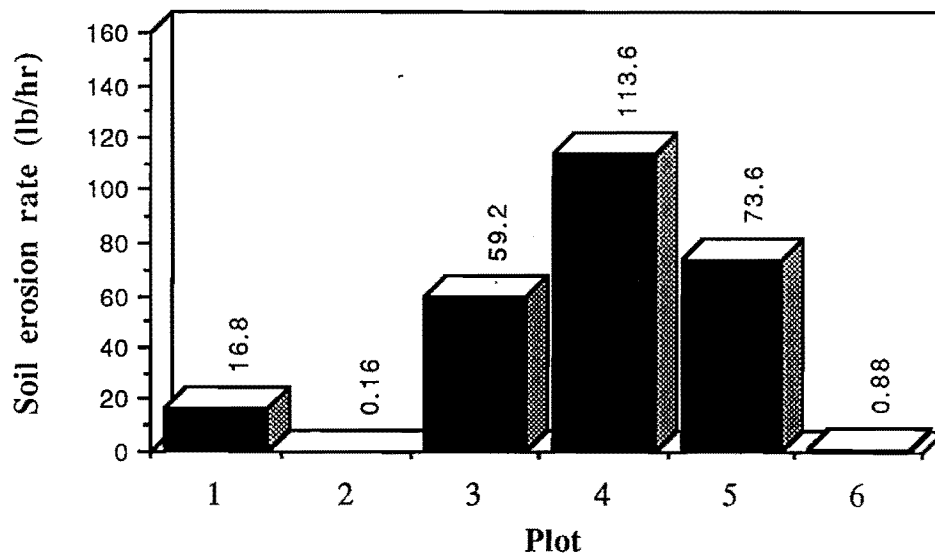
Figure 2. Water runoff and soil erosion rates for the six plots of Test 1.

**Water runoff rate.** The water runoff rates for the six plots of Test 1 are presented in Table 1 and Figure 2. As shown in the tables, the Coconut fiber channel liner (plot #2) had the best retention capacity as the water runoff rate was the smallest of all products tested. The 300 gal/Ac Entac emulsion at 4:1 dilution on plot #1 and the Proseed PS100 mulch blanket on plot #6 had the next best performances. The performance of the 200 gal/Ac Entac emulsion at 7:1 dilution (plot #3) was similar to the two control plots, plots 4 and 5.

**Soil erosion rate.** Soil erosion rates for Tests 1, 2, and 3 are presented in Figures 2, 3, and 4, respectively. They are also listed in Table 1. In Test 1, in terms of erosion protection, the Coconut fiber channel liner (plot #2), and the Proseed PS100 mulch blanket (plot #6) performed better than the two Entac emulsion applications (plots #1 and #3). Their erosion rates were two orders of magnitude smaller than those of the Entac emulsion plots. The Coconut liner and the PS100 mulch blanket performed even better when compared with the bare soil control plots (plots #4 and #5). Their erosion rates were between two and three orders of magnitude smaller than those of the control plots. From the two Entac emulsion applications, plot #1, 300 gal/Ac at 4:1 dilution, performed better than plot #3, 200 gal/Ac at 7:1 dilution. Both applications reduced the erosion rate in comparison with the control plots.

In Test 2 wherein the same products were used as in Test 1, the values of the erosion rate were similar to, although in general smaller than, those of Test 1. This conclusion is easily reached by comparing the lower parts of Figures 2 and 3. These results indicate that the higher water content of the soil in Test 2 had very little effect on the erosion rates of Test 2 over those of Test 1.

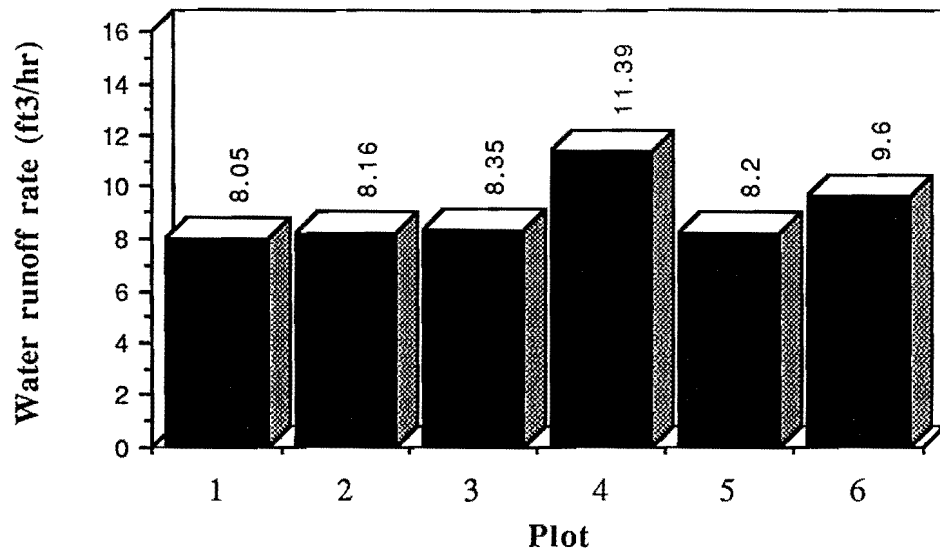
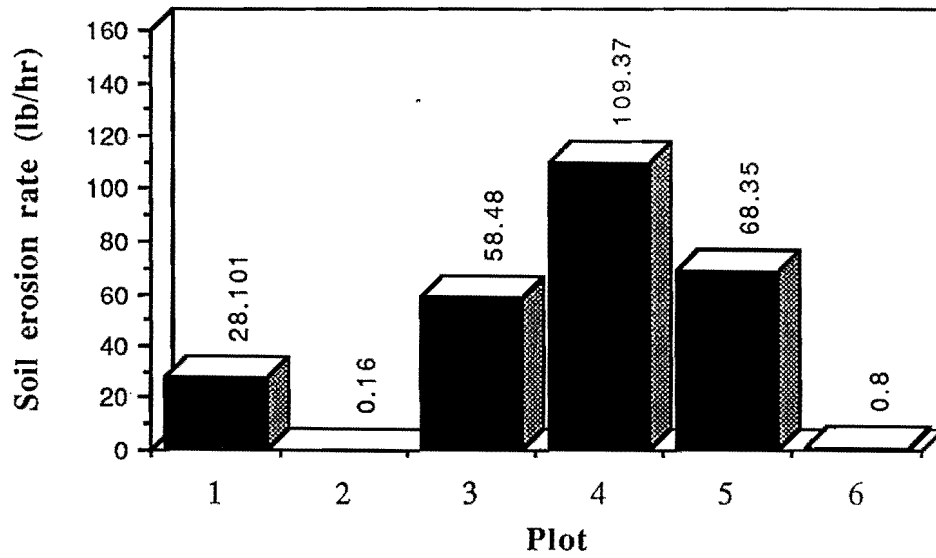
Figure 3. Water runoff and soil erosion rates for the six plots of Test 2.

The water runoff rates for Test 2, presented in Figure 3 and in Table 1, indicate very little difference between the plots. This is because the soil at the start of the rain had a high moisture content

which remained from the first run; therefore, most of the water from the second test ran off.

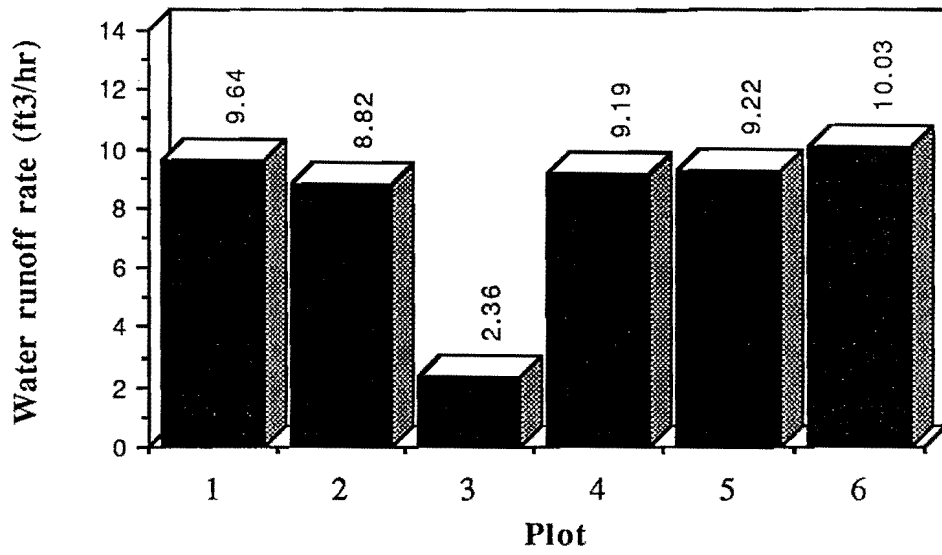
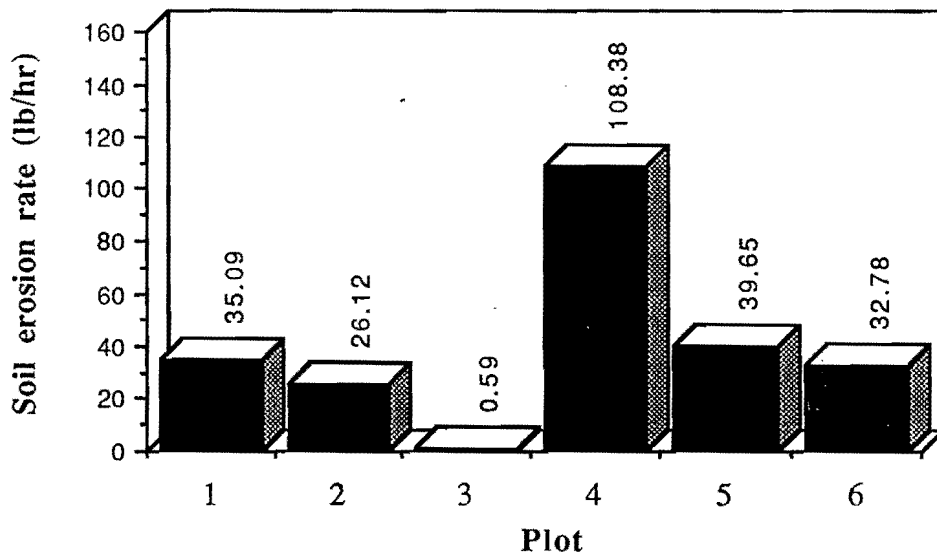
Figure 4. Water runoff and soil erosion rates for the six plots of Test 3.

For Test 3 the soil was drier than at the start of Test 2 but not as dry as at the beginning of Test 1. The water runoff rates for this test are shown in Figure 4 and Table 1. The best performance in water retention occurred for plot #3 which was covered with straw and a straight Entac emulsion. This combination was able to absorb and retain a good percentage of the total water applied so that very little runoff occurred as compared to the other plots. All other applications performed equally among themselves retaining water in comparable amounts to that of the control plot (plot #4). The runoff rates for all plots, excluding plot 3, are similar to those obtained in Test 2, indicating a considerable amount of moisture in the soil at the beginning of the test.

The results of erosion control for Test 3 indicate that the combination of straw with a straight Entac emulsion (plot #3) gave the best performance in terms of erosion protection. The erosion rate of plot #3 was two orders of magnitude smaller than were the rates of the other Entac emulsion applications (plots #1, 2, 5, and 6), and three orders of magnitude smaller than the bare soil control plot. Erosion rates for the four different Entac emulsion applications were very similar in magnitude. However the best rate resulted in plot #2, which had 300 gal/Ac Entac emulsion at 4:1 dilution followed by a second application of 300 gal/Ac Entac emulsion at 2:1 dilution. The erosion rates for all the Entac emulsion applications

were in the order of three times smaller than the erosion rate of the control plot.

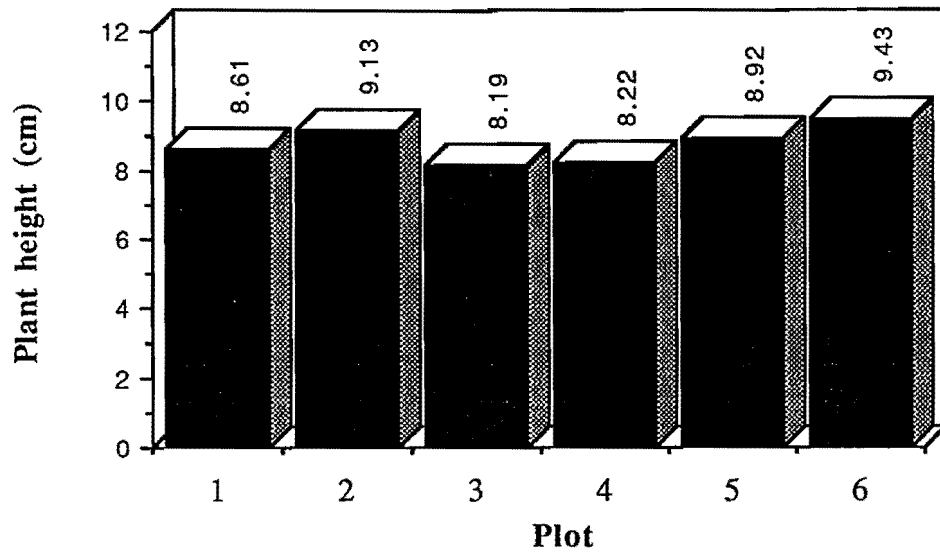
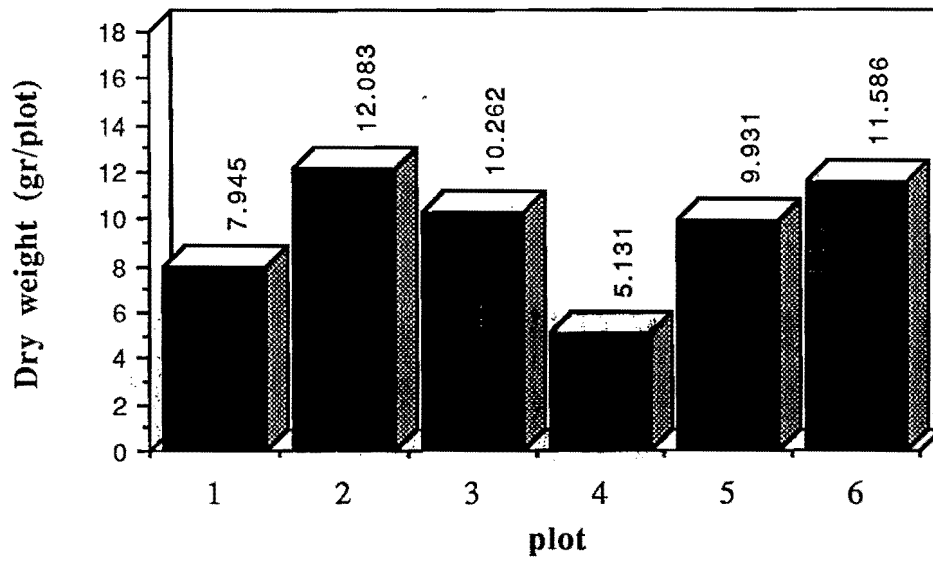
Figure 5. Plant height and dry weight data for the six plots of Test 1.

**Plant data.** Plant data were collected only for Test 1; these results are presented in Table 2. The top part of Figure 5 shows the average plant heights for all six plots. It is evident that no significant difference in plant heights existed among the different plots. This indicated that none of the erosion control methods tested had an effect on plant height. However, this test served to demonstrate that plants can grow through the Coconut fiber channel liner and through the Proseed PS100 mulch blanket.

The bottom part of Figure 5 indicates some effect of the erosion control treatments on the dry weight of plants per plot. Both the Coconut fiber channel liner (plot #2) and the Proseed PS100 mulch blanket (plot #6) produced a higher dry weight of plants per plot than did the control plots (plots #4 and #5) or the two Entac emulsion applications (plots #1 and #3). The relatively high yield in dry weight per plot of plots #2 and #6 can be attributed to the fact that they contained the highest percentage of germinating seeds, as indicated in Figure 6. The dry weight per plot for plots #1 and #3, both with Entac emulsions, were higher than control plot #4 but comparable to that of control plot #5. Again, the higher percentage of germinating seed seem to be the cause of the greater dry weight per plot. The evidence is inconclusive regarding beneficial effects of the Entac emulsion on dry weight of plants per plot.

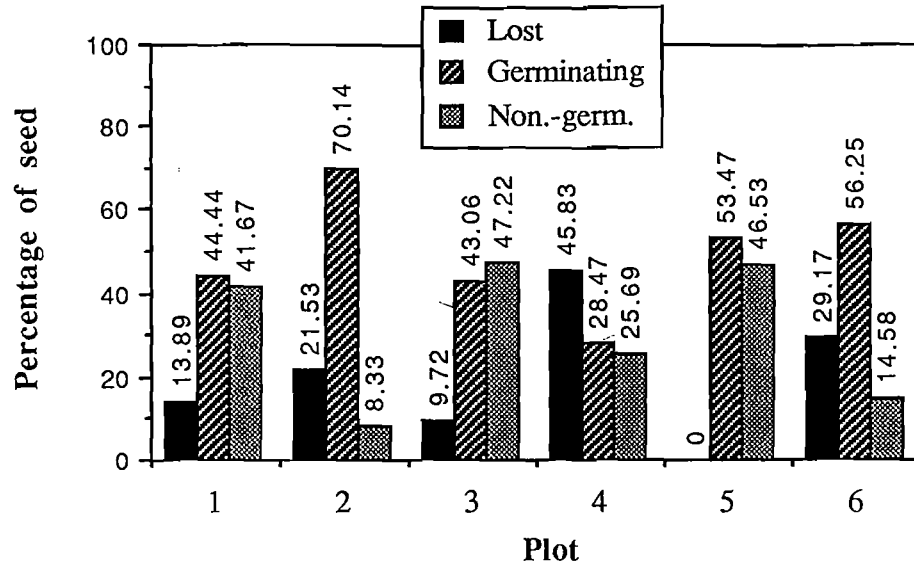
Figure 6. Percentage of seed lost, germinating and non-germinating for the six plots of Test 1.

In terms of percentages of seed lost, germinating and non-germinating, the results are presented graphically in Figure 6. The best performance in germinating seed was that of the Coconut fiber channel liner (plot #2), followed by that of the Proseed PS100 mulch blanket (plot #6). However, the latter was only slightly better than con-

trol plot #5. Strangely enough, control plot #4 lost only about half as many seeds as did control plot #5. For the two Entac emulsion plots (plots #1 and #3), the percentage of germinating seed is similar in magnitude, smaller than the other two treatments, and in between the results of the two control plots.

The large discrepancy in seed percentage data between control plots #4 and #5 may lead to unrealistic results. Control plot #5 indicates no seeds lost, which we know is not so. This result came about because the total number of plants and non-germinating seeds from the three samples taken in that plot was equal to the estimated number of seeds applied. The sample areas had an over-supply of seeds resulting in the unrealistic high count. Therefore, the data of control plot #5 in terms of seed percentages should be disregarded, and all other data compared to those of plot #4 only. If that is the case, then the performances of the Coconut liner, the mulch blanket, and the two Entac emulsion applications are definitively better than the performance of control plot #5 in terms of the percentage of seed retained and germinating.
