# Evaluation of Selected Mulches and Specialty Erosion Control Products Under Simlated Rain

Final Report

**UTAH WATER RESEARCH LABORATORY**

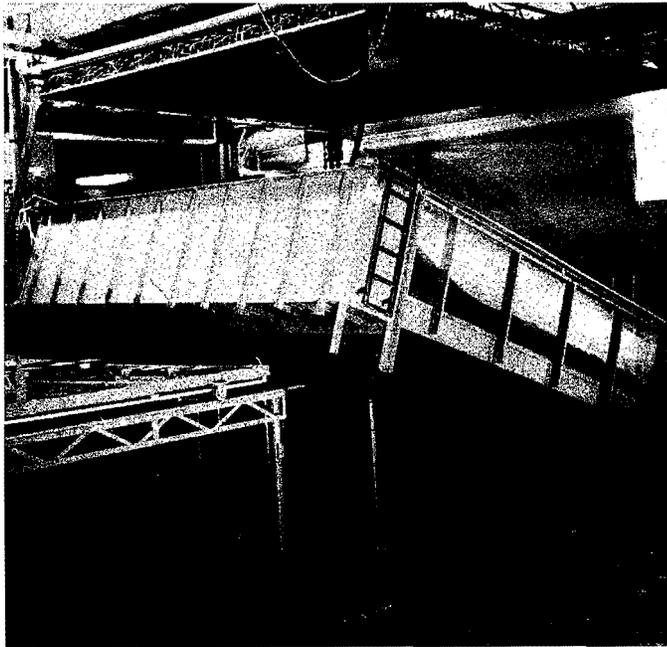
The flume can be tilted hydraulically to any slope up to  $43^\circ$  from horizontal. Figure 1 shows the rainfall simulator in position over the tilting flume.

Figure 1. Rainfall simulator and tilting flume.

Approximately 1-foot depth of soil is supported in the tilting flume by a metal grating covered with filter cloth through which water can drain. The flume is divided into three test plots, each measuring approximately 4 feet by 19.5 feet. These plots are separated from each other and from the side walls of the flume by 2-foot wide buffer strips. Runoff from each test plot is captured in a plastic tub, then is dried and weighed for determining the exact amount of mulch and soil leaving the plot.

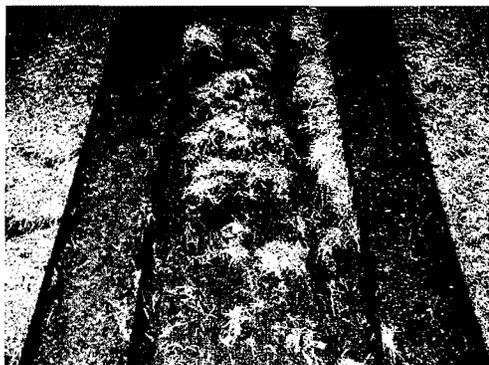
1. Conwed netting over straw.  
Center plot failed after 1-hour  
of rain at 8-inches per hour.

d) After 1 hour of running time the straw and sediment to a depth of 4 to 5 inches slid beneath the netting in the center plot. Staples in the lower half of the plot were pulled out by the slide, but staples on the top half of the slope kept the net from sliding.

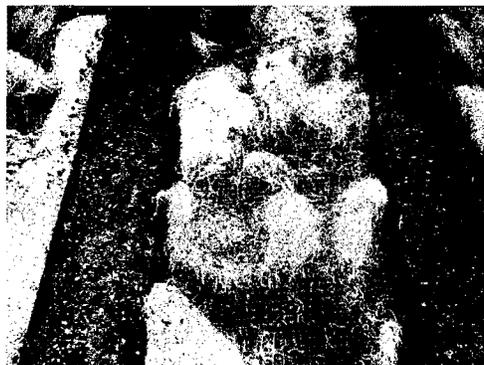
2. American Excelsior Blanket  
over compacted soil after 1-  
hour of rain at 8-inches per  
hour.

a) When wood fibers and ground surface became saturated, fibers and soil slid downslope beneath the netting, forming dams at each staple. As water continued to run, it flooded over dams in some places and went around them in others, eventually developing rills, then gullies.

b) All three slopes exhibited partial failure within 10 minutes of running time, allowing fibers and soil to slide downslope. The center slope failed again about 7 minutes later and the material slid further downslope, lodging against staples at the lower end of the blanket.
