Minimizing Risk Associated with Imaging Payloads: Lessons Learned from a CCD Experiment Gone Awry[^]

***Todd W. Goforth, +Scott R. Cannon**

*Maxwell Technologies, Alb., NM. gofortht@maxwell.com

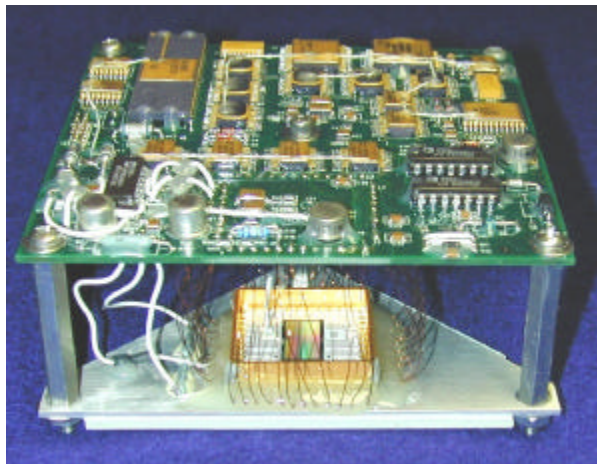
Figure 1. Top View of the CCD Experiment Board

This experiment is intended to operate as a sort of flying laboratory bench, with a charge coupled device as the central Device Under Test (DUT). The experiment board was designed to contain all of the hardware and software necessary to stimulate and exercise the DUT to produce enough data to properly characterize its performance. The flight circuit board is shown in figures 1 and 2, and each functional section of the board is described in the paragraphs that follow.

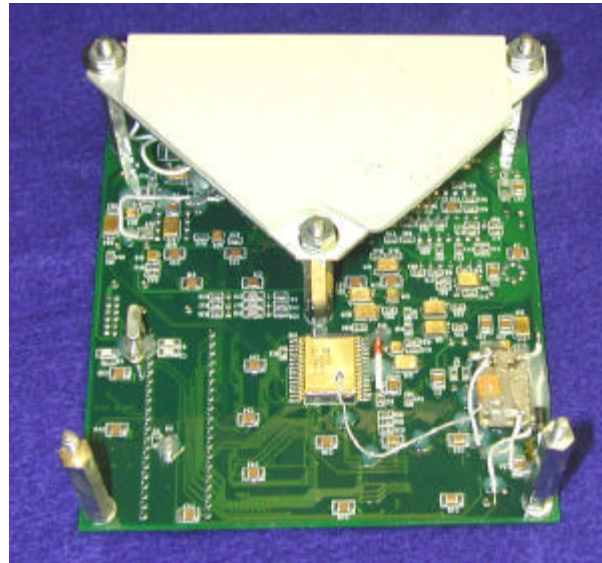
Figure 2. Bottom View of the CCD Experiment Board

The light sources were mounted on the underside of the experiment board, directly above the DUT (refer to figure 2). Although the use of these light sources appeared to be very straight forward during the early stages of the design effort, they would later present various problems which are discussed in another section of this paper.

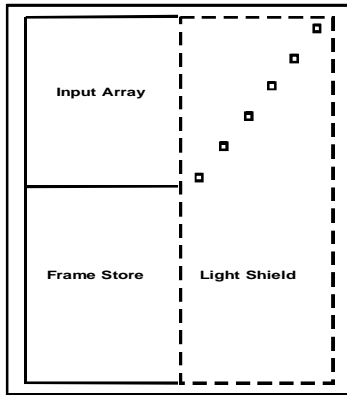
Figure 3. Block Diagram of the CCID-22

The DUT used on this experiment is the CCID-22. This device is manufactured by MIT Lincoln Labs. The CCID-22 is a 516x512 array containing both an imaging array and a frame store array. The block diagram for this part is shown in Figure 3. The CCID-22 that was used for the development of this experiment included a light shield that covered all of the pixels except for six small windows of 3 x 3 pixels.

In operation, the Input Array (IA) is clocked one line at a time into the Frame Store (FS), which is clocked to the serial output register. The serial output register is then clocked to transfer the data to the output. The CCID-22 has duplicated connections to facilitate operation of both a left (L) and right (R) side.

In addition to the right and left side inputs, there are also two outputs, one for each side. In normal operation, all of the pixel signals from one side of the array go out one output, while the other half go out the other. However, it is also possible to change the clocking scheme so that all of the pixel signals go out only one output. This is the operating mode that was selected for use on this experiment.

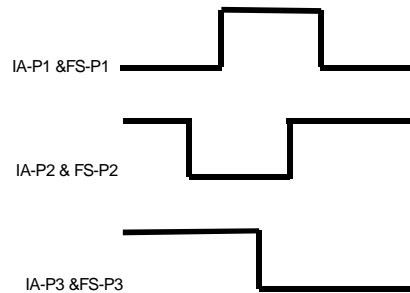
Figure 4. Diagram of Parallel Timing Waveforms

Since the clocking for the input and frame store arrays are independent, the CCID-22 can be operated in several ways. The simplest, which is the clocking scheme used for the STRV-1d experiment board, is to use identical clocking for both arrays. This simultaneously shifts the entire array of pixels, both the input and frame store arrays, down by one line per clock cycle. Figure 4 depicts the relative timing of the three signals used for the parallel clocking of this part.

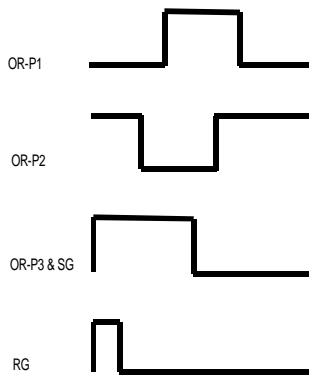
Figure 5. Diagram of Serial Timing Waveforms

Three clock sequences are required before the first signal associated with the first illuminated pixel appears at the output. In addition to the three clock sequences needed for a CCD transfer, the serial clocking also requires the Read Gate (RG) to be clocked. This clock is involved in transferring the charge between the CCD structure and the output stage. The relative timing of the various serial clocks is shown in Figure 5.

Note that these clock patterns are what would be used if it were desired to clock data out through *two* outputs. In order to send all of the data out one output, as was done on this experiment board, the P1 and P2 clocks were switched. Therefore, to send all of the pixel data out of the left output, P1-OR-R was fed the OR-P2 signal shown above, and P2-OR-R was fed the OR-P1 signal shown above. The OR-P3 and RG signals remain the same for both inputs.

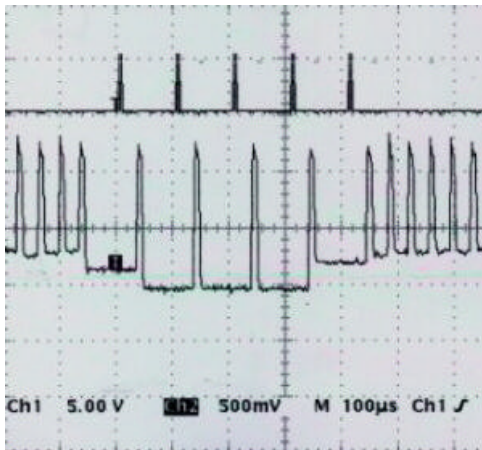
Figure 6. Oscilloscope Screen Image Showing a Typical Response for one Row of Pixels in one Window (Lower Trace) .

When properly adjusted, and in a controlled environment, the DUT response was very clear and very measurable. Figure 6 shows the response of a particular row of pixels in a particular window. The response of the pixels at either end of the window is weaker due to the edges of the light shield casting shadows on them.

proper operation (refer to figures 6 and 7), and the board was again readied for vibration testing. In order to prevent a repeat of the previous failure a bead of staking compound was used around the entire bottom edge of the DUT (this can be seen in figure 1). Although we had previously determined that using staking compound on the DUT would inhibit thermal transfer, at this point we had no choice but to use it. The ends of the manganin wires were also staked at the printed circuit board and at the DUT.

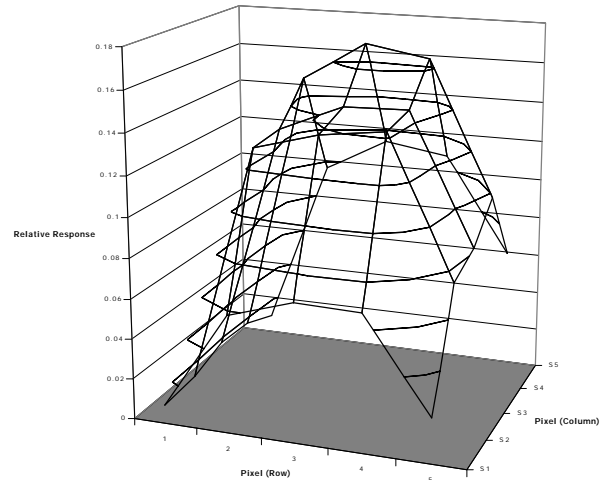
Figure 7. Relative Response for a typical Window of Pixels

A three-dimensional plot of the relative response for an entire window that is properly illuminated is shown in figure 7.

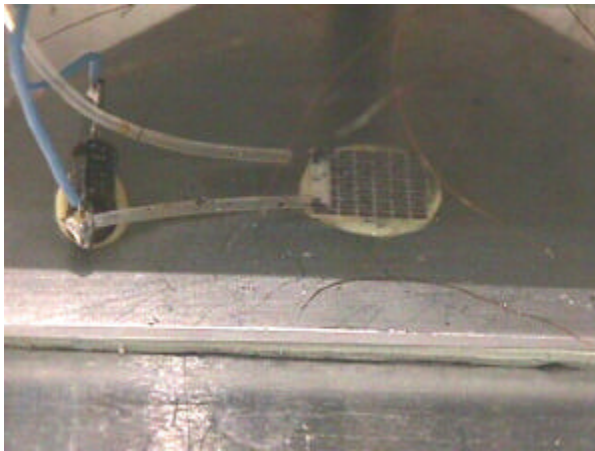
Figure 8. Image of Thermo-Electric Cooler Mechanical Failure

During the next attempt to vibration test the experiment more serious problems were encountered. During the random vibration portion of the testing the TEC structure failed. This failure caused the DUT to become completely detached from experiment. Figure 8 shows the bottom portion of the TEC still bonded to the aluminum heat sink, but the top of the TEC and the DUT have broken loose. This failure resulted in the complete destruction of the CCID-22. By the time a replacement part was procured the project had suffered a major slip in the delivery schedule.

With the new staking in place the experiment passed the vibration testing, and all other environmental qualification tests that were required.
