Minimizing Risk Associated with Imaging Payloads: Lessons Learned from a CCD Experiment Gone Awry[^]

ABSTRACT. The number of uses for imaging devices in space is rapidly increasing. To evaluate suitability for space-based surveillance and star tracker operation, an experimental payload was developed based on an experimental Charge Coupled imaging Device (CCD). This payload was to have flown on the small STRV-1d satellite (a joint US and British program) to collect data during 600+ minute highly elliptical orbits. These orbits were intended to expose the CCD to high radiation levels and possibly significant solar flare events. The main objective of the experiment was to measure the degradation of the Charge Transfer Efficiency (CTE) of the device, and to characterize its overall performance in an orbit that would provide a significant radiation threat. Due to the inherent complexities and fragility of experimental CCD devices, many hardware and software obstacles were encountered and many lessons were learned. Vibration and environmental testing issues were of particular significance. By underestimating the difficulty of mechanical mounting, cooling, software operation and clocking

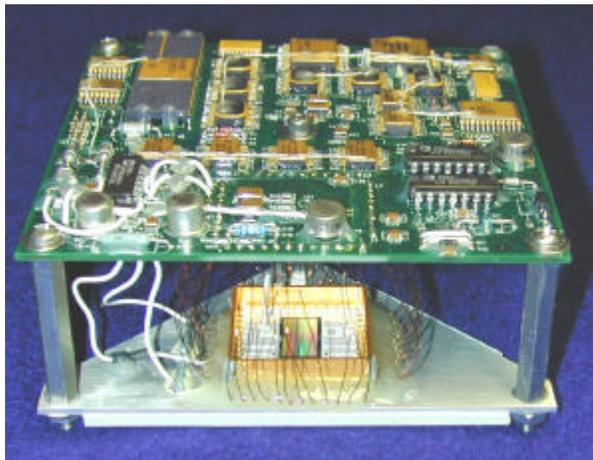
Figure 1. Top View of the CCD Experiment Board

This experiment is intended to operate as a sort of flying laboratory bench, with a charge coupled device as the central Device Under Test (DUT). The experiment board was designed to contain all of the hardware and software necessary to stimulate and exercise the DUT to produce enough data to properly characterize its performance. The flight circuit board is shown in figures 1 and 2, and each functional section of the board is described in the paragraphs that follow.

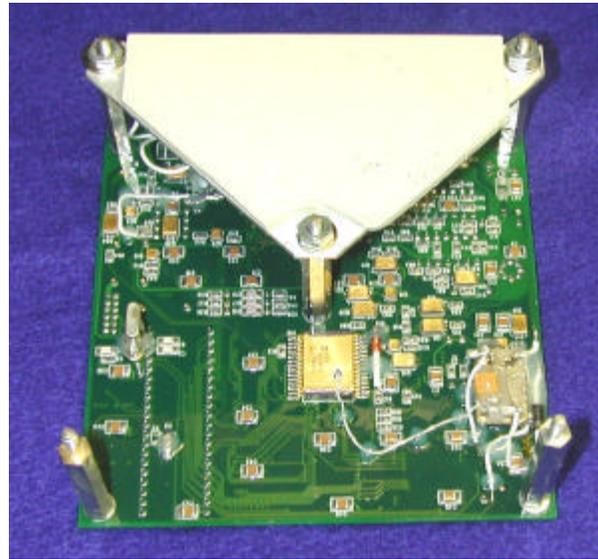
Figure 2. Bottom View of the CCD Experiment Board

The light sources were mounted on the underside of the experiment board, directly above the DUT (refer to figure 2). Although the use of these light sources appeared to be very straight forward during the early stages of the design effort, they would later present various problems which are discussed in another section of this paper.

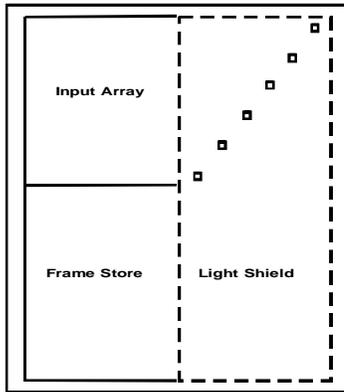
Figure 3. Block Diagram of the CCID-22

The DUT used on this experiment is the CCID-22. This device is manufactured by MIT Lincoln Labs. The CCID-22 is a 516x512 array containing both an imaging array and a frame store array. The block diagram for this part is shown in Figure 3. The CCID-22 that was used for the development of this experiment included a light shield that covered all of the pixels except for six small windows of 3 x 3 pixels.

In operation, the Input Array (IA) is clocked one line at a time into the Frame Store (FS), which is clocked to the serial output register. The serial output register is then clocked to transfer the data to the output. The CCID-22 has duplicated connections to facilitate operation of both a left (L) and right (R) side.

In addition to the right and left side inputs, there are also two outputs, one for each side. In normal operation, all of the pixel signals from one side of the array go out one output, while the other half go out the other. However, it is also possible to change the clocking scheme so that all of the pixel signals go out only one output. This is the operating mode that was selected for use on this experiment.

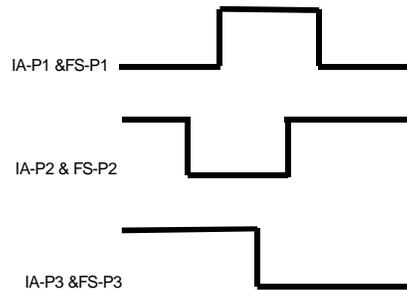
Figure 4. Diagram of Parallel Timing Waveforms

Since the clocking for the input and frame store arrays are independent, the CCID-22 can be operated in several ways. The simplest, which is the clocking scheme used for the STRV-1d experiment board, is to use identical clocking for both arrays. This simultaneously shifts the entire array of pixels, both the input and frame store arrays, down by one line per clock cycle. Figure 4 depicts the relative timing of the three signals used for the parallel clocking of this part.

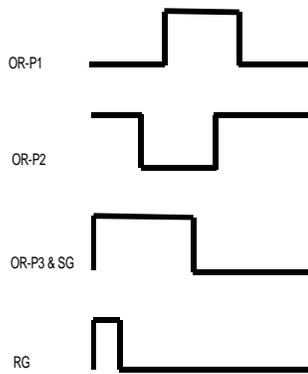
Figure 5. Diagram of Serial Timing Waveforms

Three clock sequences are required before the first signal associated with the first illuminated pixel appears at the output. In addition to the three clock sequences needed for a CCD transfer, the serial clocking also requires the Read Gate (RG) to be clocked. This clock is involved in transferring the charge between the CCD structure and the output stage. The relative timing of the various serial clocks is shown in Figure 5.

Note that these clock patterns are what would be used if it were desired to clock data out through *two* outputs. In order to send all of the data out one output, as was done on this experiment board, the P1 and P2 clocks were switched. Therefore, to send all of the pixel data out of the left output, P1-OR-R was fed the OR-P2 signal shown above, and P2-OR-R was fed the OR-P1 signal shown above. The OR-P3 and RG signals remain the same for both inputs.

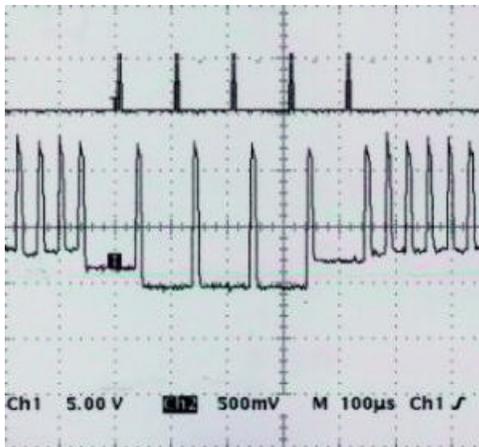
Figure 6. Oscilloscope Screen Image Showing a Typical Response for one Row of Pixels in one Window (Lower Trace) .

When properly adjusted, and in a controlled environment, the DUT response was very clear and very measurable. Figure 6 shows the response of a particular row of pixels in a particular window. The response of the pixels at either end of the window is weaker due to the edges of the light shield casting shadows on them.

proper operation (refer to figures 6 and 7), and the board was again readied for vibration testing. In order to prevent a repeat of the previous failure a bead of staking compound was used around the entire bottom edge of the DUT (this can be seen in figure 1). Although we had previously determined that using staking compound on the DUT would inhibit thermal transfer, at this point we had no choice but to use it. The ends of the manganin wires were also staked at the printed circuit board and at the DUT.

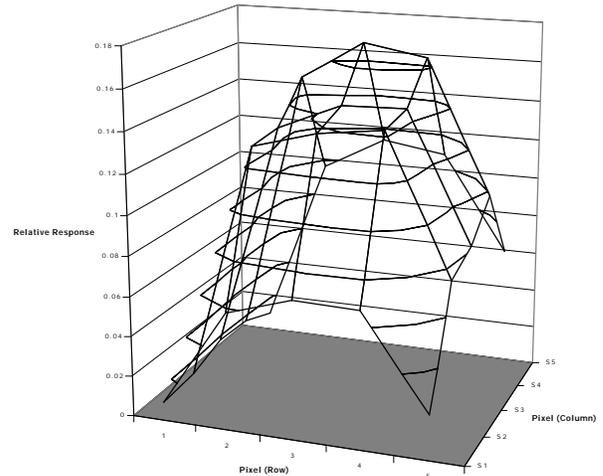
Figure 7. Relative Response for a typical Window of Pixels

A three-dimensional plot of the relative response for an entire window that is properly illuminated is shown in figure 7.

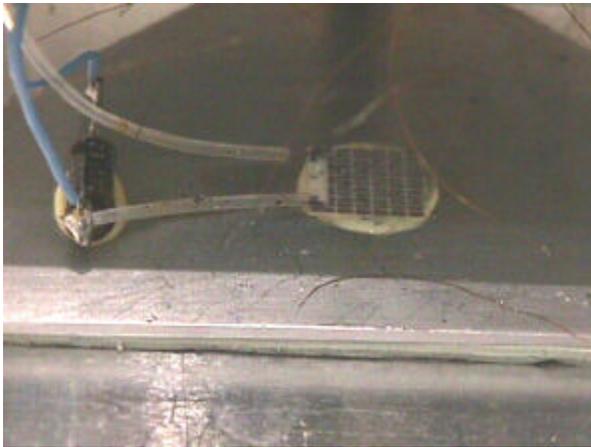
Figure 8. Image of Thermo-Electric Cooler Mechanical Failure

During the next attempt to vibration test the experiment more serious problems were encountered. During the random vibration portion of the testing the TEC structure failed. This failure caused the DUT to become completely detached from experiment. Figure 8 shows the bottom portion of the TEC still bonded to the aluminum heat sink, but the top of the TEC and the DUT have broken loose. This failure resulted in the complete destruction of the CCID-22. By the time a replacement part was procured the project had suffered a major slip in the delivery schedule.

With the new staking in place the experiment passed the vibration testing, and all other environmental qualification tests that were required.
