Simulation of UV Radiation Degradation of Polymers on MISSE-6 in the Low Earth Orbit Environment

Degradation of Space Polymers: A Case Study

Department of Physics
4900 Project
Research Mentor: J.R. Dennison
April 2015

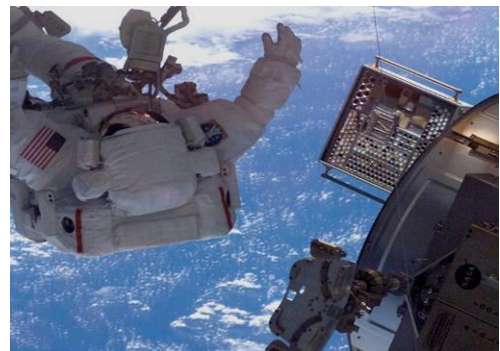
Figure 1 MISSE-6 on ISS.

Materials International Space Station Experiment 6 (MISSE-6) was a NASA funded project that began in 2007 to test varying effects on materials whilst exposed to the space environment. This collaborative effort brought various universities, aerospace companies, and government organizations together to expose samples to the space environment in order to characterize the degradation of materials used in space component design (2). Samples of various materials used in space-component design were flown on MISSE-6 and spent 18 months suspended from the Columbus Space Laboratory, off the side of the International Space Station (ISS) see Figure 1.

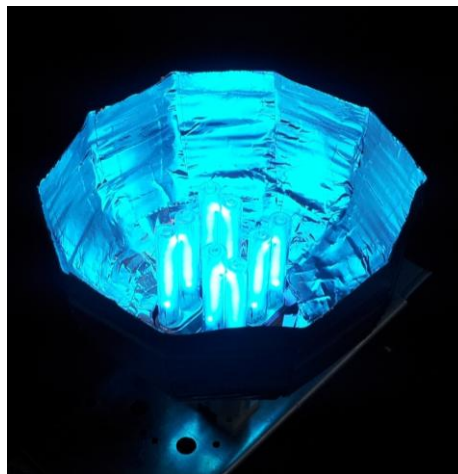
Figure 10, (top right) The light array is an image of the deuterium lamp configuration that allows for uniform light

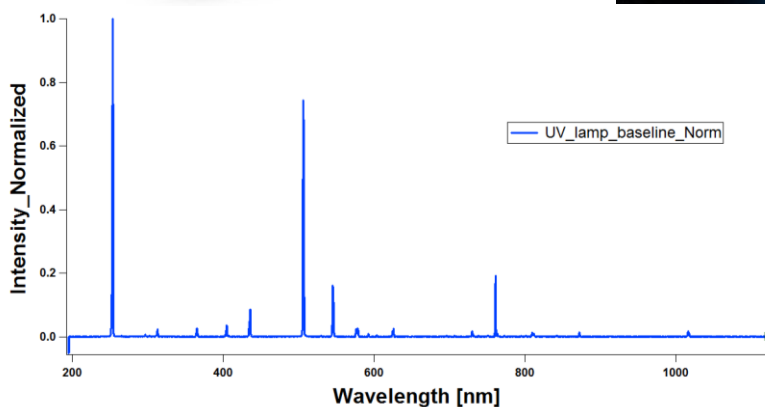
Figure 11, (bottom left) Wavelength spectra of the UV/deuterium lamp configuration, pictured above. Note the intense peak at 250 nm, right in the range of UV spectrum of UV in vacuum.

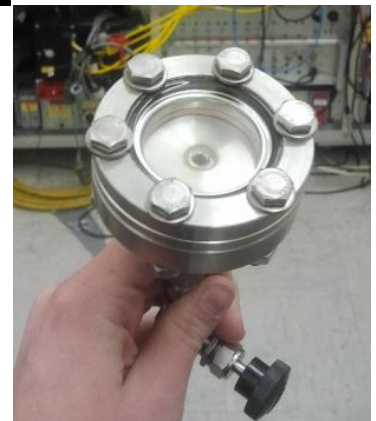
Figure 12, (bottom right) Mini vacuum chambers were assembled to house the samples during the UV

UV light. To most accurately represent the space environment the Mylar™ samples were placed under vacuum for the duration of their exposure.

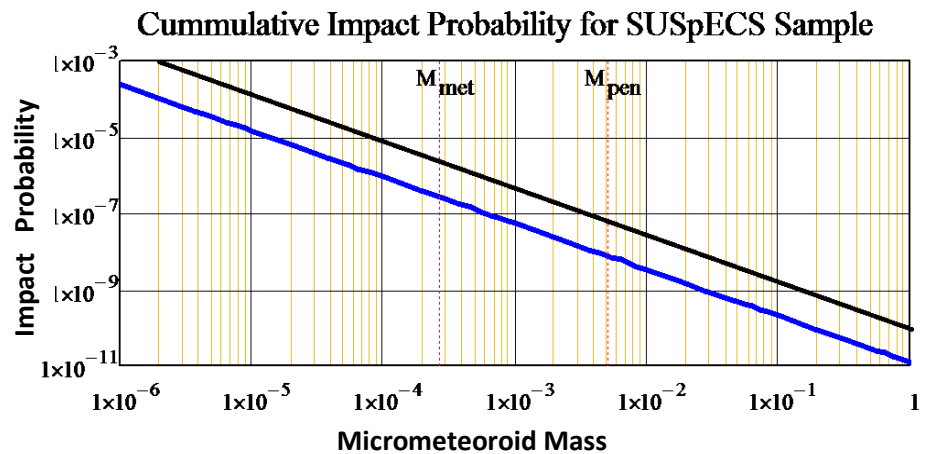
Figure 14, (right) Impact probability of a micrometeoroid striking a SUSpECS sample and penetrating through a SUSpECS sample.

As is notably visible in figure 13, the Mylar™ sample was struck by space debris while suspended from the ISS. In order to analyze the impact two assumptions were made; first that the impacting object was roughly spherical and second that it was comprised of astroidal debris rather than cometary. Through calculations of the velocity of ISS and in turn the kinetic energy of the micrometeoroid calculations of the mass of micrometeoroid were made, see table (14). It was found to be an approximate 182 Million to 1 chance that this particular sample was struck.
